Observation Report

Project: PSD: Kamiak Elementary School

Date: January 18, 2018

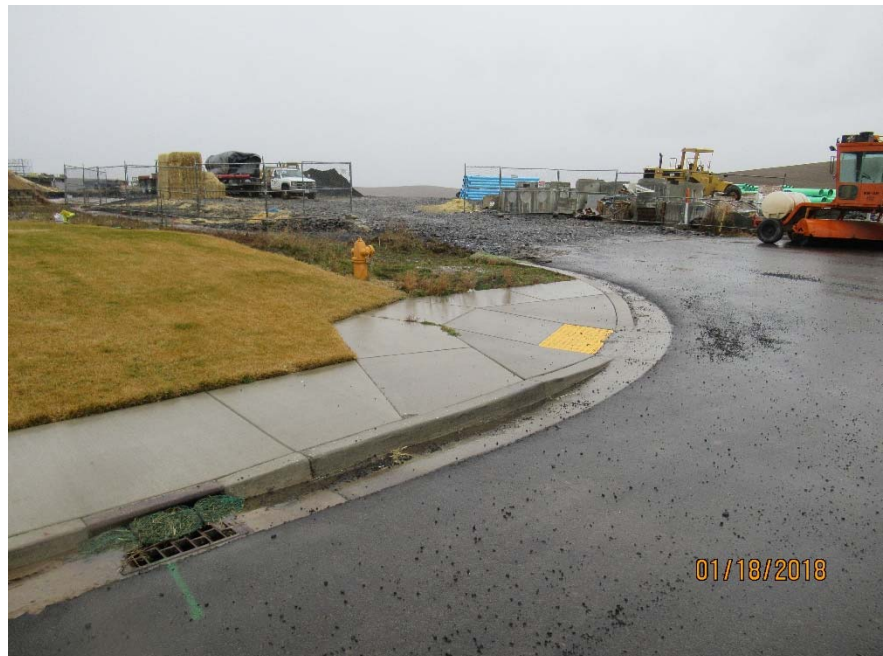
1. Appears the contractor has placed a fence and gate at temporary road entrance.

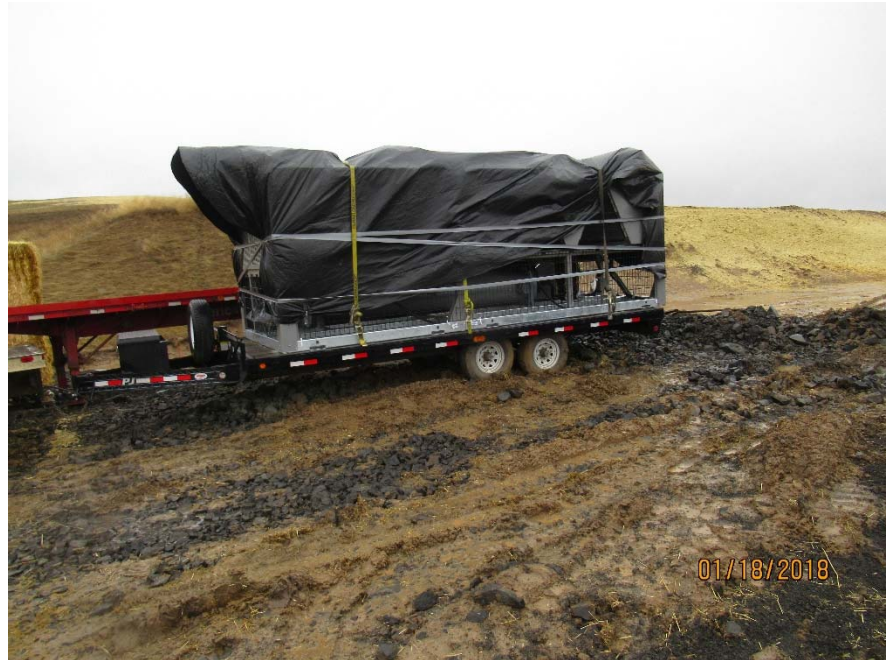
2. The chiller was delivered last week. Contractor placing concrete housekeeping pad for it to be set on.

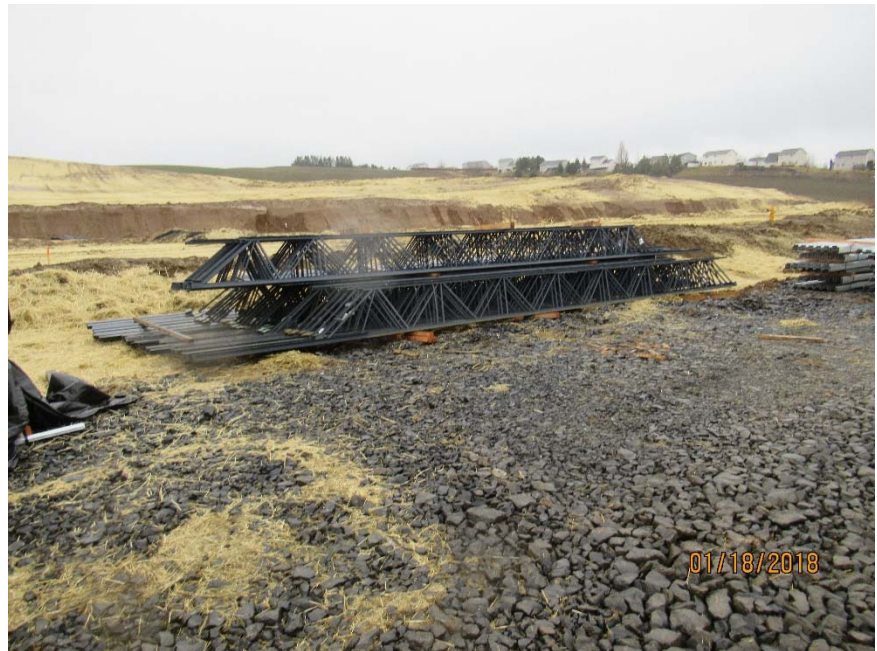
3. Appears the contractor has accepted delivery of roof trusses. Should be installing them within the next few weeks.

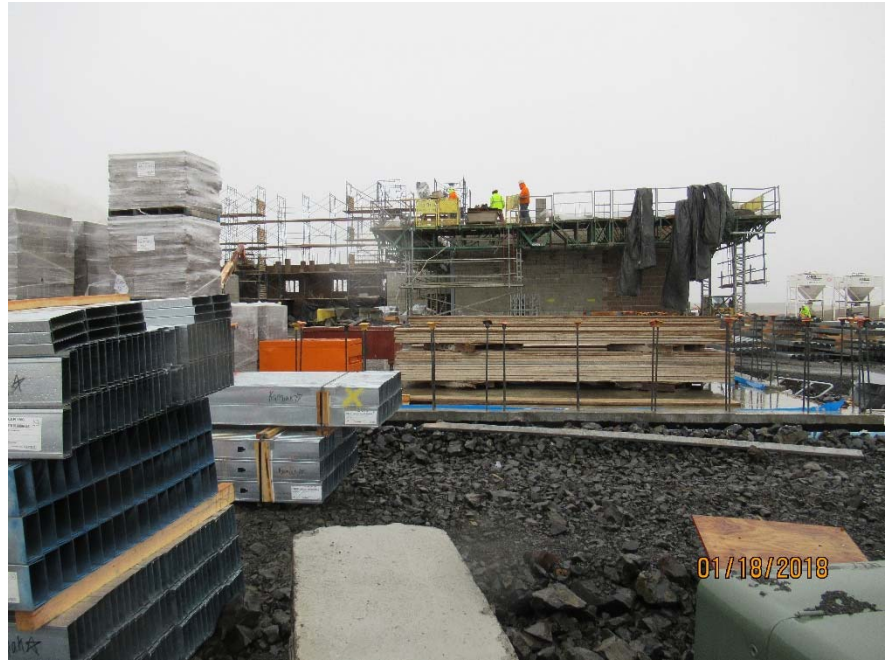
4. Appears contractor is continuing laying up CMU at Kitchen, Stage and Gymnasium.

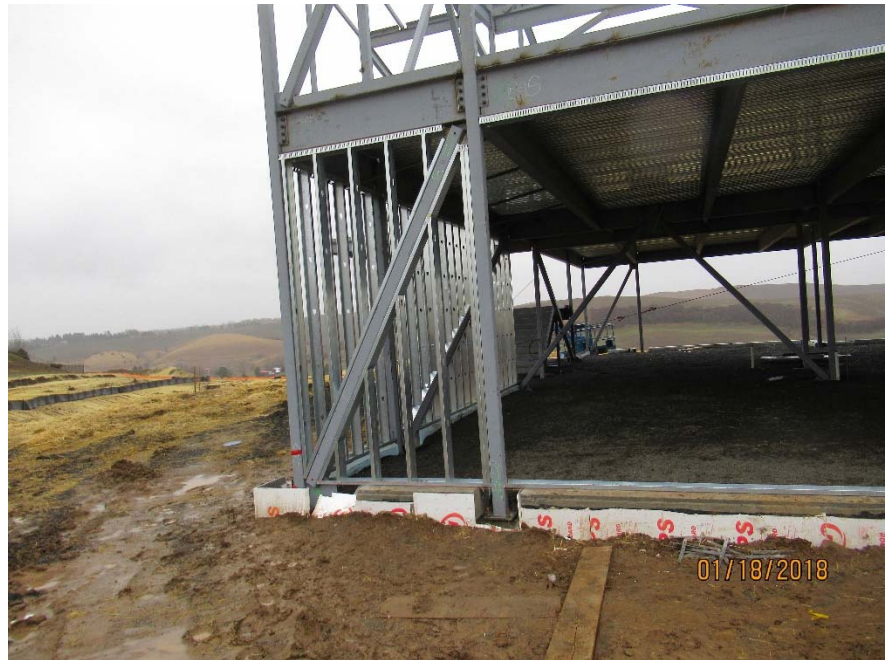
5. Appears the contractor has begun lower floor exterior wall framing. Beginning at the south end of Area A.

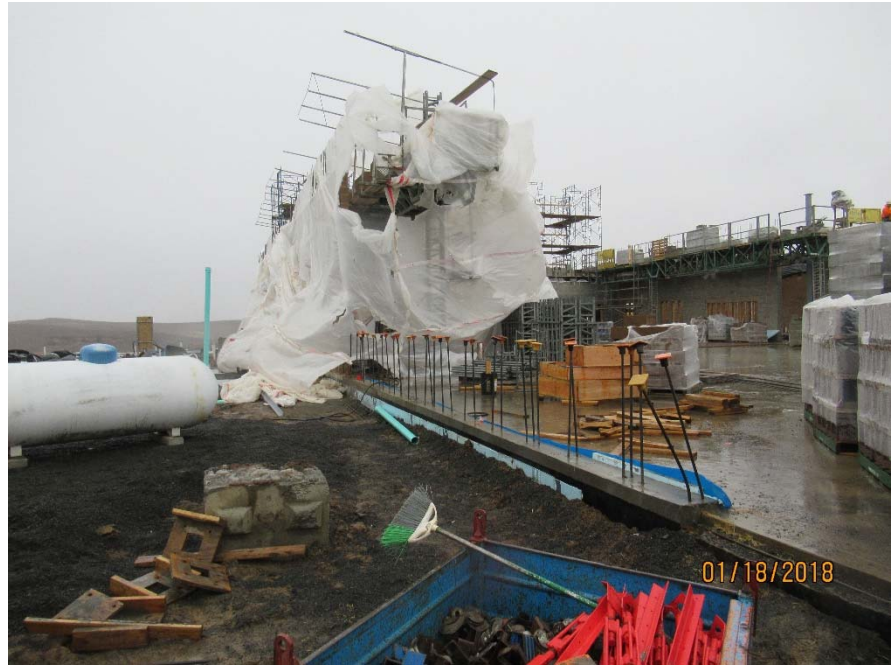
6. Weather today is extremely windy as well as raining. Appears the tenting on the CMU wall at grid line "T" is being tore apart. By the time I left the tenting was for the most part removed by the contractor.

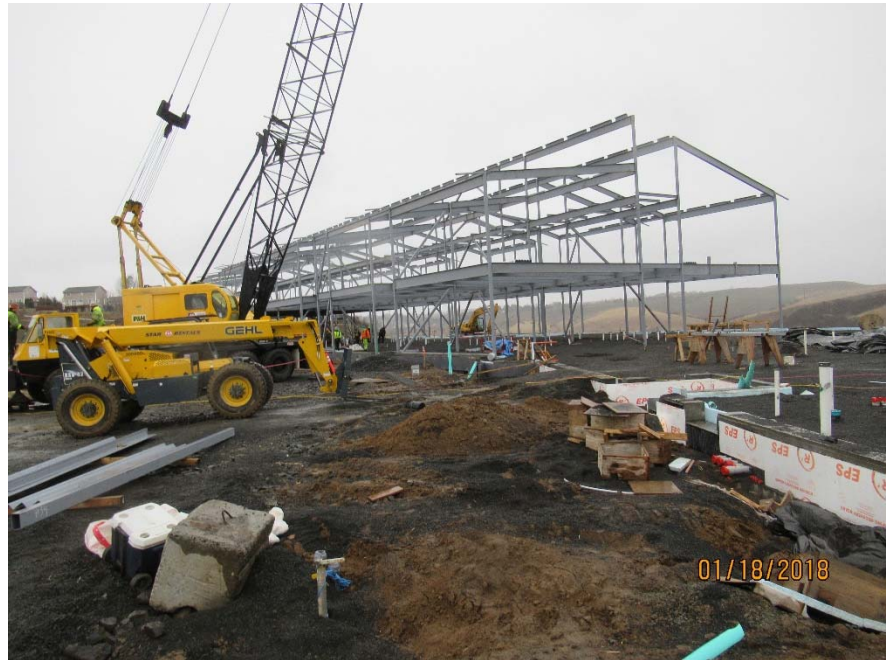
7. It appears the contractor is having a problem with the crane. It may be broke down. No steel erection taking place, may be a good thing as it is windy.

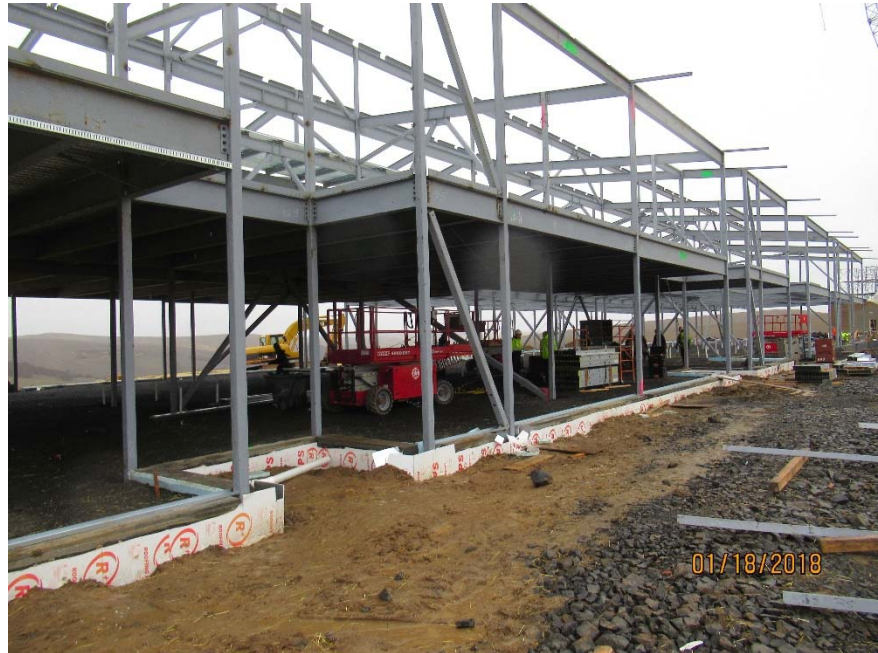
8. Contractor has laid second floor steel decking. Appears contractor is working from south end, the decking is placed to about grid line “M”.

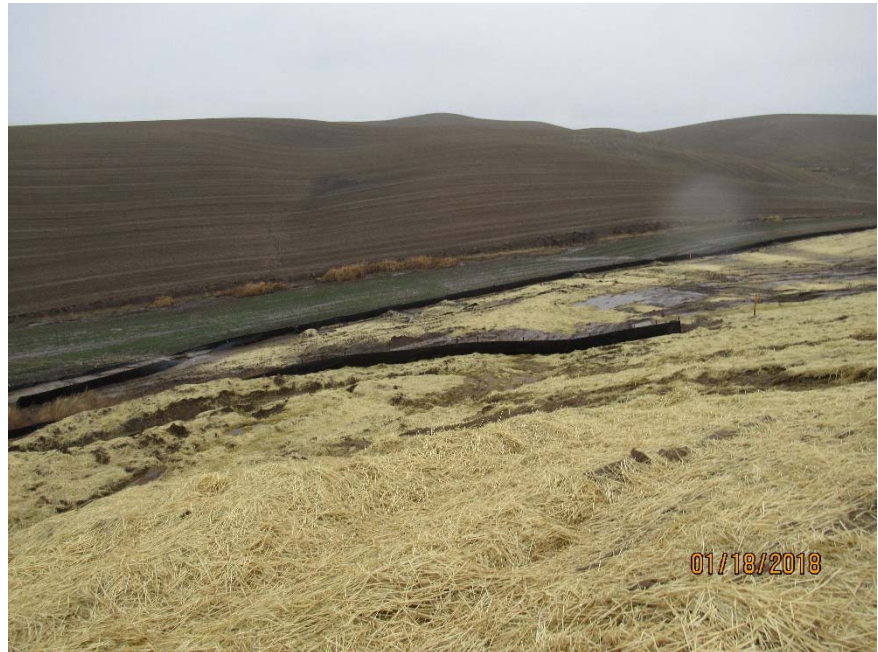
9. Looking northwest onto developer lots north of Kamiak. It appears runoff has over run the silt fence.

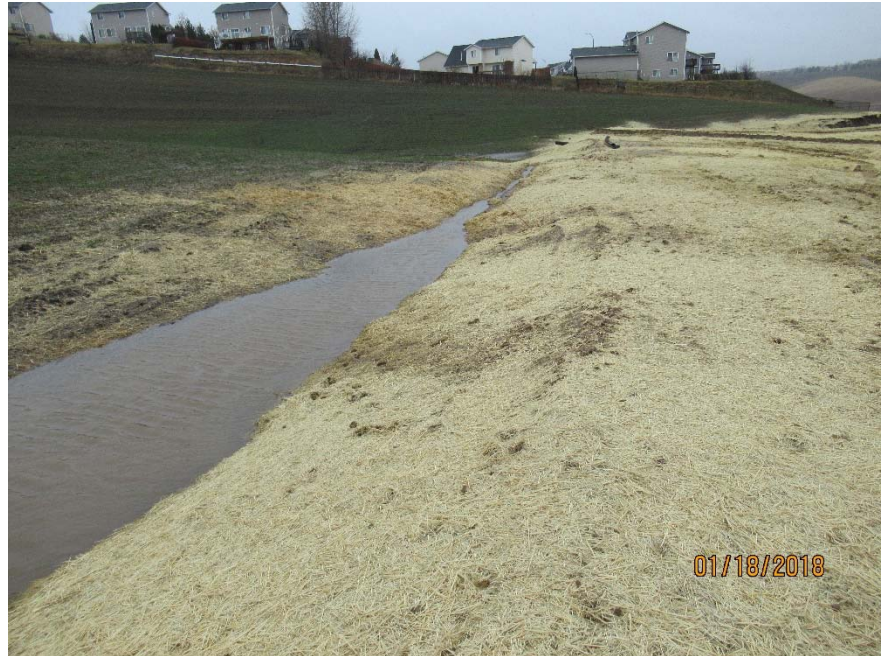
10. Looking southerly east of what will be NW Terre View Drive. Appears the retainage pond is holding water and slowing run off to the south.

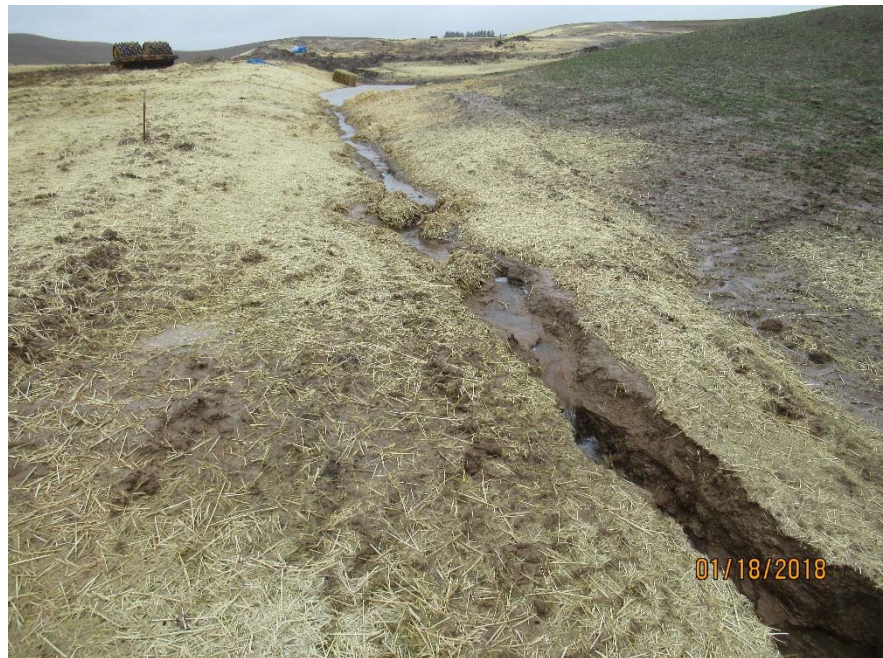
11. Looking northerly above mentioned retention pond is at the top of this photo. It appears the overflow of pond is running to the south at a fairly rapid rate. NW Terre View Drive is to the left in this photo.

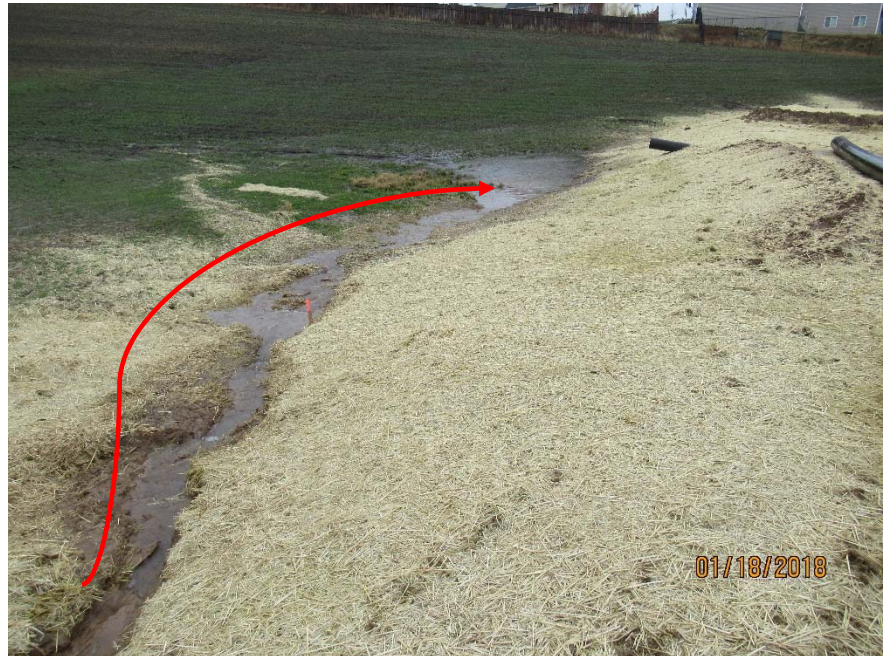
12. Looking southerly from the same location in photo 11 above. Note the drainpipe to the right of this photo is much higher than the water line. According to Walker, this southern pond keeps accepting water but it never fills up.

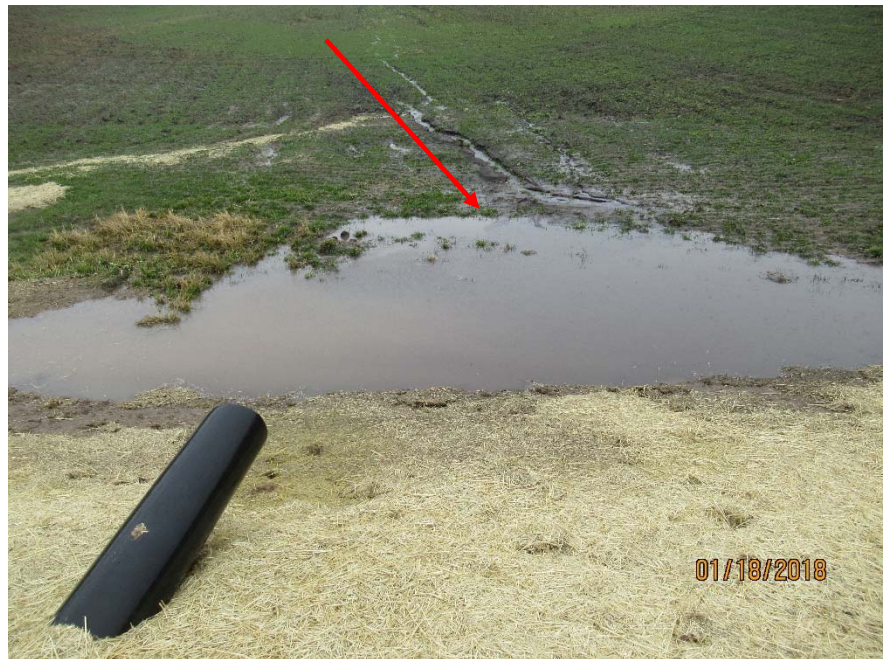
13. This photo is looking east at the retainage pond mentioned in photo 12 above. Again this pond is accepting not only the run off from the north it is also accepting the runoff from the field valley to the east.

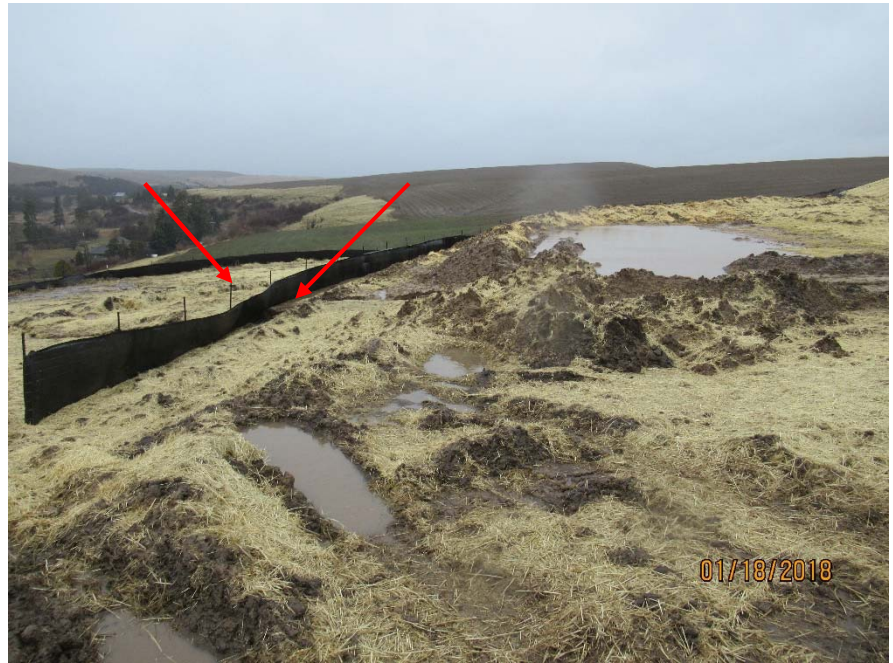
14. Photo is looking northwesterly. This is a retention pond the contractor has dug to collect runoff on the Kamiak site. The left arrow is pointing to condition in photo 16 below and the right arrow is pointing to condition in photo 15 below.

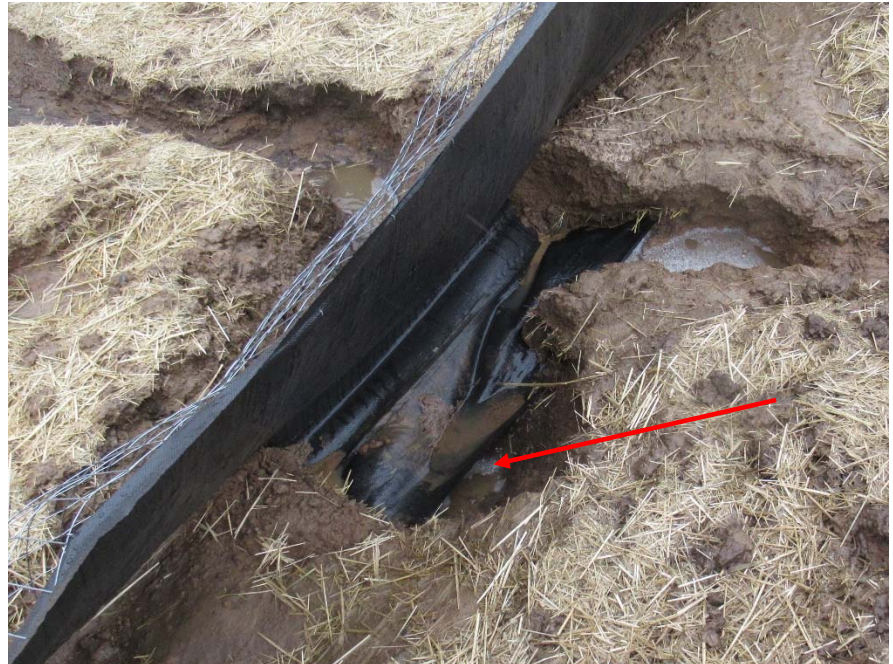
15. It appears the Kamiak retaining pond overflow has gotten through the silt fence. Contractor needs to address.

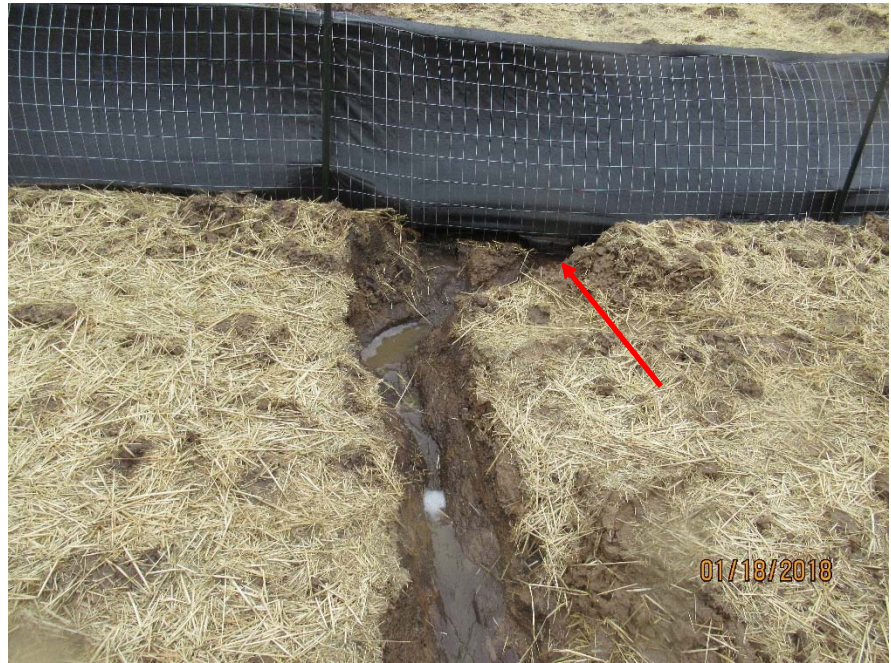
16. It appears the Kamiak retaining pond overflow has gotten through the silt fence. Contractor needs to address.

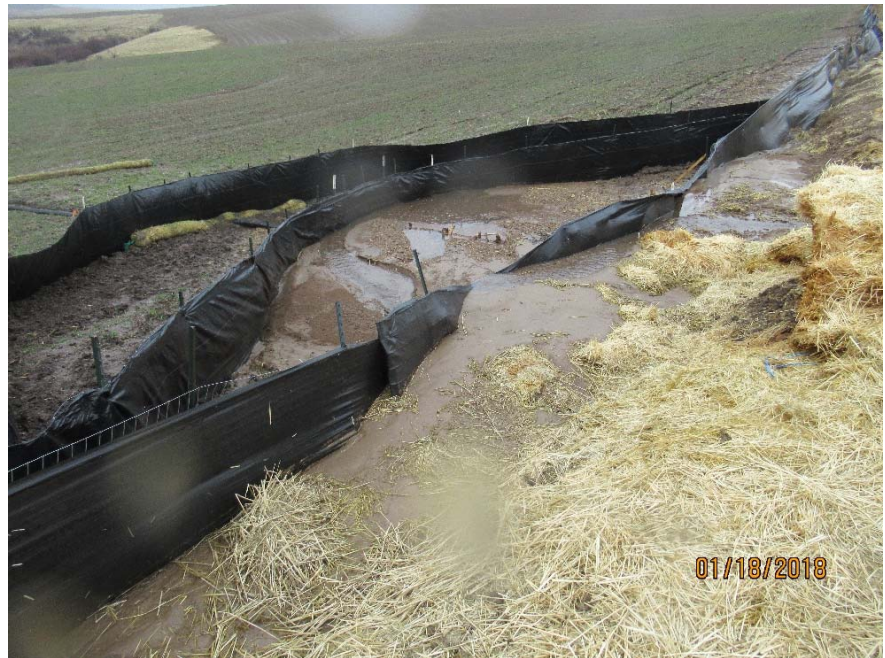
17. NOTE this condition does not appear to be related to photos 14, 15 and 16. This location is north of those conditions. It does however appear to align with what was once a valley that has been backfilled. It appears the eastern end of this filled valley is shown in photo 13 above. Just out of this photo to the right is photo 19 below.

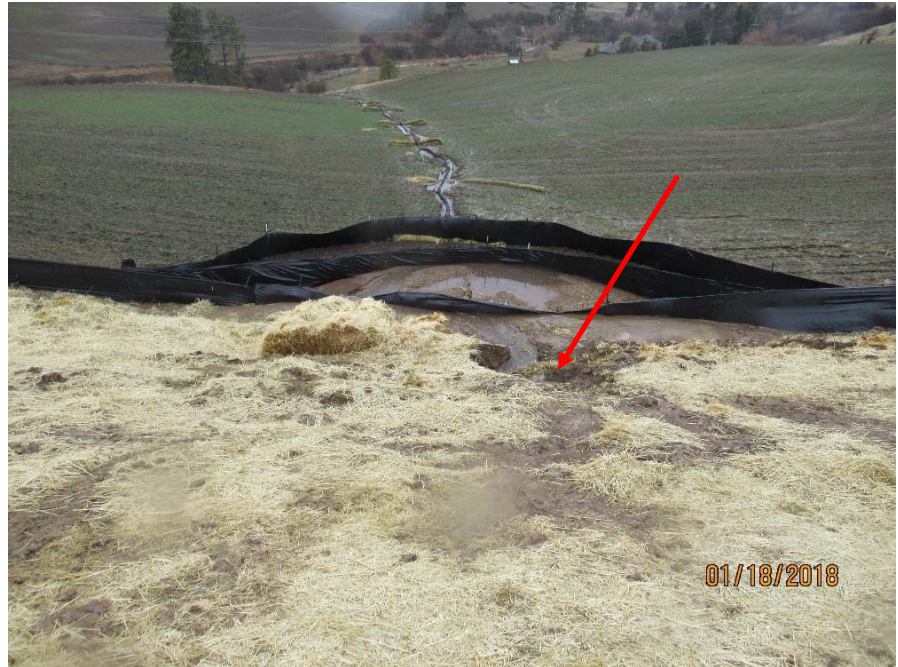
18. Looking past the Contractor added silt fencing. The contractor has also added a drainage pipe as well as waddles. Arrow is pointing at condition in photo 19 below.

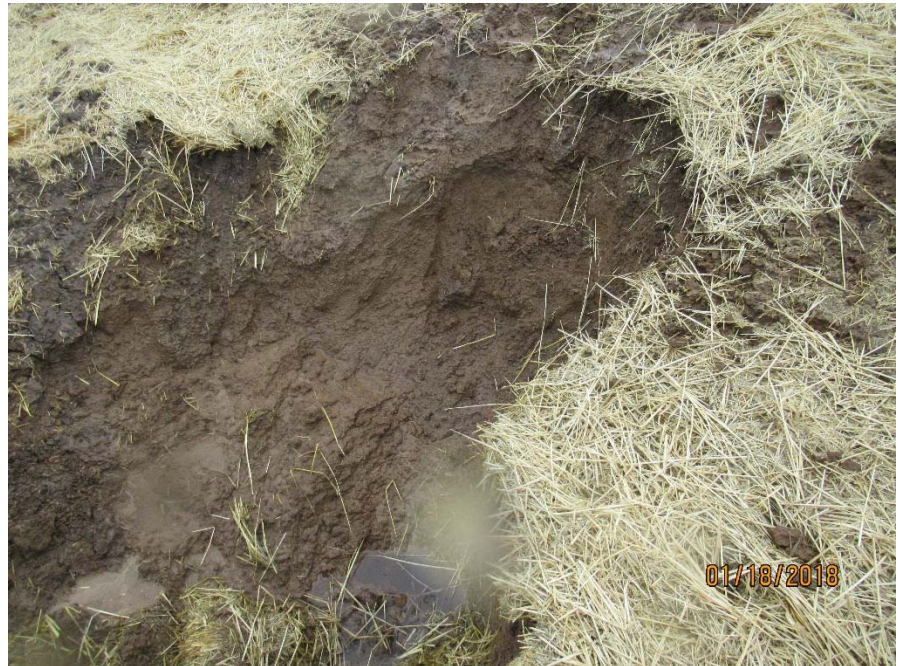
19. Water is coming from the ground. Appears to be in alignment with what was once a valley, and has been backfilled to be the new lower field.

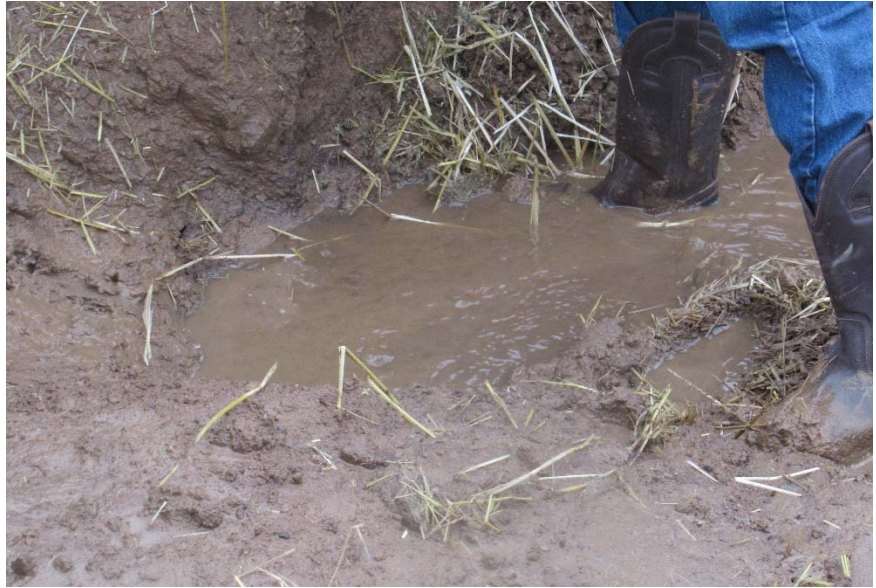
20. Water bubbling up from the ground. Contractor will be sending in an RFI asking the geotechnical engineer review the condition.
