**Project: PSD: Kamiak Elementary School****Date: January 3, 2019****Weather conditions:**

Discussion with: See Construction Progress Meeting minutes dated 1/3/19**Construction Activities:**

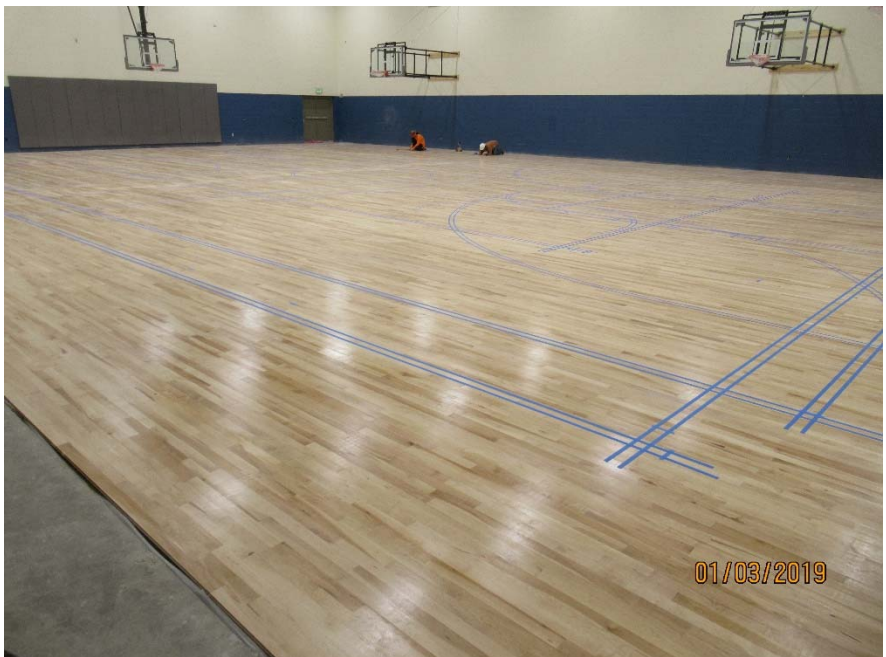
1. The gymnasium floor has been installed, sanded, sealed and the contractor is taping off for the striping. Striping colors were approved today.

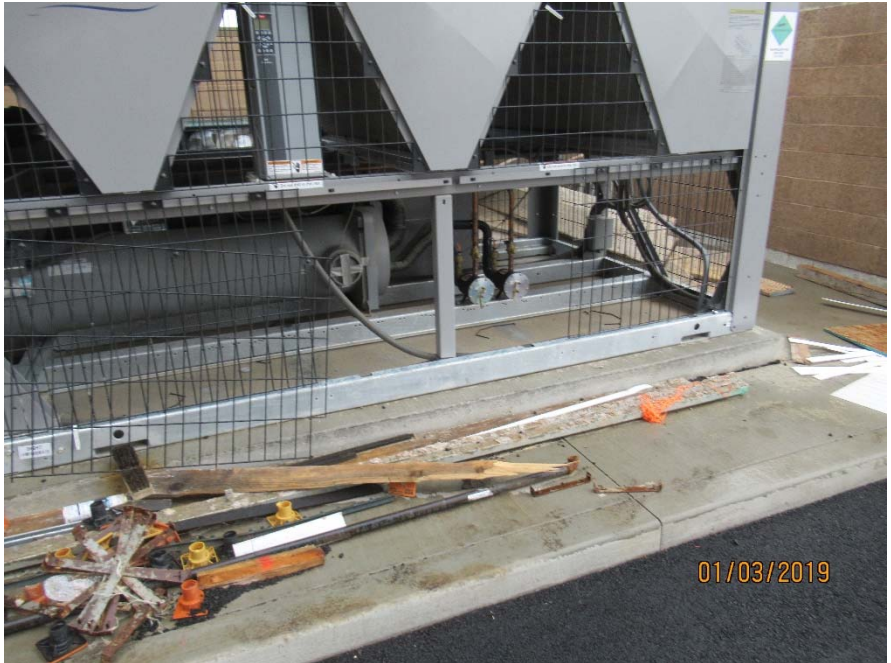
2. It appears the contractor is preparing to install piping to the chiller.

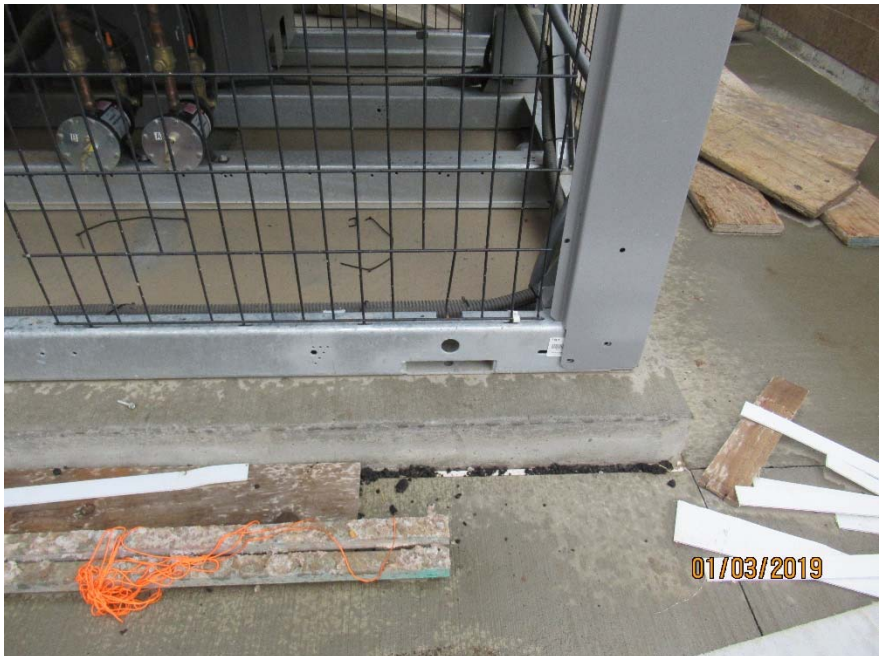
3. I reminded the contractor to be sure and attach the chiller to the slab.

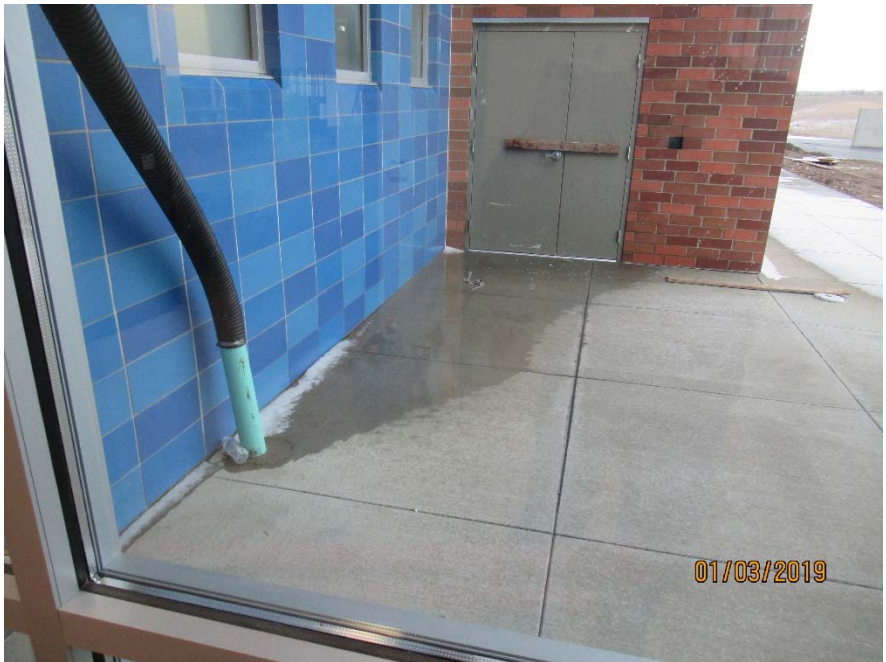
4. It appears the water off the roof is flowing to the double doors 135B that go into Janitors room 135. We have had water intrusion through this door before the threshold was installed.

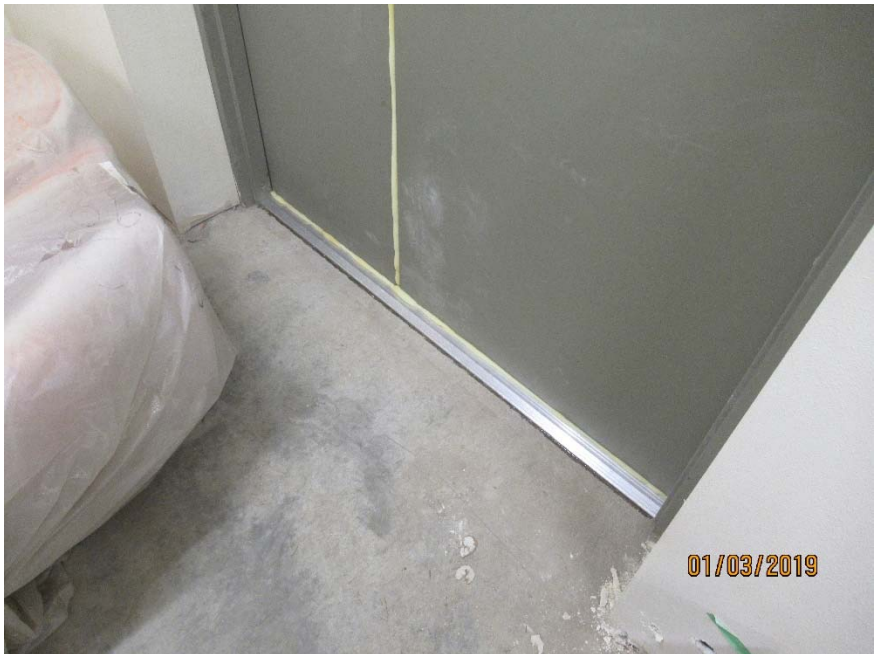
5. This is the inside of door 135B. The contractor has installed the threshold and caulked it to keep the water out.

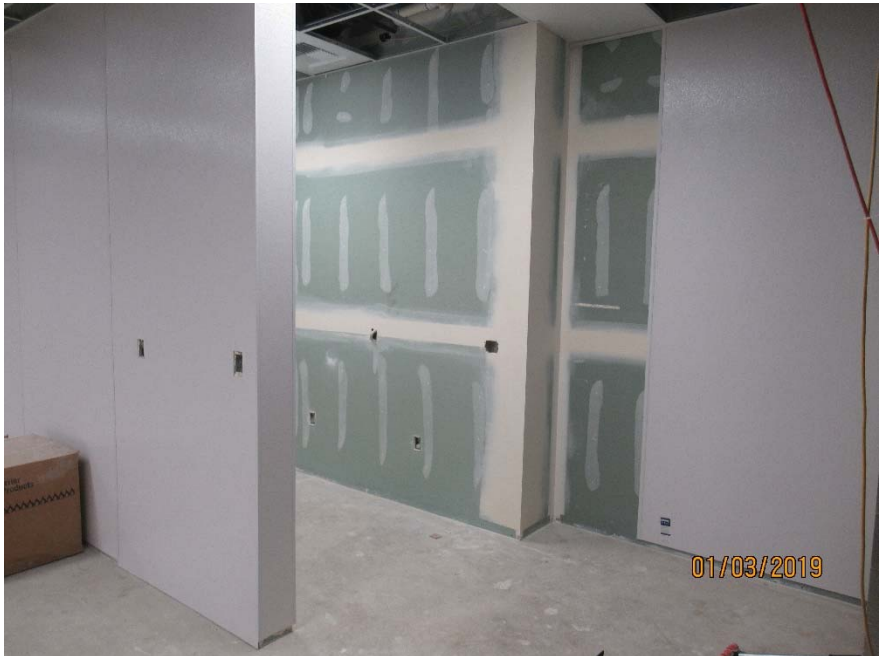
6. Contractor is installing FRP panels in the Kitchen.

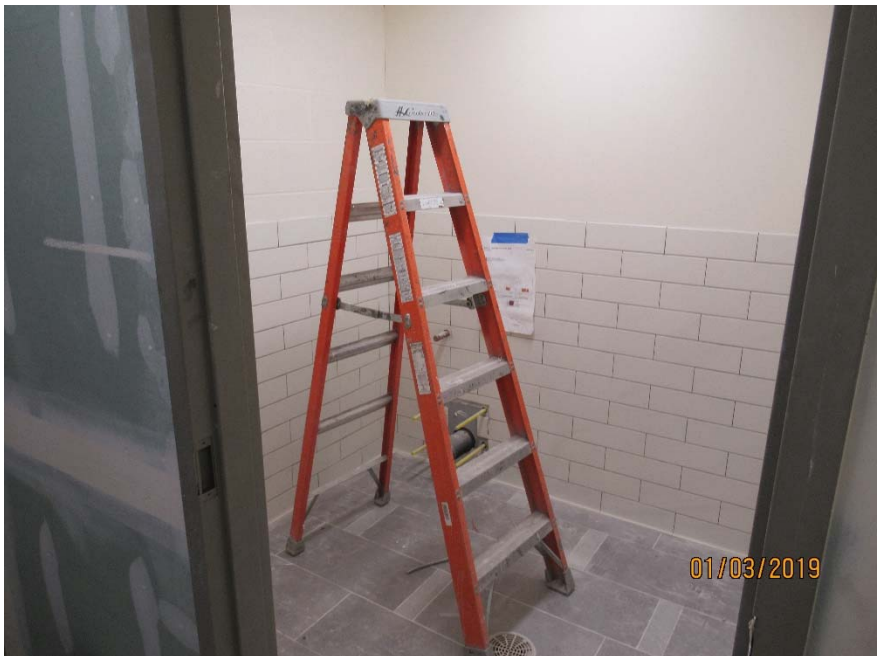
7. Appears the plumbers still needs to install the fixtures in the Kitchen restroom 143A.

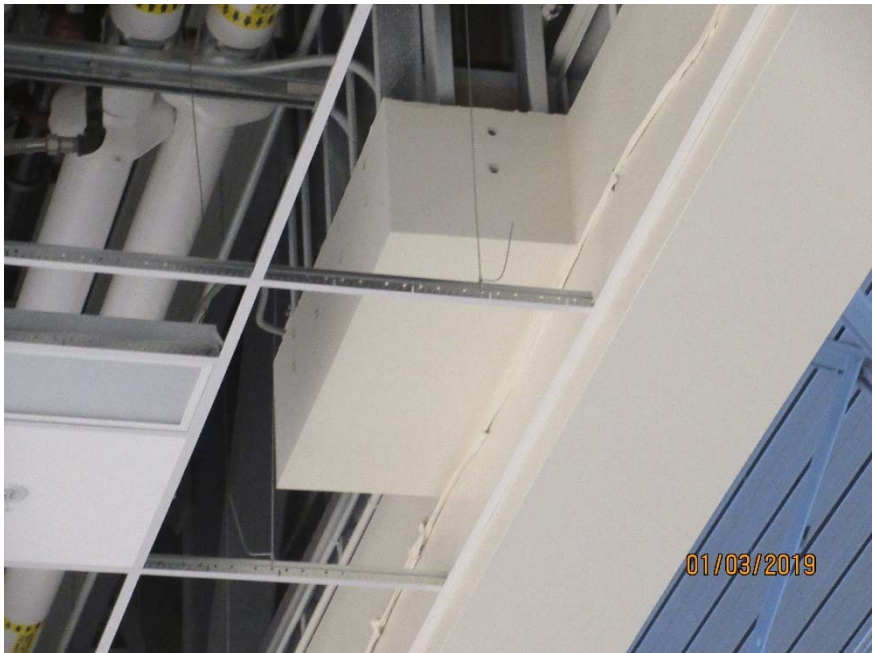
8. It appears the contractor has drilled 2 holes at either side and 4 holes in the back of the projector box in the Multi-Purpose room. I question if this is enough to allow cross ventilation for the projector. I informed the team at the progress meeting that I felt the side walls and the back wall should be removed to open the projector box to the soffit area allowing maximum cross ventilation.

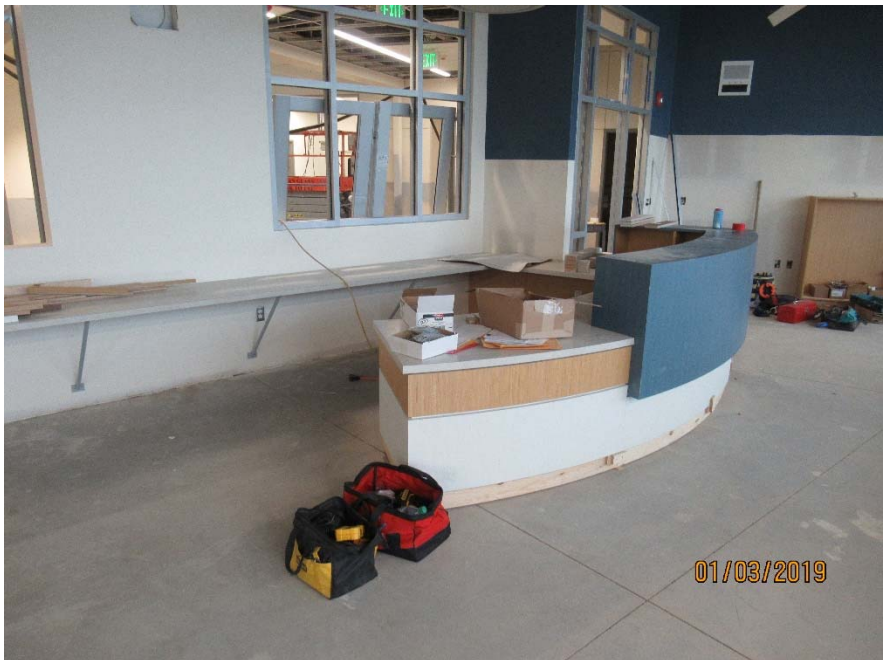
9. Contractor continues installation of casework in Library as well as other locations in the building as spaces become ready.

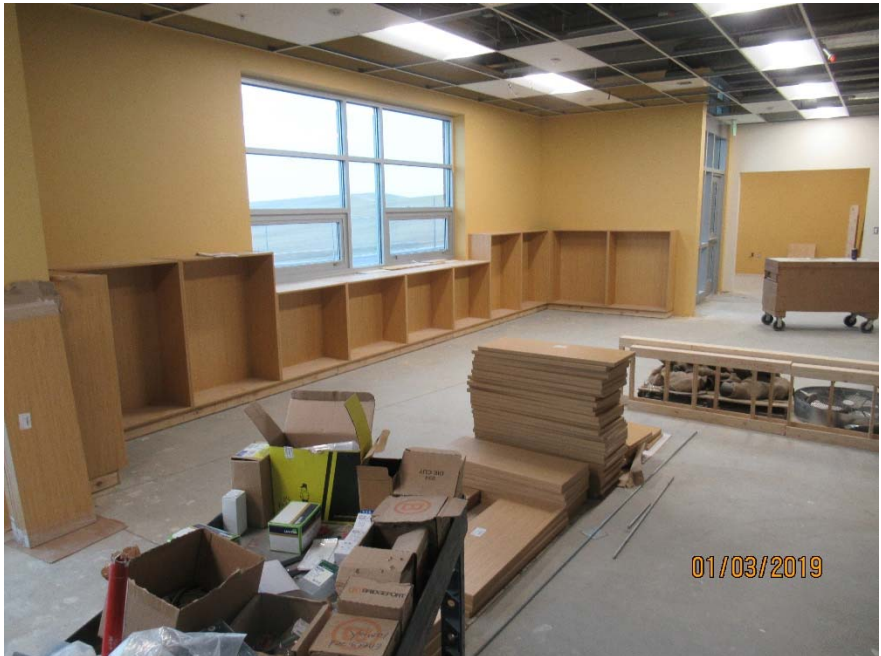
10. Casework shelving in the Library.

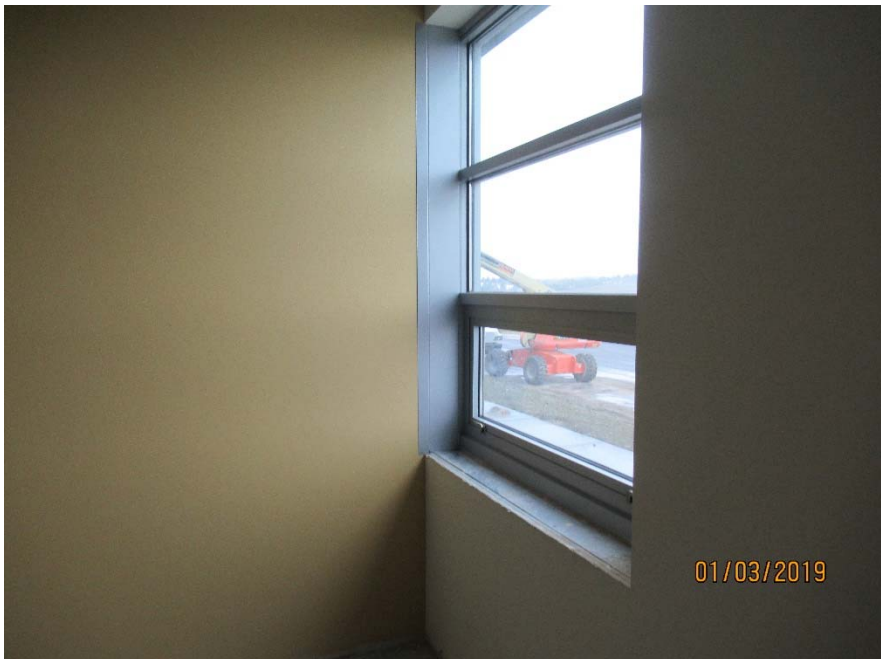
11. Contractor has installed some of the break metal dividers where the wall meets the window frame.

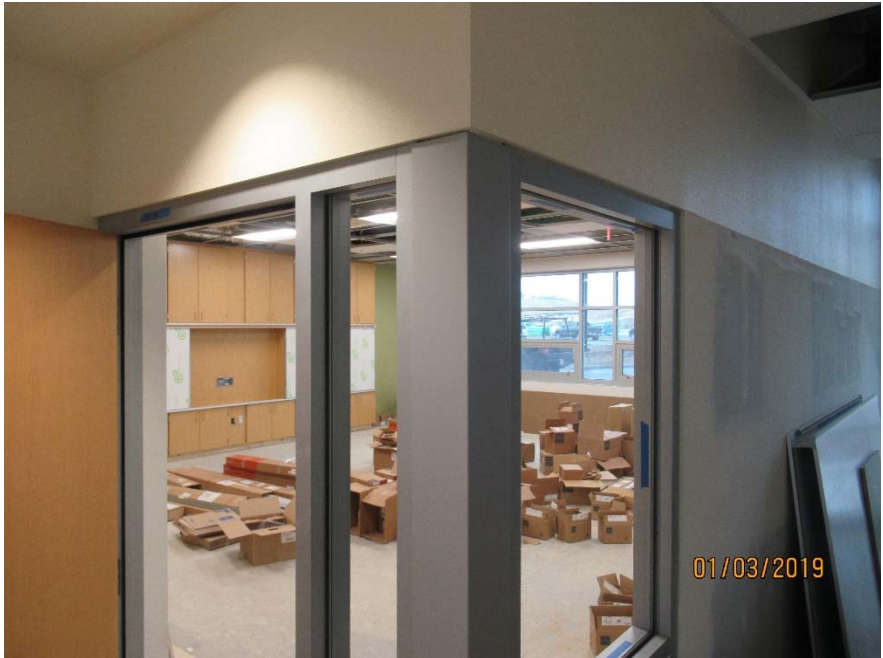
- 12. The contractor has installed
One (1) break metal corner
piece at Classroom 106.**

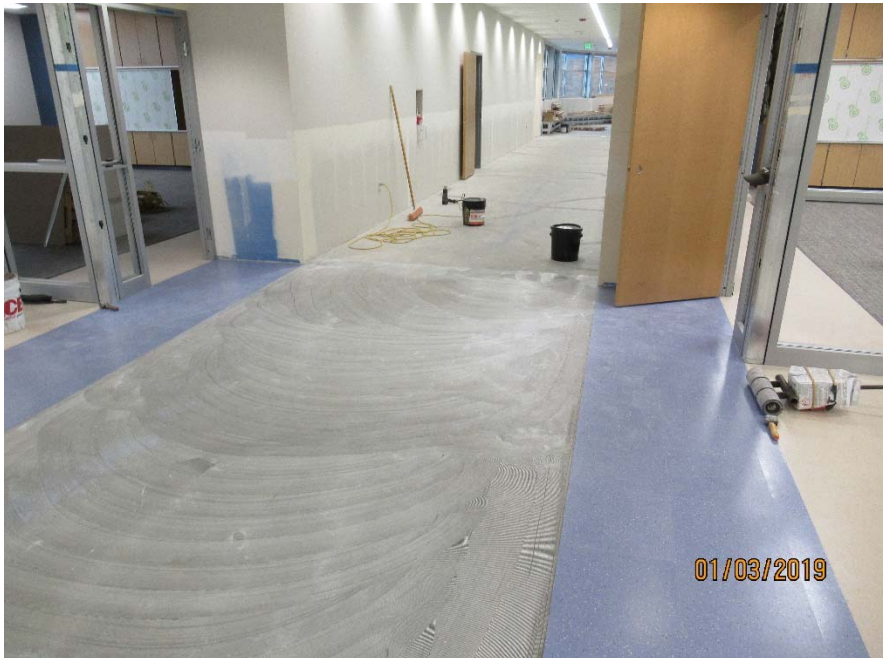
- 13. Contractor continues to
install VCT in the upper
floor main hallway.**

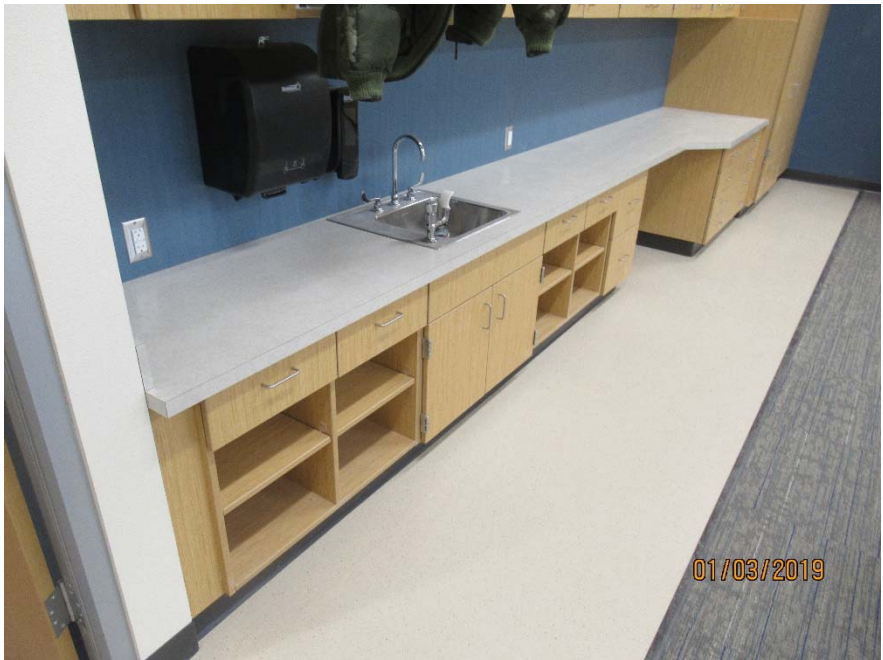
- 14. It appears the contractor has begun installing sinks and fixtures in upper level classrooms.**

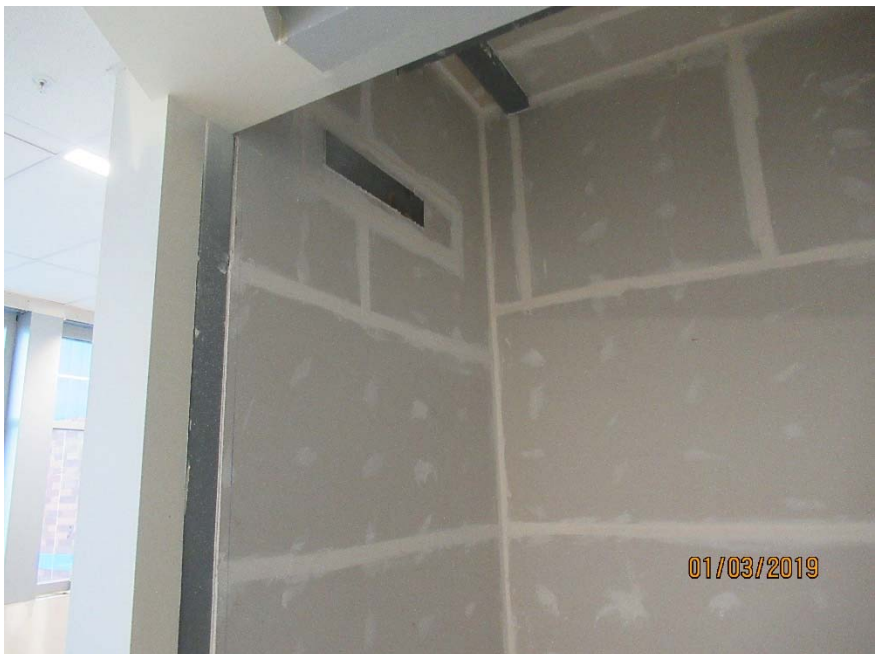
- 15. Elevator shaft appears ready to receive the elevator. Contractor has informed the team delivery is expected the second or third week of March.**
