**Project: PSD: Kamiak Elementary School****Date: October 25, 2018****Weather conditions:**

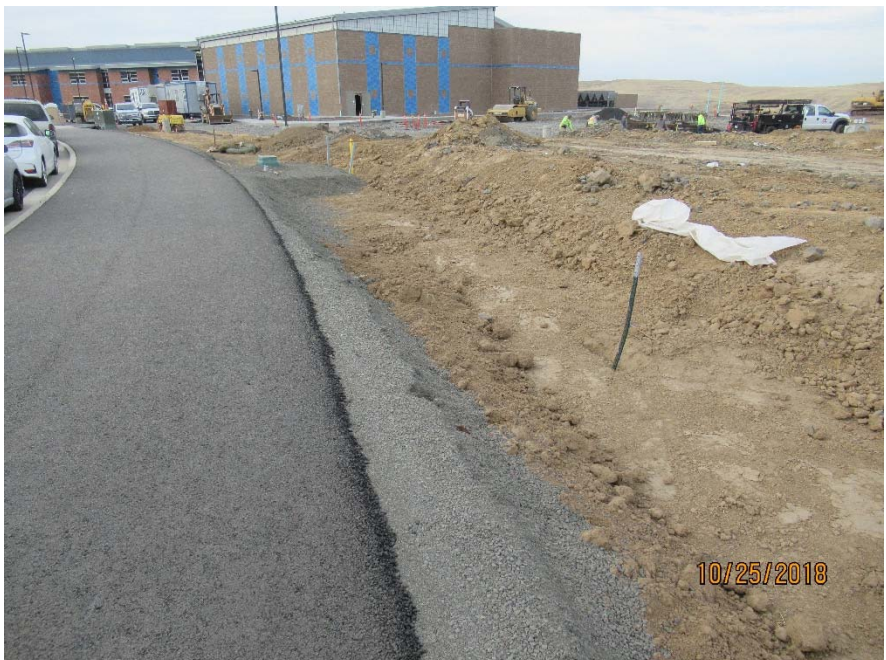
1. It appears the contractor has removed the rock from the temp. access road.

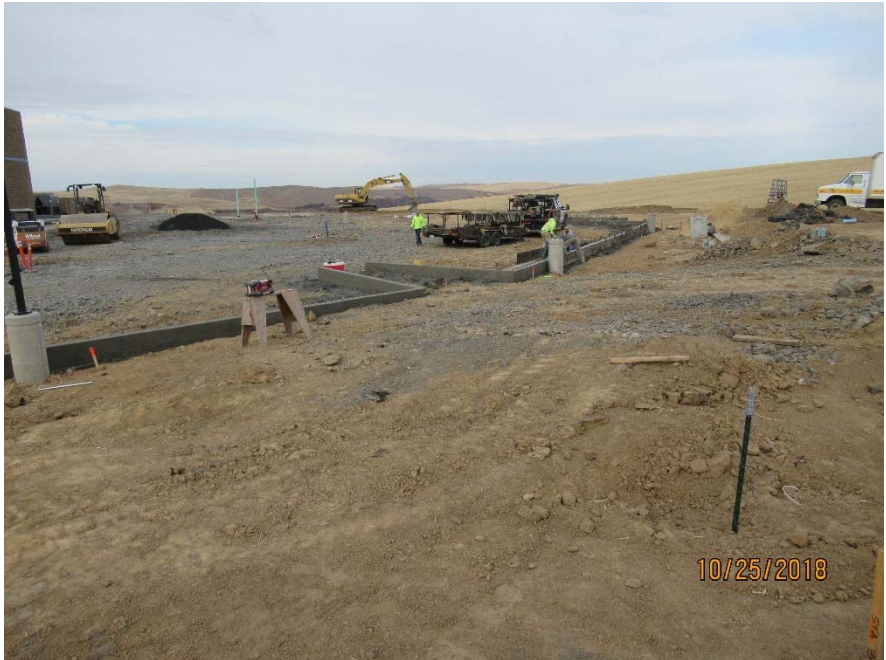
2. Contractor is placing north curbs at the north lot. If the weather holds out the contractor plans on placing asphalt the week of 11/5/18.

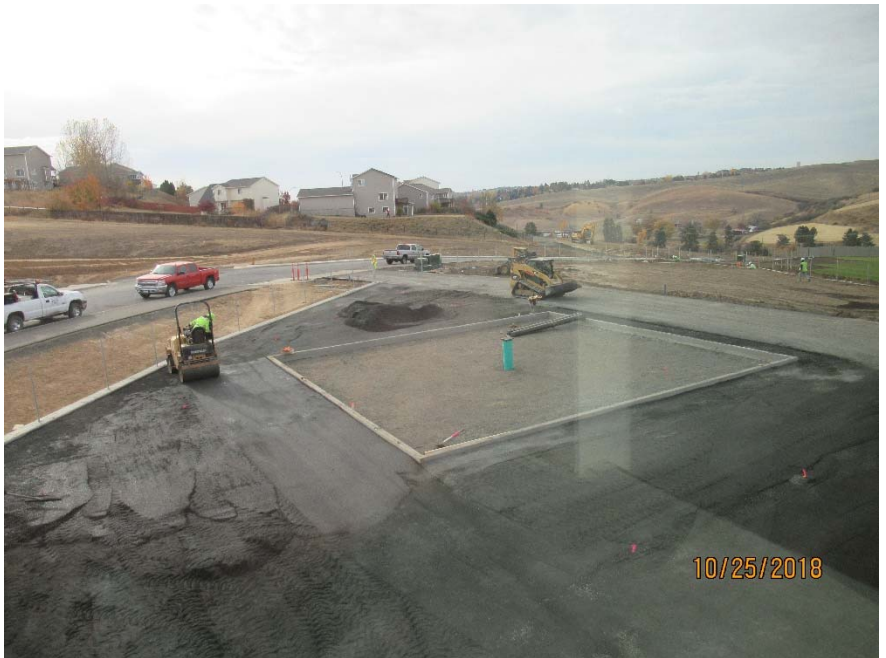
3. It appears the contractor is preparing subgrade for light duty asphalt placement at the same time as the north parking lot.

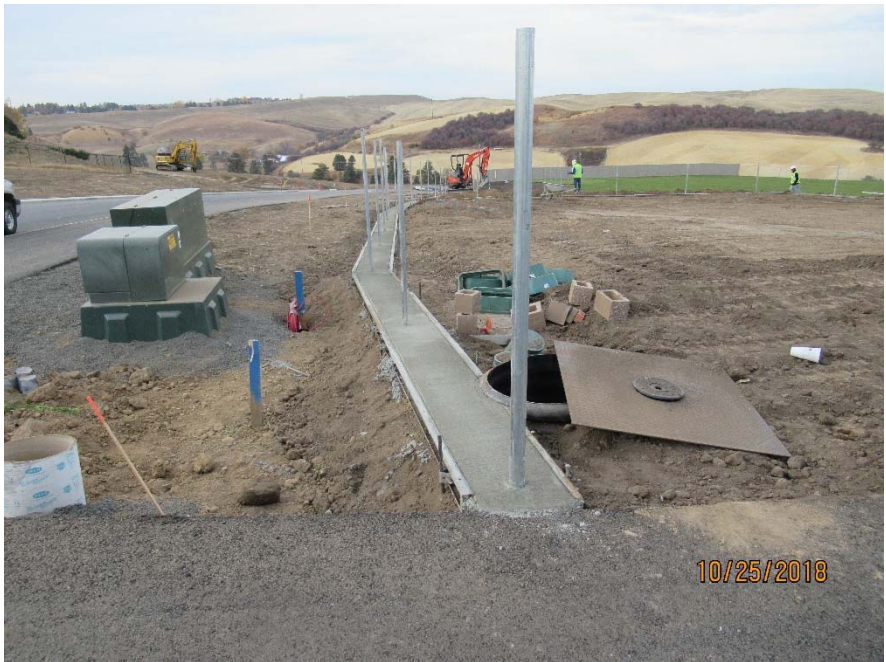
- 4. Contractor has gotten most if not all the mow strips in place now.**

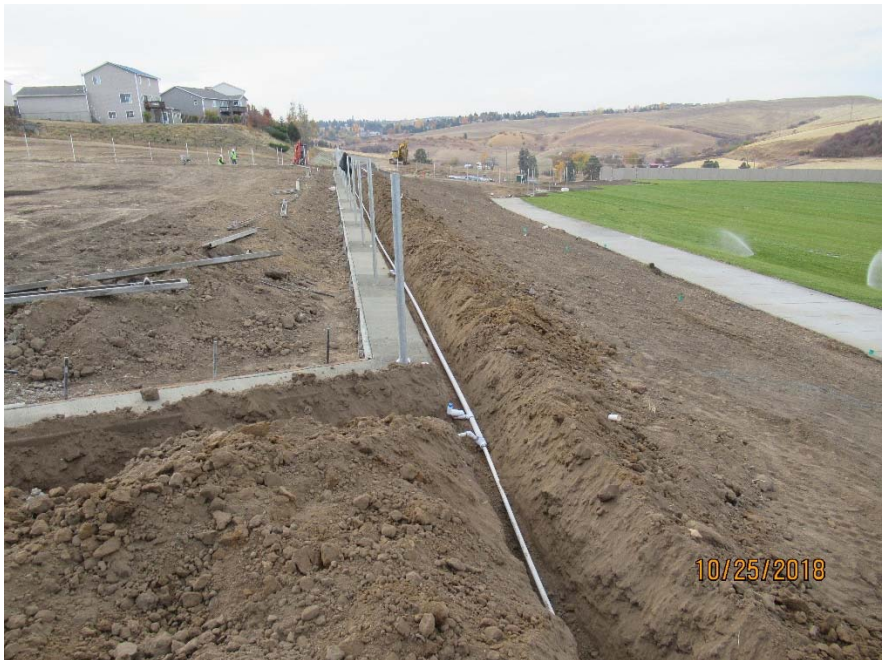
- 5. Contractor is finishing installation of irrigation west of the south play area.**

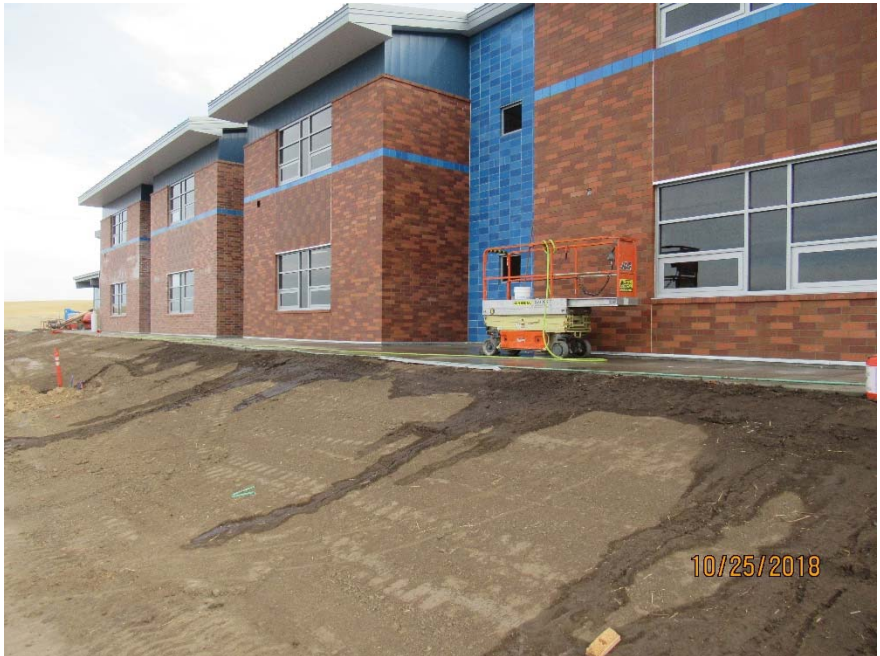
6. It appears the contractor continues to clean masonry.

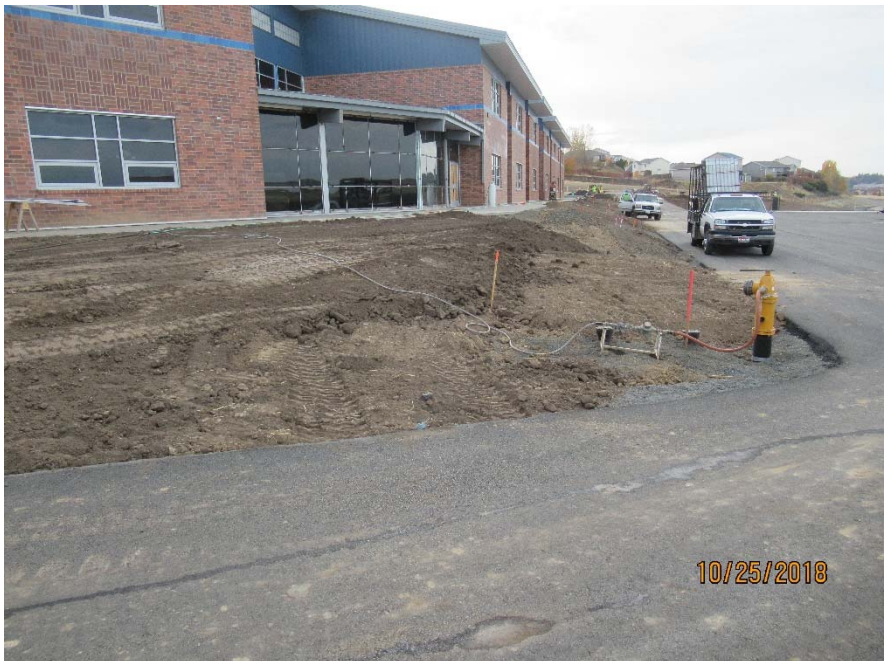
7. The contractor has not yet formed or placed the stairs between the Vestibule 129 and the hard surfaced play area.

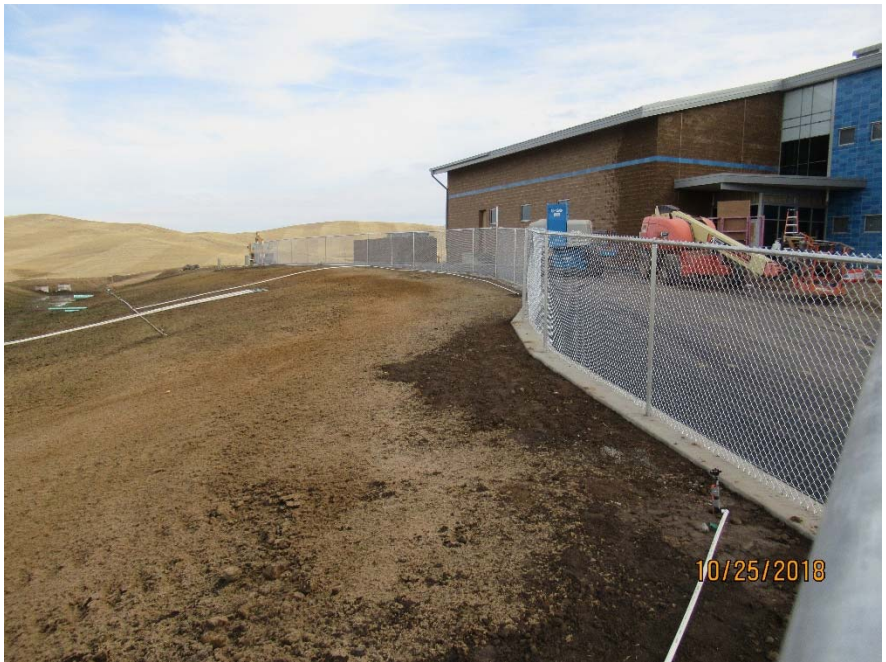
8. It appears the installer of the fence or mow strip has disrupted the hydroseed slope. I will keep an eye on it in the spring to see if grass sprouts through the dirt.

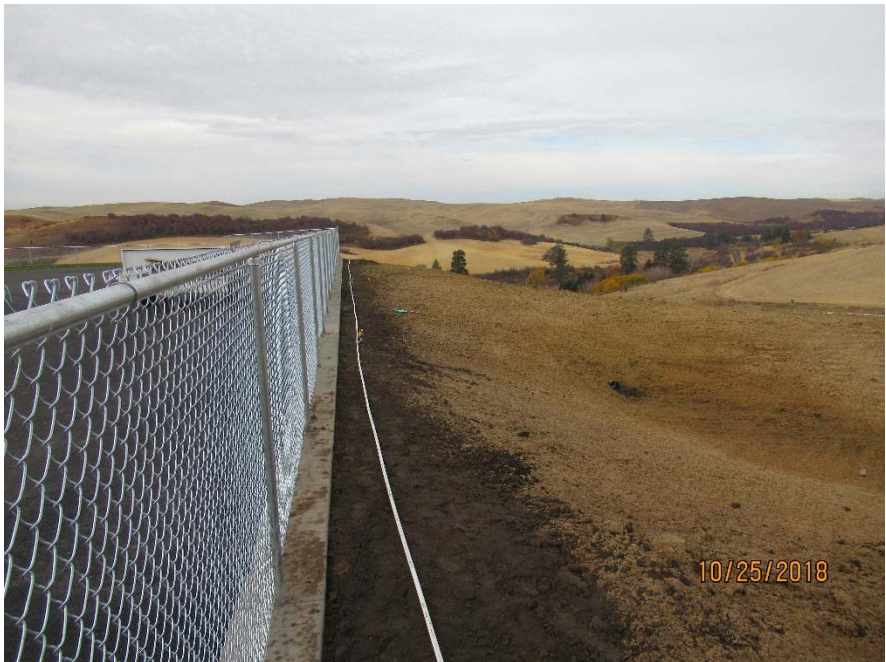
9. It appears the installer of the fence or mow strip has disrupted the hydroseed slope. I will keep an eye on it in the spring to see if grass sprouts through the dirt.

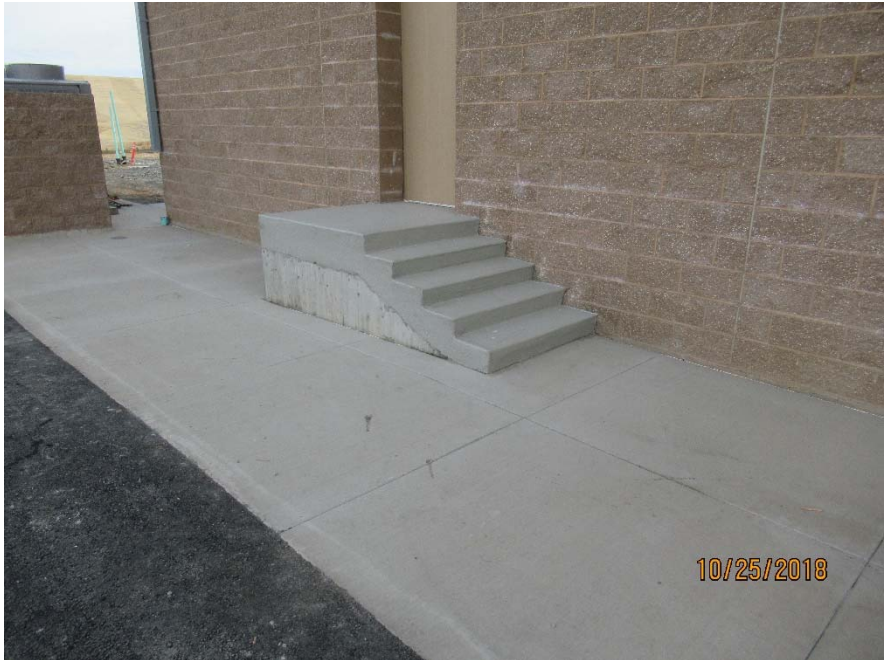
- 10. Contractor has placed the steps at the Stage exterior door. There may be a question from the contractor concerning the guard railing on this stair.**

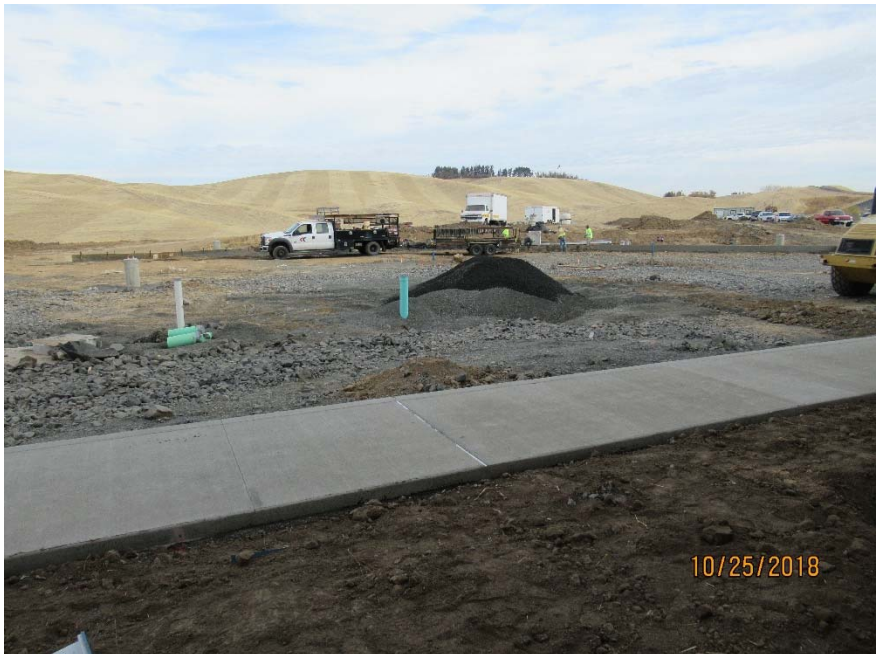
- 11. Contractor working on preparing north parking lot. Placing curbing.**

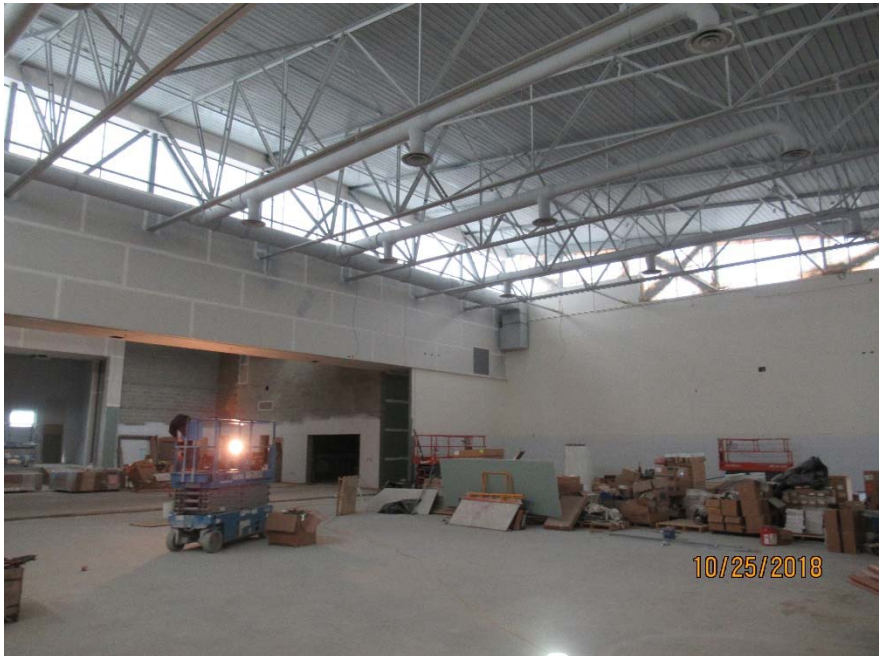
- 12. It appears the CMU in the Gym has been primed (block filler) and the structure painting is in progress.**

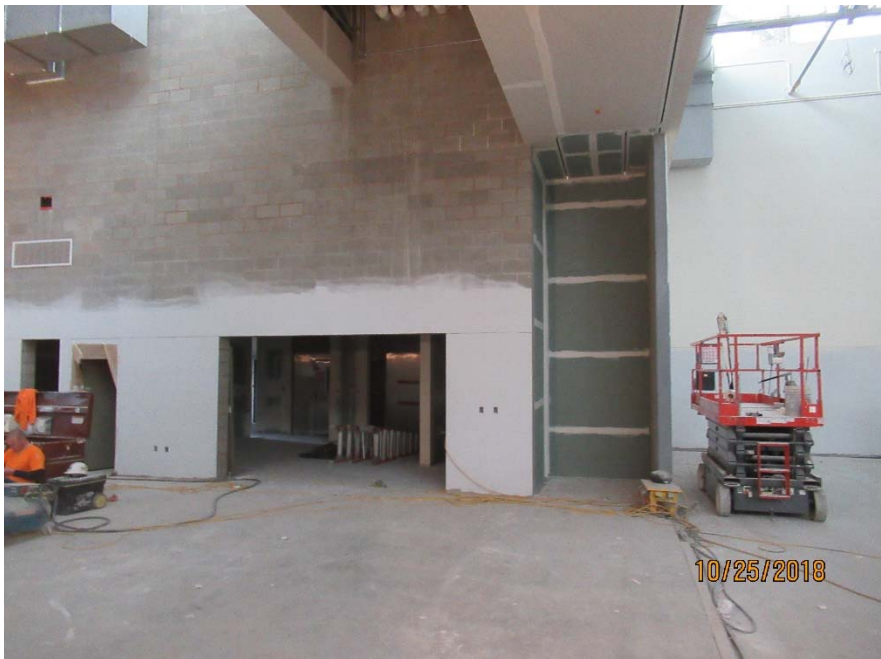
- 13. It appears the contractor is in the process of priming (block filler) in the Multi-Purpose Room.**

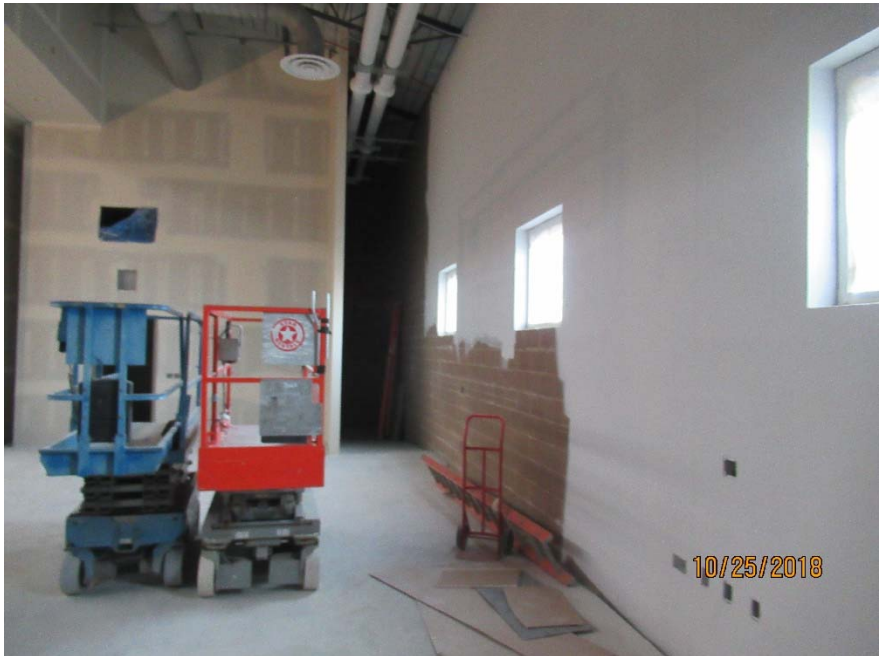
- 14. It appears the contractor is in the process of priming (block filler) in the Stage.**

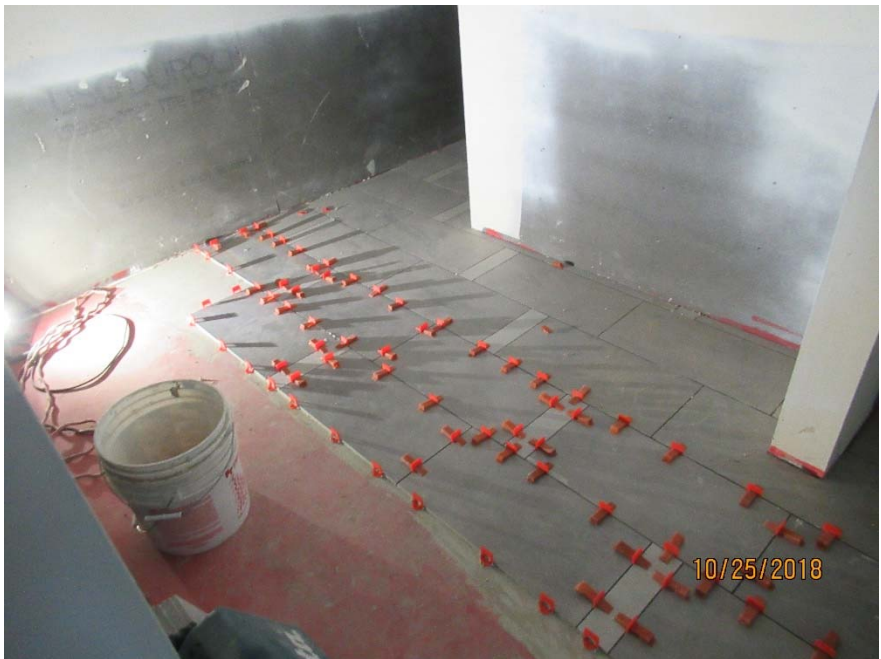
- 15. Contractor has begun installation of floor tile in toilet rooms 150 and 152.**

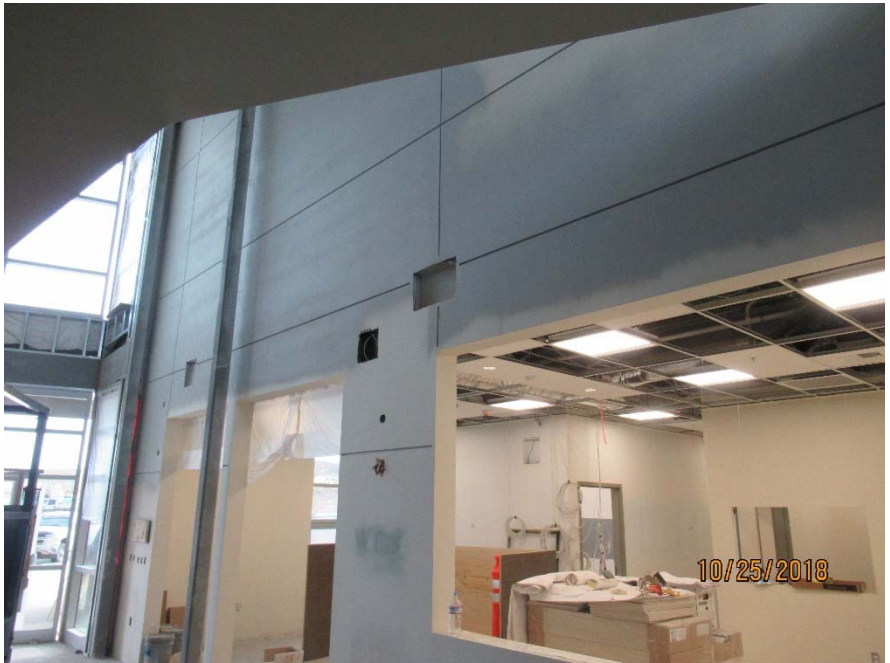
- 16. It appears the painter has primed the Main Entry area.**

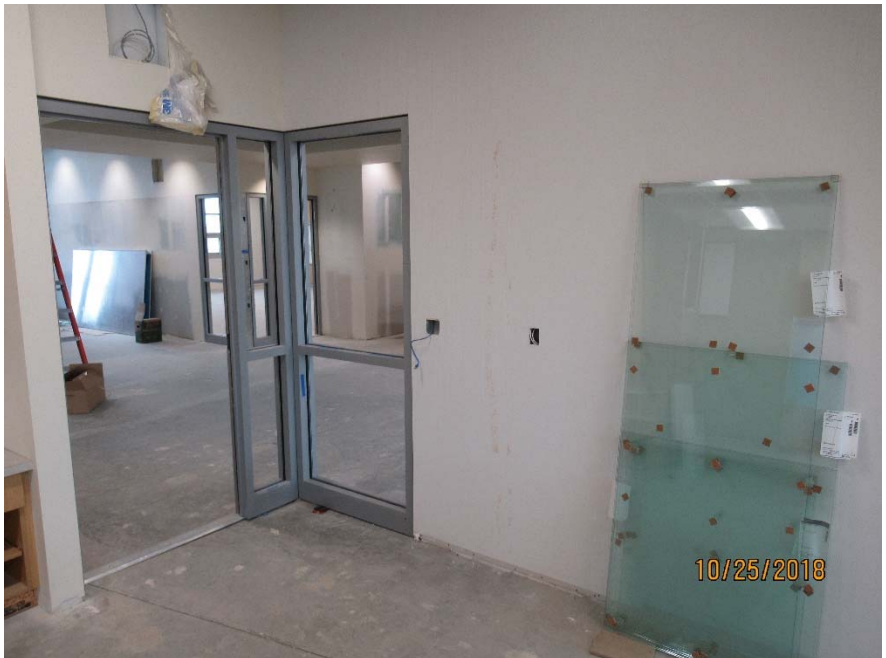
- 17. Installation of interior aluminum frames and glazing is underway.**

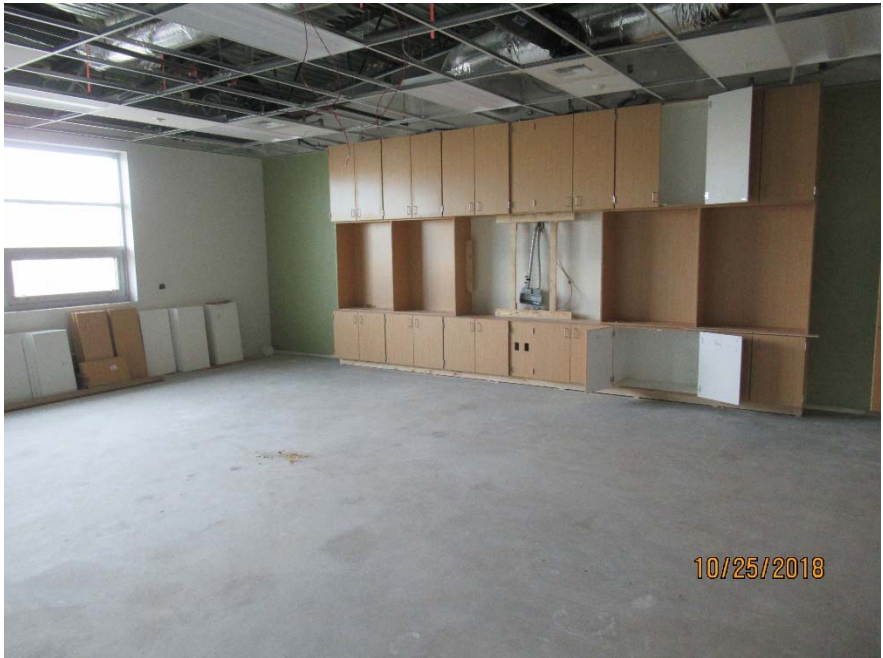
18. Lower level: Casework installation continues.

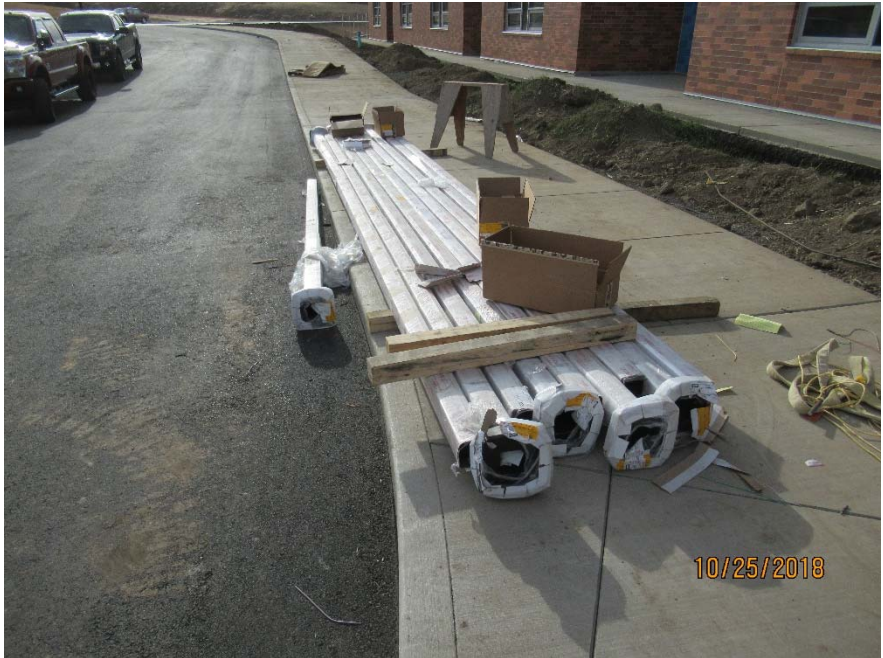
19. Contractor has accepted delivery of site lighting poles and fixtures.

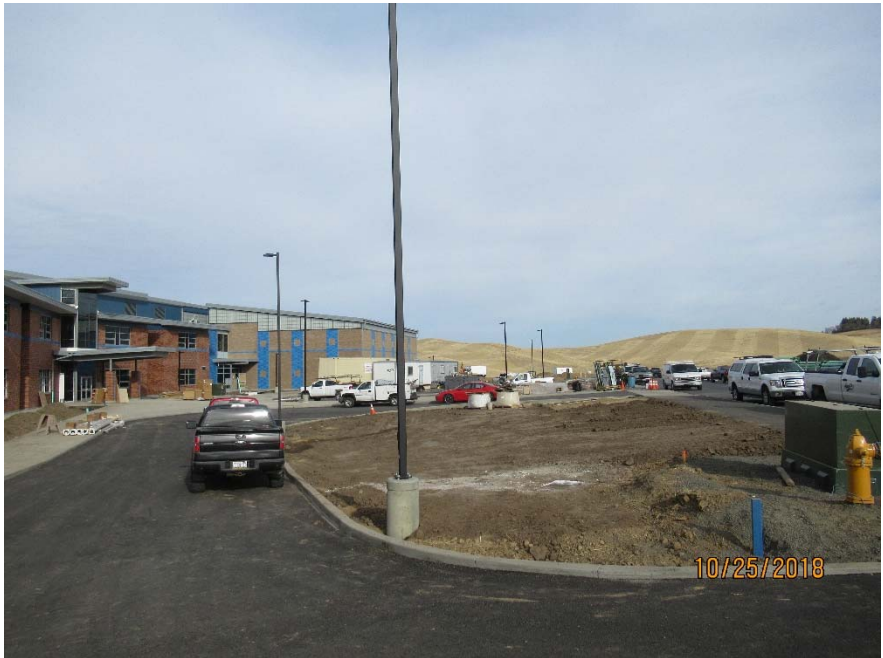
- 20. There are a number of site lighting poles and fixtures have been erected.**
