**Project: PSD: Kamiak Elementary School****Date: November 15, 2018****Weather conditions:**

Discussion with: No Construction Progress Meeting today 11/15/18. I toured the project with Ned Warnick, Derek Oliver, Joe Thornton and Evan Hecker.

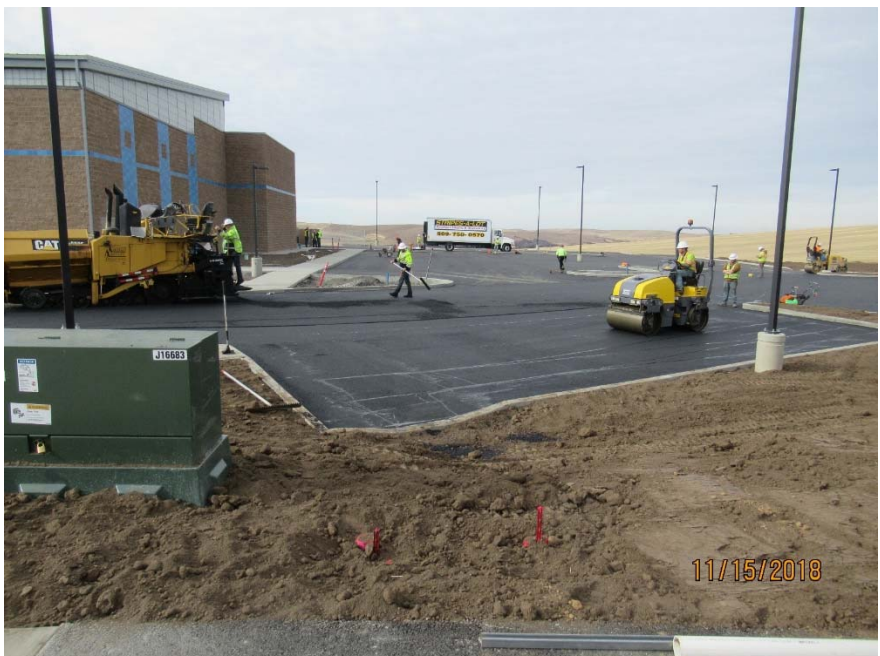
1. Contractor appears to be finishing laying asphalt at a portion of the North parking lot that they didn't get done yesterday. As you will see in photo 8 below, the asphalt contractor moved to the south play area while I toured the building.

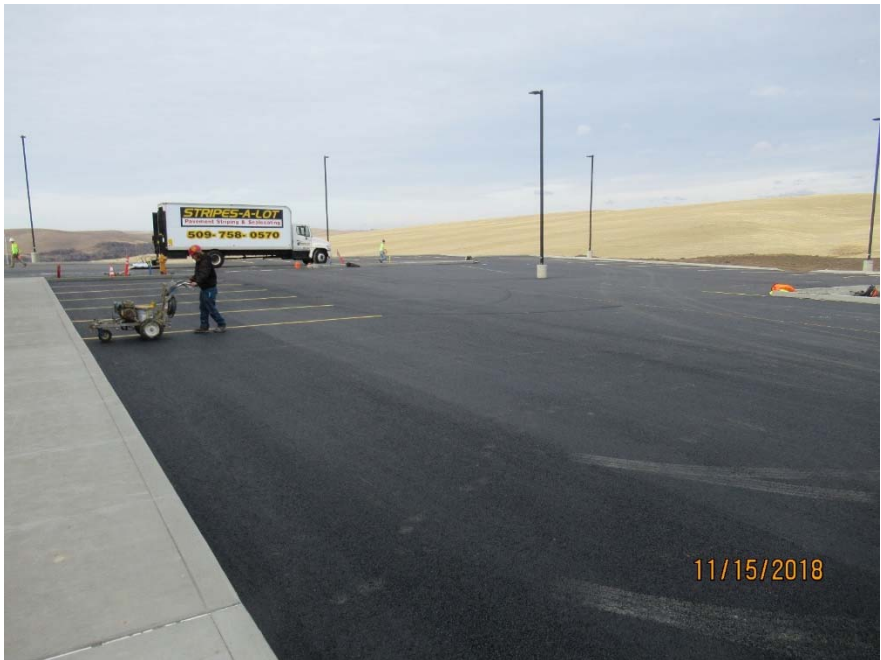
2. **Appears the contractor is striping North parking lot that was asphalted yesterday.**

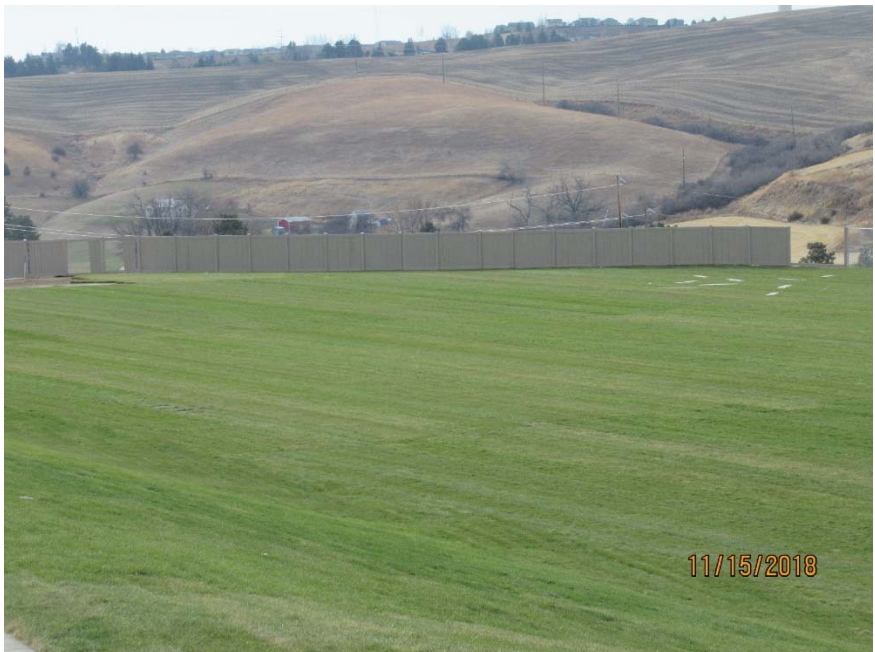
3. **The contractor has not fixed the vinyl fence nor have they picked up the fence pieces strung across the play field.**

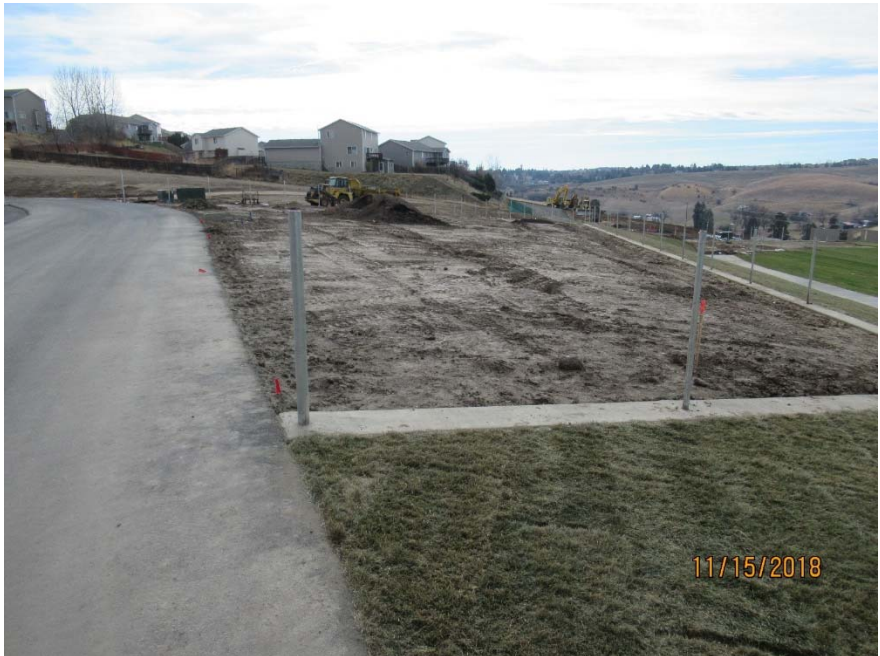
4. It appears the landscaper is done for the year. There has been no change to the south play area.

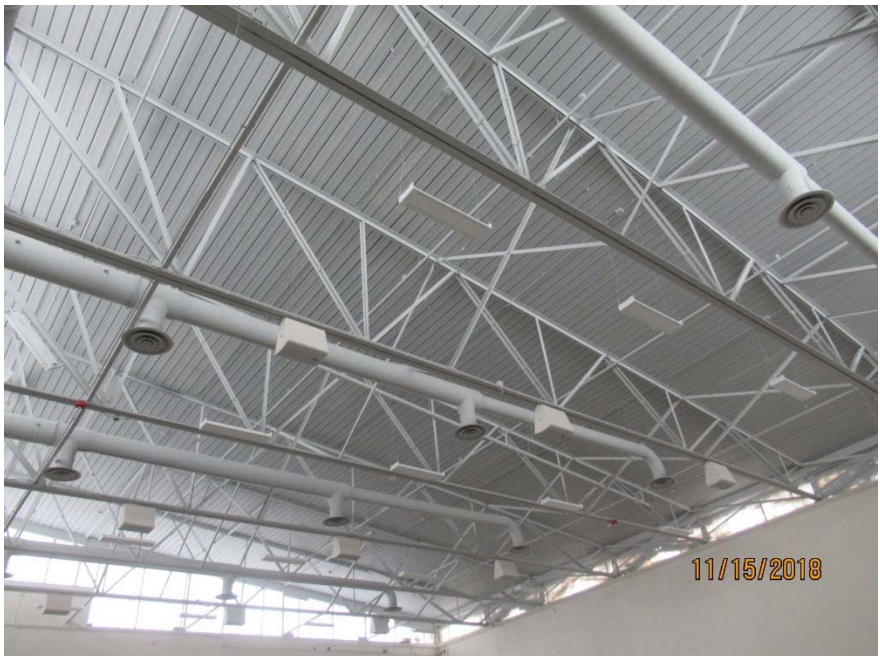
5. The contractor has placed some of the lighting in the gymnasium.

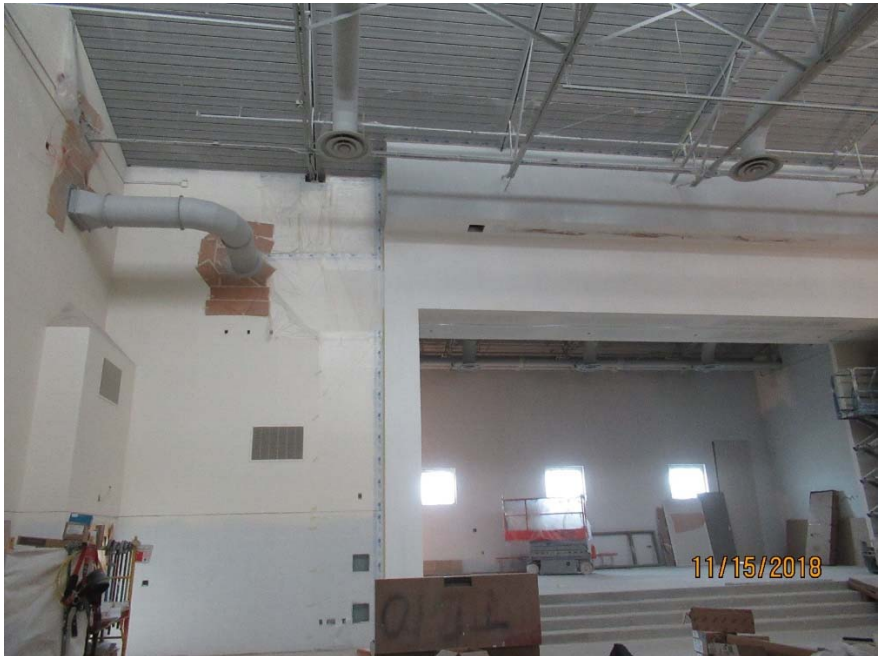
6. It appears the painter is painting the ductwork in the Multi-purpose room.

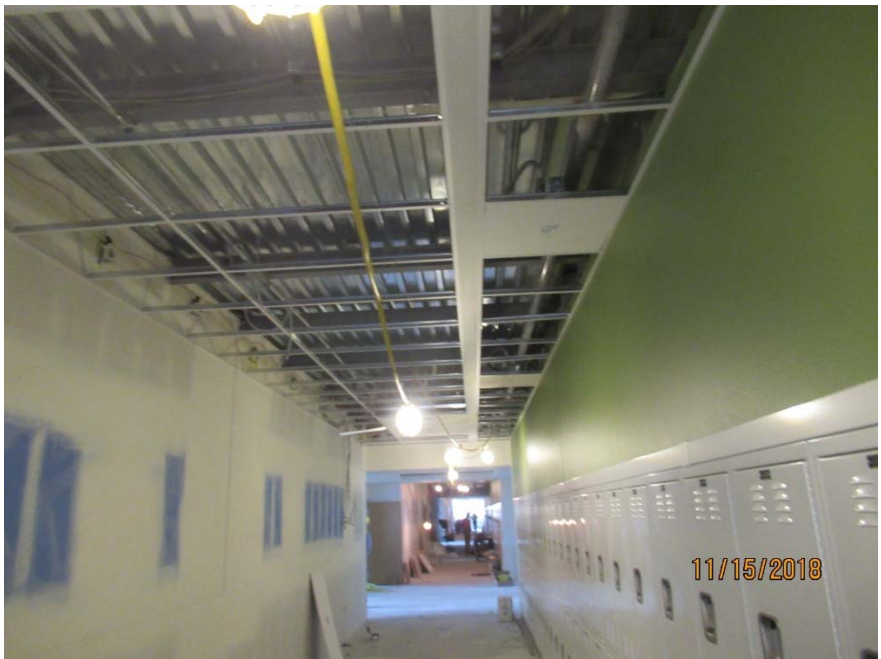
7. Contractor has installed some of the lighting in the upper level corridors.

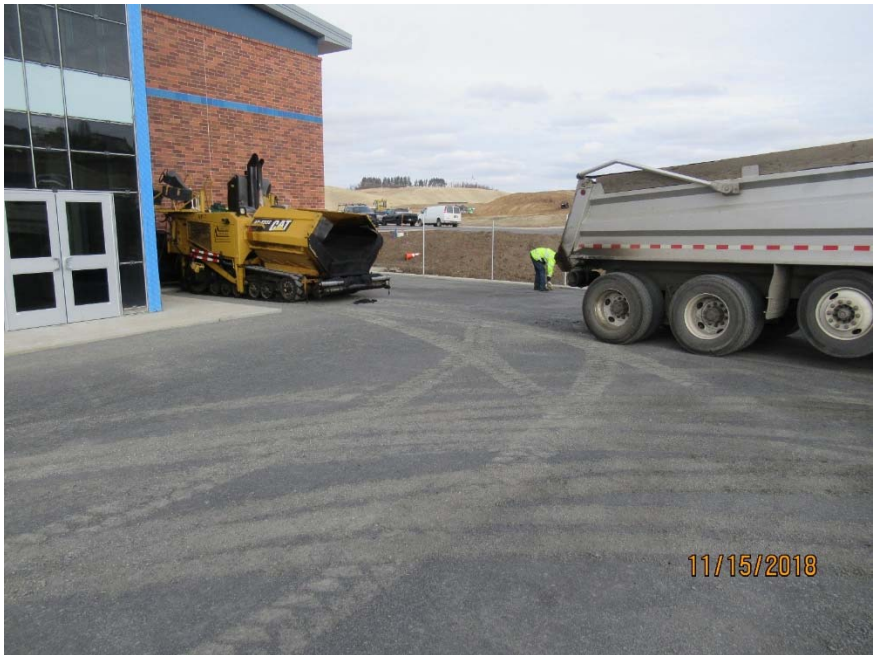
8. The asphalt contractor appears to be setting up to [place asphalt at the hard surface play area at the south playground.

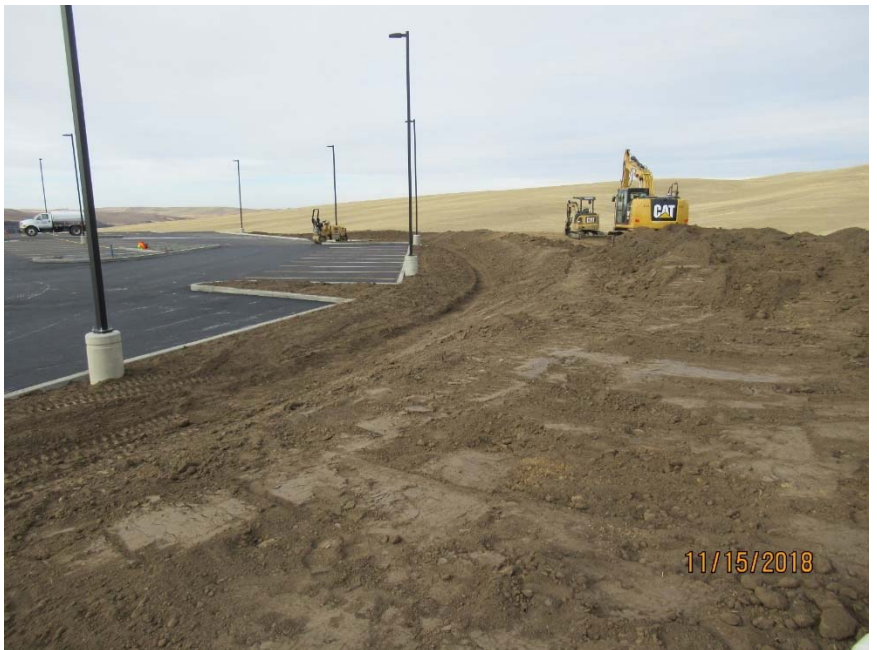
9. It appears the contractor has roughed in the pond north of the north parking lot.

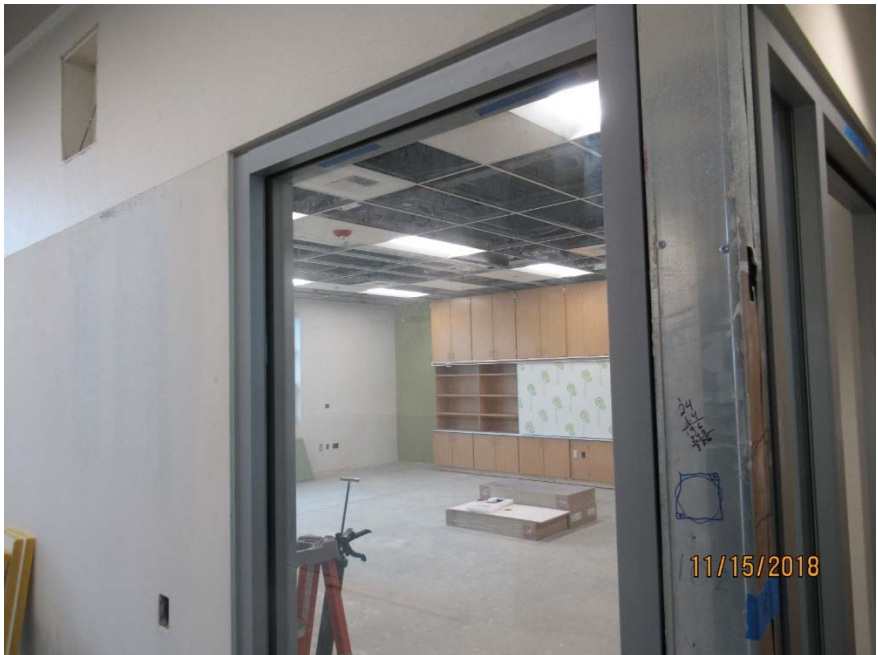
- 10. It appears the contractor is installing glazing in the interior classroom windows. The glass is loose in the frame. See below.**

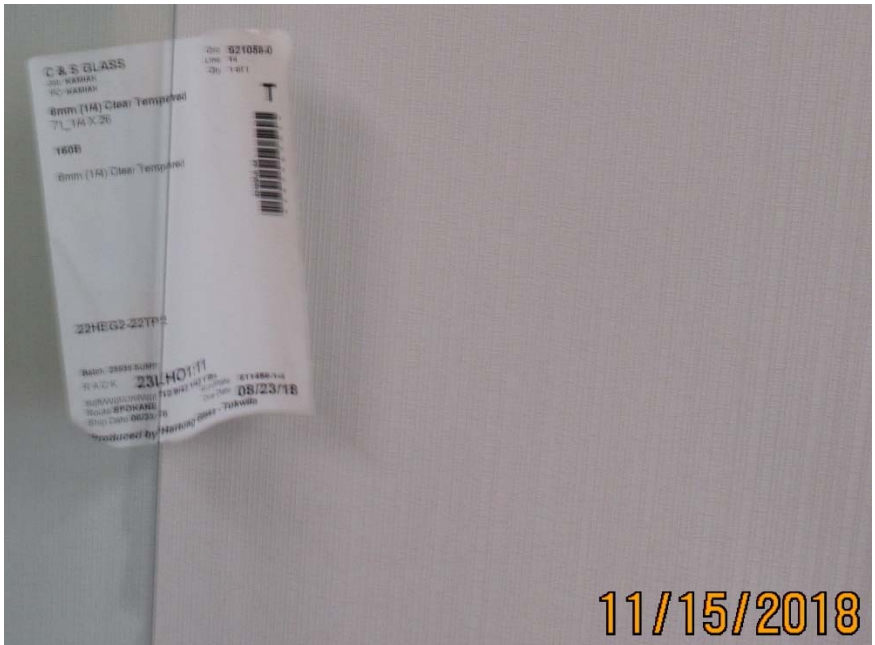
- 11. It appears the contractor is installing 1/4" tempered glass. This is incorrect because this was changed to laminated safety glass (two layers of 3/16" thick clear float glass, laminated with 0.060" thick poly vinyl butyl interlayer) with the acceptance of PR-25 on 8/23/18.**

Deficiencies: Covering the HVAC diffusers an ongoing issue not yet addressed. The tall storefront at breakout spaces has not yet been sealed on the inside between floors. Both these issues are addressed in the commissioning issues log. Contractor installing incorrect glazing in interior window frames.
