## Observation Report

**Project: PSD: Kamiak Elementary School**

**Date: November 2, 2017**

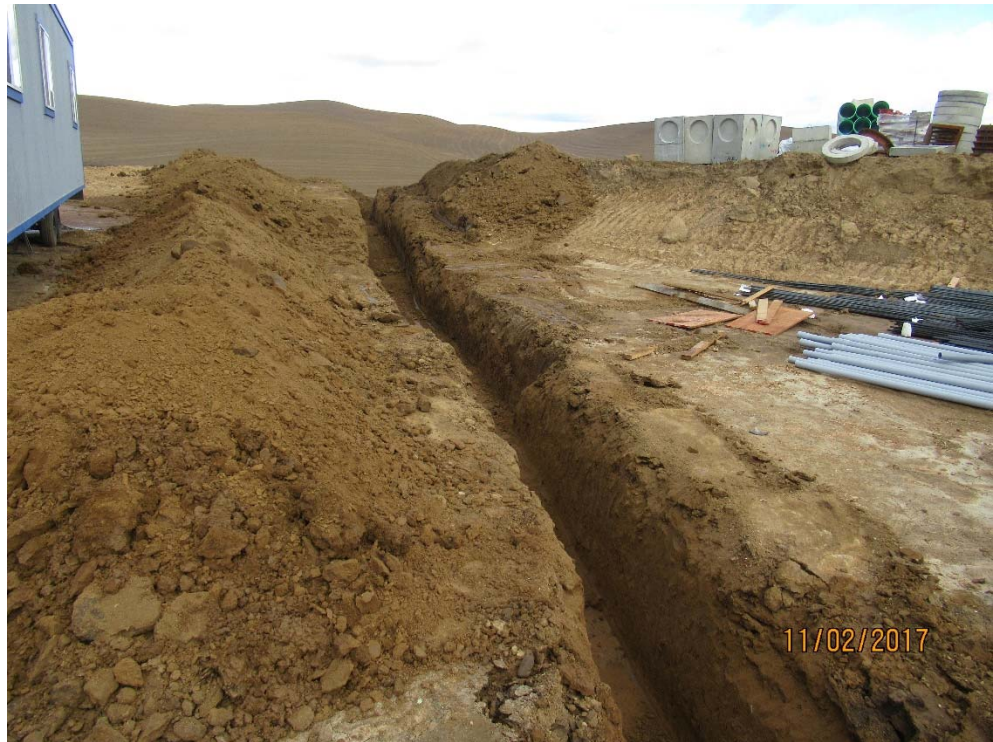
1. Appears the contractor has dug the trench for temporary power.

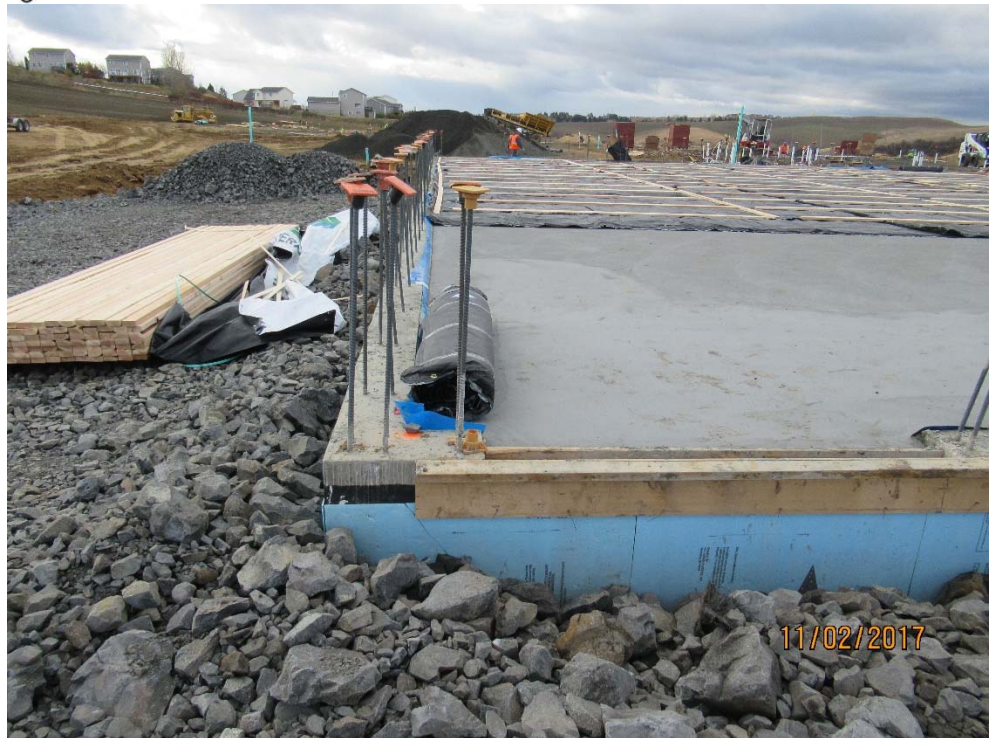
**2. Looking south:**

**Appears the contractor has placed the concrete slab for the gymnasium. Appears the contractor is covering concrete with blankets to contain heat during the curing overnight.**

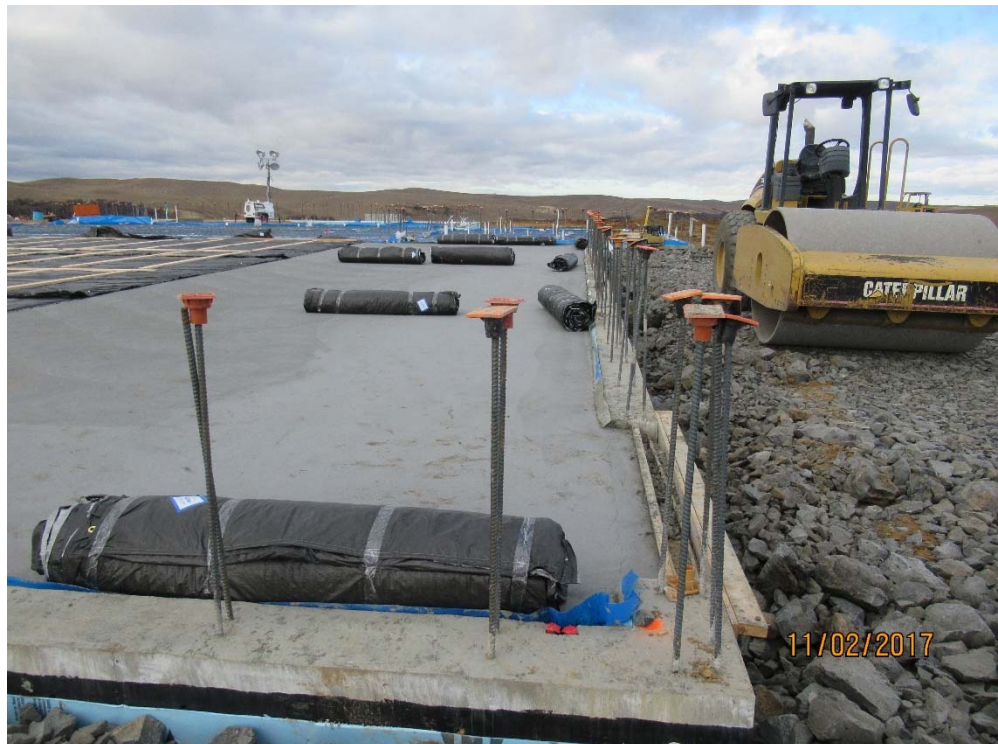
**3. Looking west:**

**Appears the contractor has placed the concrete slab for the gymnasium. Appears the contractor is covering concrete with blankets to contain heat during the curing overnight.**

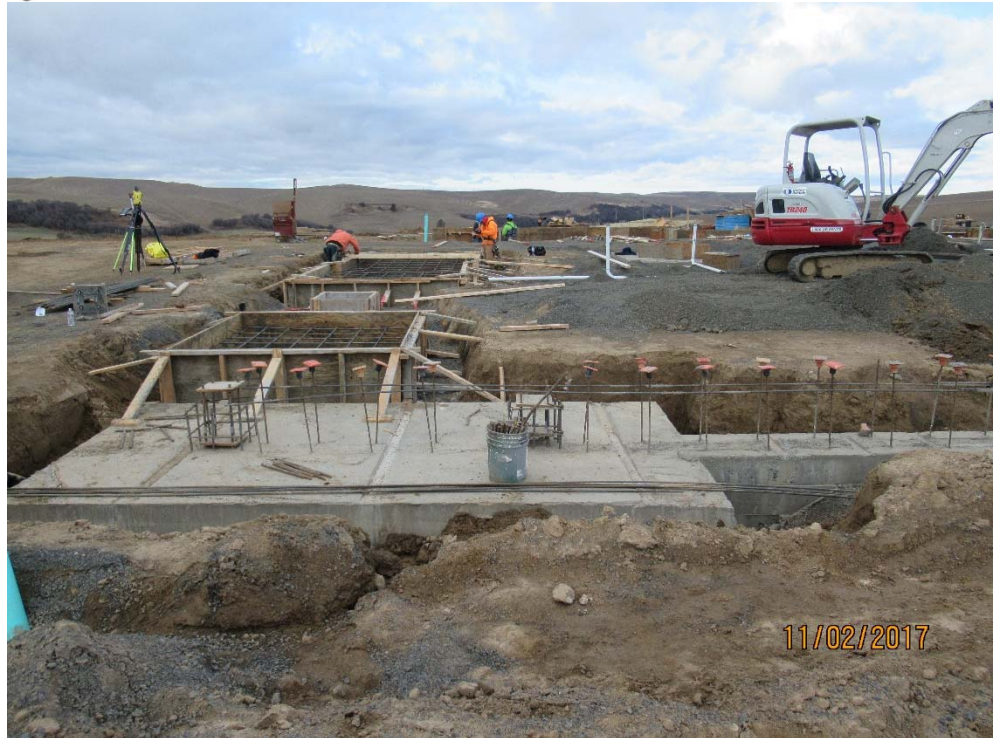
**4. Looking west along grid line "O". Appears the contractor has framed and placed rebar in the 2 interior footings.**

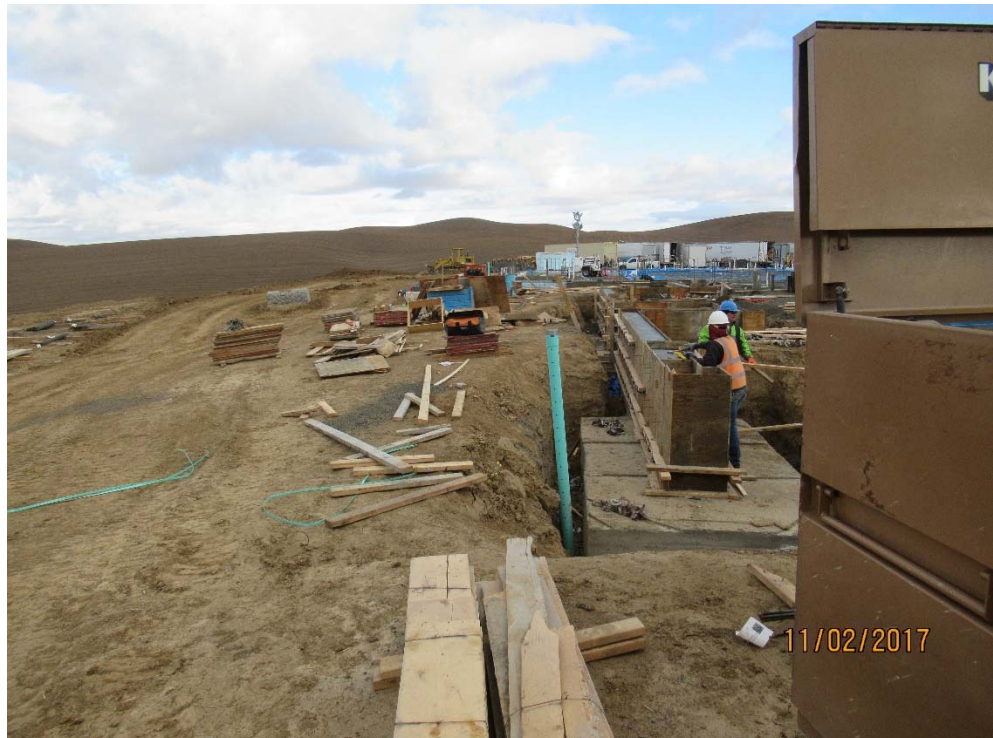
**5. Looking north along grid line "T". The contractor has placed the exterior wall stem walls and appears to be striping forms.**

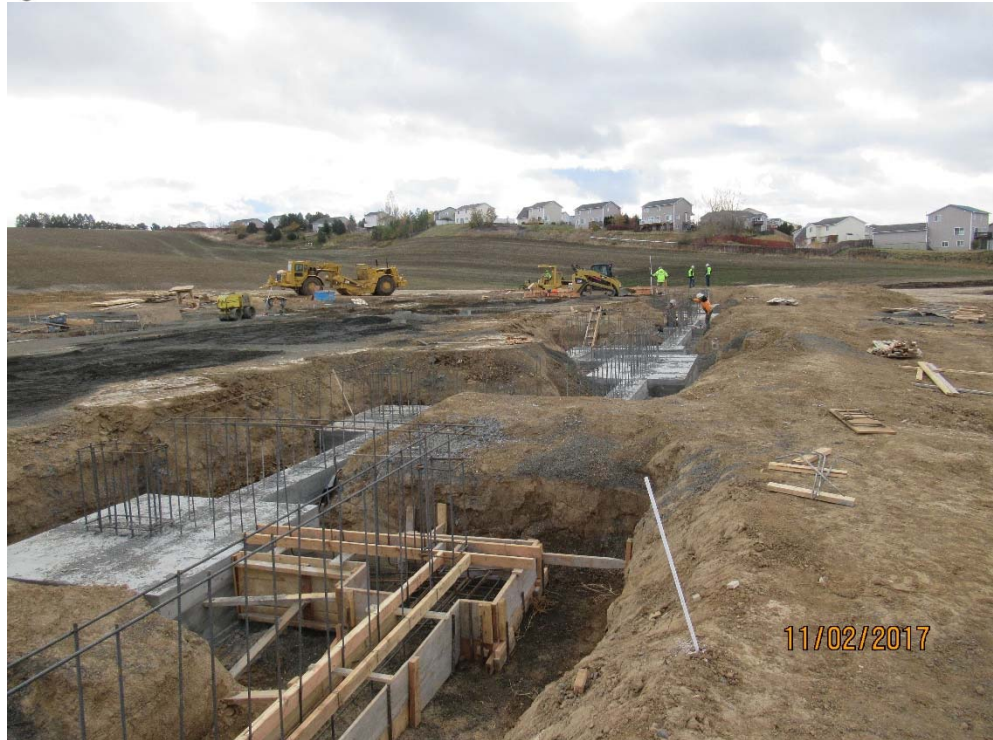
**6. Looking south along grid line “S”. Appears footings from gridline “H” to south end of building have been placed. Exterior footing forms from grid line “H” to “L” also appear to be placed.**

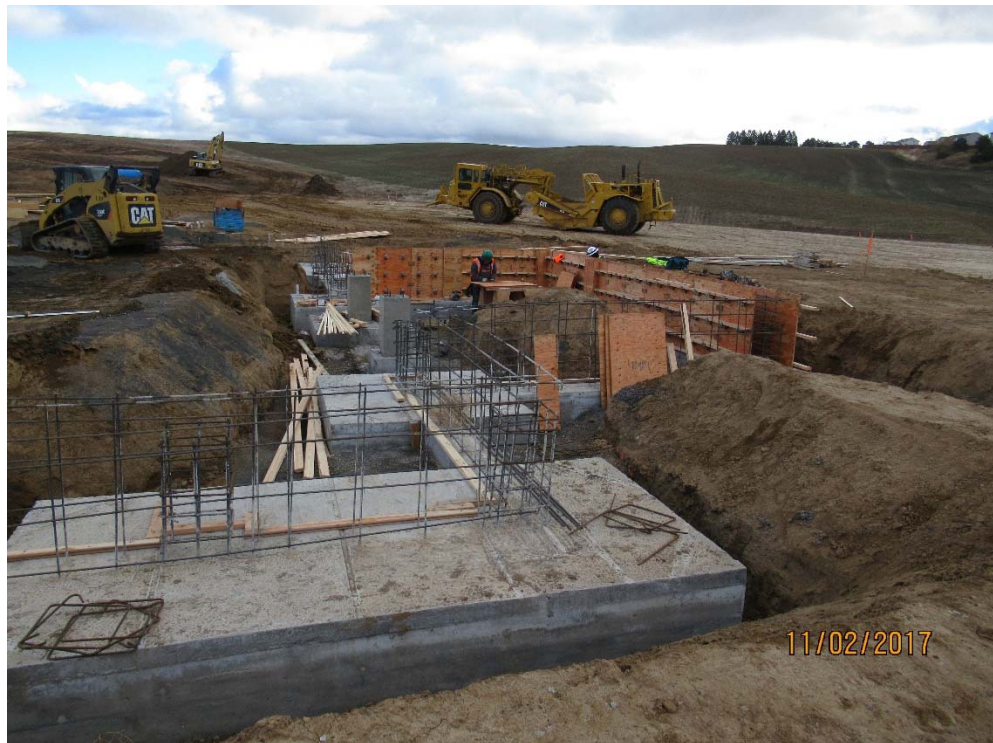
**7. Looking east along grid line along grid line “B”. Appears footings have been placed and the contractor is forming stem walls. Note in the background earthwork contractor continues to move dirt to lower playfield as well as placing dirt at the building south end kindergarten play area.**

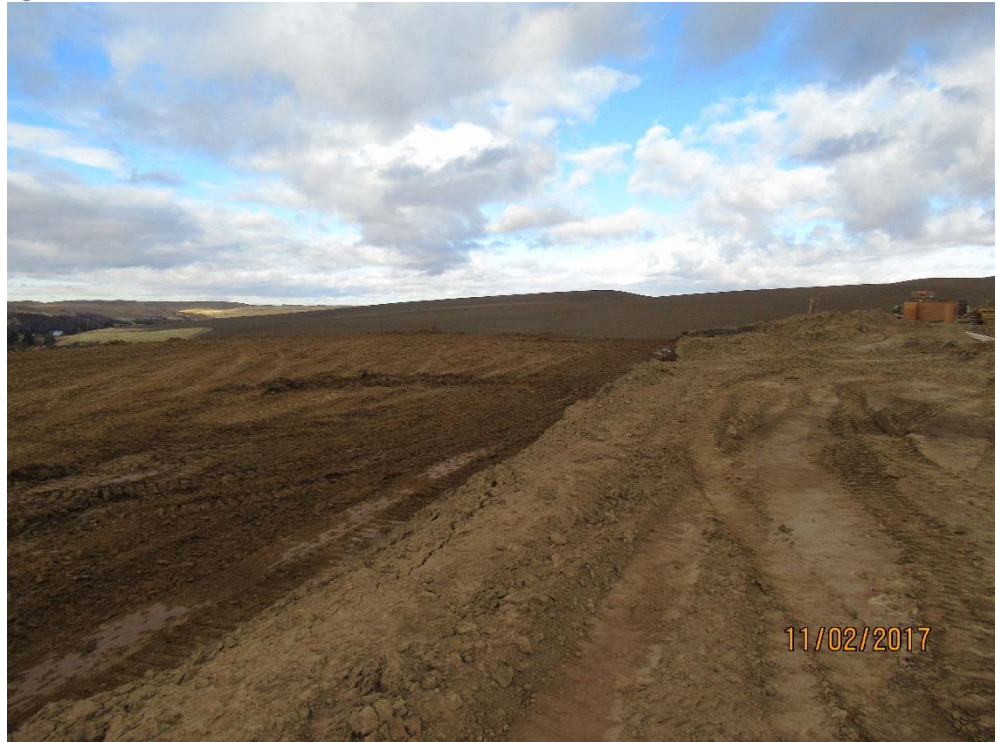
**8. Looking north:  
10/18/17 report from  
GPI says the west  
(upper) playfield is  
approximately 4 feet  
below subgrade.**

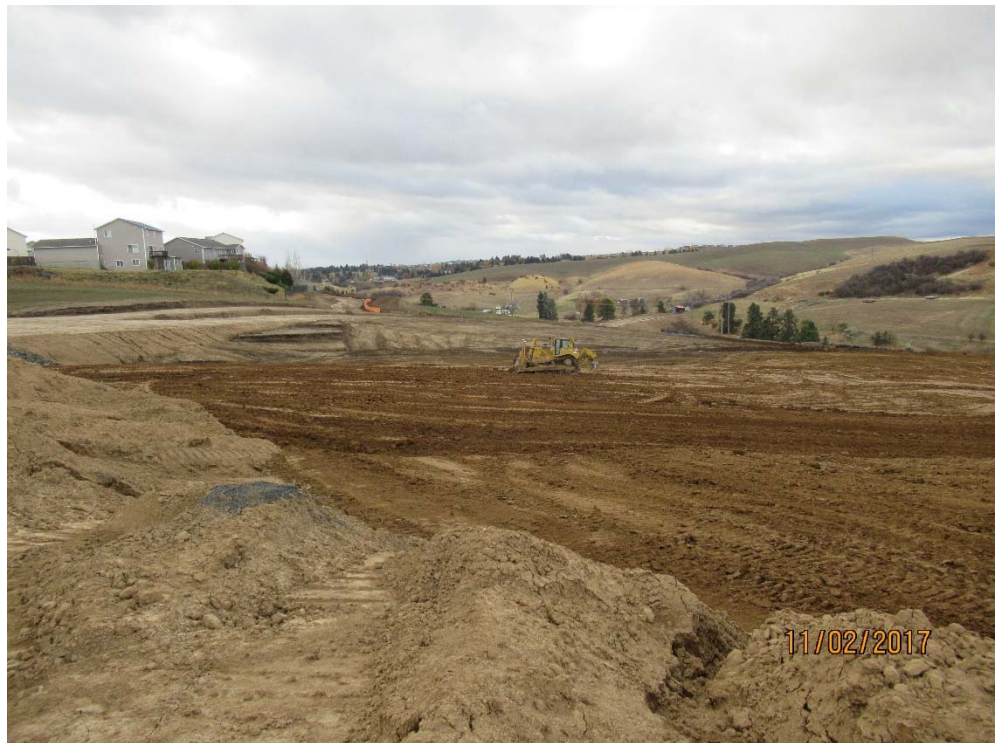
**9. Looking south:  
Appears the earthwork  
contractor continues to  
move dirt from the east  
side of what will be  
NW Terreview Drive to  
the south (lower)  
playfield.**

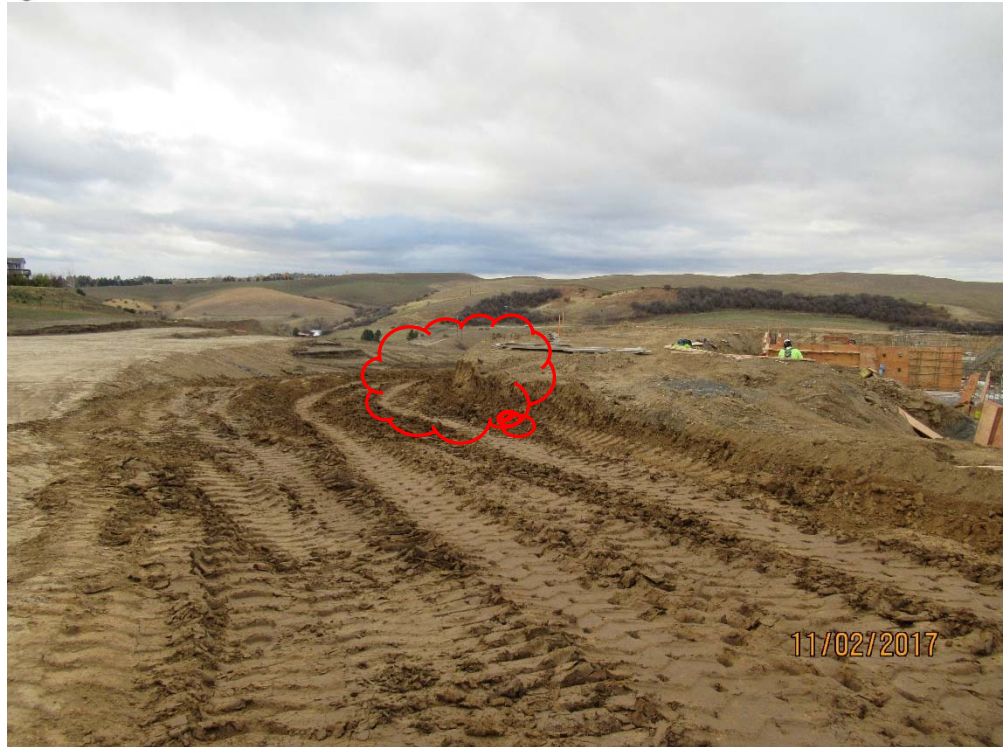
**10. Looking west:**  
Appears the earthwork contractor is building up the area south of the kindergarten play area. The near vertical drop off has been reduced considerably.
