**Project: PSD: Kamiak Elementary School****Date: November 29, 2018****Weather conditions:**

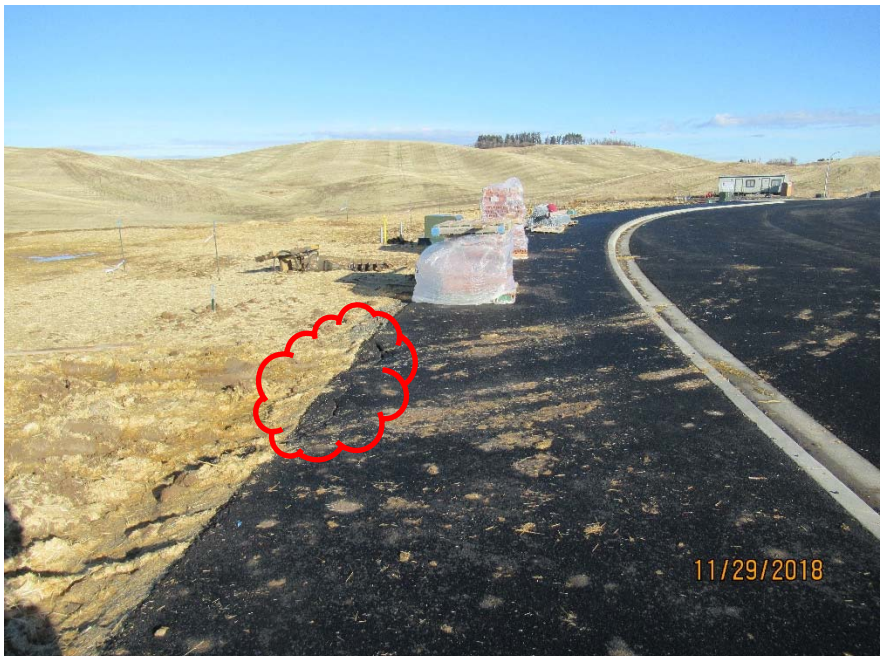
1. It appears the developer has applied straw erosion control to the lots north of the Kamiak site. The pallets of building materials on the asphalt path belong to Kamiak contractor(s). The Kamiak contractor is aware they damaged the asphalt path in bubbled area and will repair it in the spring.

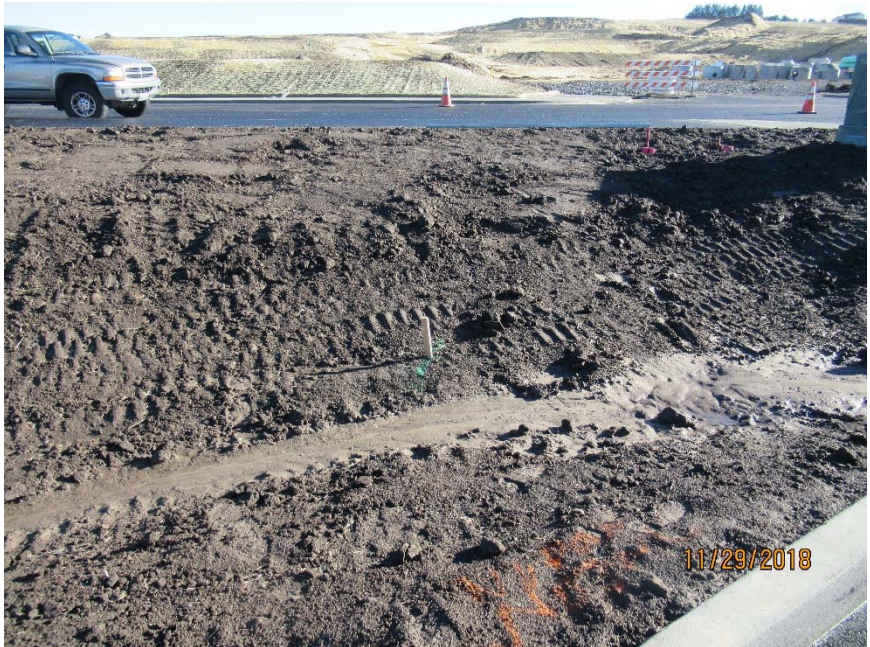
2. The stake in the center of this photo is the location where the Kamiak northern sewer pipe ends. The connection was not made by the developer. View is looking to the east.

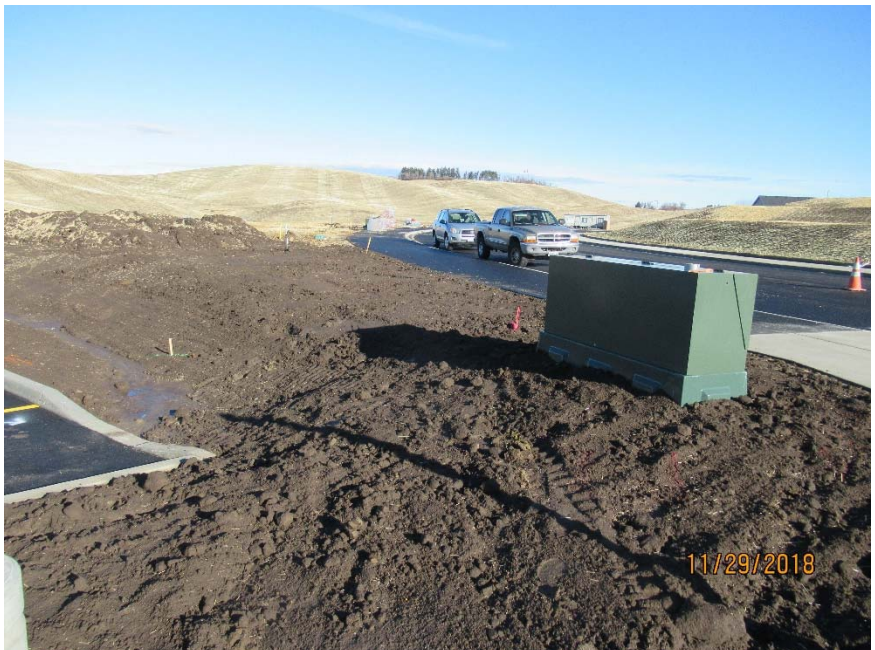
3. The developer's contractor is not sure where the end of their sewer pipe is located. They will be back next week to dig up both pipes and make the connection.

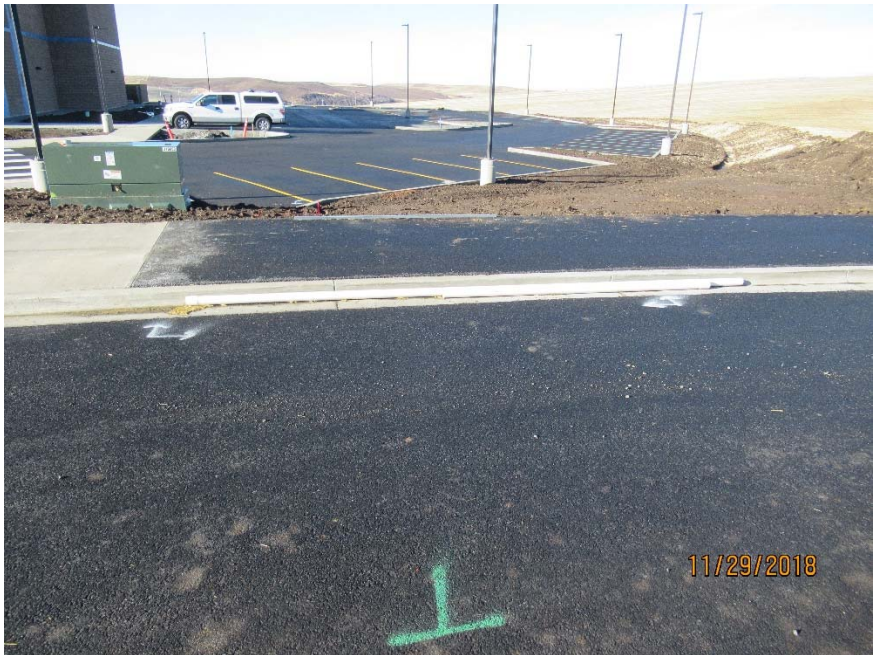
4. The inverted “T” in this photo designates where it is believed the “Y” is located for connection of the sewer line mentioned above. It appears that this “Y” is down stream of the pipe from Kamiak.

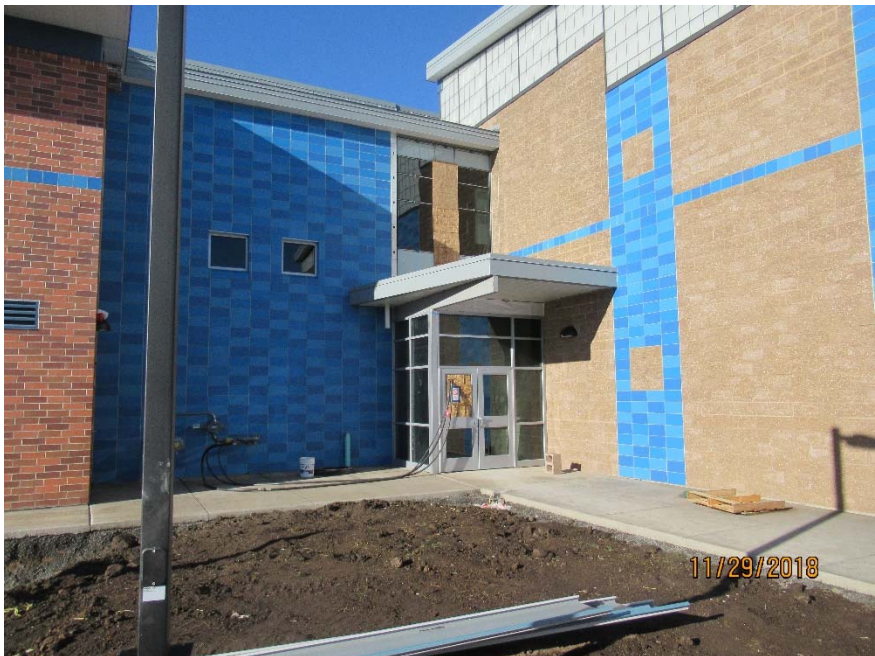
5. It appears the contractor has taken delivery of more glazing. We are hoping that all exterior glazing will be installed soon so the contractor can finish installation of framing closure pieces.

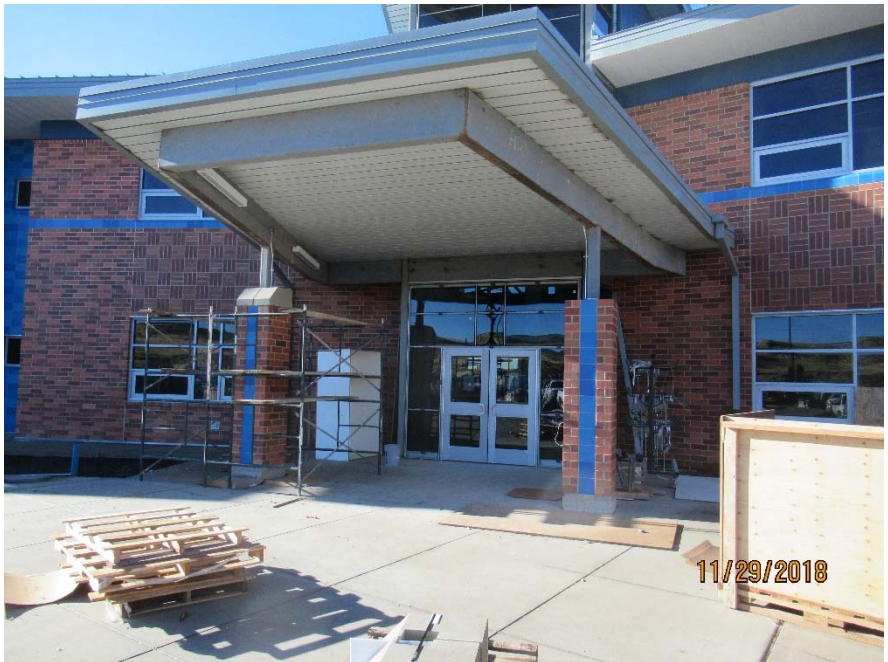
6. Contractor has installed one set of precast caps at the top of the 2 columns at the main entrance.

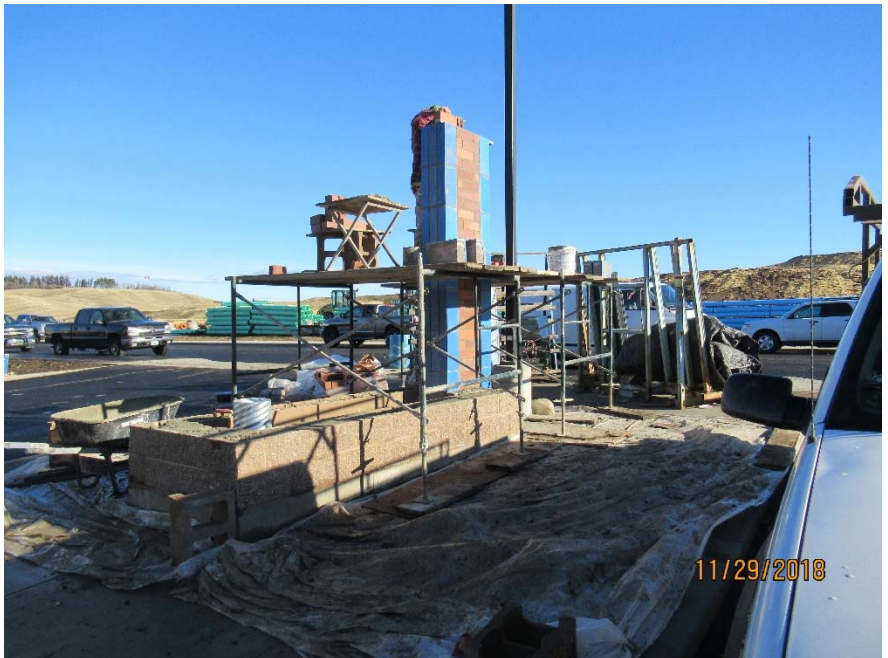
7. Masons constructing the school monument signage masonry.

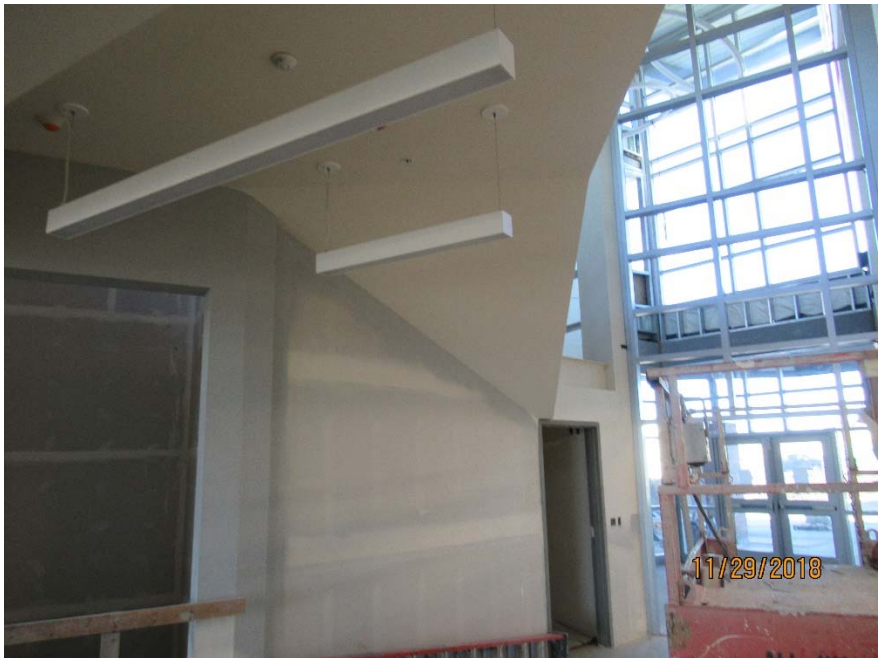
8. It appears the painting has been completed at the main entrance. Where the wallboard appears unfinished is where compact laminate will be installed.

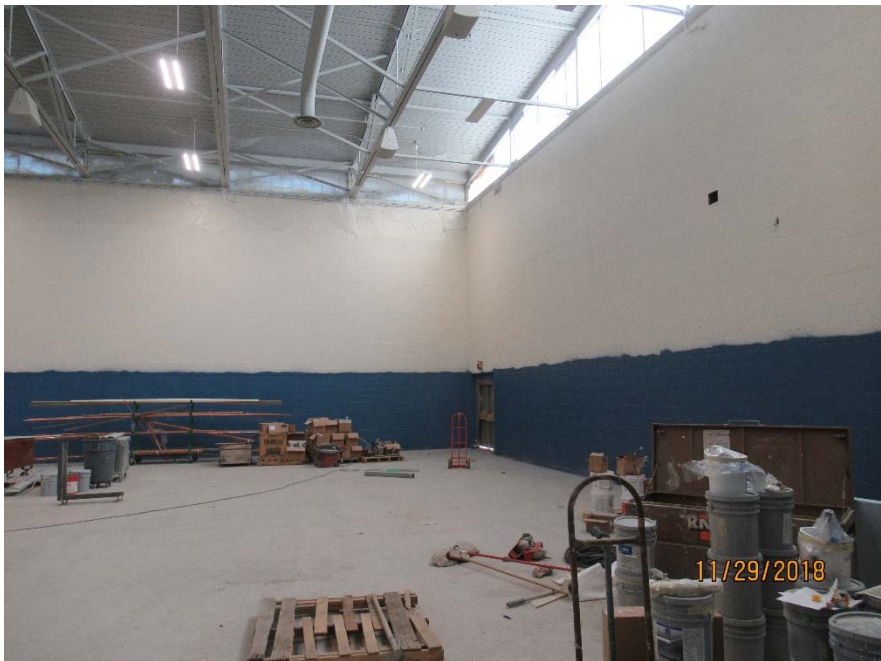
9. Gymnasium painting lower wall is underway.

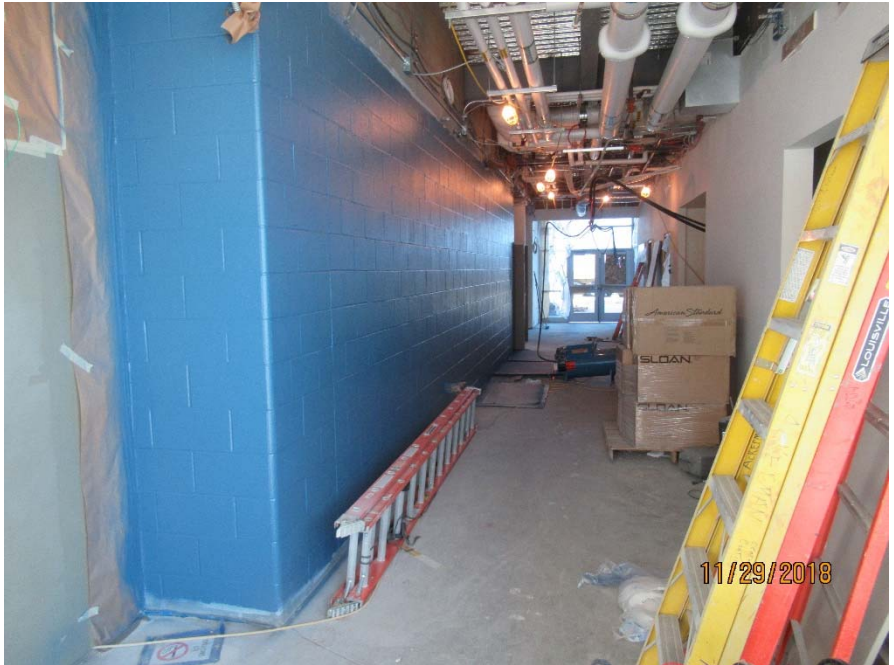
- 10. Painter has painted accent wall in Corridor 140 just south of the Gymnasium.**

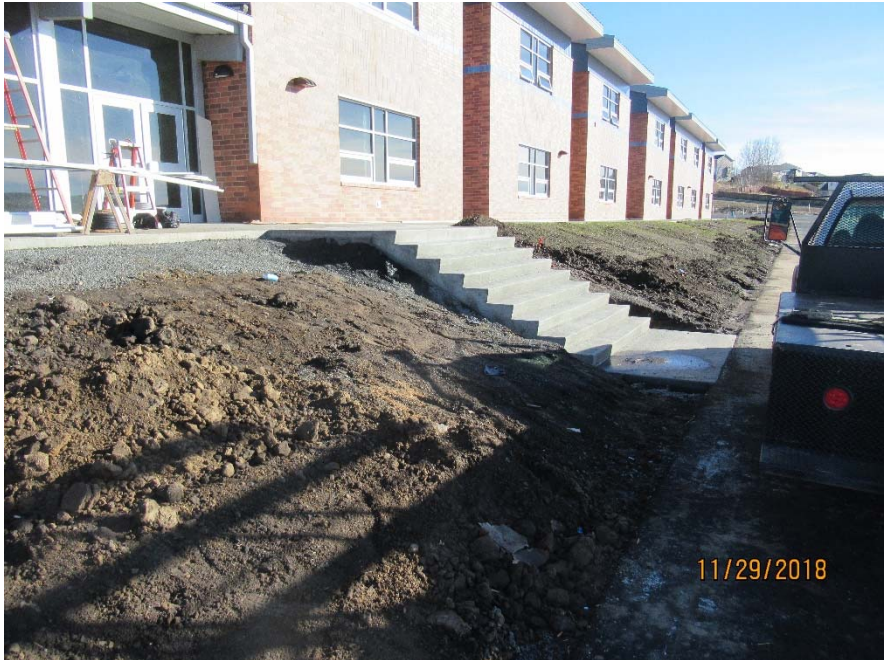
- 11. Contractor has stripped the forms from the exterior stair from building to play area.**

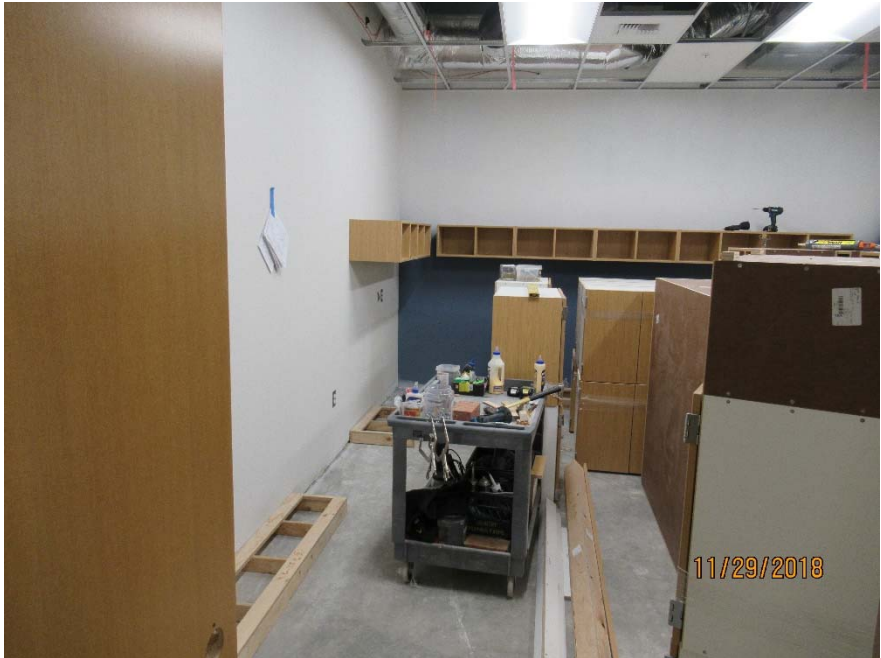
**12. Casework installation on the lower floor Area B continues.**

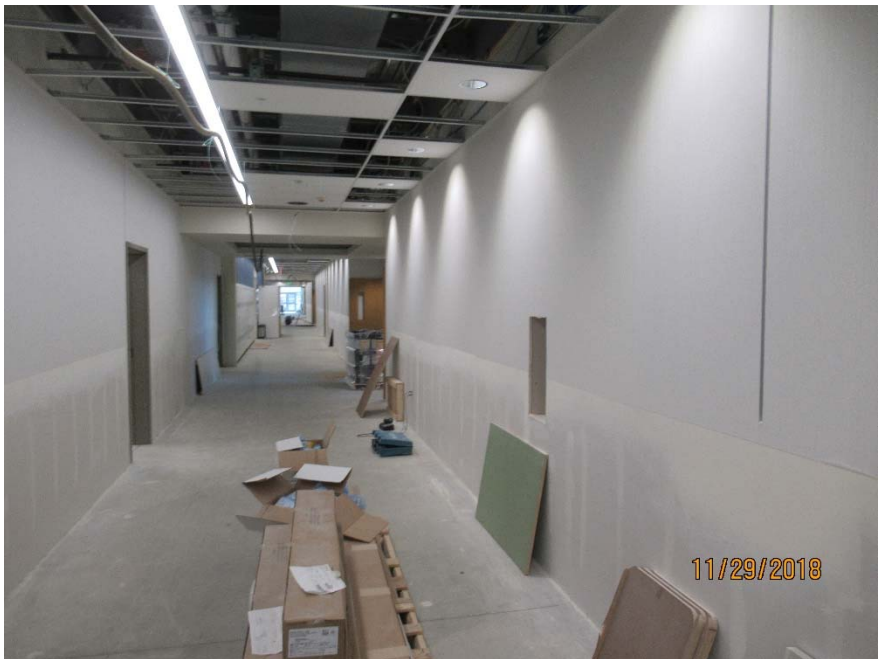
**13. Corridor 120 looking south. Contractor has hung upper wall covering.**

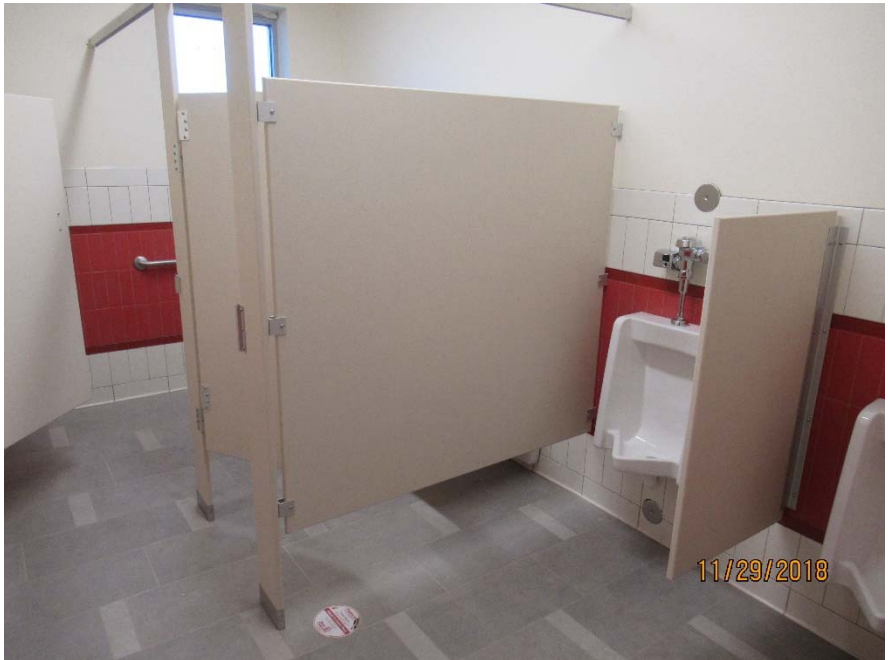
**14. Installation of rest room  
toilet compartments is  
underway.**

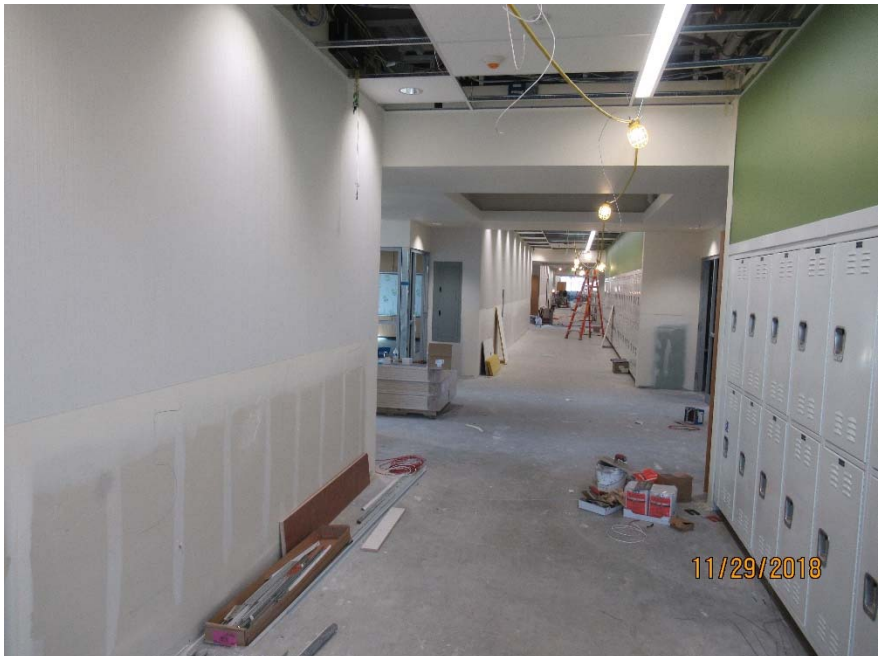
**15. Corridor 220. Contractor  
has hung upper wall  
covering.**

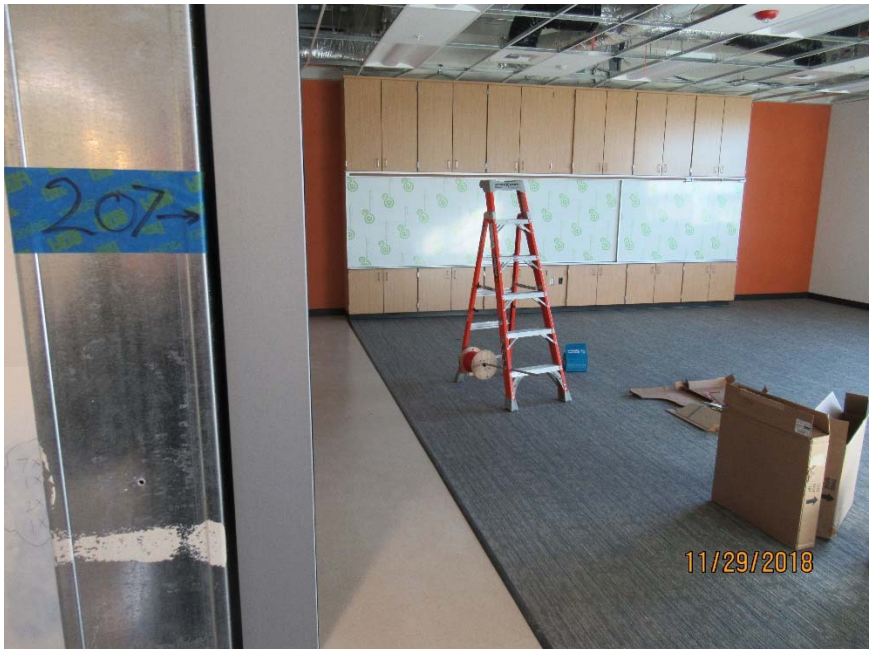
**16. Flooring contractor has placed carpet and floor tile in the following classrooms: 202, 206, 207, 208, 211, 212, 213, 217, 221, 225, and carpet I work room 219.**
