**Project: PSD: Kamiak Elementary School****Date: December 20, 2018****Weather conditions:**

Discussion with: See Construction Progress Meeting minutes dated 12/20/18**Construction Activities:**

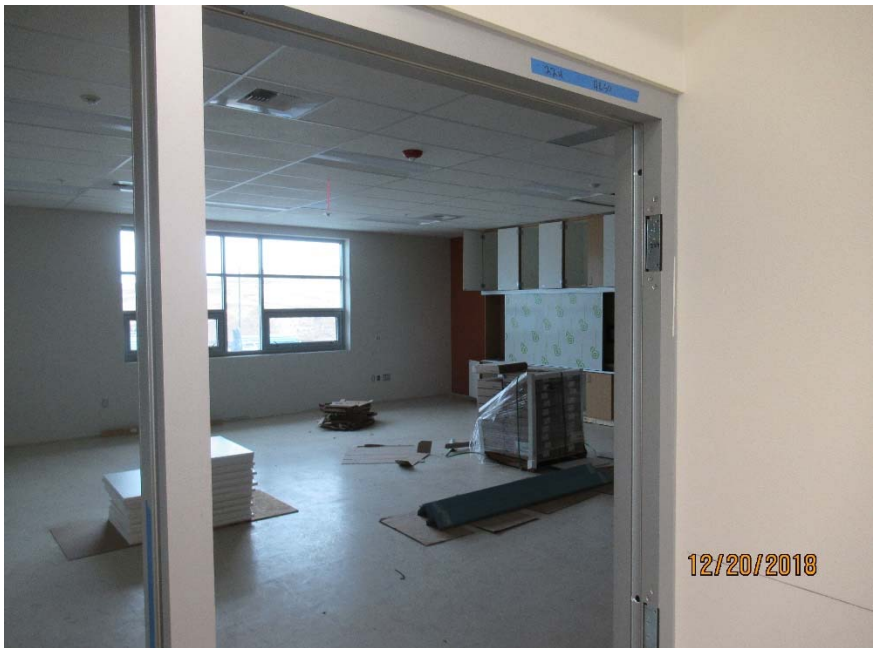
1. Floor tile has been installed in Steam Classroom 224 and Art Classroom 227.

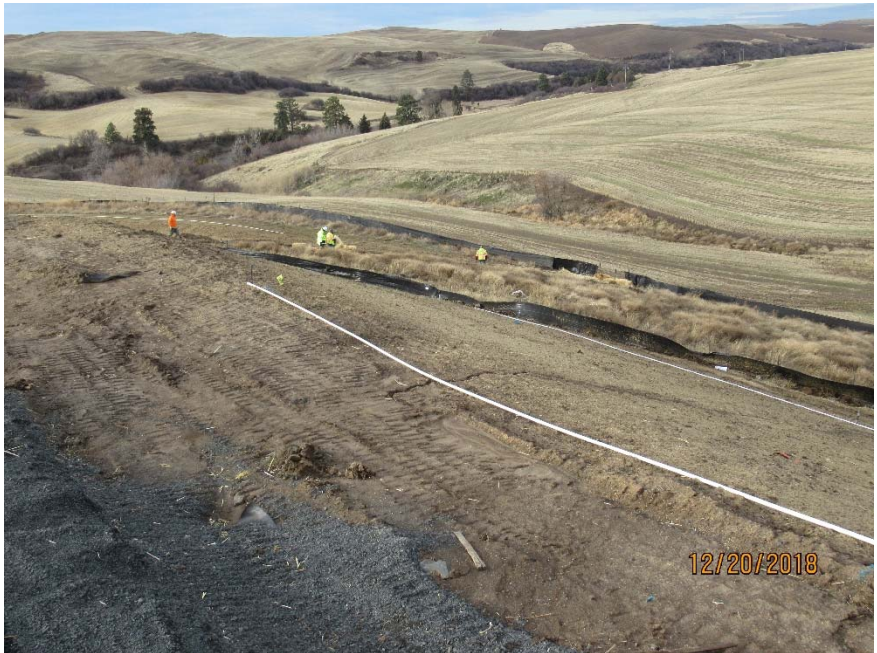
2. It appears Motley is placing straw bales where there has been erosion.

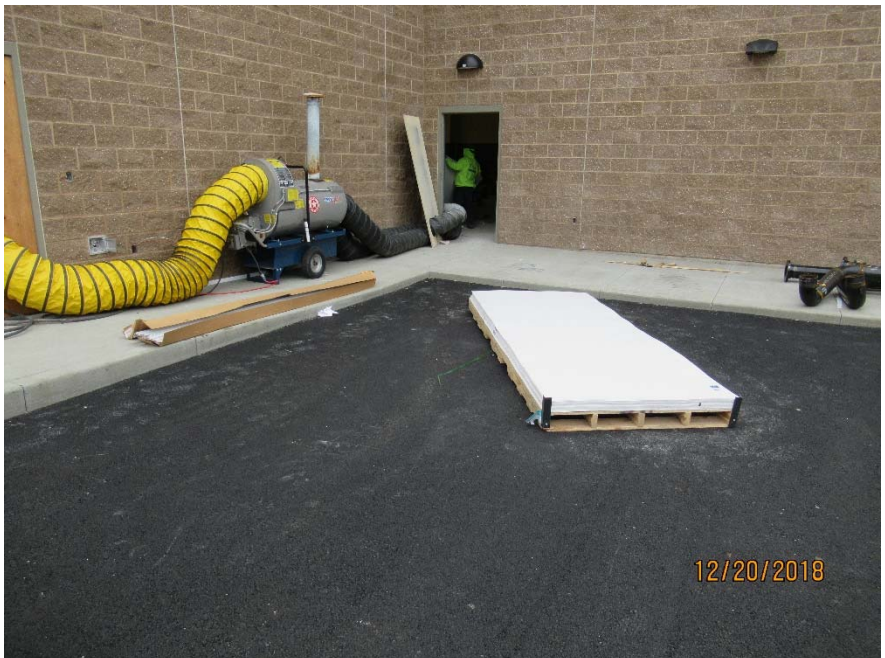
3. Contractor has accepted delivery of FRP and is currently taking material into building.

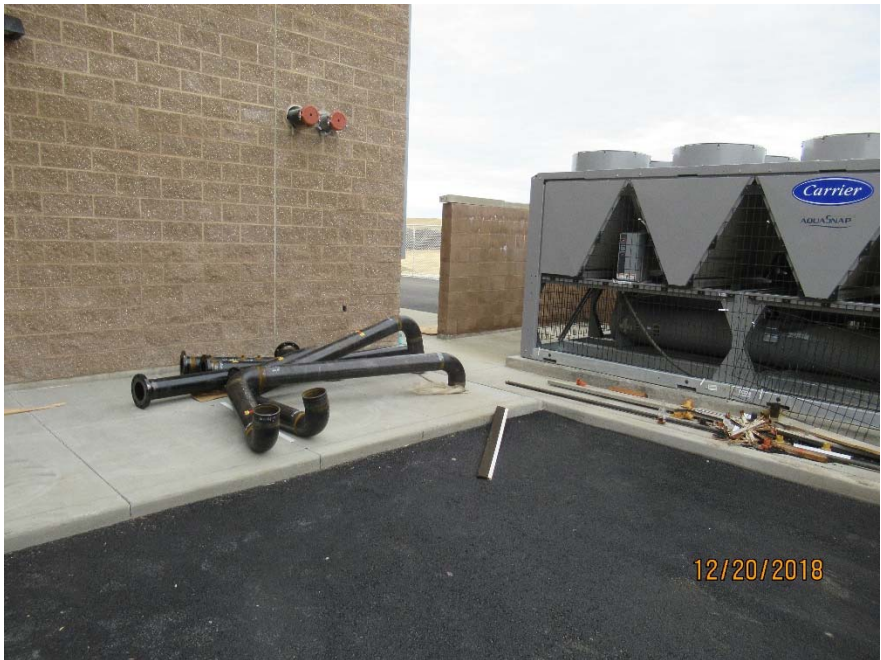
4. It appears the piping to connect the chiller to building piping has been delivered.

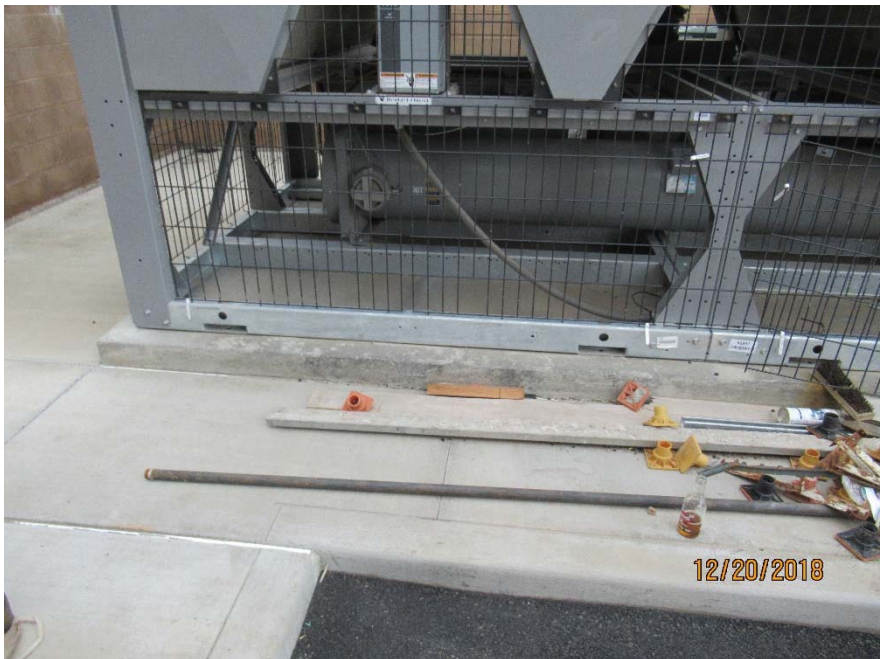
5. Contractor still needs to permanently attach the chiller to the slab.

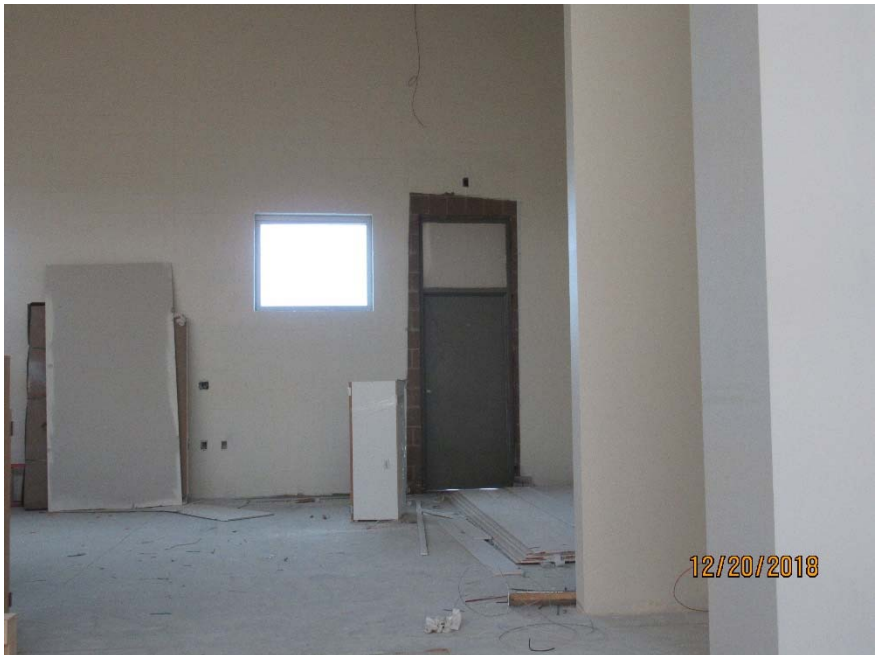
6. The HM exterior door on the Stage has been installed.

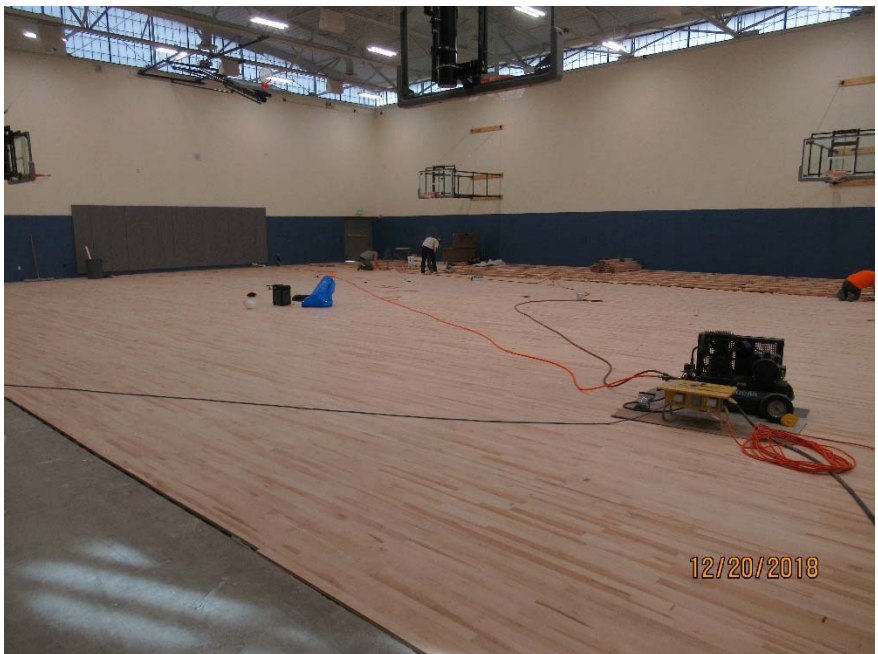
7. Contractor installing gymnasium flooring.

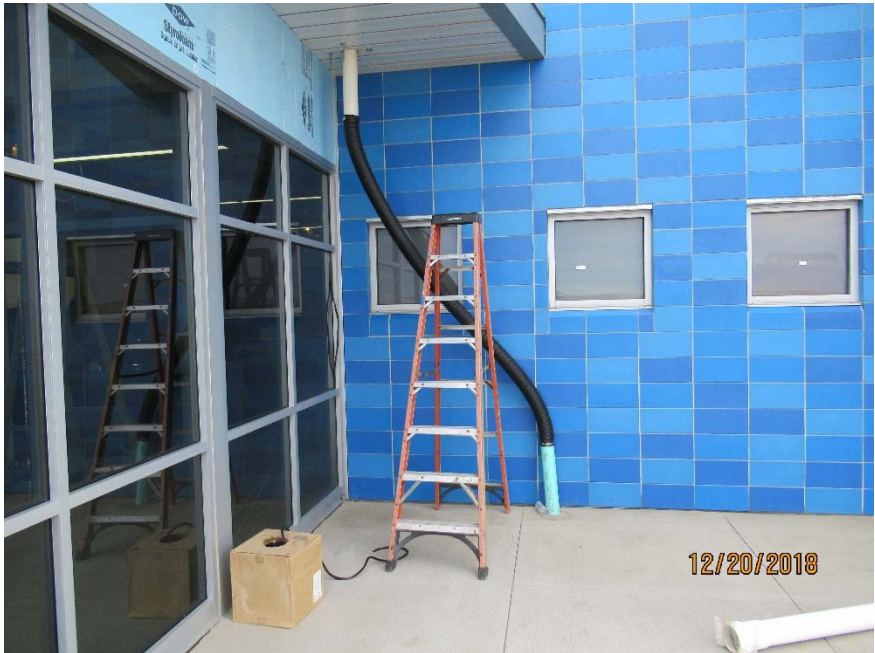
8. Contractor has attached the roof downspout to the storm drain pipe with a temporary flexible pipe. This should stop the water intrusion at the base of the clearstory frame until the final pipe connection is made. I have ESD 101 Industrial Hygienist coming to the site on Friday 12/21/18 to test for moisture inside the building in this area as well as others where water intrusion is a concern.

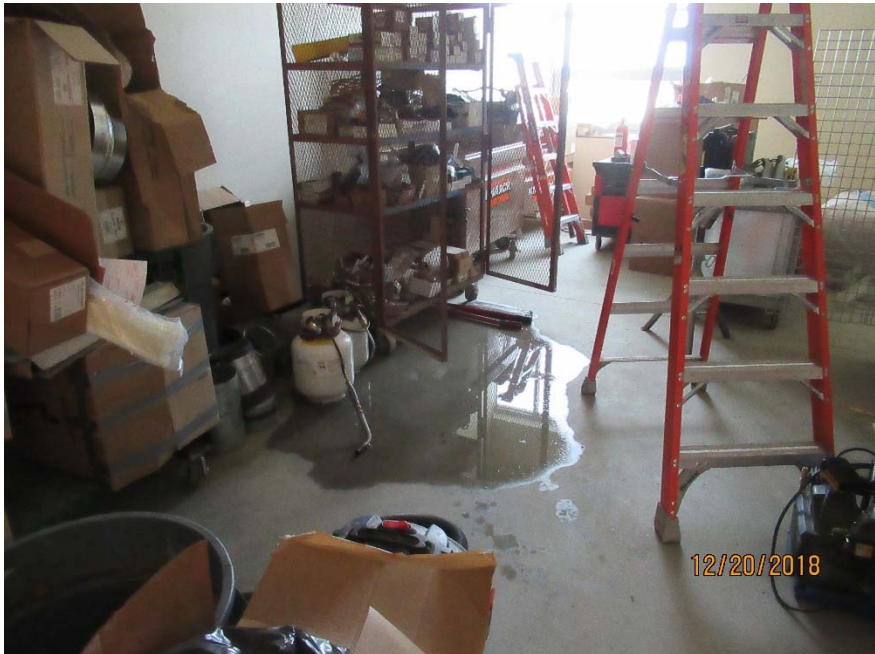
9. There was water intrusion at Janitor / Storage 135, this room is to the right of the photo above. Water got in under exterior door as the threshold is not yet installed. I have ESD 101 Industrial Hygienist coming to the site on Friday 12/21/18 to test for moisture inside the building in this area as well as others where water intrusion is a concern.

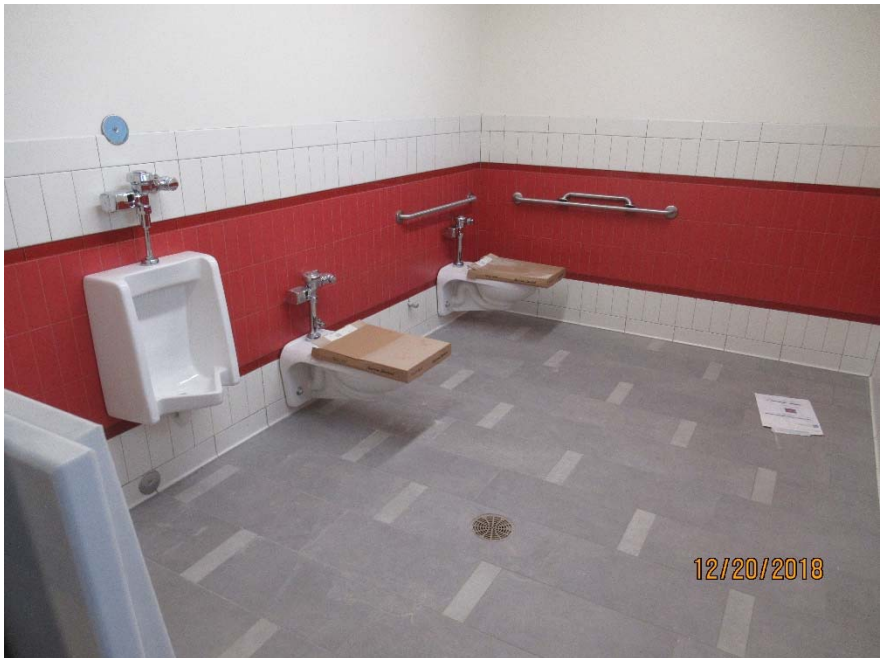
- 10. Appears restrooms 150 and 152 do not have the partitions installed yet. The other restrooms have the partitions installed.**

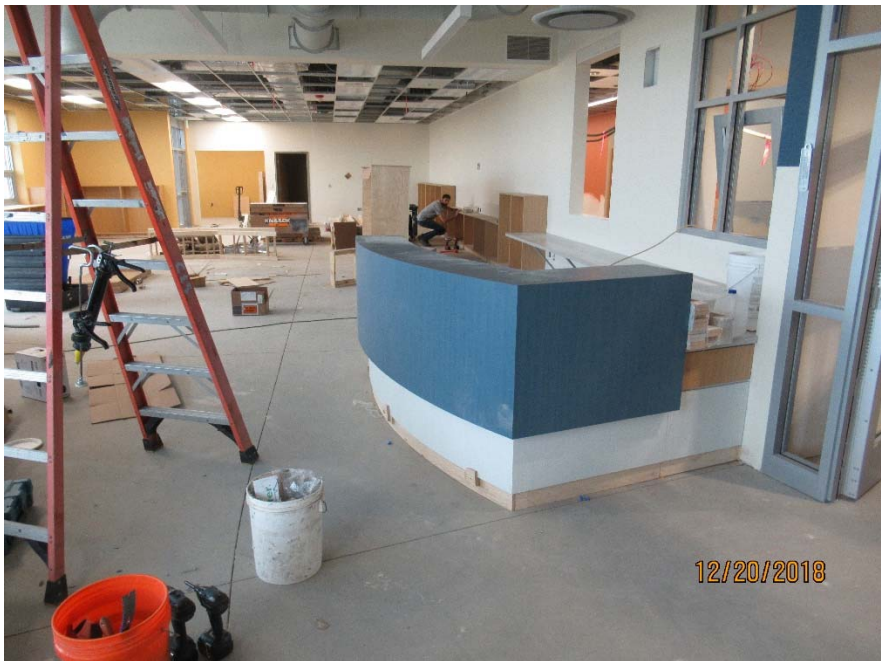
- 11. It appears the contractor is installing Library casework and circulation desk.**

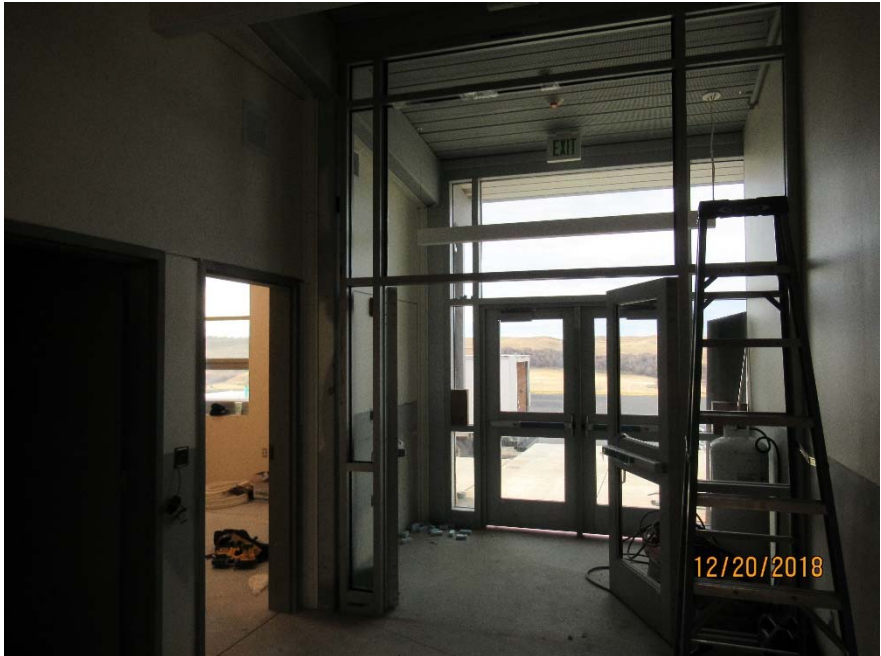
- 12. Contractor has begun installation of interior double doors to make Vestibule 129.**

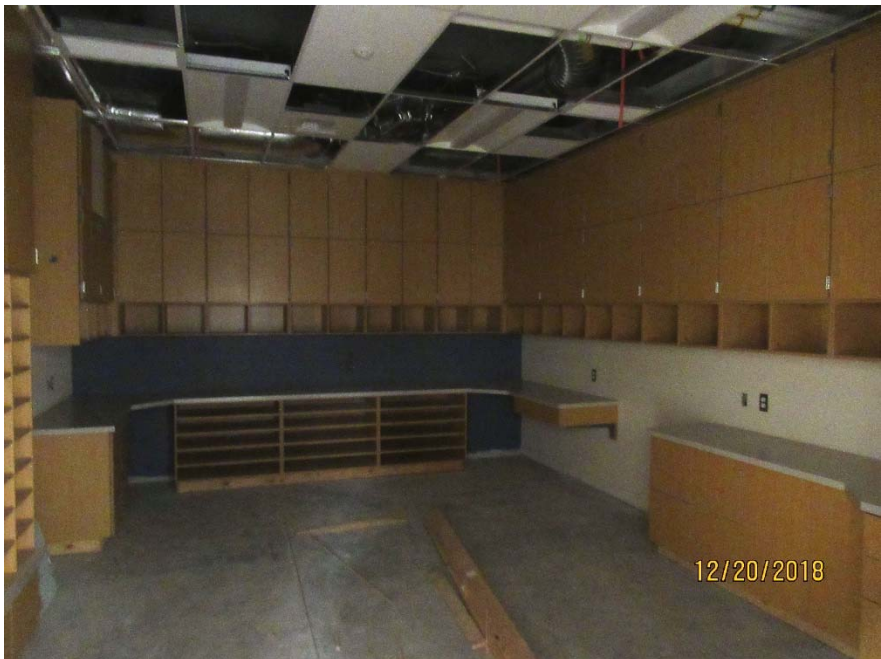
- 13. Casework installation in Staff work room 118M appears complete. Plan view of this room shows a square, which I believe is meant to be an island work station in the middle of the room. There are no elevations or sections showing this work station.**

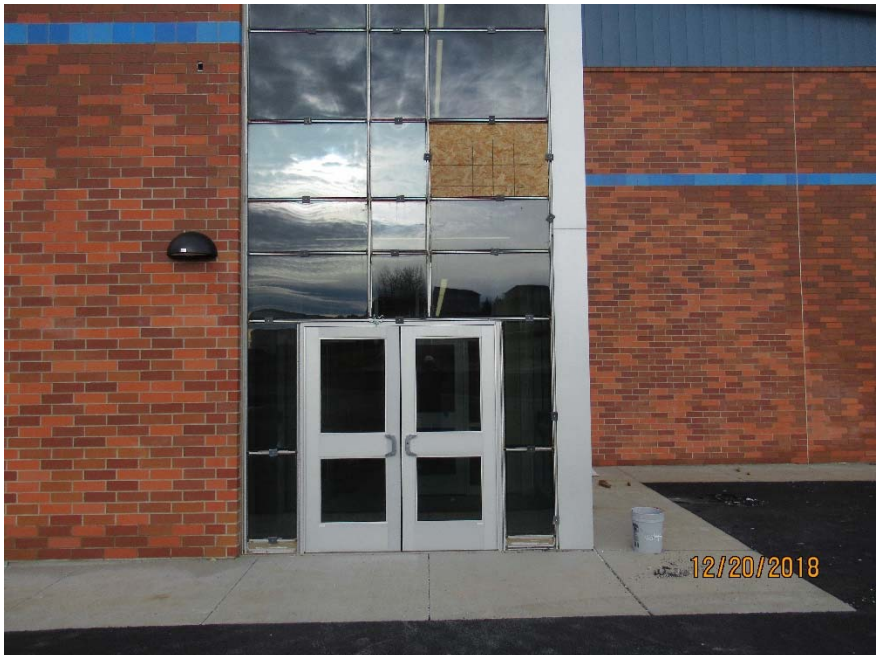
- 14. This is the south end of the building. A piece of glazing has fallen out of the frame. The contractor stated there was a screw failure. Spandrel glass will be replaced. I have ESD 101 Industrial Hygienist coming to the site on Friday 12/21/18 to test for moisture inside the building hard lid in this area as well as others where water intrusion is a concern.**

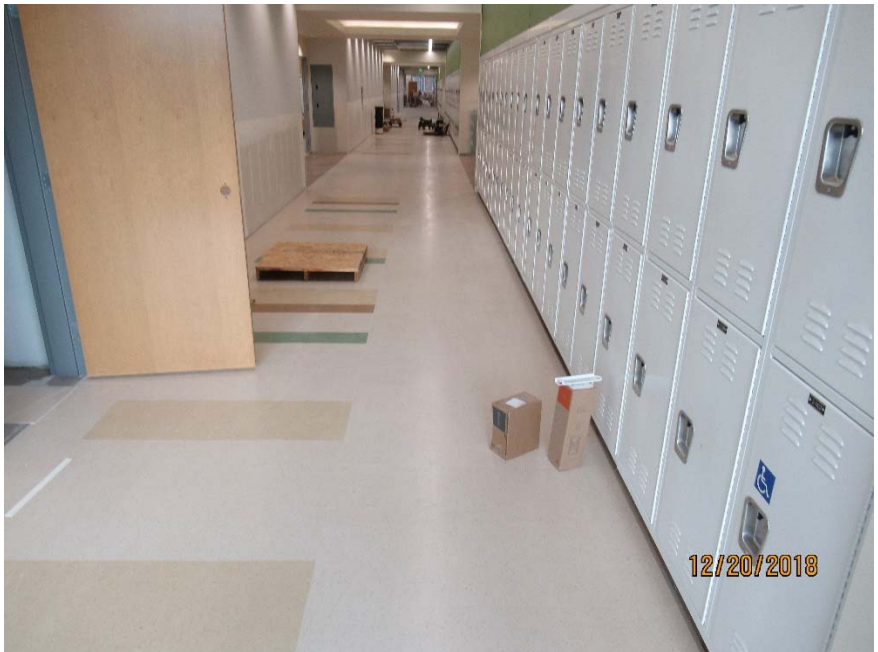
- 15. Contractor has placed floor tile on the second floor Area A.**

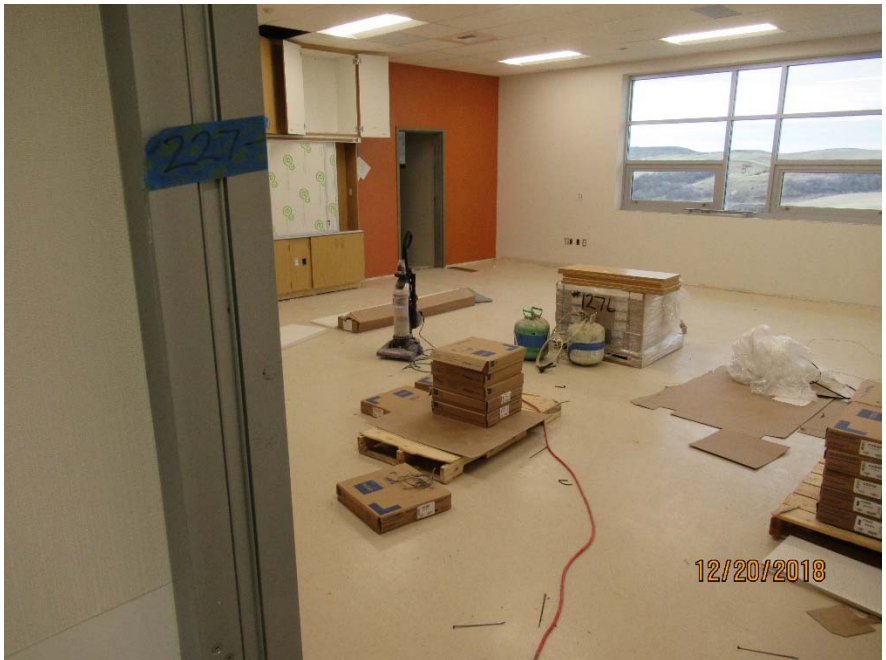
16. 227 tile floor

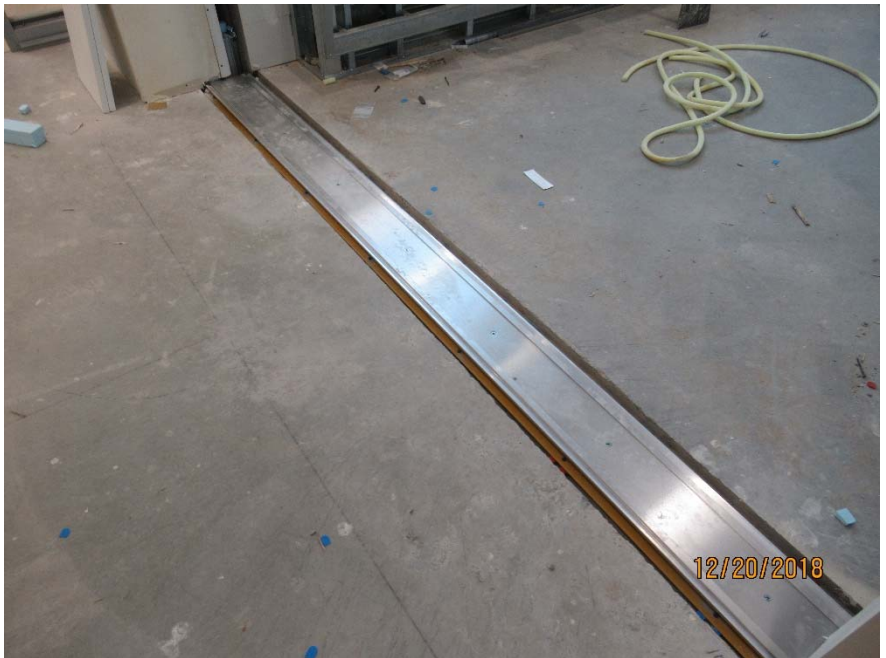
17. Floor expansion joint

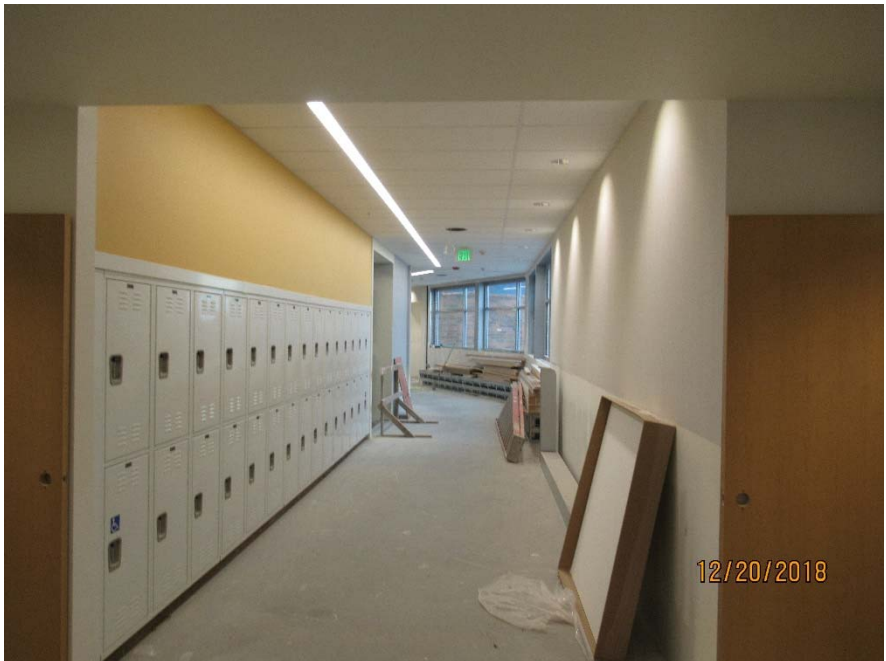
19. Contractor has placed ceiling tile on the second floor Area B.

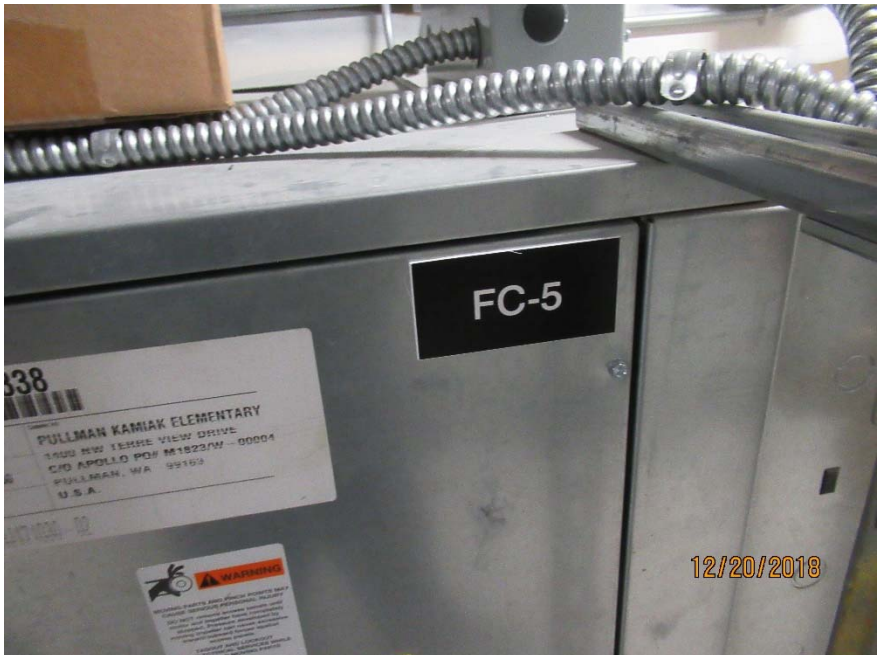
20. While I was walking through the mezzanine I noticed Fan Coils 1, 2, 5, 6, 7, 8, 9, 10, 11, 12, 13, 15, 15, 16, 17, 18, 24, 26 and 33 were running. I determined they were running by the noise and vibration when I touched them. The Fan Coils not listed were quiet and not vibrating.

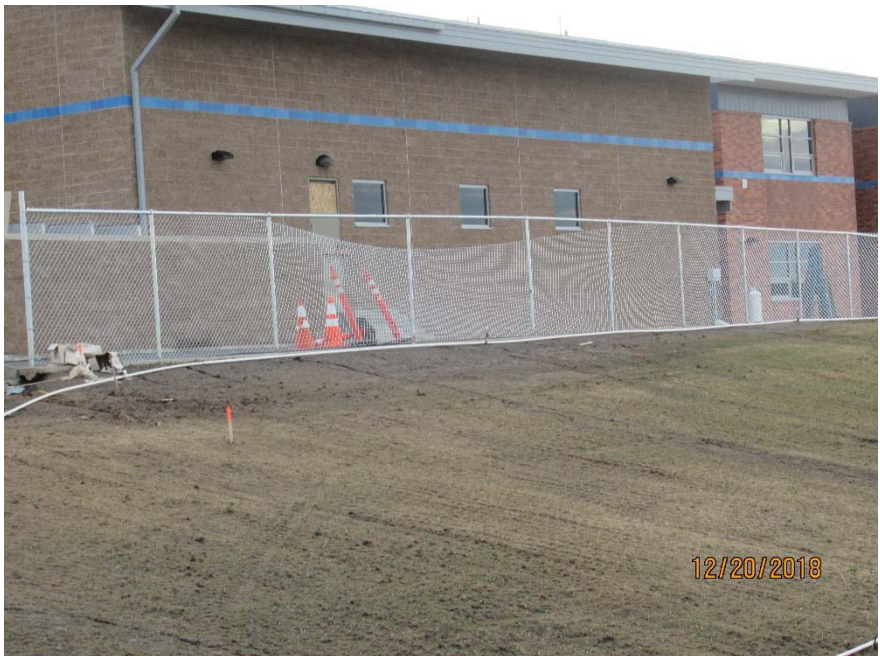
21. It appears a piece of the chain link fence has come loose. Contractor notified.

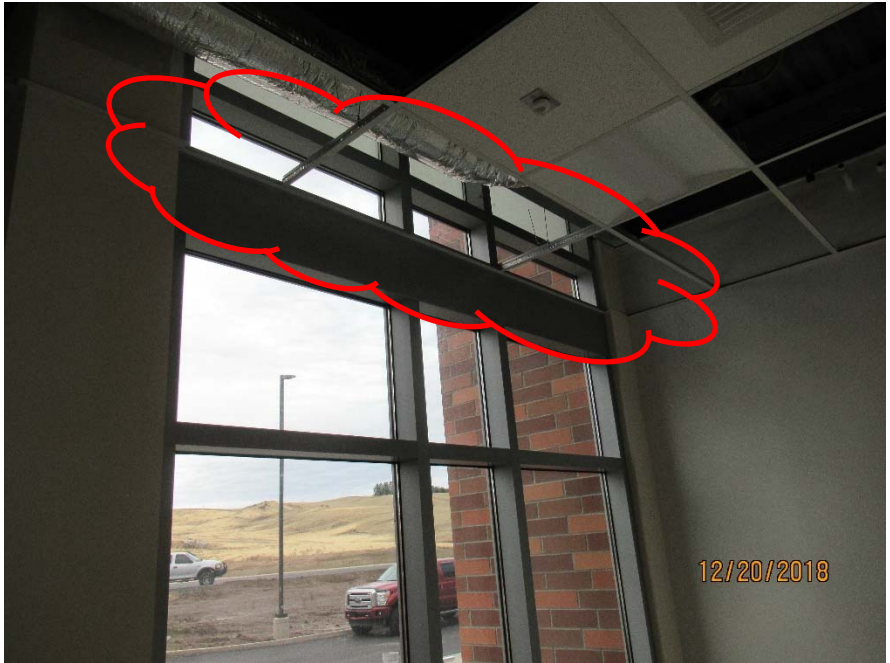
22. It appears the drop ceiling is below the clear window glazing. There needs to be either 3 more pieces of spandrel glazing installed or the ceiling raised. The Architect has been notified.

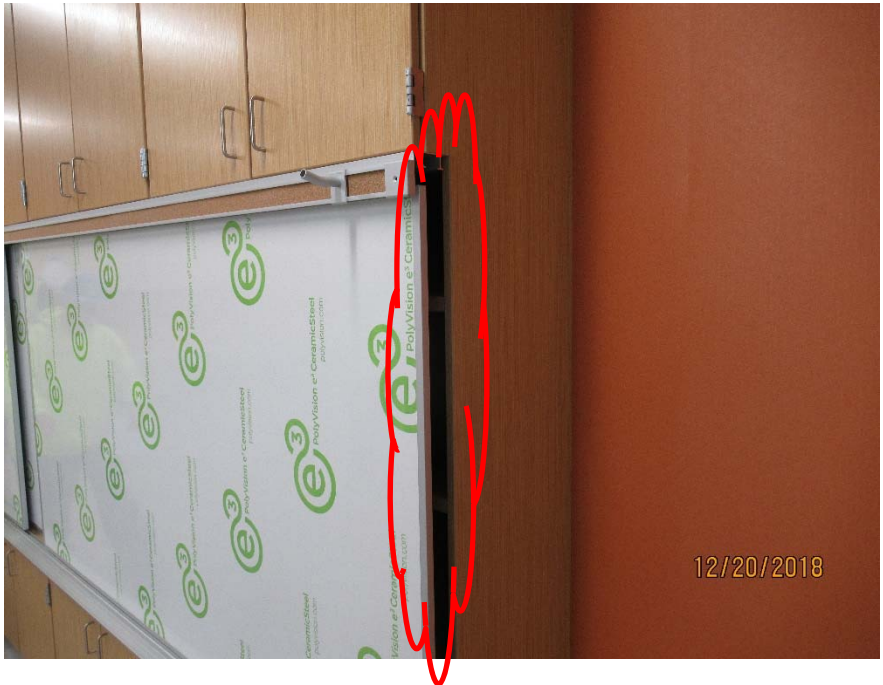
23. The gap between the back of the marker board and the casework is under review by the Architect.

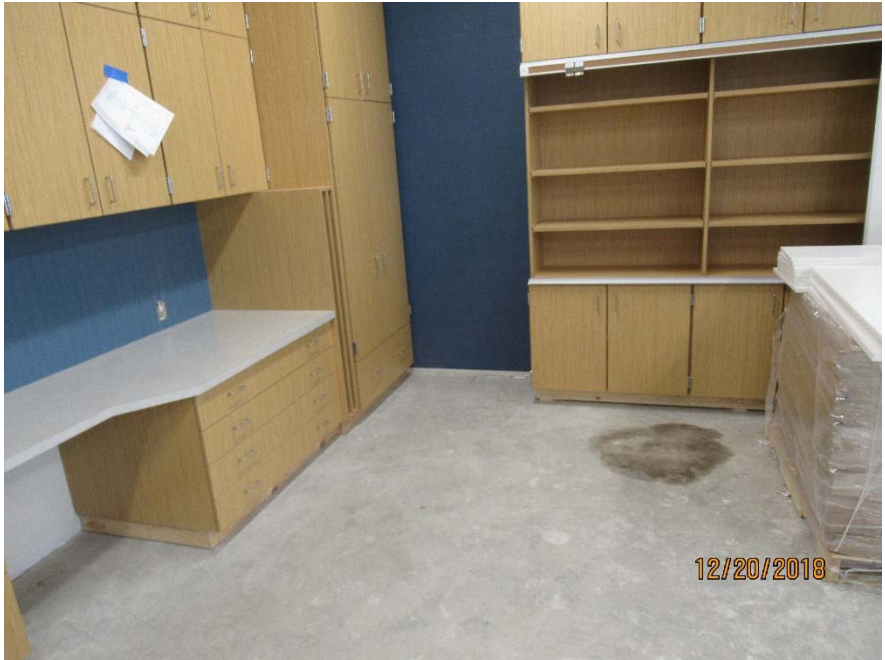
24. I notified the contractor that something is on the concrete floor. Room 119 Flex Classroom, I mentioned my concern if this is not completely removed it may disrupt proper adhesion of carpet tile.
