**Project: PSD: Kamiak Elementary School****Date: December 6, 2018****Weather conditions:**

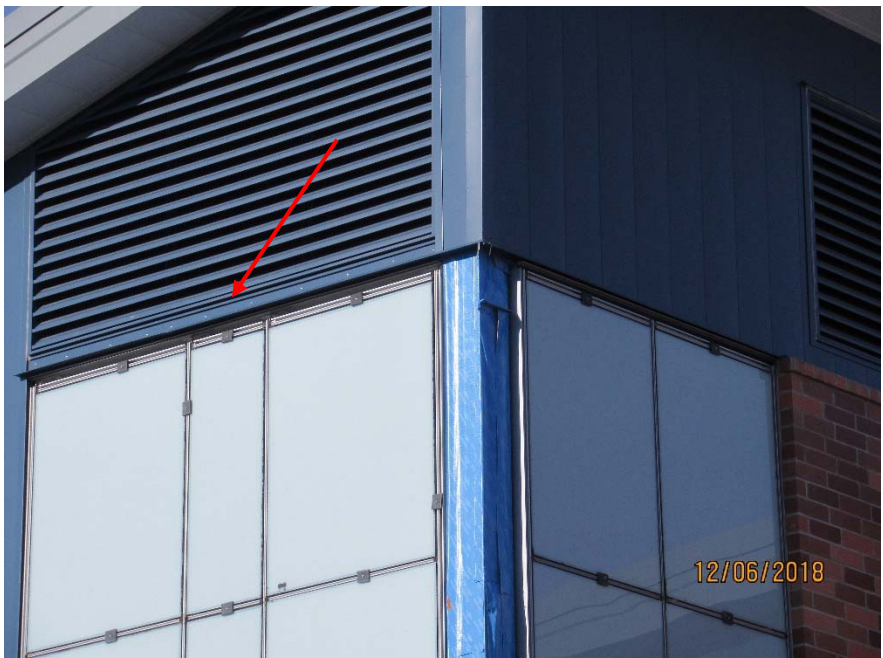
1. I pointed out to the Architect that it appears there is no metal paneling over the installed drip edge. The shiny screw heads can be seen. The Architect assured me that this condition is in fact water tight. The contractor said they will get up there and paint the screw heads to match. Arrow is pointing to the area in question.

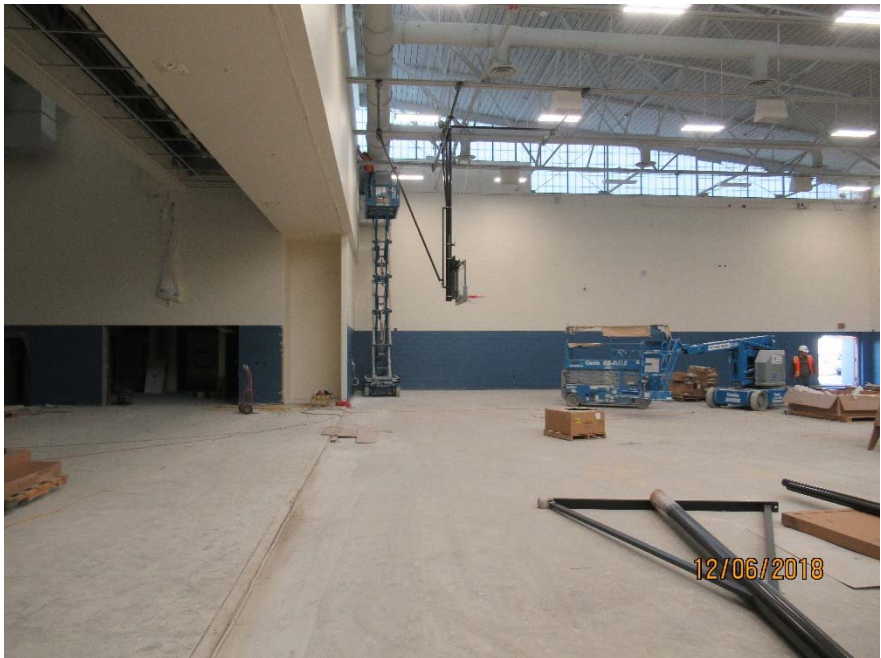
2. Contractor is installing basketball backboards.

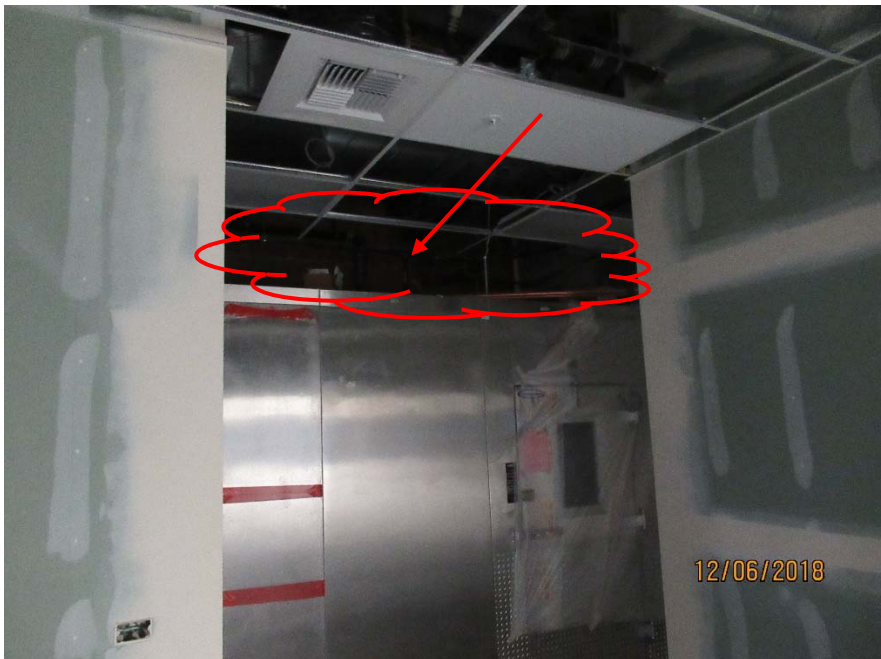
3. I pointed out to the Architect that I could not find in the drawings a requirement for a closure piece from the top of the freezer/cooler to ceiling nor does the ceiling plan show the ceiling continuing to walls past the cooler/freezer. Arrow is pointing to the area in question.

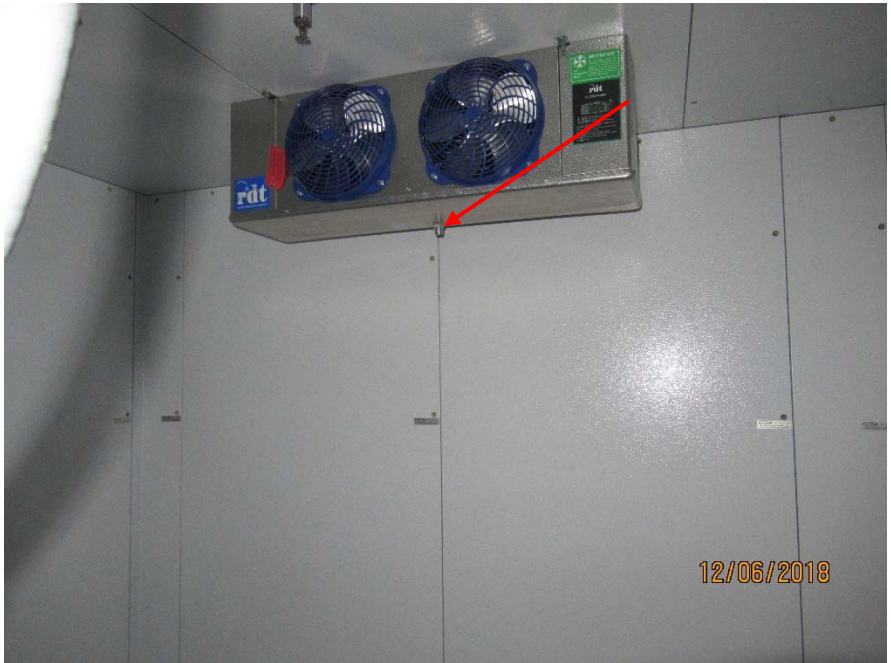
4. This photo and that below are concerning the lack of condensation line piping from the freezer coils or the cooler coils is not installed. According to the contract documents this pipe should route out the back of the freezer. The same condition in the cooler. I notified the contractor of this issue.

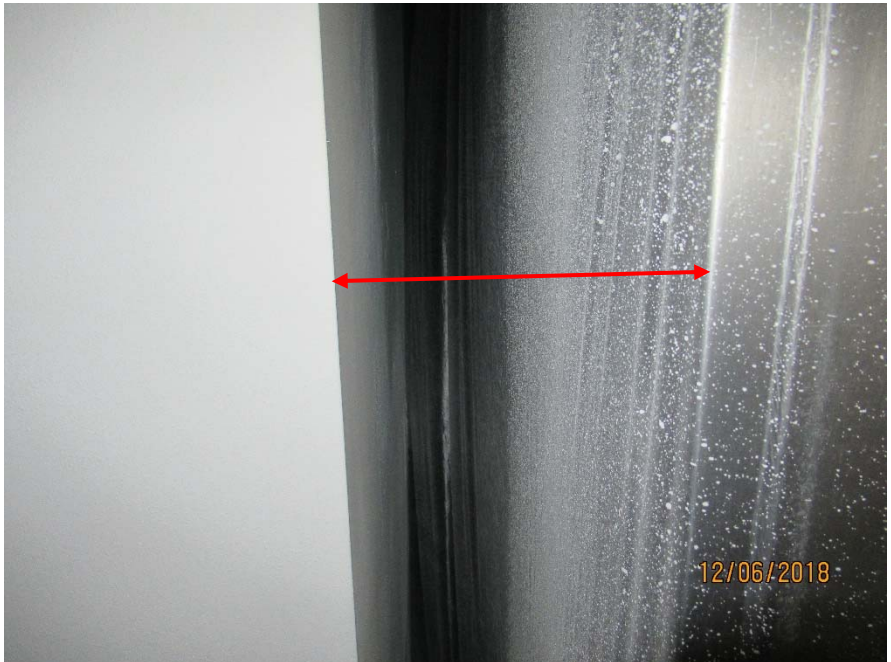
5. The reason the lack of installed condensate line is a concern is due to the fact this line needs to be installed within the 6" space between the back and side exterior wall of the cooler/freezer and the inside face of the adjacent wall. I stated my concern that this is nearly impossible at this point. The contractor said they will address the issue with the appropriate subcontractor and the line will get installed.

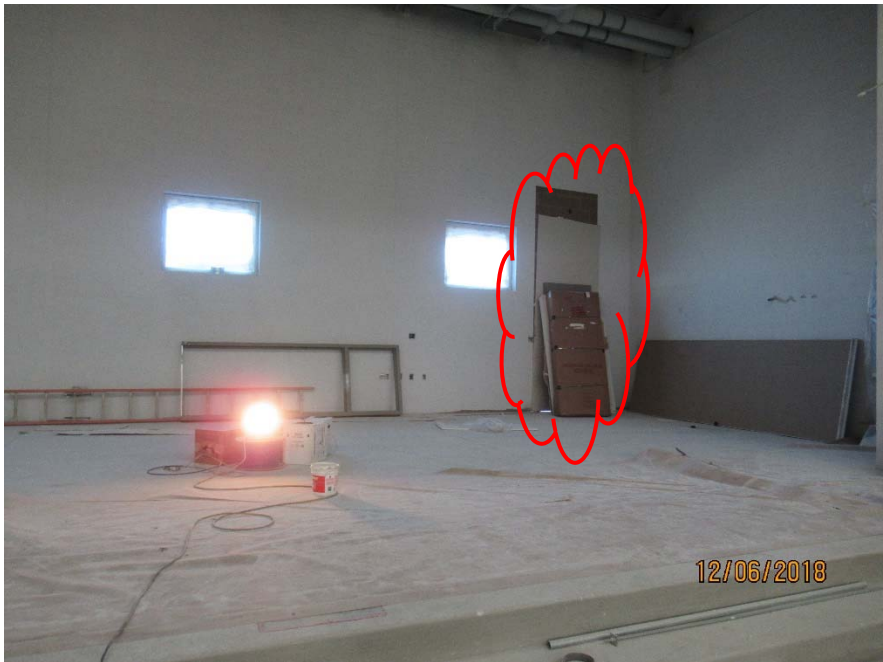
6. I asked the contractor is there is an issue brewing with the exterior door from the Stage. It appears all the other exterior hollow metal doors have been installed except for this one. And it appears the painter painted around the board that was attached over the rough opening to secure it. The contractor stated there was no issue he was aware of and the frame and door will be installed and area around it will be painted.

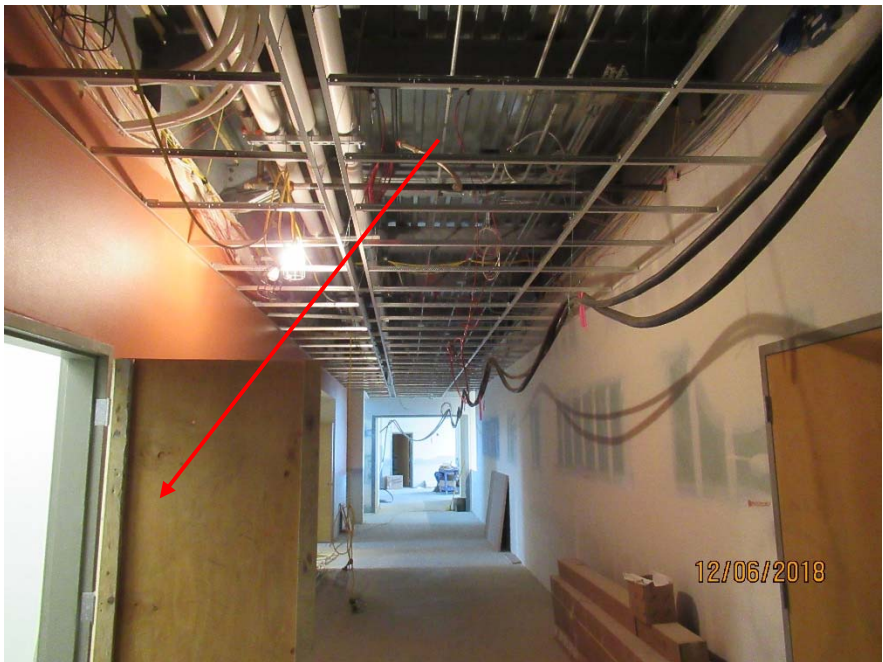
7. Contractor appears to be installing ceiling grid in the corridor in Area B first level. Note the electrical room still has a plywood door that is secured with a pad lock. This is a code requirement until the room can be secured by another means.

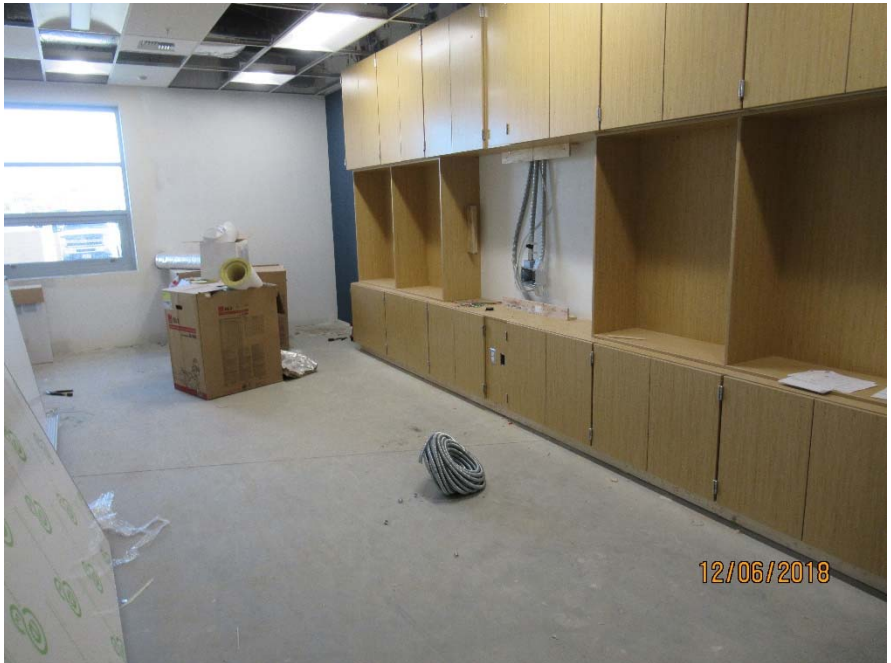
8. Casework installation continues on the lower level.

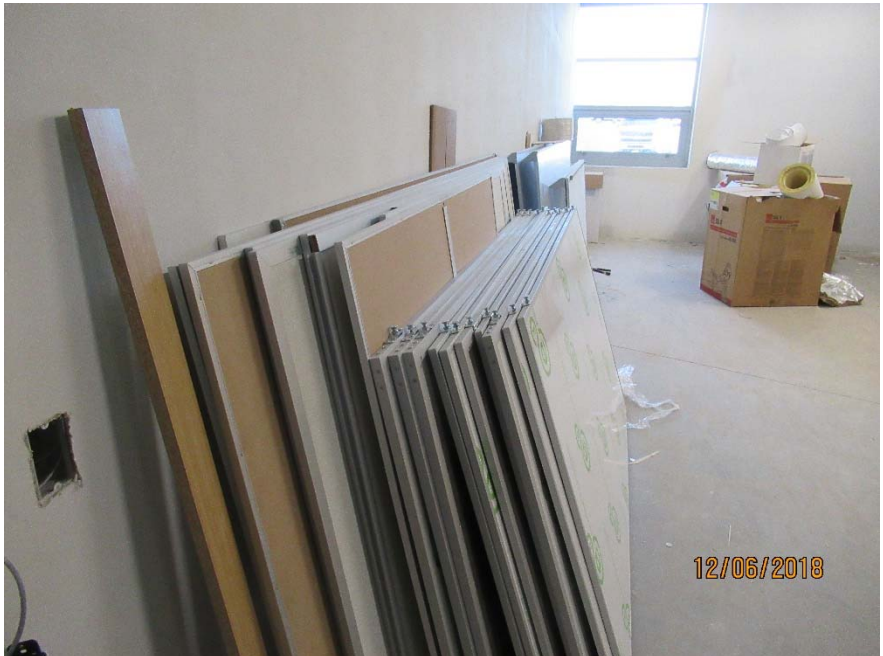
9. Staged tack boards and marker boards for the lower level.

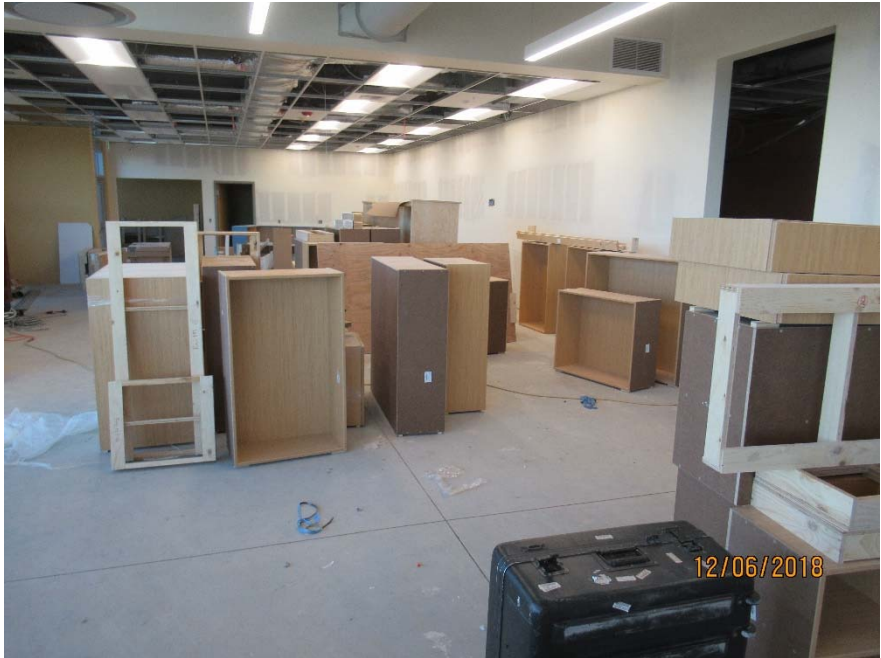
10. Library casework staged in Library.

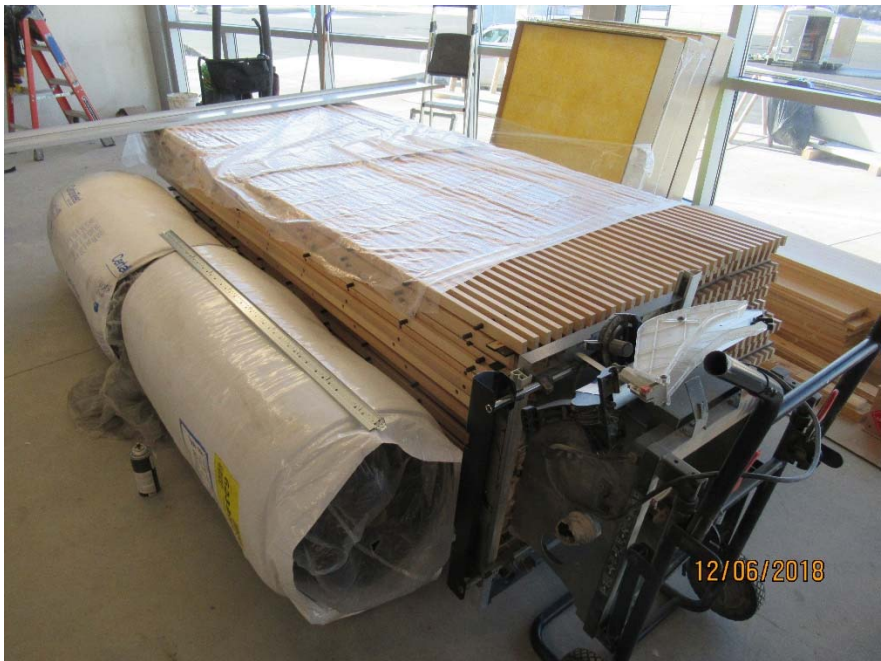
11. Contractor has taken delivery of wood ceiling material.

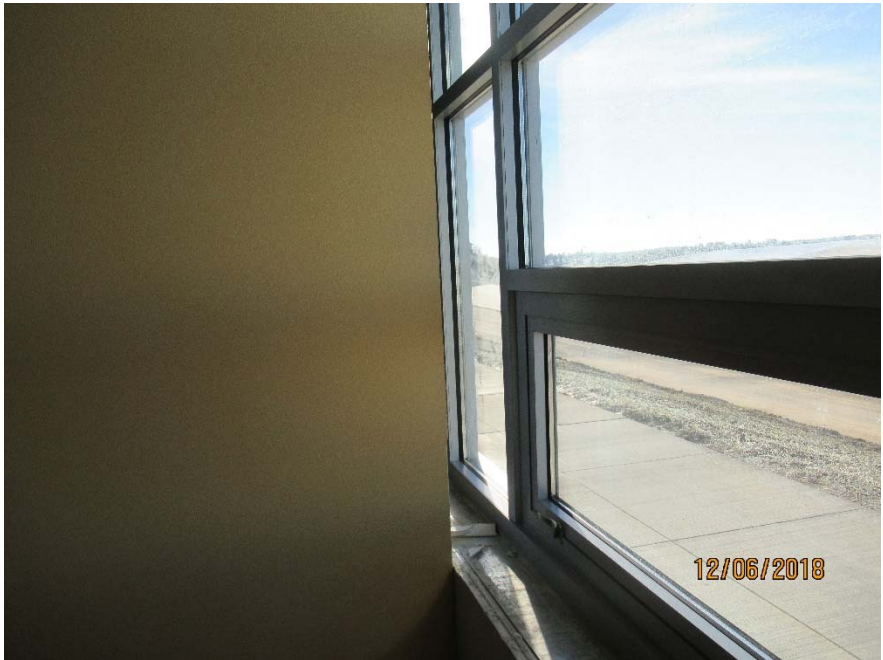
- 12. Contractor has not yet installed any of the break metal pieces to be installed between the end of wall and window frame. Likely the contractor is waiting for the interior window sills to arrive on site and be installed.**

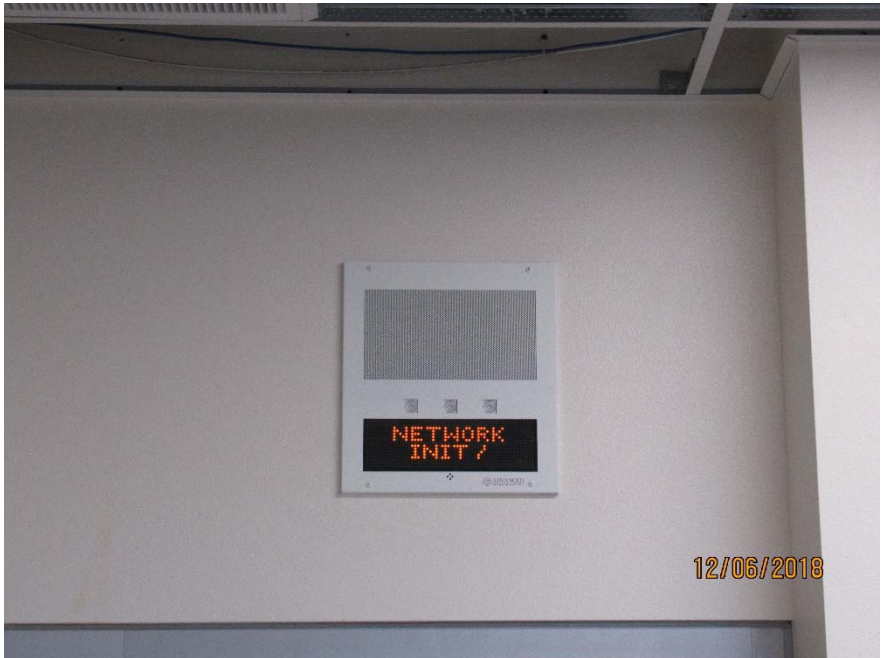
- 13. It appears EVCO has begun installing and programming the clock intercom system on the lower level.**

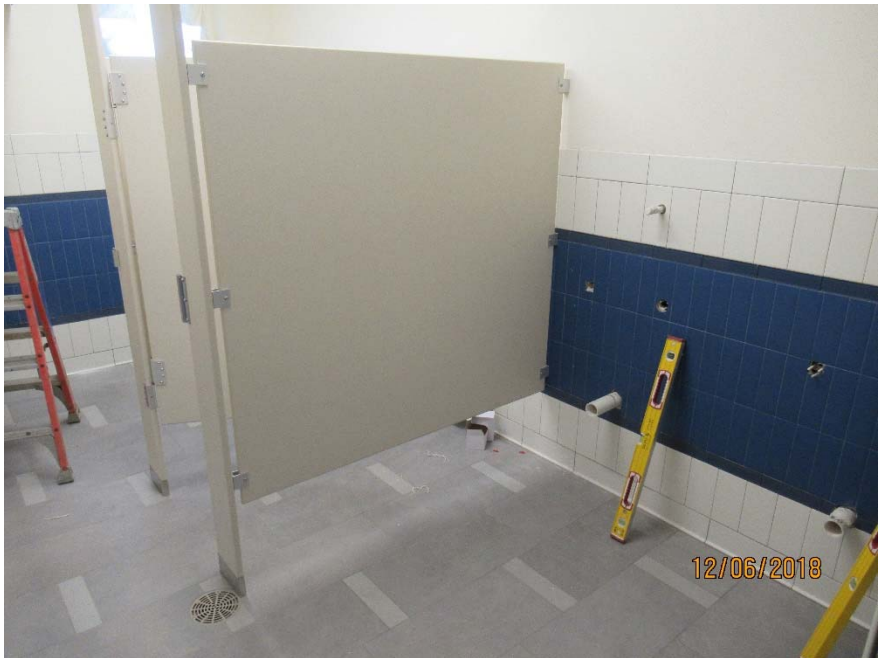
- 14. Upper floor restrooms have most the partitions installed but none of the fixtures. In this photo you can see the urinal partition has not yet been installed.**

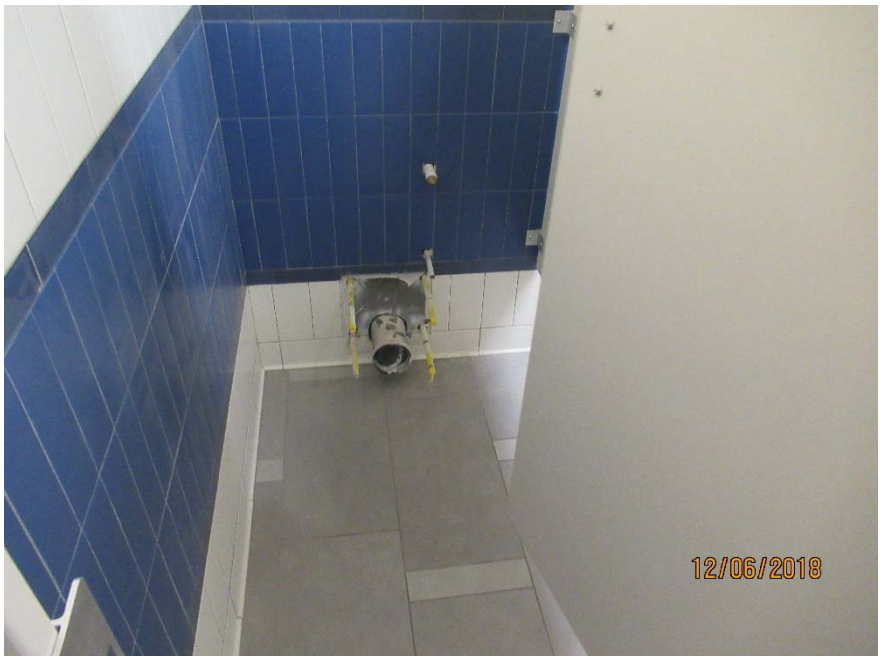
- 15. Upper floor restrooms have most the partitions installed but none of the fixtures.**

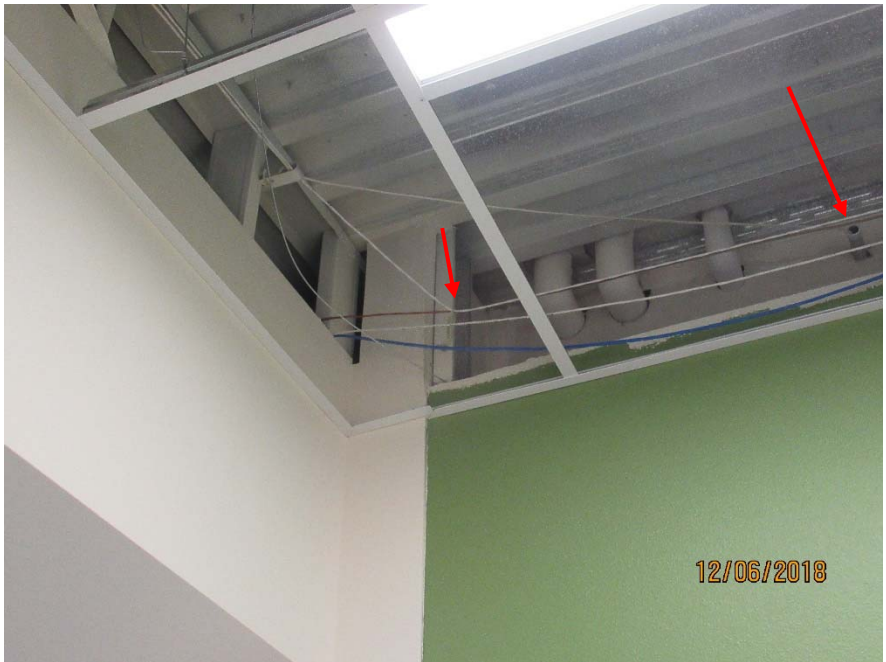
16. I pointed out to the contractor and the Architect that it appears to be locations where the wiring is pulled quite tight. I noted this is a commissioning issue but wanted to raise contractor awareness.

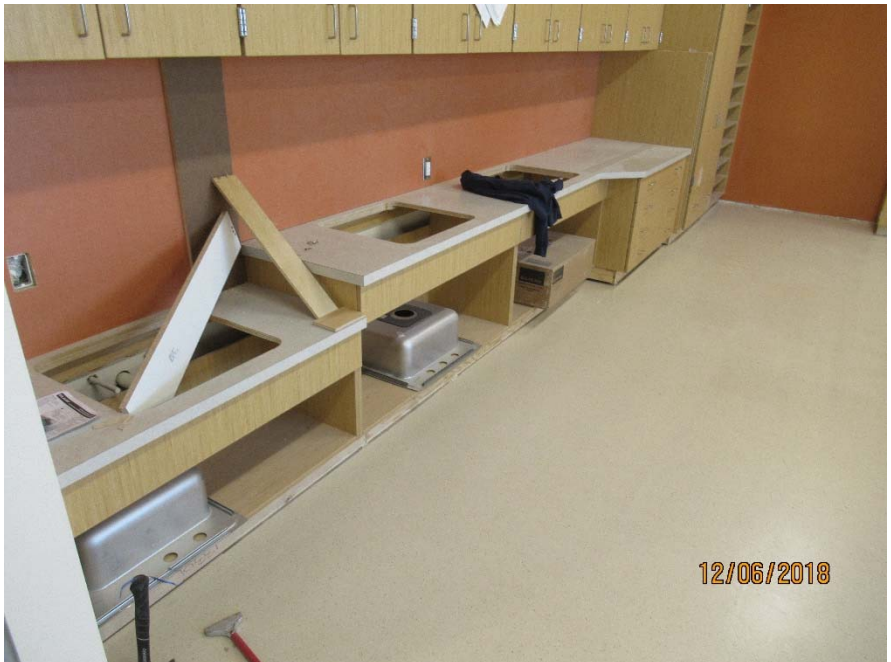
17. Upper level, Casework installation continues.

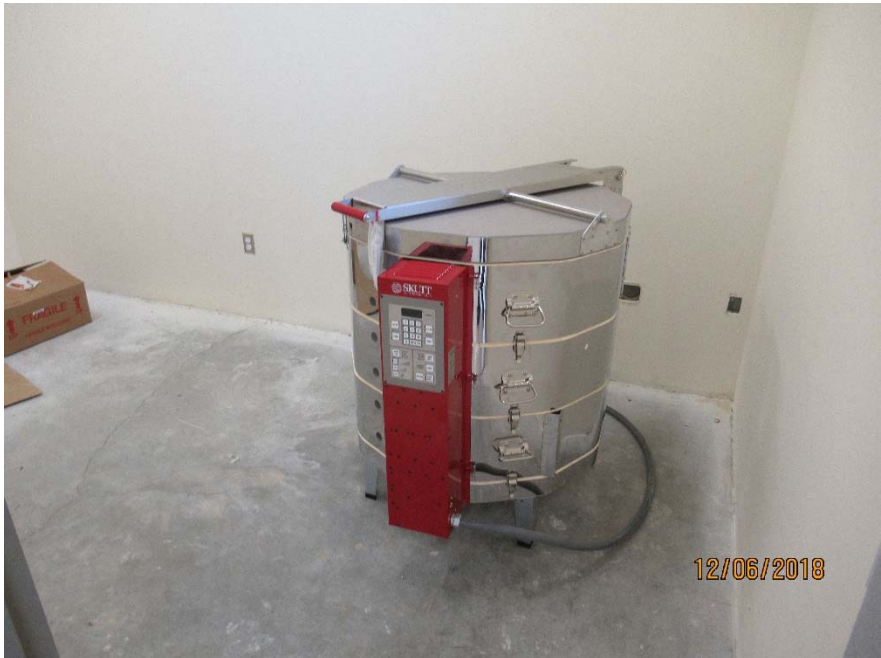
18. The contractor has accepted delivery of the kiln. It is staged in the room it will be hooked up in. I expect the contractor will clean and seal the exposed concrete floor before the kiln is finally placed and wired up.

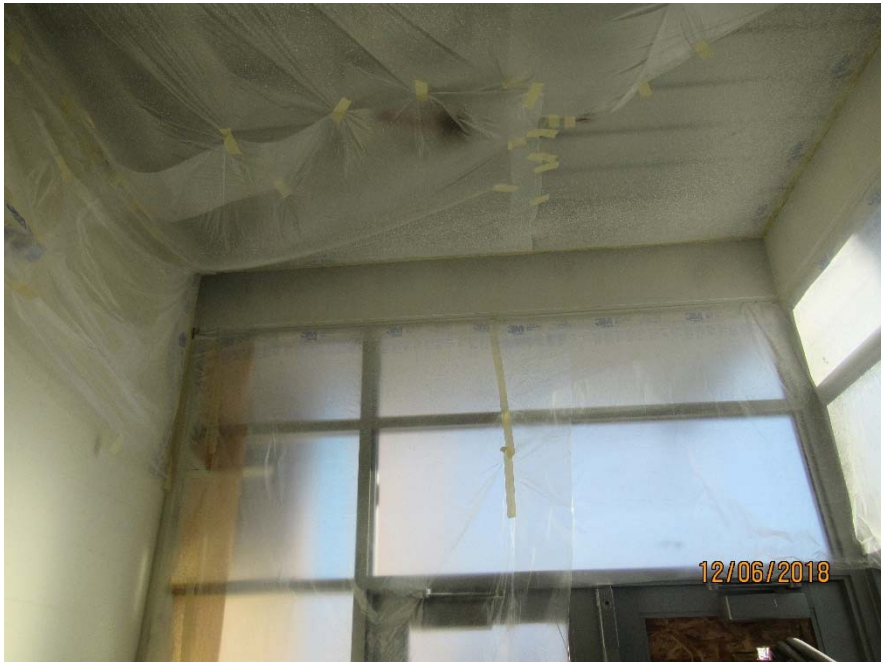
19. Painting continues in certain areas on the first level, toilet rooms and select
