**Project: PSD: Kamiak Elementary School****Date: February 21, 2019****Weather conditions:**

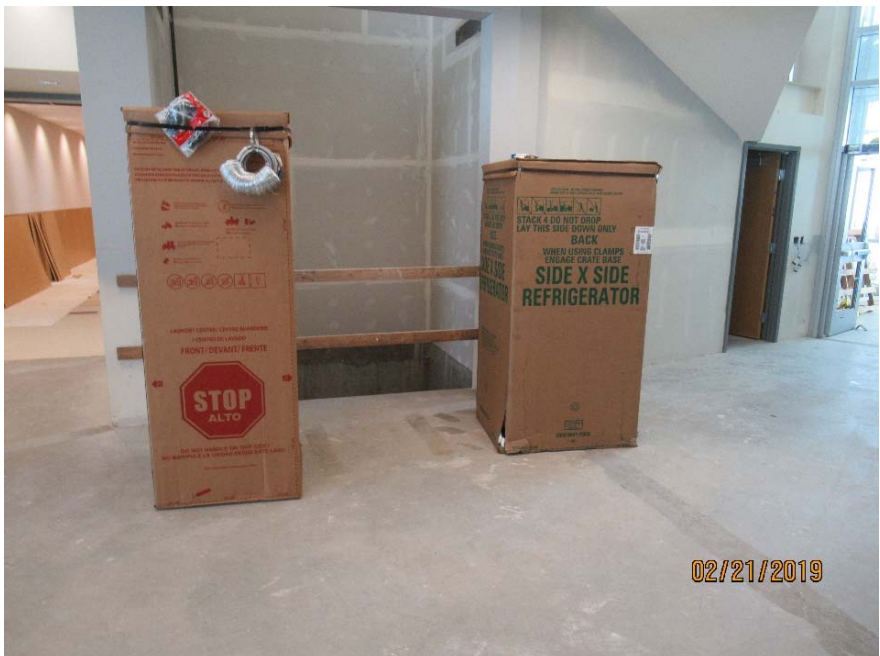
- The contractor has accepted delivery of appliances. This is accepted Alternate 9 – Residential Appliances.

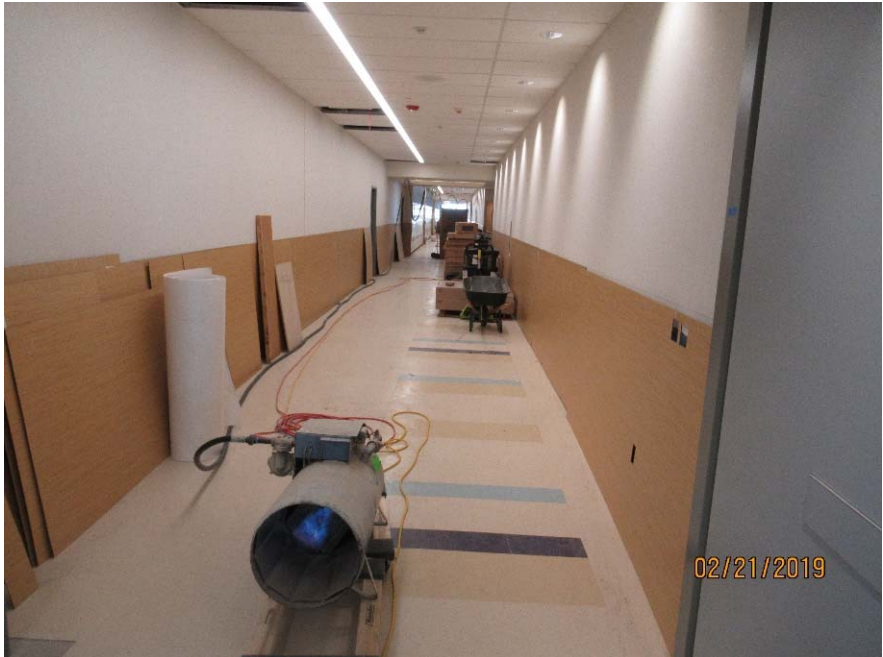
2. Contractor continues installation of FRP in lower corridor.

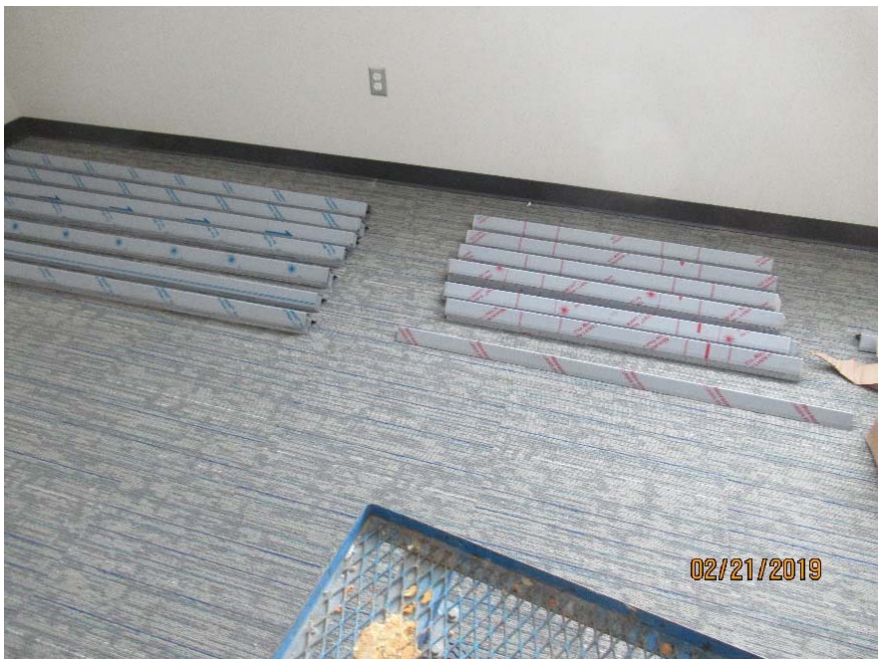
3. Contractor has accepted delivery of corner guards.

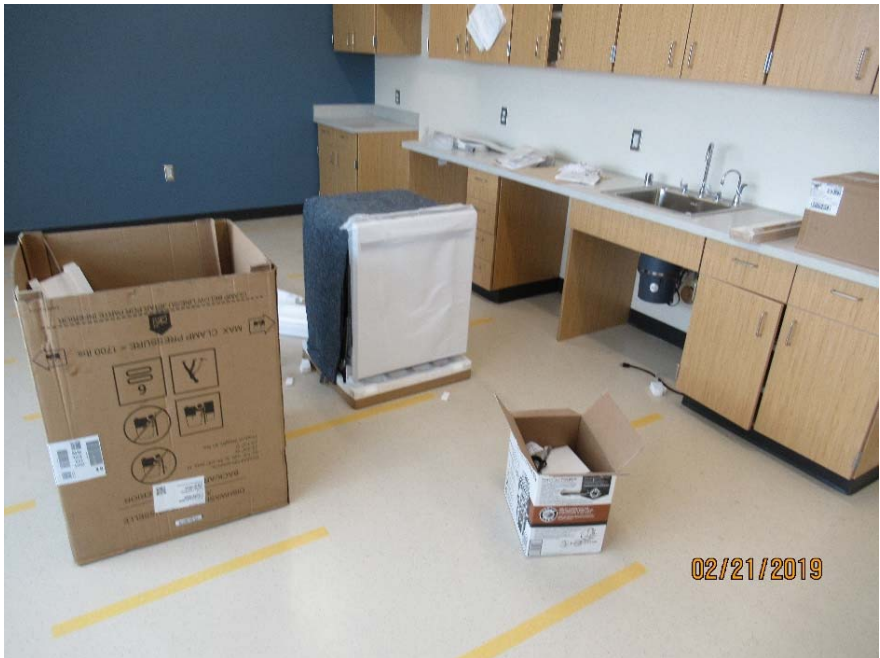
4. Dishwasher installation in progress in Breakroom 118N.

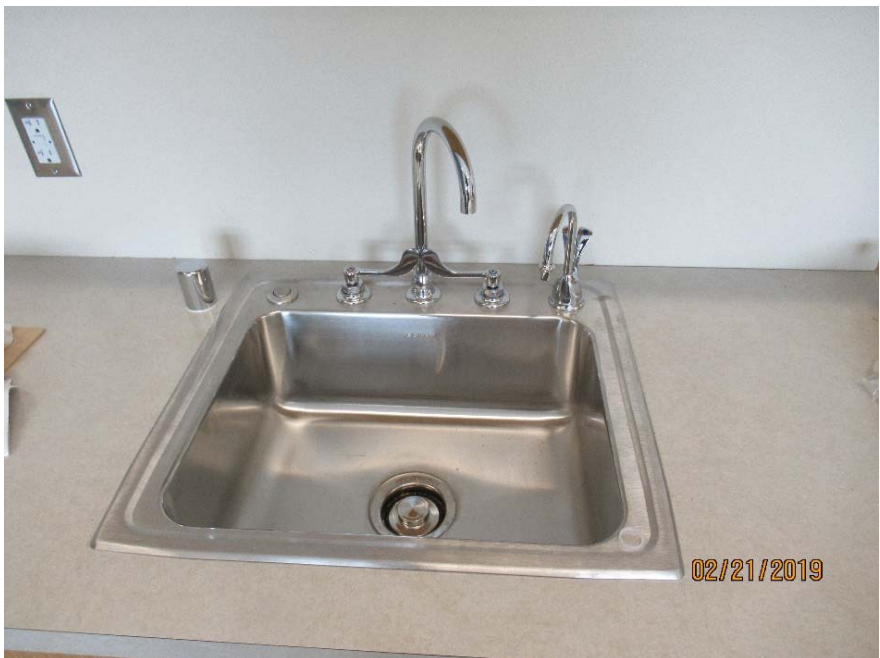
5. In Breakroom 118N: It appears the vent and garbage disposal have been installed per direction. COP 78, the change of the faucet handles (shorter ADA) has yet to be priced.

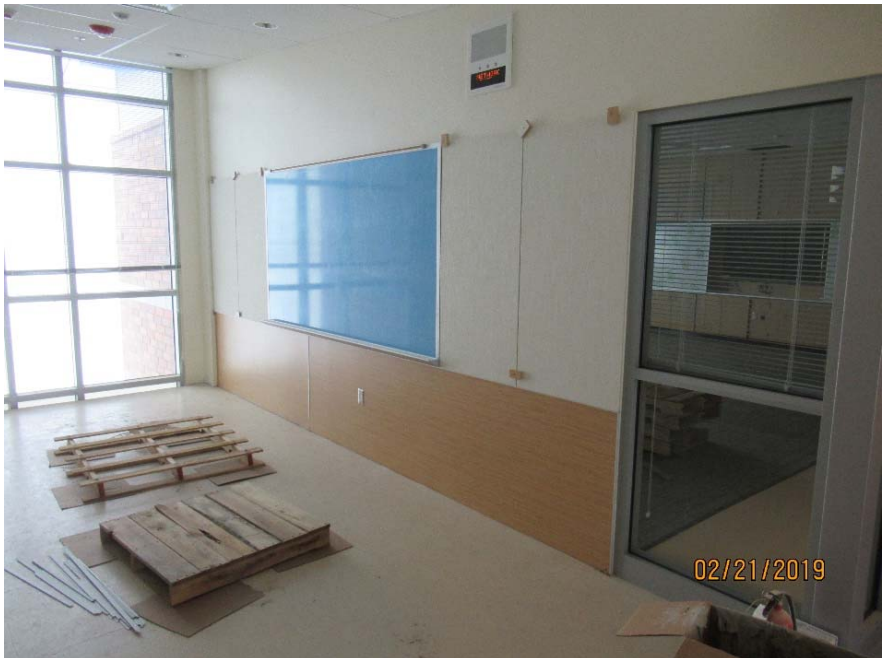
- 6. Contractor has used screws and blocks of wood to secure the tack boards while the adhesive dries.**

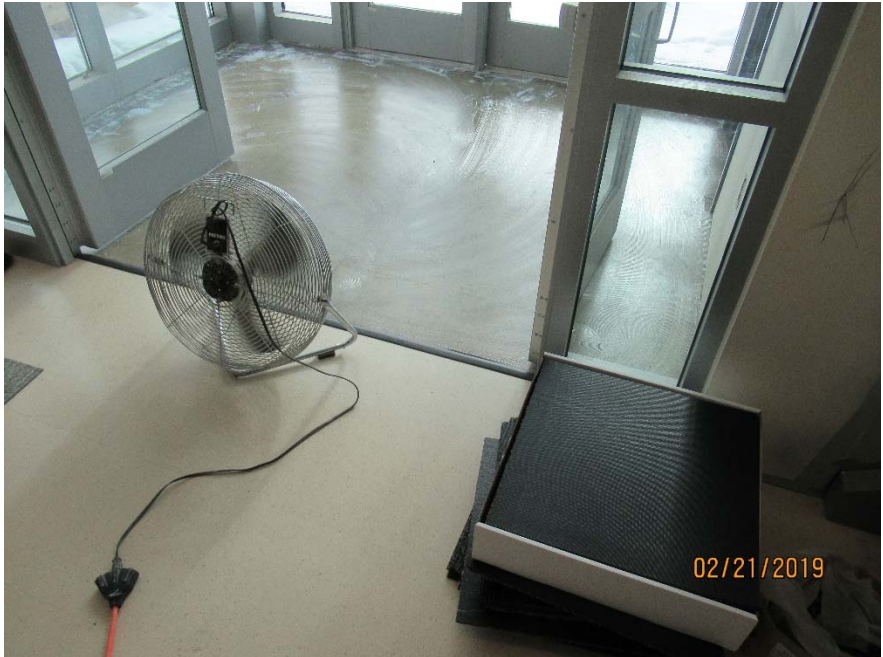
8. **Appears the contractor has applied adhesive for walk off carpet at Vestibule 100.**

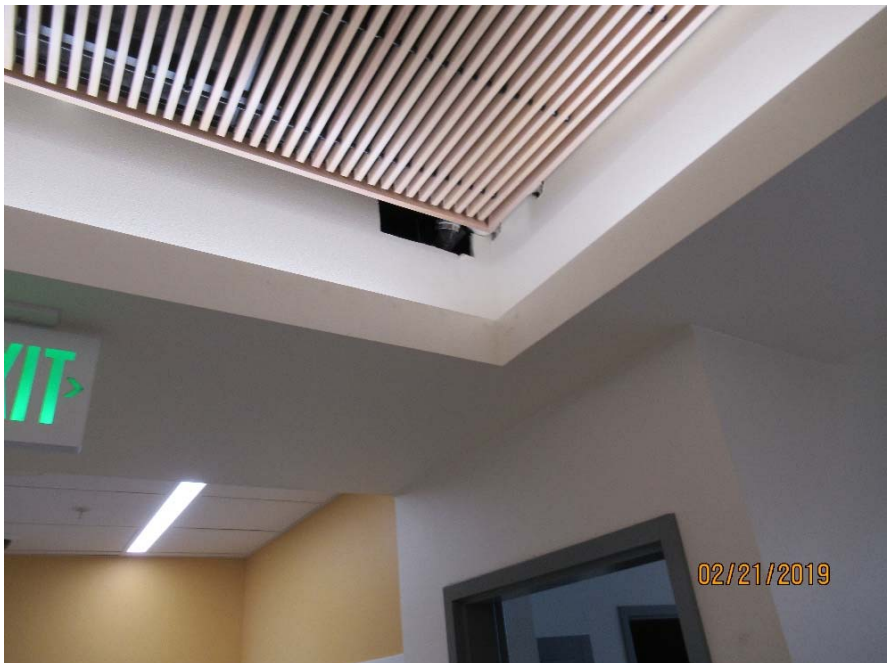
9. **It appears the contractor still needs to repair wallboard at wood slat ceiling area.**

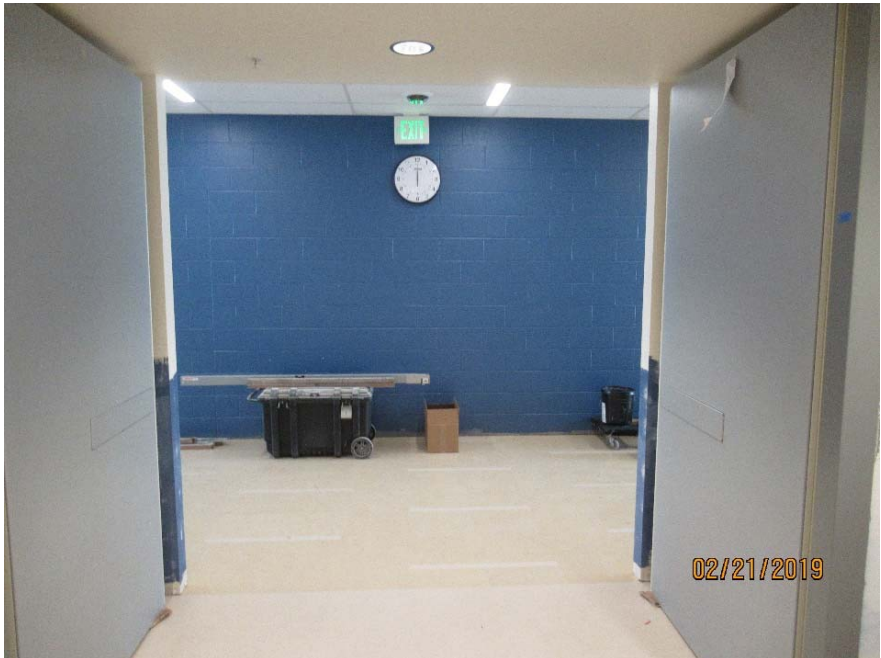
- 10. It appears the analog clock has been installed at the end of Corridor 126, in Corridor 140. The exit sign is not aligned with clock and Camera.**

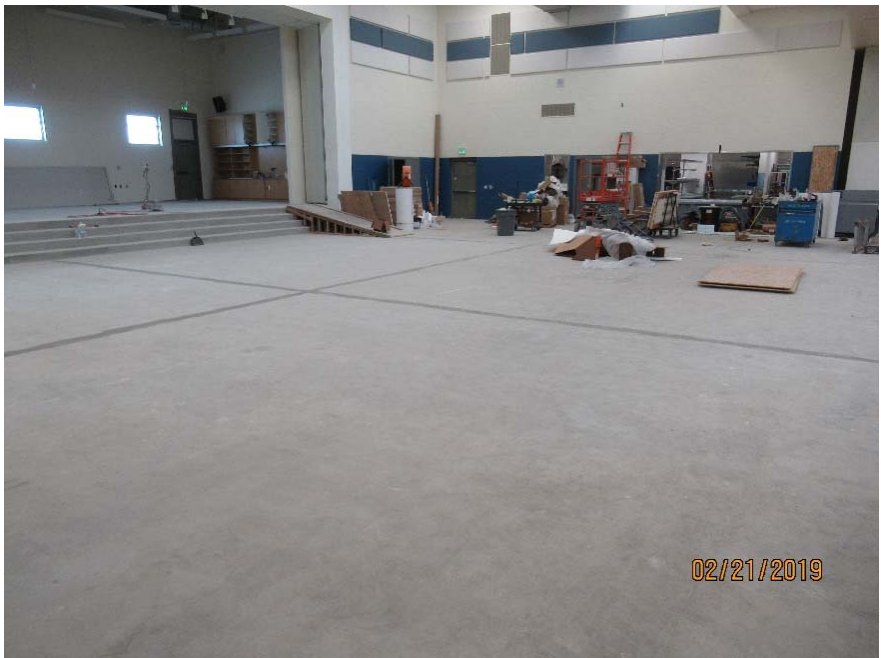
- 11. Appears the contractor is prepping the Multi-Purpose room floor for tile.**

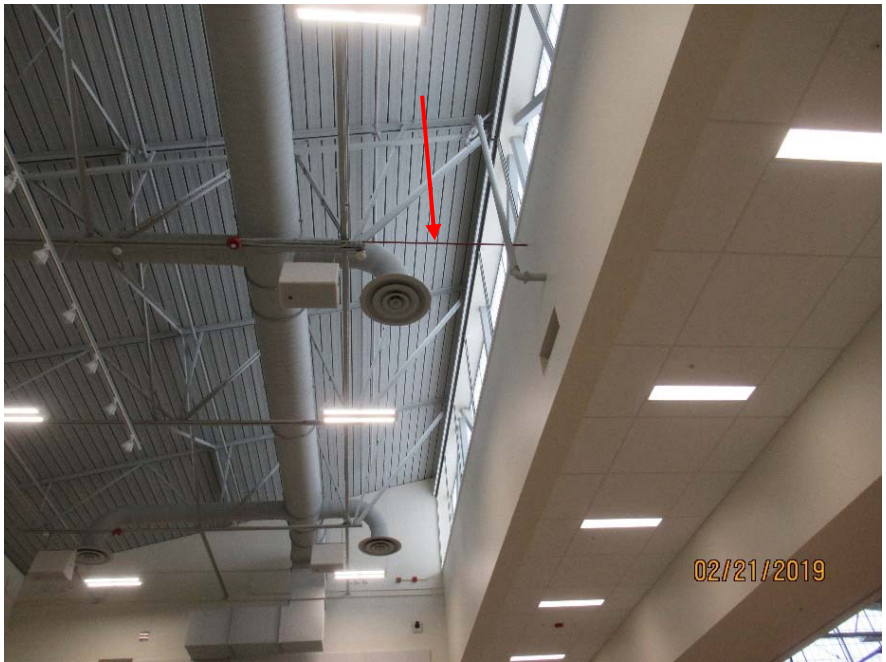
12. Although difficult to see in this photo, there is a piece of conduit that is half painted to match structure and the other half is red. Contractor notified today that the entire length of this conduit needs to be painted to match structure like the other conduits.

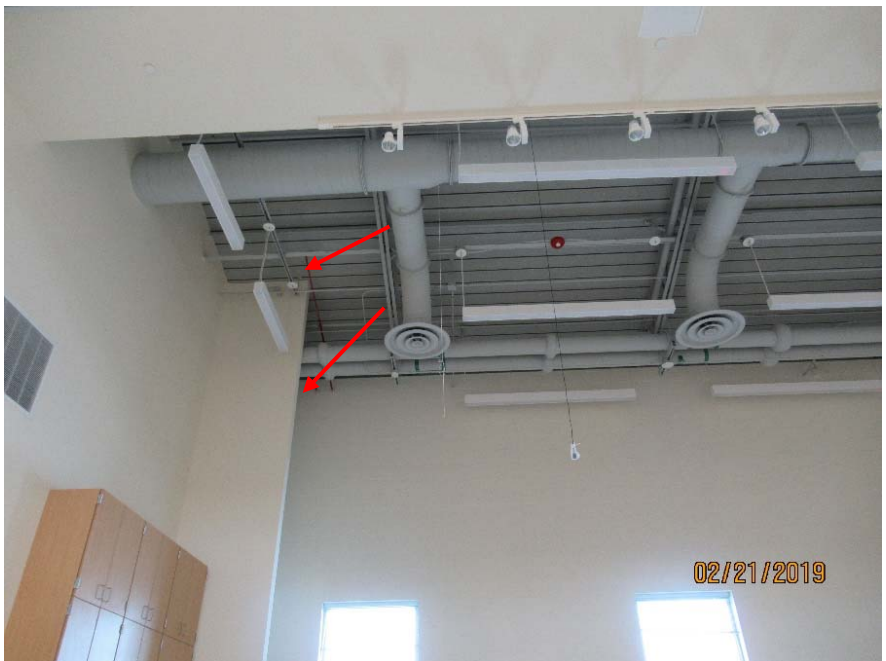
13. Although difficult to see in this photo, there are 3 pieces of conduit that are painted red. Contractor notified today that the entire length of these conduits need to be painted to match structure like the other conduits.

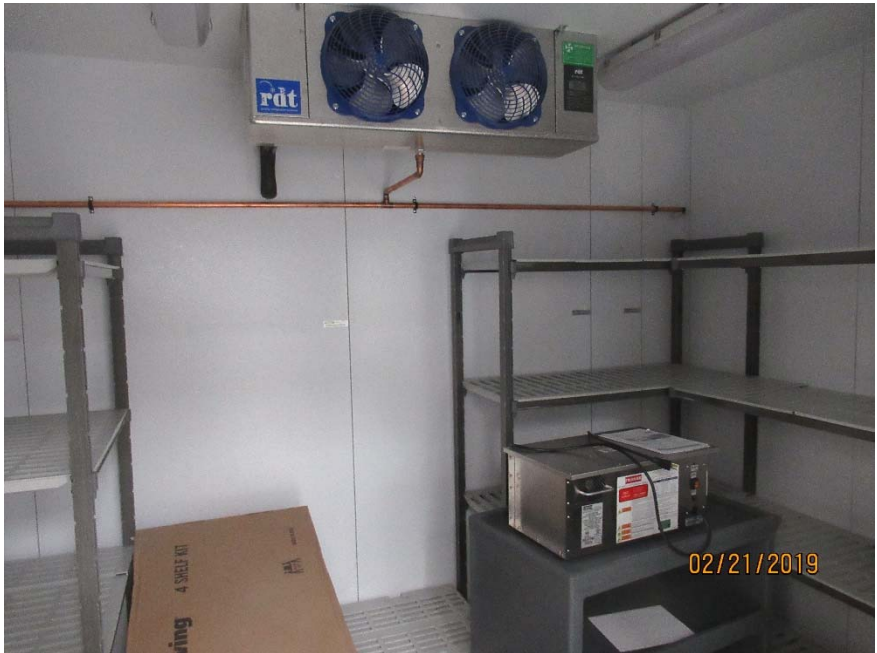
- 14. It appears the contractor has installed the shelving in the walk in refrigerator in the Kitchen.**

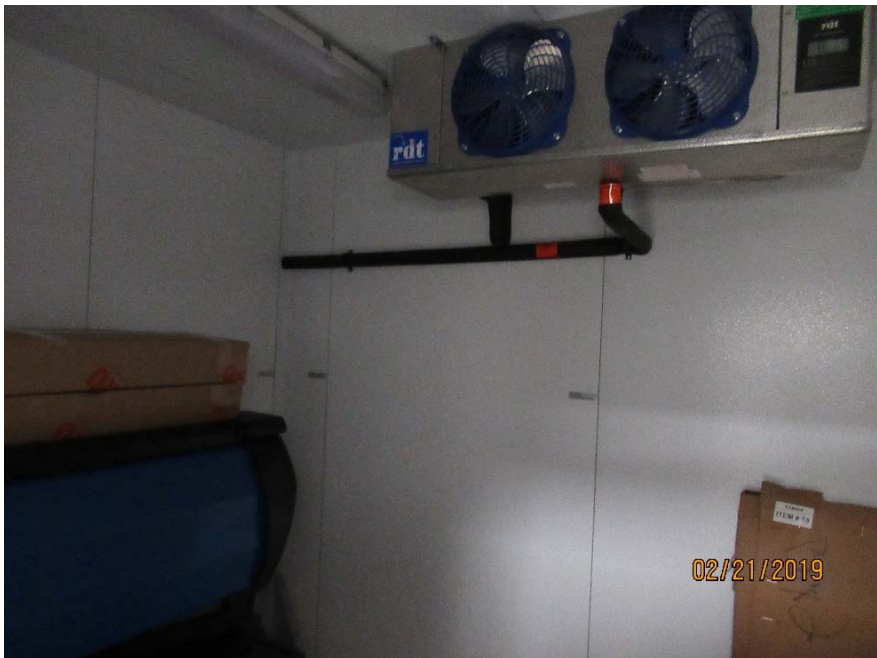
- 15. It appears the contractor has installed the insulation on the condensation line in the walk in freezer in the Kitchen.**

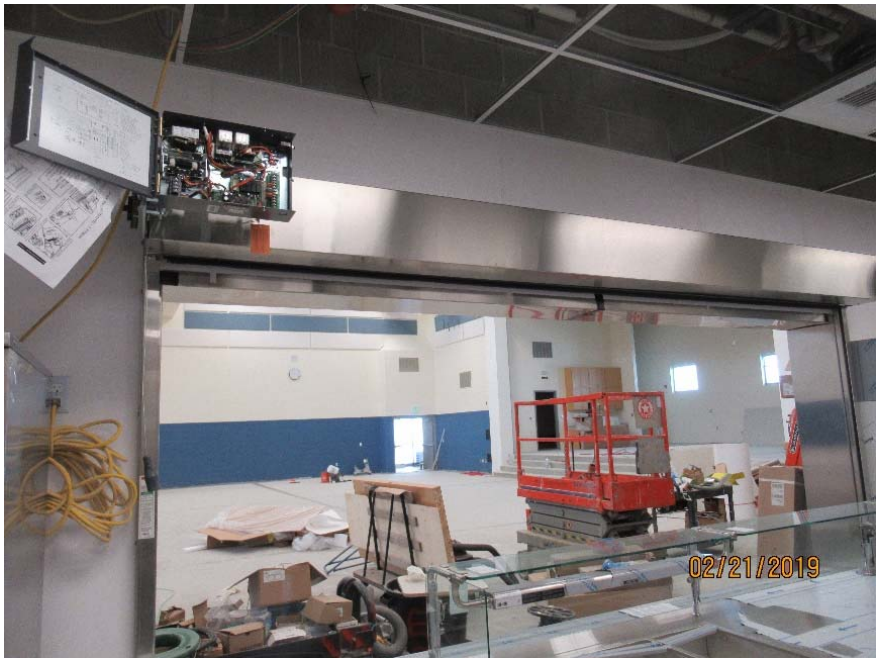
- 16. Appears the contractor is in the process of powering up the Kitchen roll up door.**

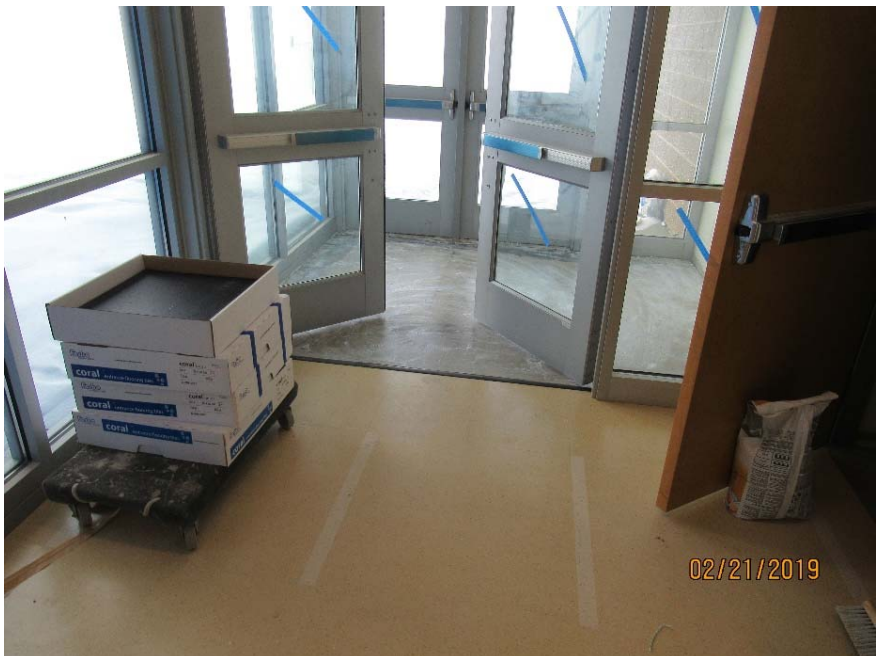
- 17. Appears the contractor has applied adhesive for walk off carpet at Vestibule 160.**

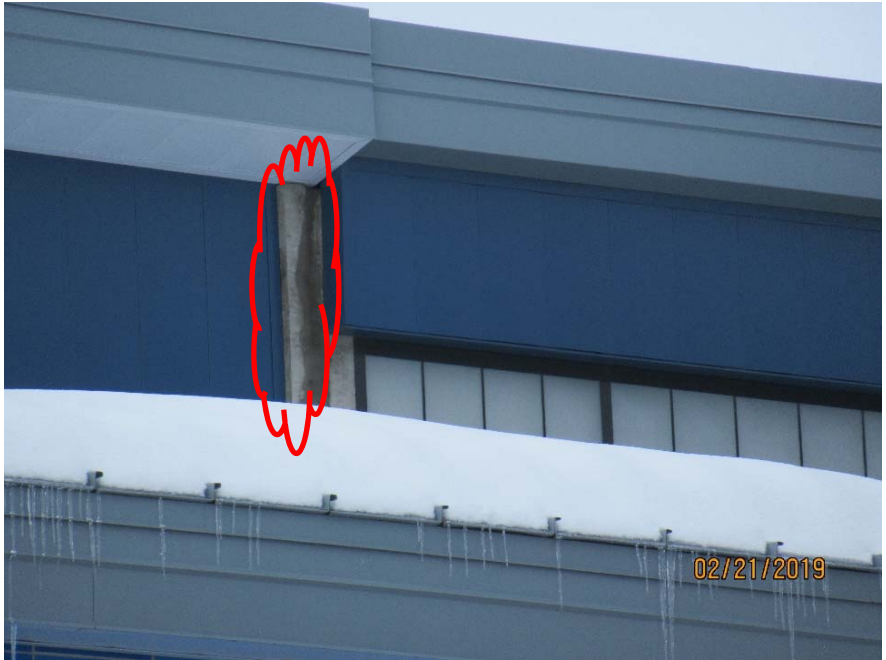
18. There appears to be a portion of the building that shows to have blue siding does not have siding. I notified the Architect of this today.
