Observation Report

Project: PSD: Kamiak Elementary School

Date: February 22, 2018

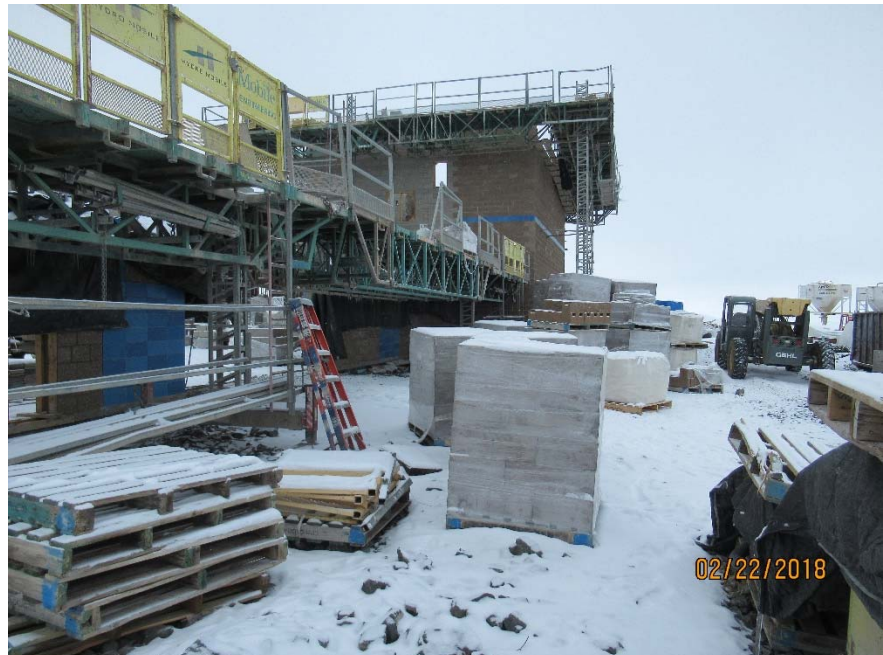
1. It appears the cold weather has hampered the masons' progress on the gymnasium walls.

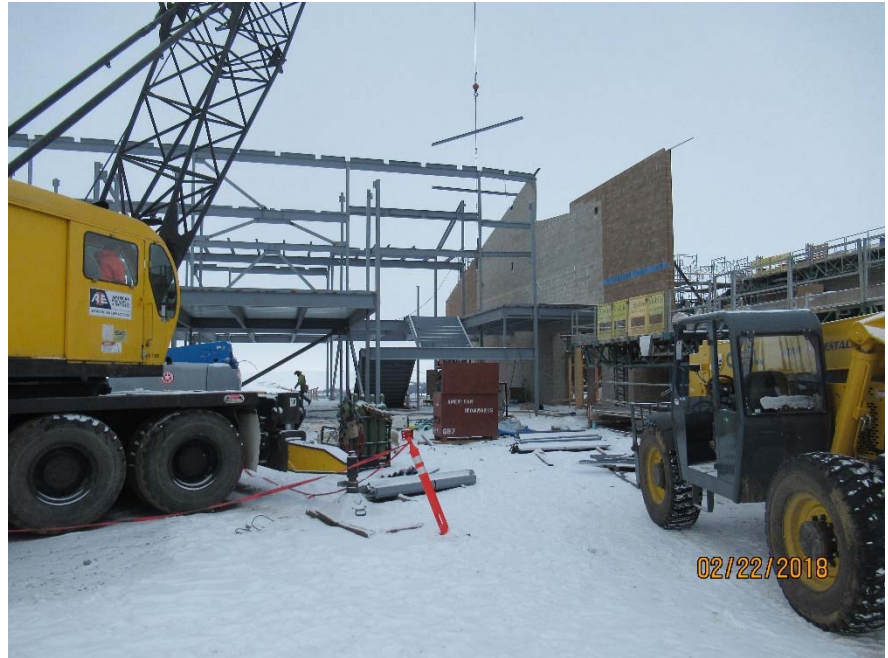
2. Steel erectors continue placing steel for Area B.

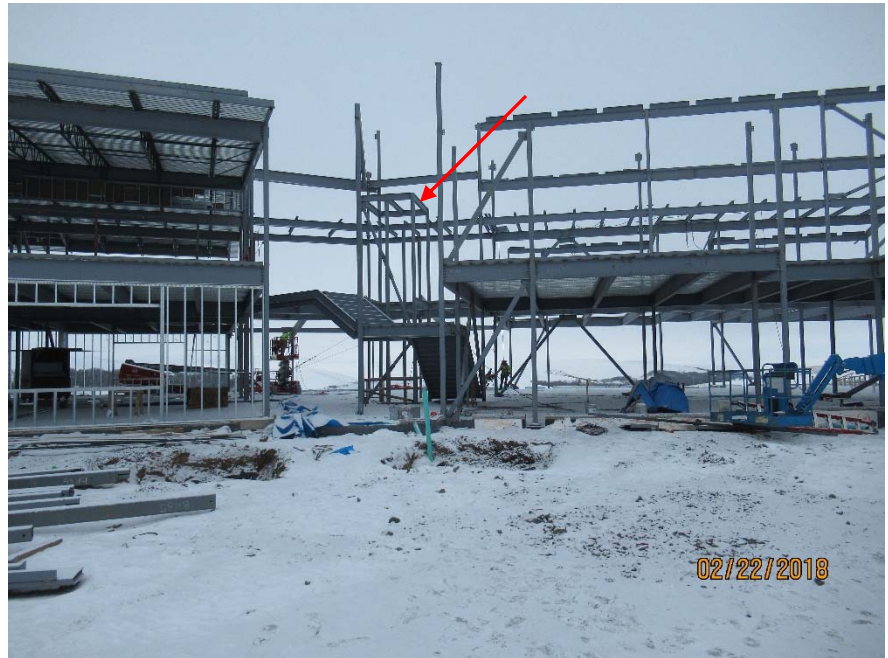
2. Progress on Area B steel erection. Arrow is pointing to elevator pit.

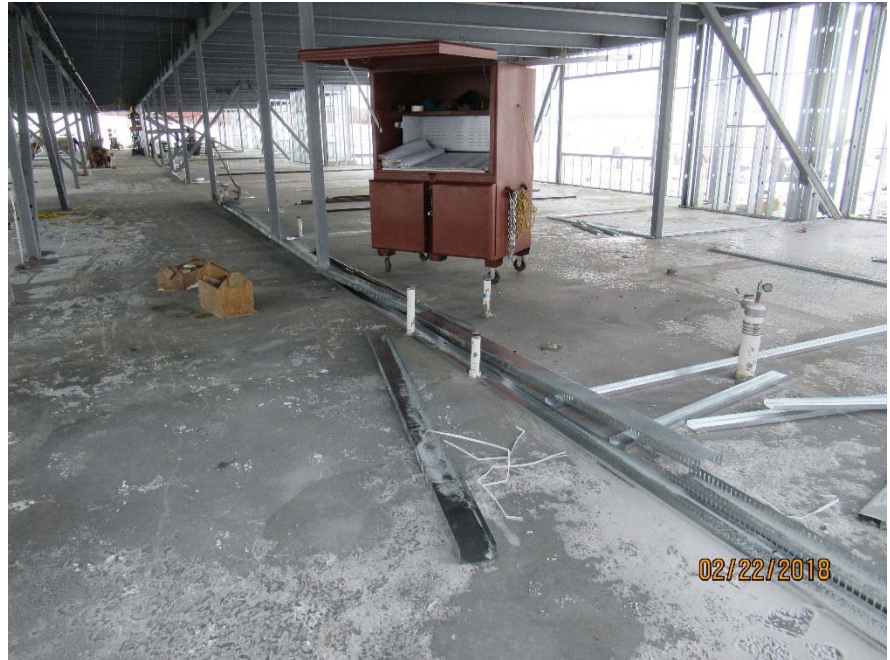
3. **Wall framer has begun laying out walls on ground floor Area A.**

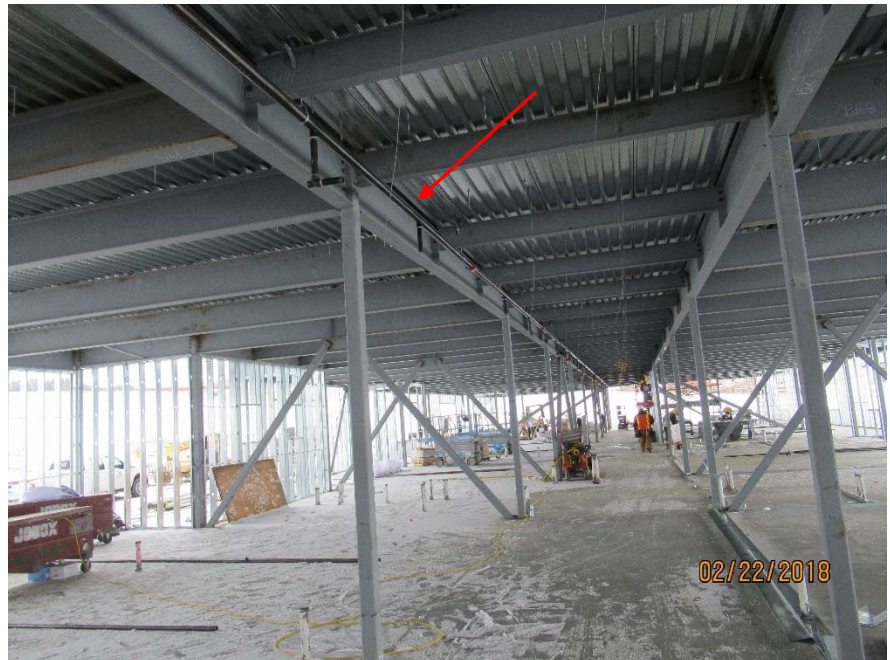
4. **Appears contractor has begun installing main fire sprinkler lines.**

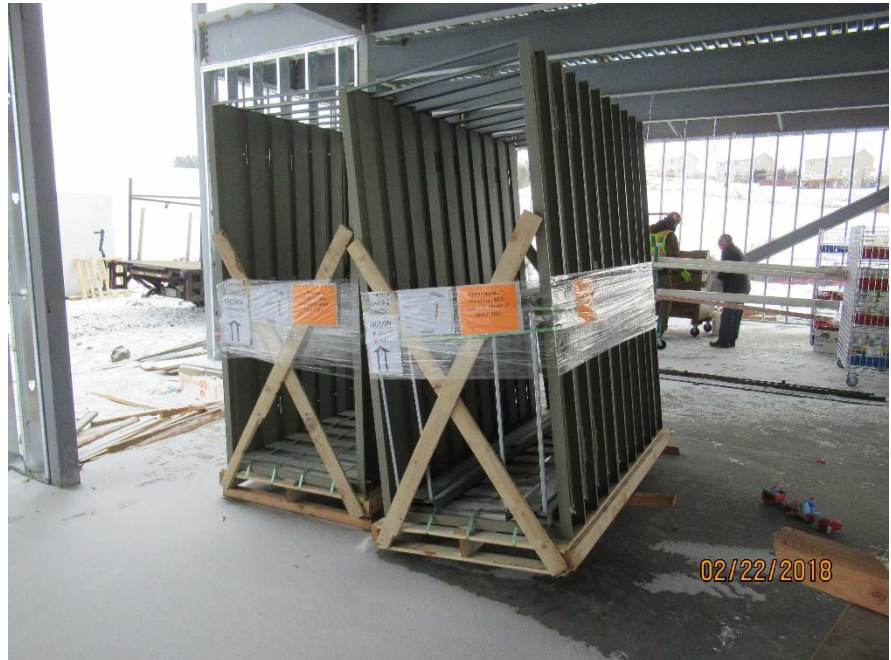
5. Contractor has taken delivery of hollow metal doorframes.

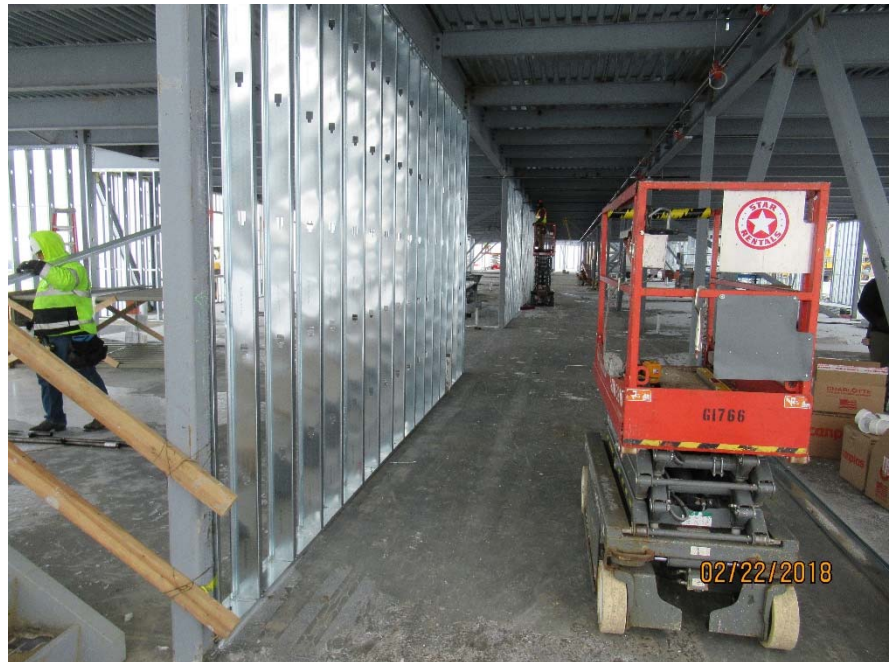
6. Wall framer has begun installing interior hallway wall.

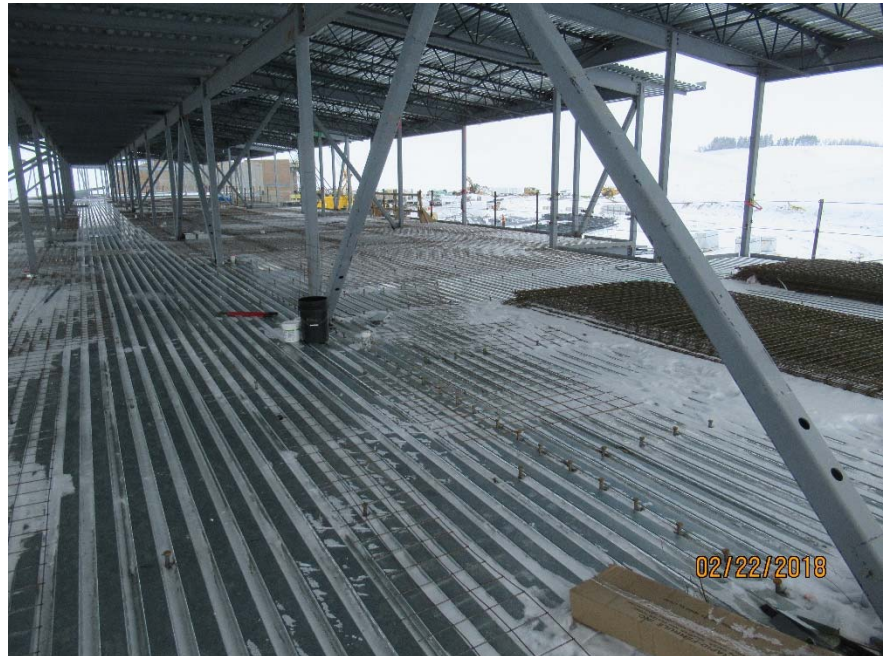
7. Does not appear any progress has taken place on the upper floor. The cold weather has hampered slab placement.

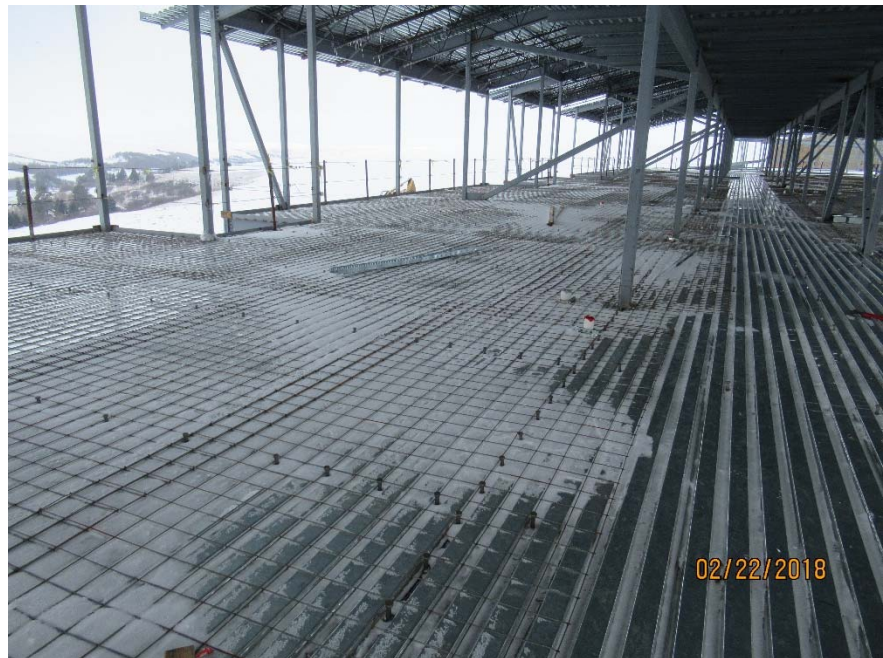
9. Does not appear any progress has taken place on the upper floor. The cold weather has hampered slab placement.

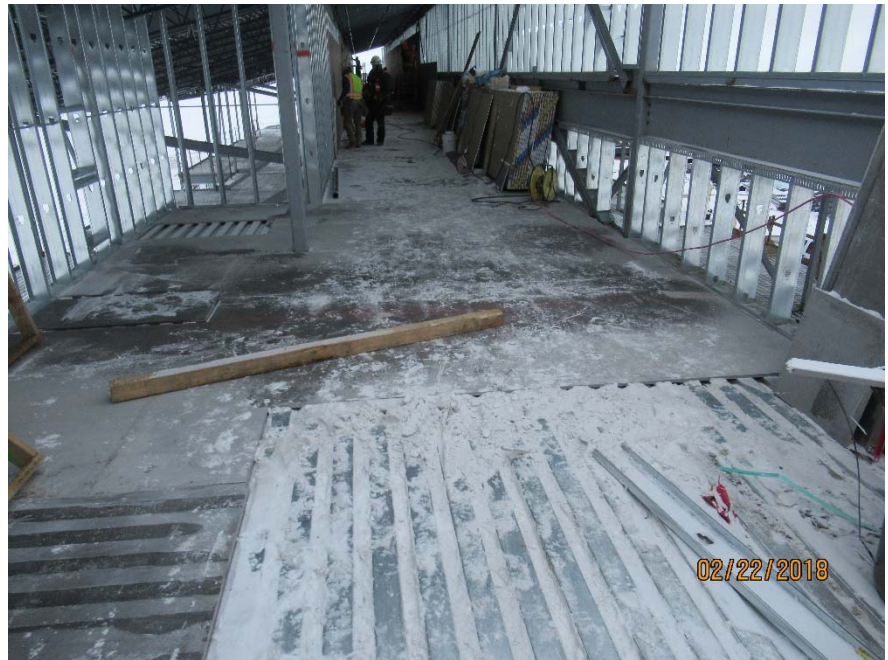
10. It appears the cement board floor installation is nearly complete on the mezzanine deck in Area A.

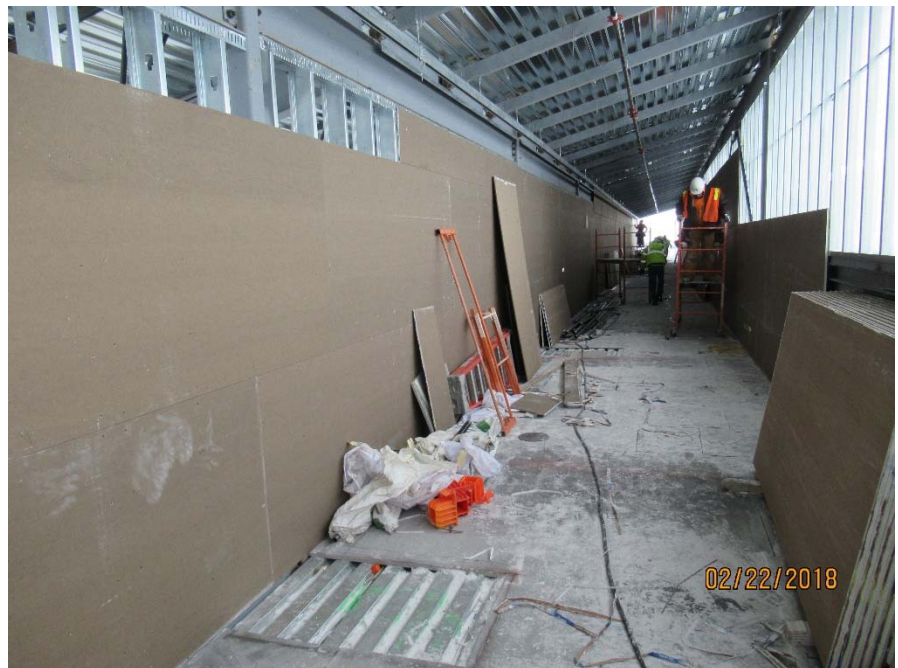
11. Installation of Firecode Core Type 1 wallboard on mezzanine level is in progress.

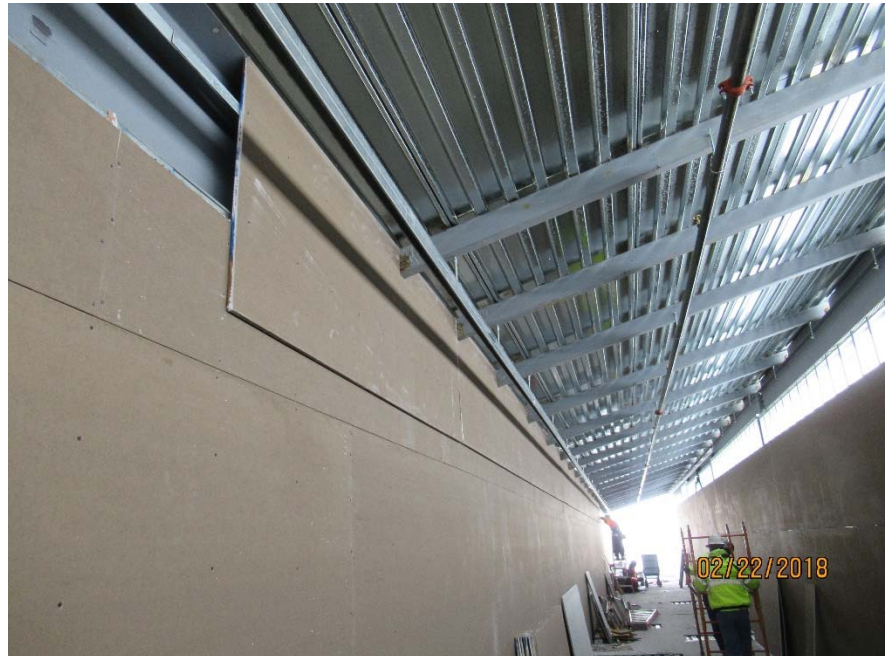
12. Installation of Firecode Core Type 1 wallboard on mezzanine level is in progress. Joints are specified to be fire taped. At the progress meeting today when Walker asked if they could caulk instead of fire tape the joints in the mezzanine the Architect sealing of the joints is strictly for sound mitigation. It is acceptable to caulk where there is an access problem but he would like fire taping at all locations possible.

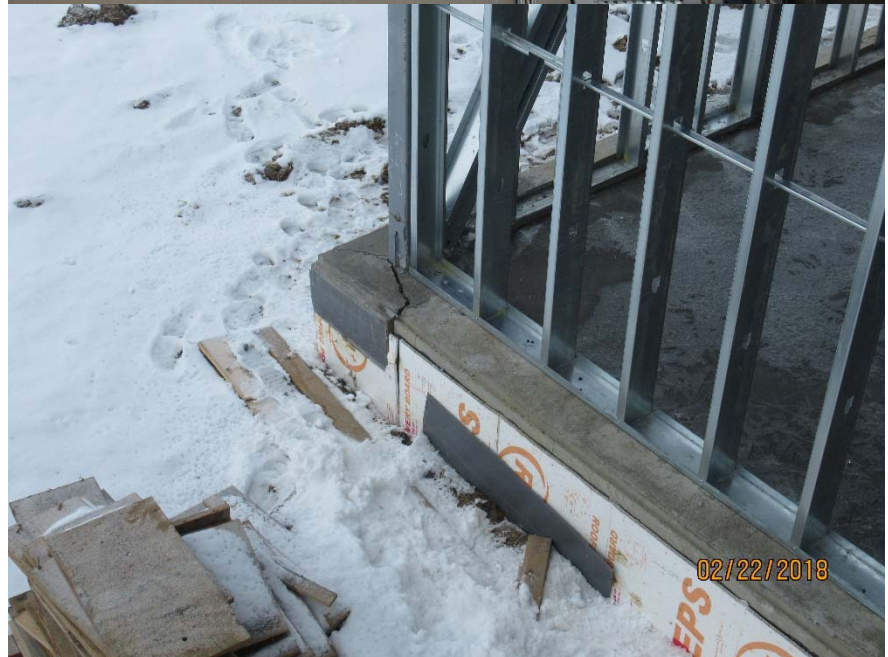
13. It appears there are a number of locations where pour backs have cracked loose of the column and surrounding concrete. Walker states this is not a structural issue but a cosmetic one, which will be addressed.

Deficiencies: Although not a structural deficiency, I believe the sever cracking of the exterior corner pour backs is at the least a cosmetic deficiency that needs to be addressed to the acceptance of the Design as well as Owner team. Addressing this issue now before building around and over it will only make it harder to get access to the issue. I have included this issue in the project meeting minutes to track.

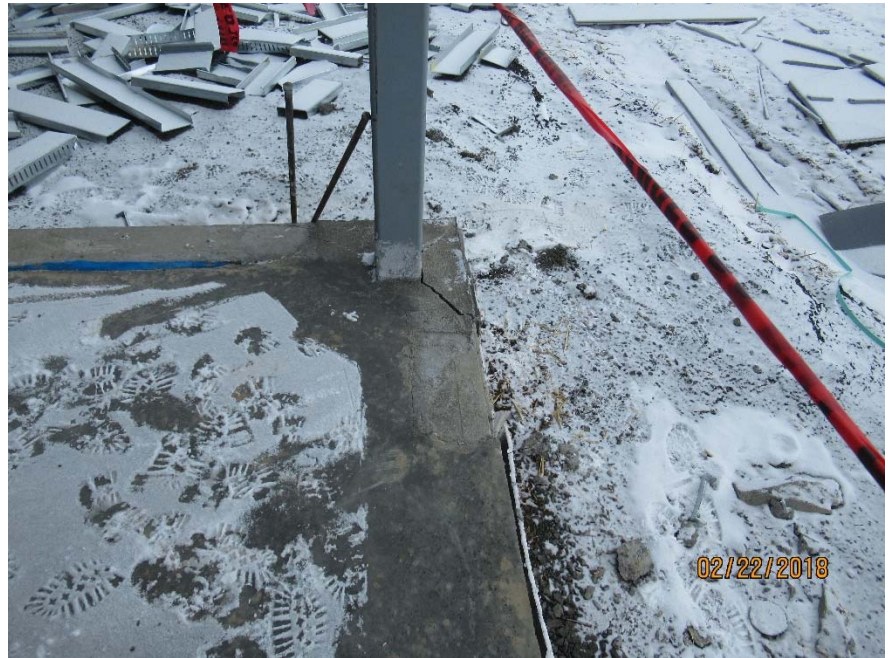
14. It appears there are a number of locations where pour backs have cracked loose of the column and surrounding concrete. Walker states this is not a structural issue but a cosmetic one, which will be addressed.

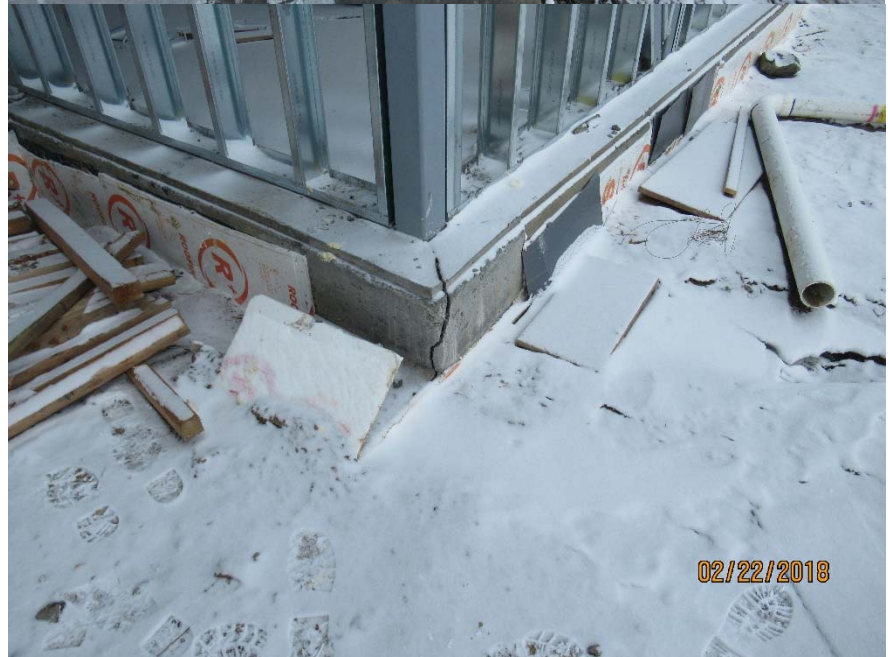
15. It appears there are a number of locations where pour backs have cracked loose of the column and surrounding concrete. Walker states this is not a structural issue but a cosmetic one, which will be addressed.

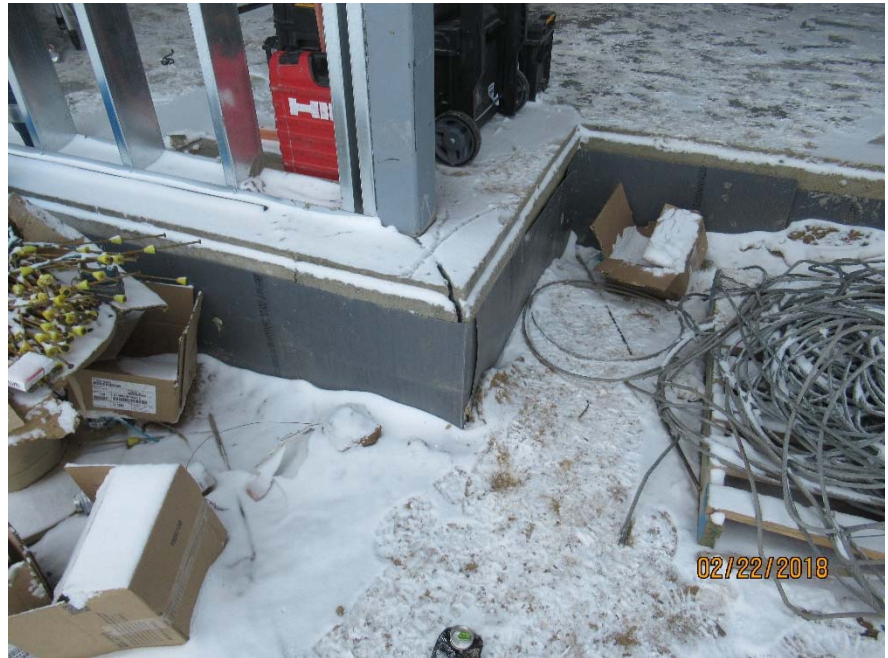
16. It appears there are a number of locations where pour backs have cracked loose of the column and surrounding concrete. Walker states this is not a structural issue but a cosmetic one, which will be addressed.

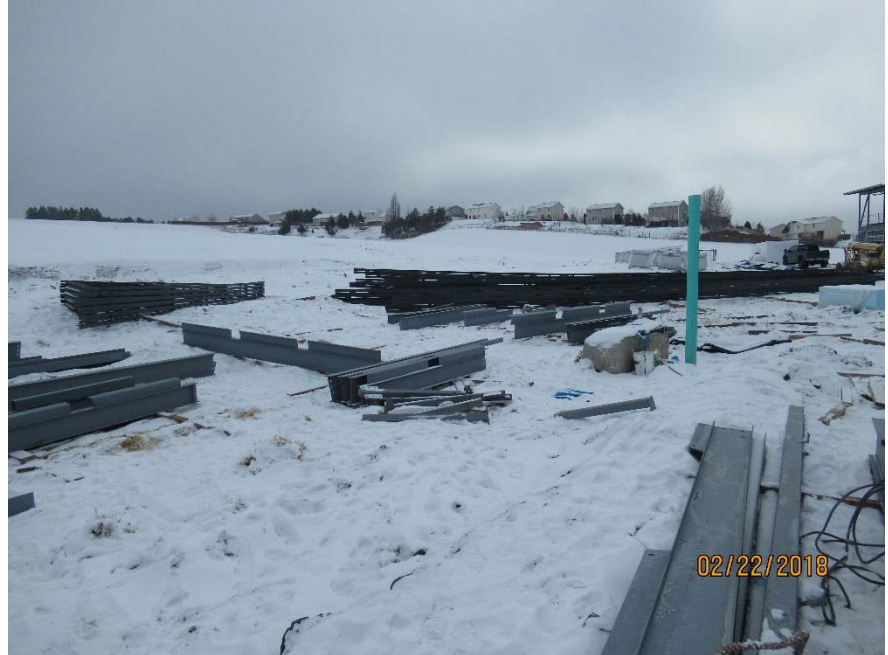
17. It appears the contractor has taken delivery of more structural steel for area B as well as trusses.

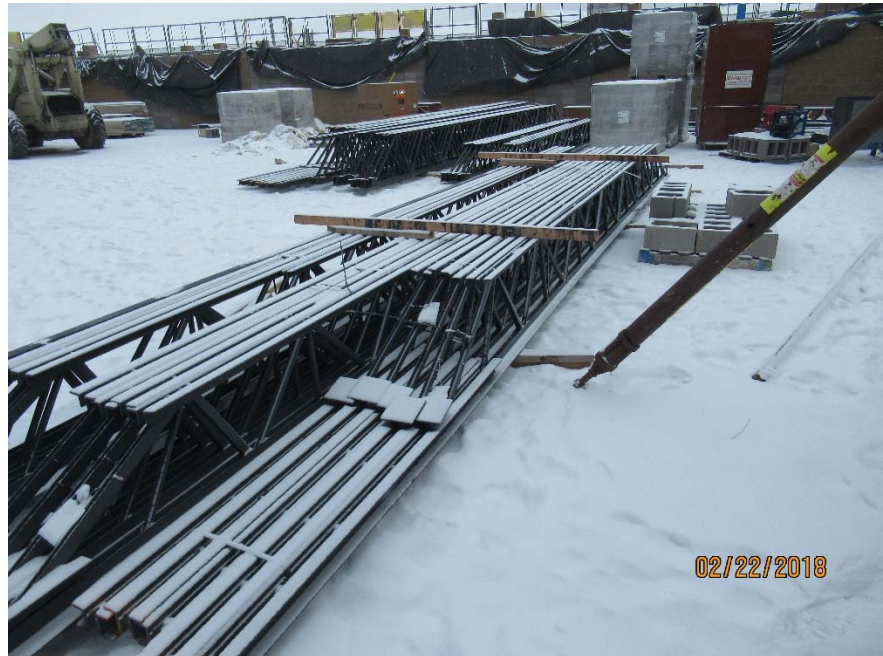
18. It appears the contractor has taken delivery of more trusses.
