**Project: PSD: Kamiak Elementary School****Date: March 15, 2018****Weather conditions:**

Discussion with: See Construction Progress Meeting dated 3/1/18.**Construction Activities:**

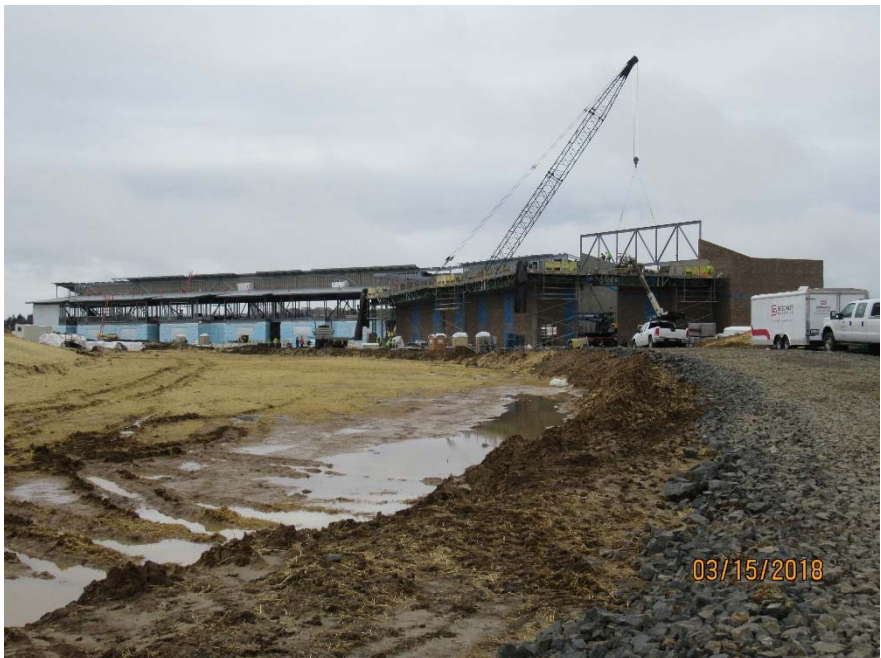
1. Overall photo of Kamiak Elementary School – Looking southwest.
NOTE: the contractor is working on placement of the first of two huge trusses in the gymnasium.

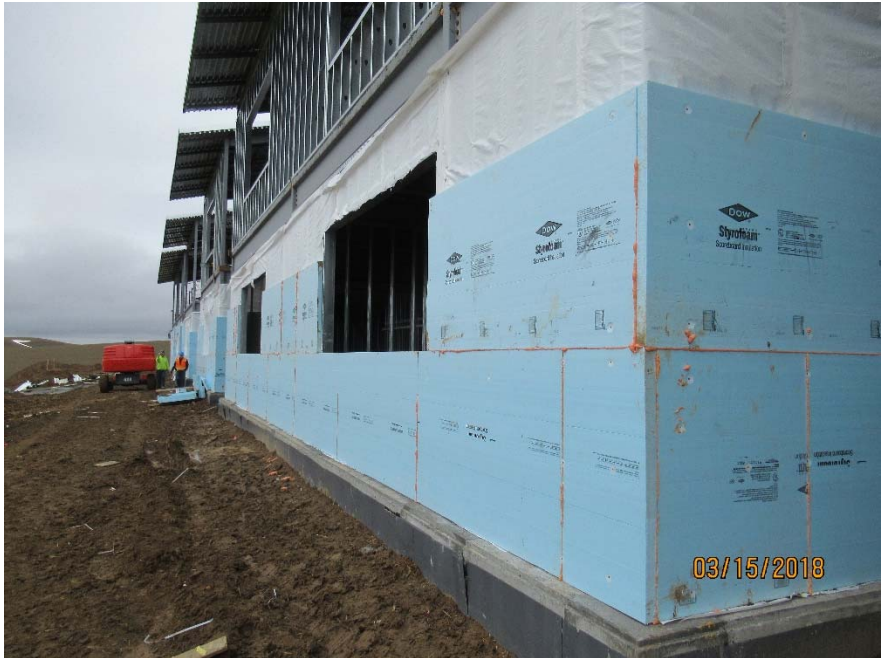
2. Looking north along the west exterior wall of the classroom wing.

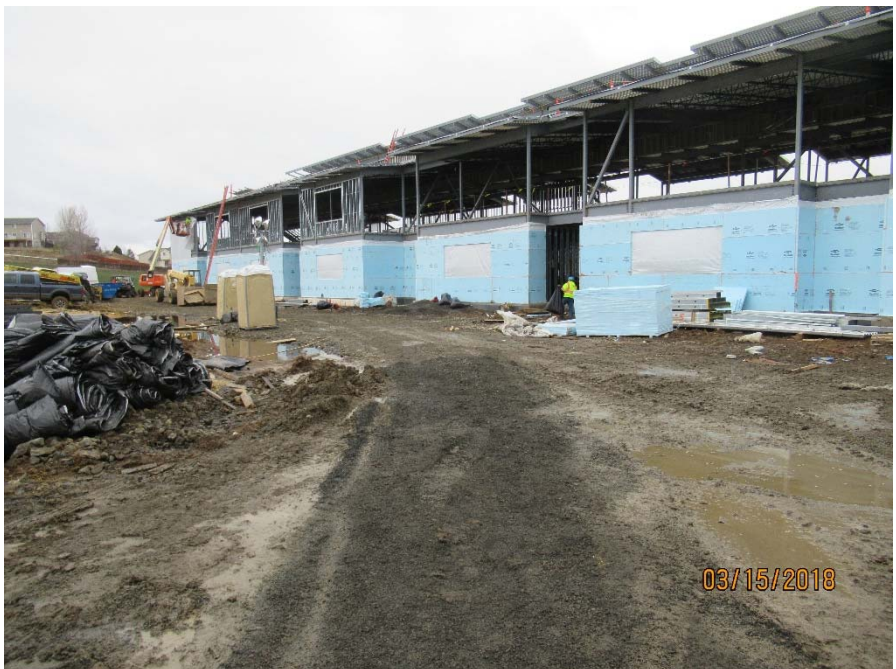
3. Looking south at the east exterior wall of classroom wing.

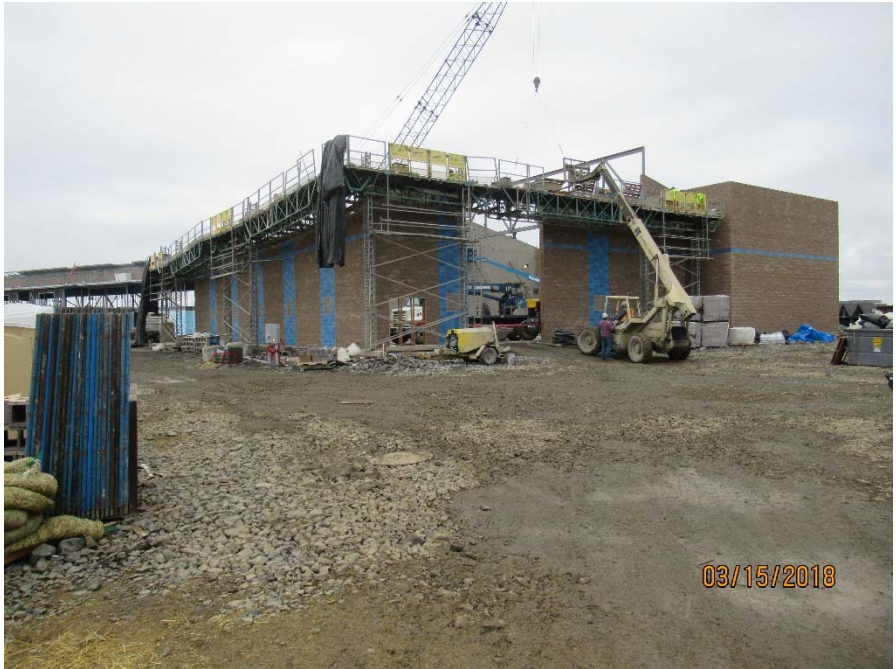
4. Contractor appears to be making fast progress on the gymnasium exterior walls.

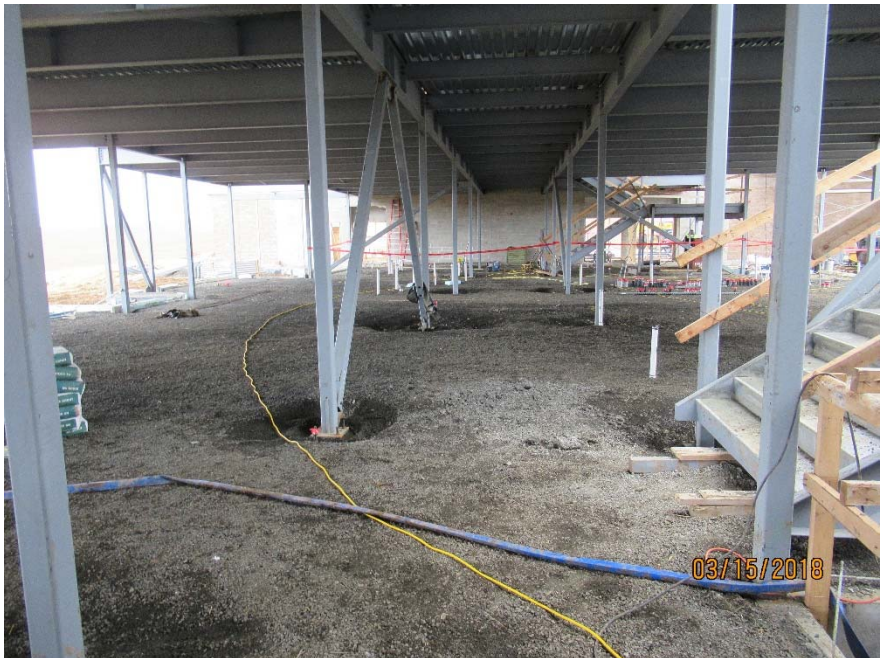
5. Contractor clearing out Area B in preparation of the installation of vapor barrier as well as reinforcing for next concrete pour. NOTE: The stairway at the right of the photo, the stair treads have been poured.

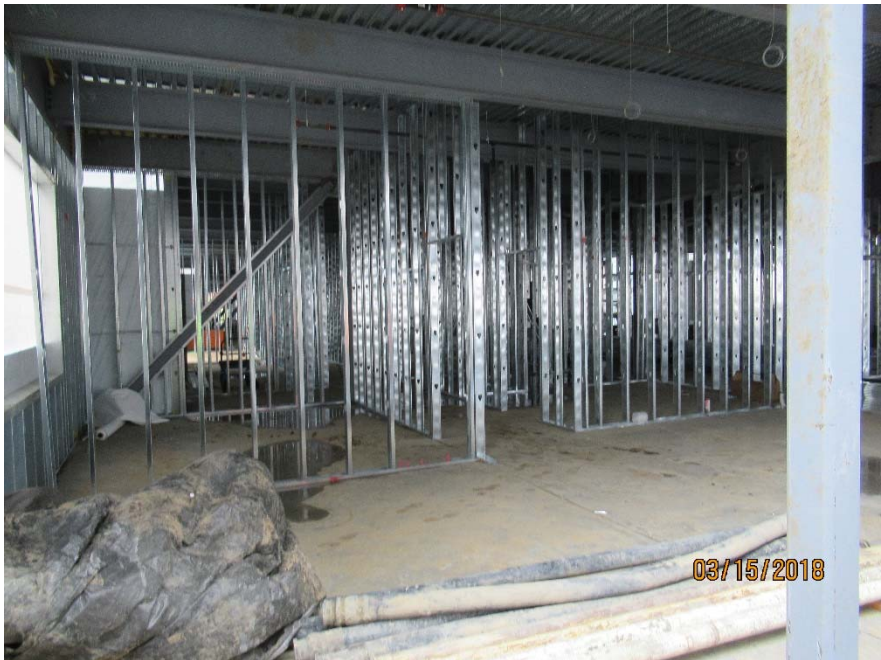
6. It appears the contractor is nearly complete with interior wall framing in Area A lower floor.

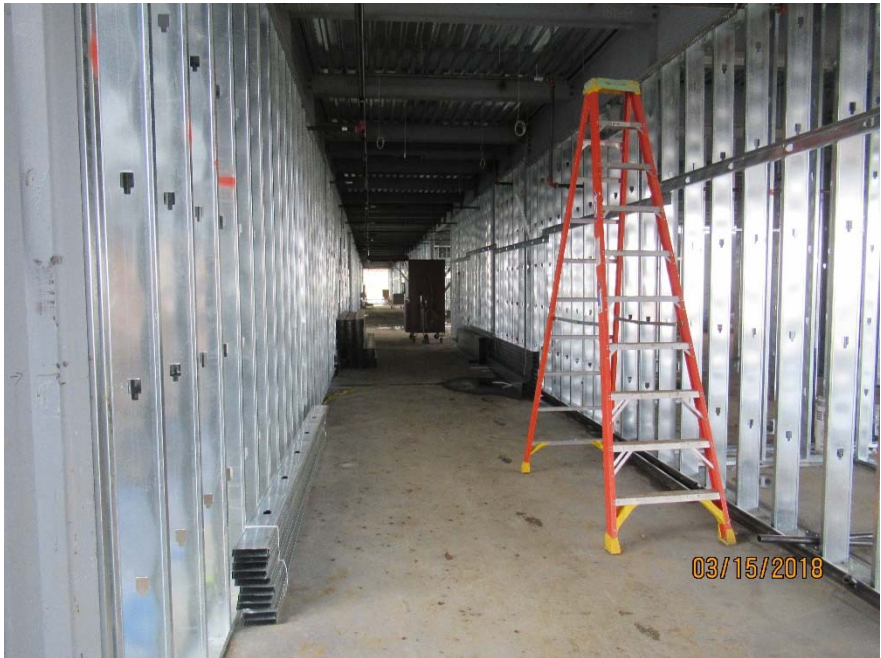
7. It appears the contractor is nearly complete with interior wall framing in Area A lower floor. Although hard to see in this photo installation of the fire sprinkler piping continues.

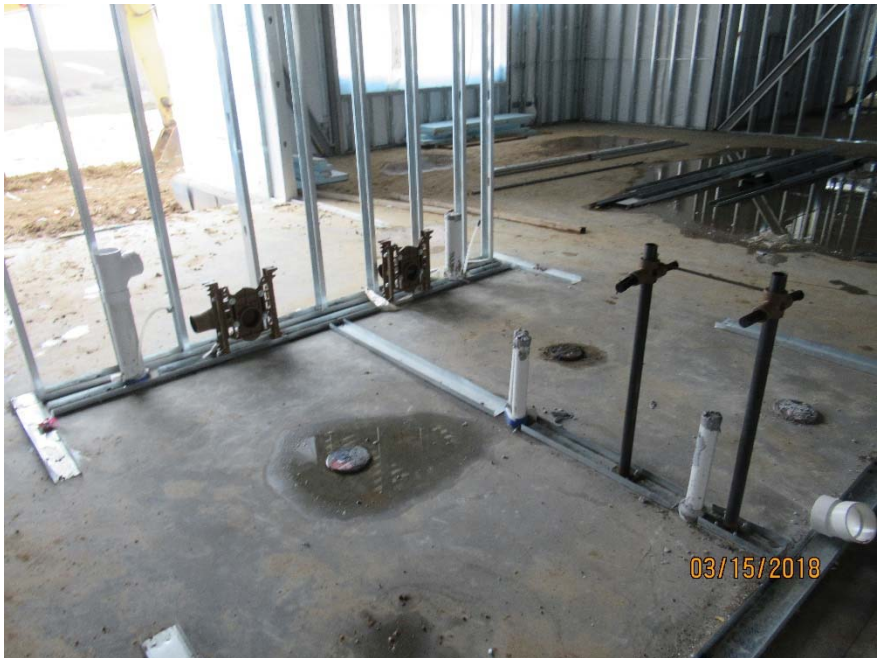
8. **Appears the contractor has installed the toilet and sink carriers in Restrooms 111A and 115A Area A lower floor.**

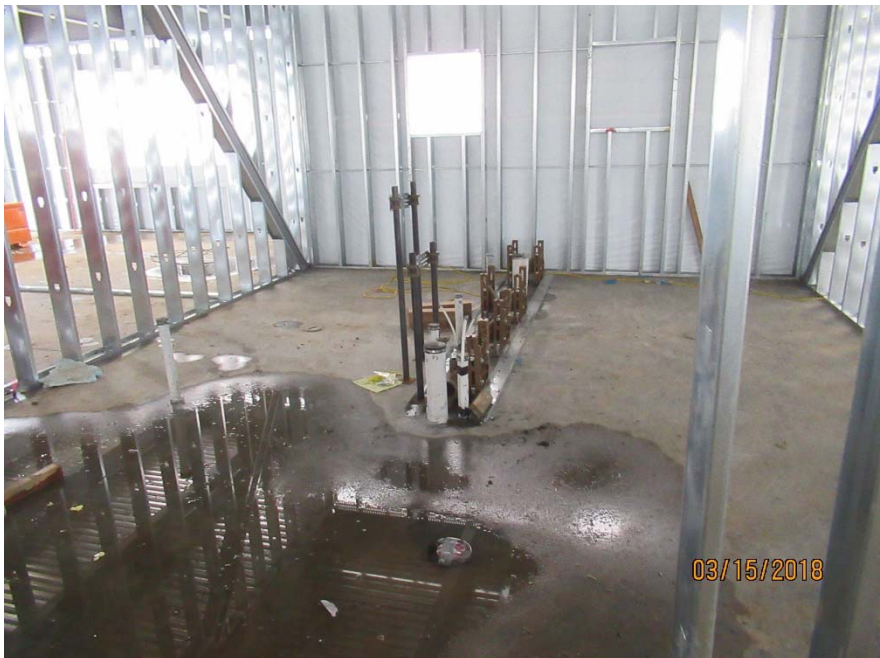
9. **Appears the contractor has installed the toilet and sink carriers in Restrooms 114 and 116 Area A lower floor.**

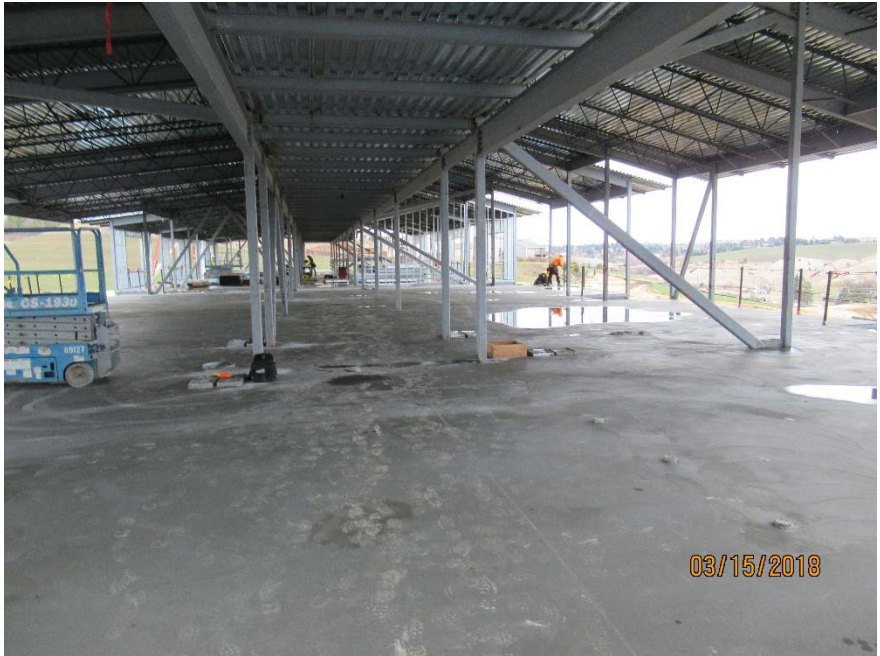
- 10. Looking south Area A upper floor. Appears wall framing has begun.**

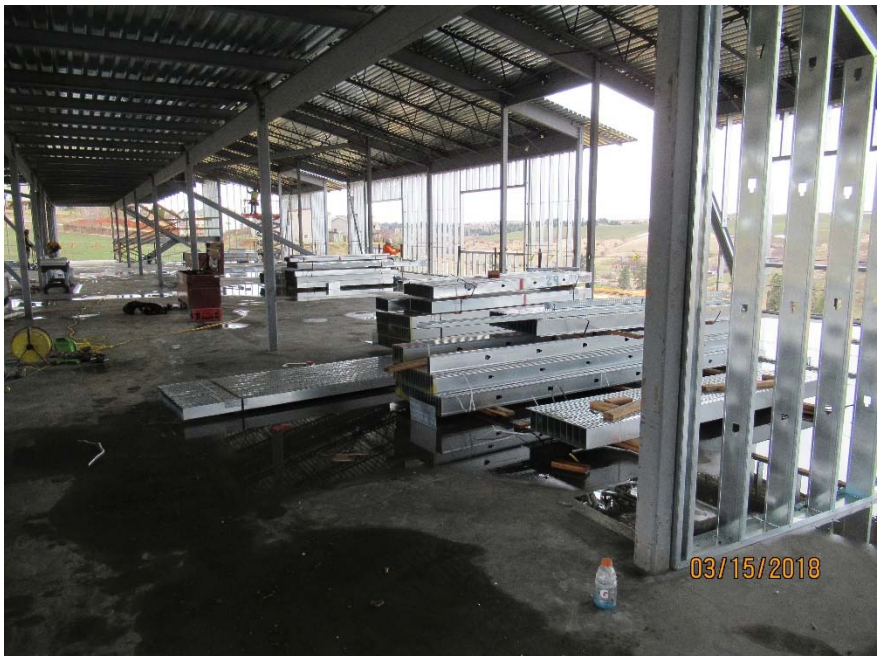
- 11. Looking south Area A upper floor. Appears wall framing has begun.**

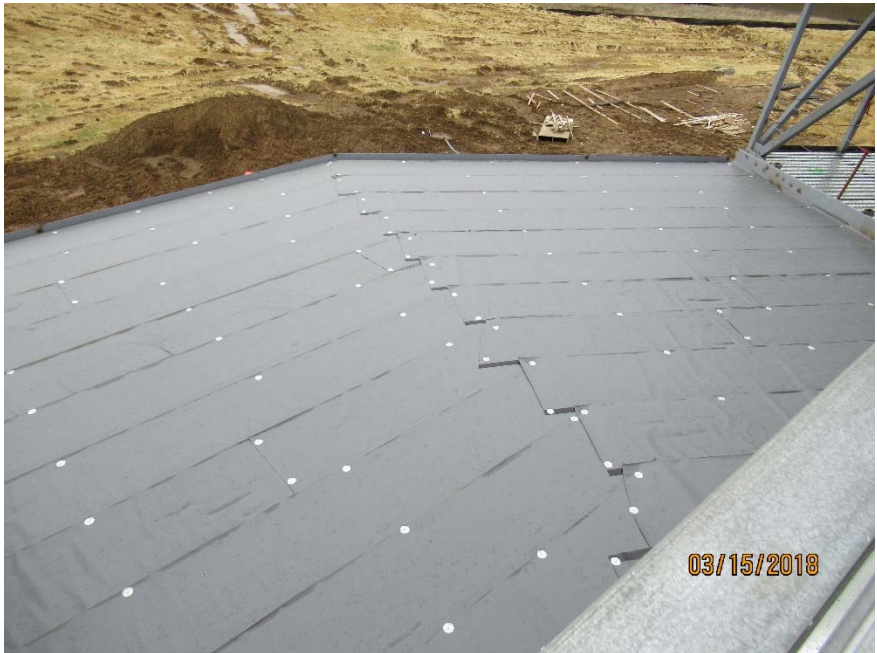
- 12. Looking west from upper floor Area B onto Library roof. Contractor has installed ice and water shield in an effort to keep Epic Deck factory installed insulation dry per discussion as pervious Construction Progress Meeting.**

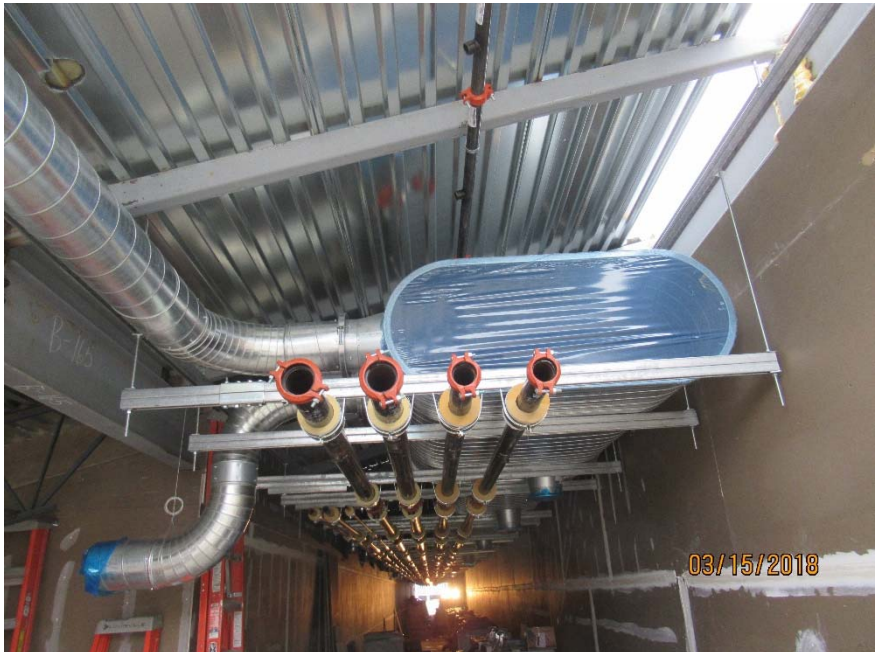
- 13. Mezzanine level, looking north. Appears the contractor has installed fire sprinkler lines, large ductwork as well as racking pipe.**

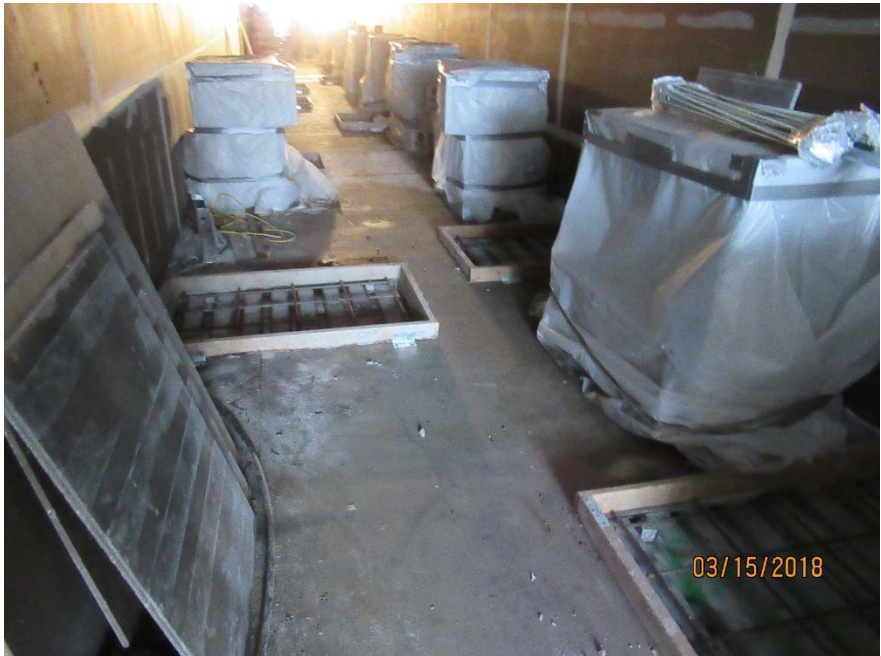
14. Mezzanine level, it appears contractor has placed all the fan coils in the mezzanine next to their formed housekeeping pads. Contractor has scheduled pouring concrete for the pads tomorrow.

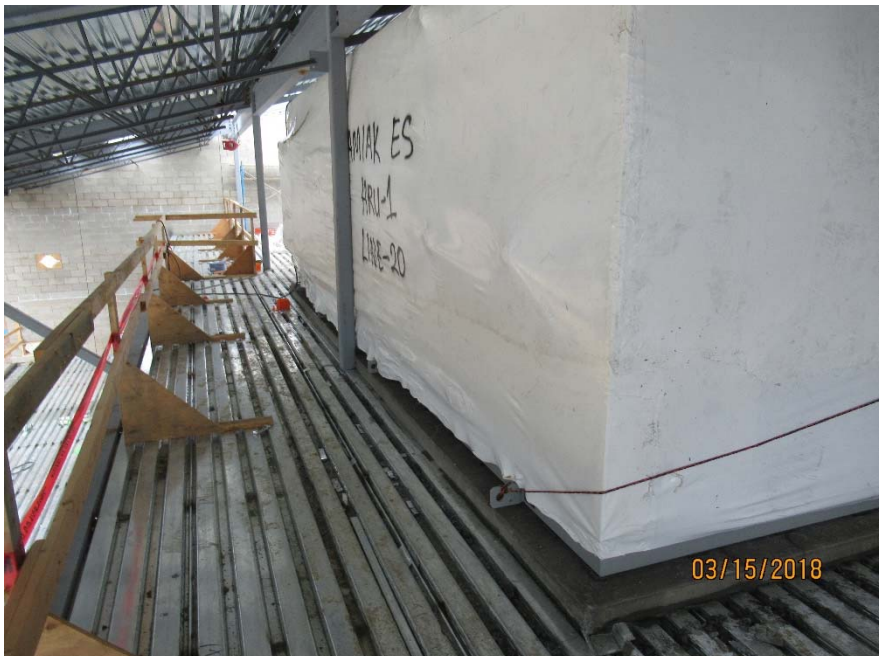
15. Appears the housekeeping pad has been placed and the HRU-1 has been set near the north end of the mezzanine.
