**Project: PSD: Kamiak Elementary School****Date: March 7, 2019****Weather conditions:**

Discussion with: See Construction Progress Meeting minutes dated 3/7/19**Construction Activities:**

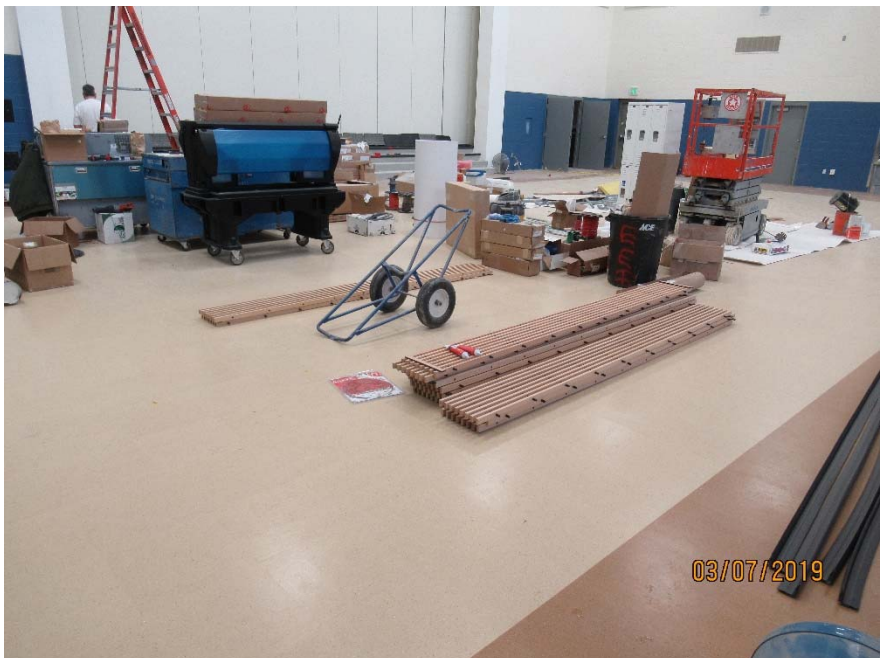
1. Contractor has taken delivery of additional ceiling wood slats to replace the splintered installed ones. This was mentioned in an earlier Observation Report.

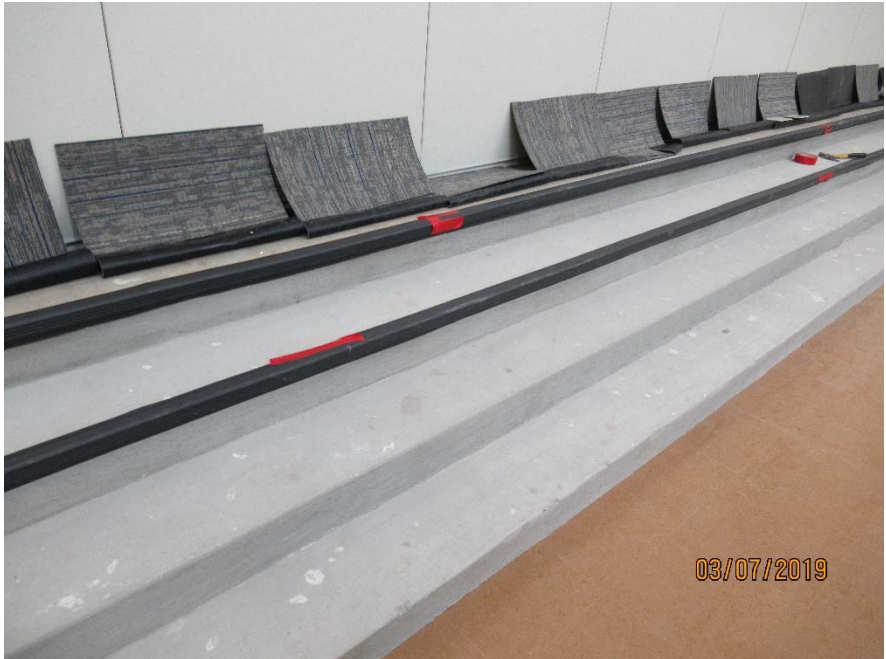
2. Contractor is installing step nosings reading for installation of carpet treads and risers.

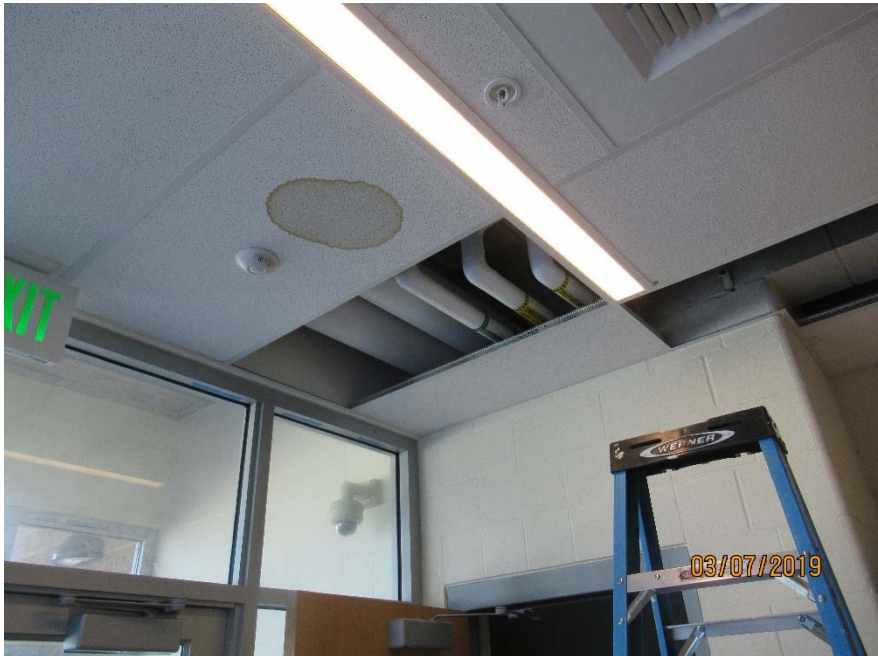
3. Appears there is a roof leak. Contractor currently working on snow removal from the roof over Vestibule 160 to gain access to the roofing membrane.

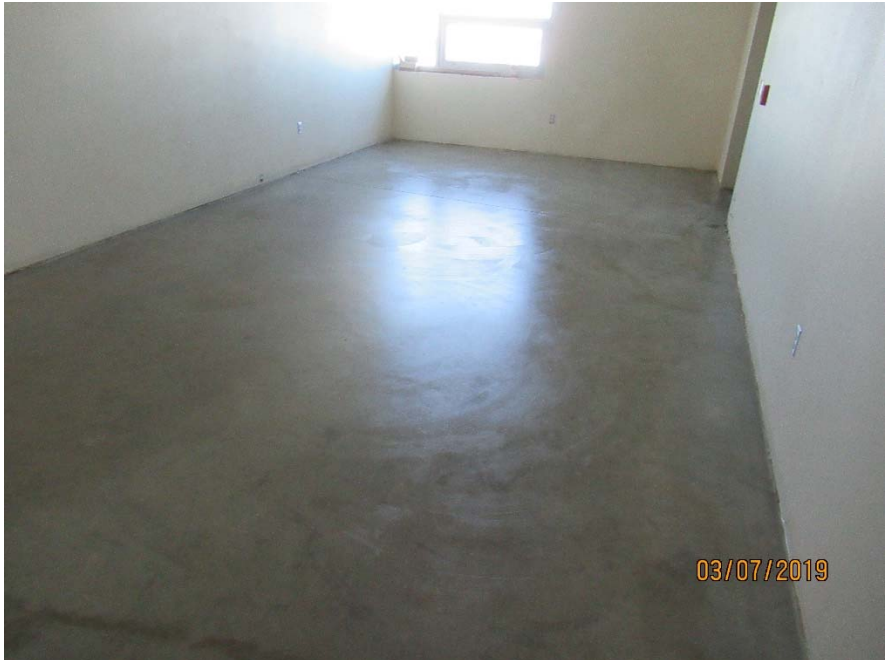
4. It appears all the bare concrete floors have been sealed with the exception of Storage room 139A.

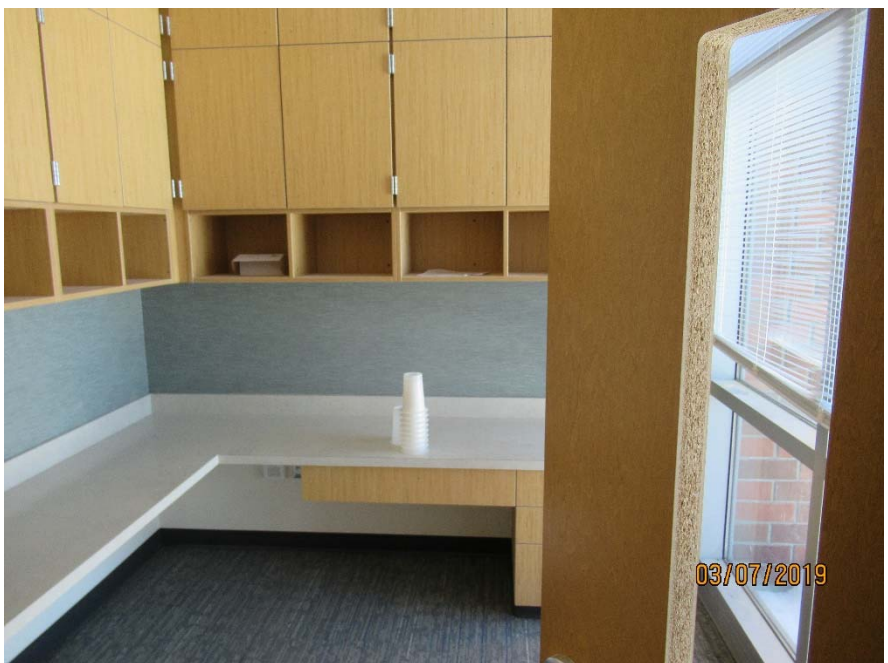
5. Although most of the casework is installed Work Space 132A appears to be missing casework door and drawer pulls and the door is missing window glazing and frame.

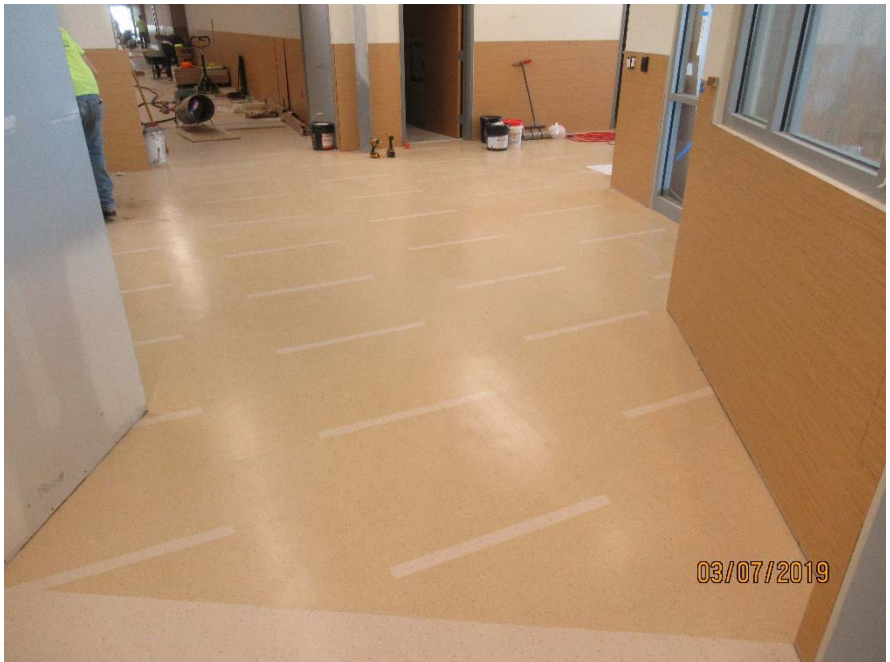
6. Appears the contractor is nearly complete with flooring installation of Corridor 124, outside the Library.

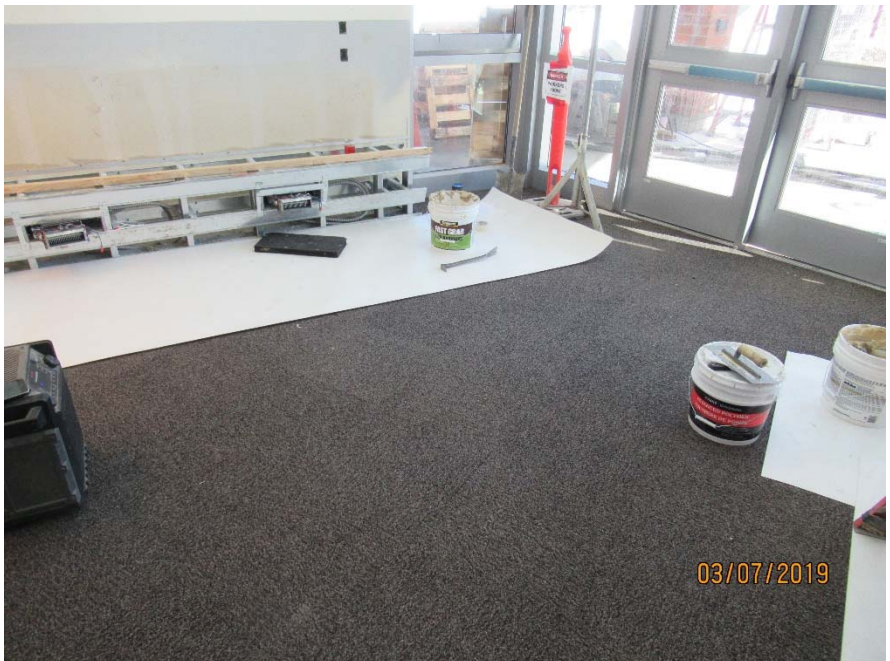
7. Walk off mat has been installed in Vestibule 122.

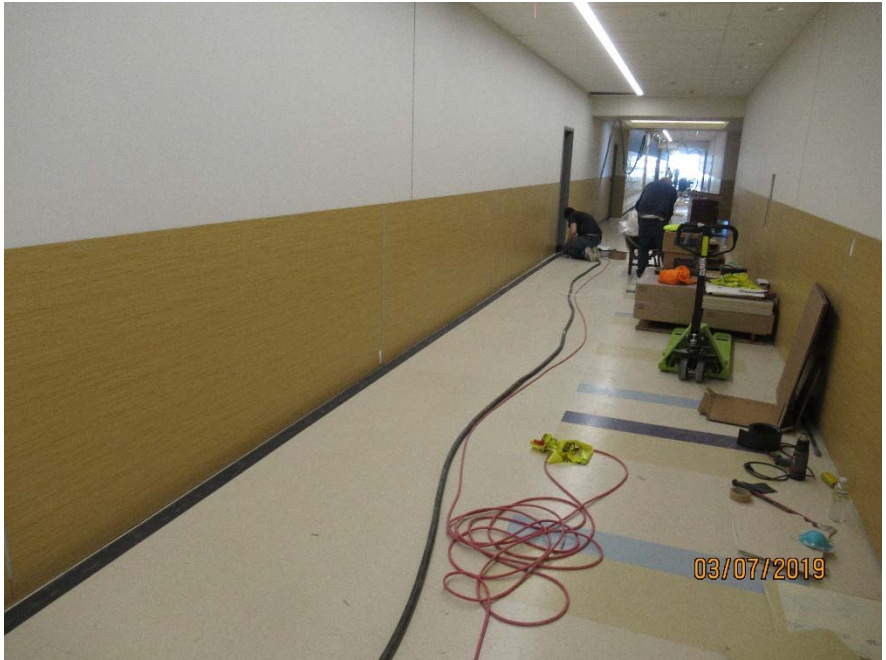
- 8. Contractor is installing wall base in Corridor 120.**

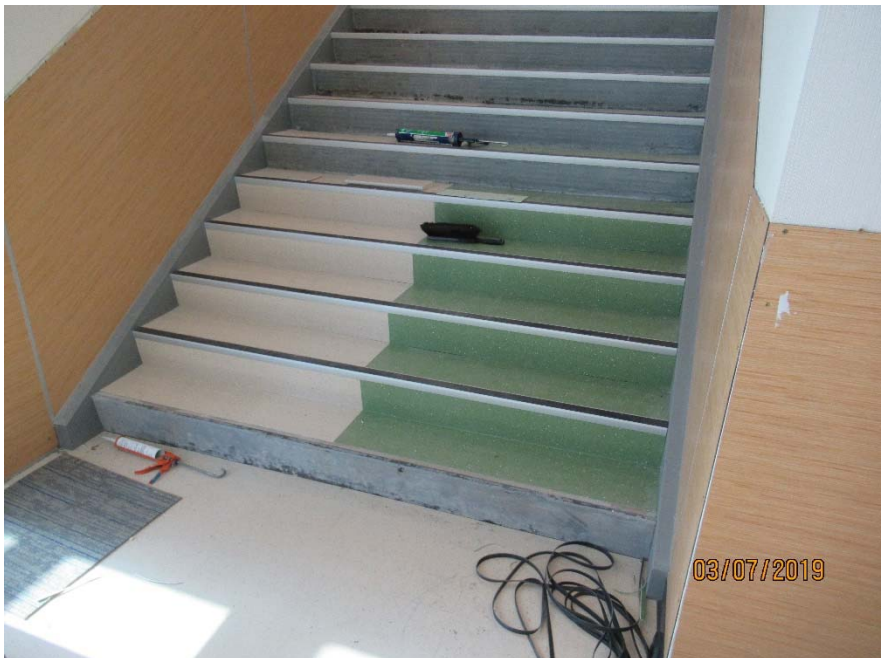
- 9. At the north stair the contractor has removed the rubber riser previously installed and is installing vertical tile per the contract documents.**

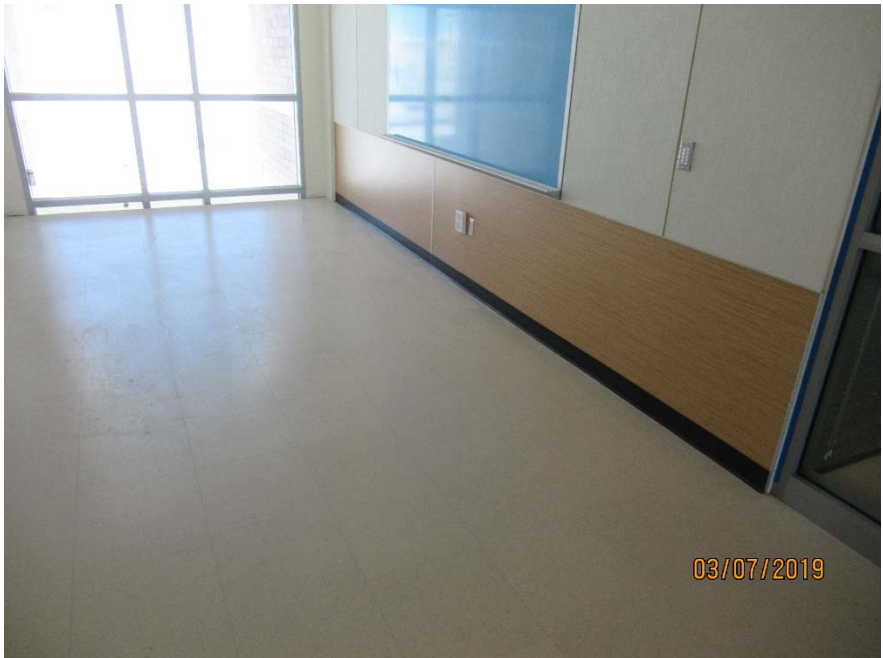
- 10. There are a number of breakout spaces that appear nearly complete. There is still a breakmetal angle to be installed at the base of the window wall.**

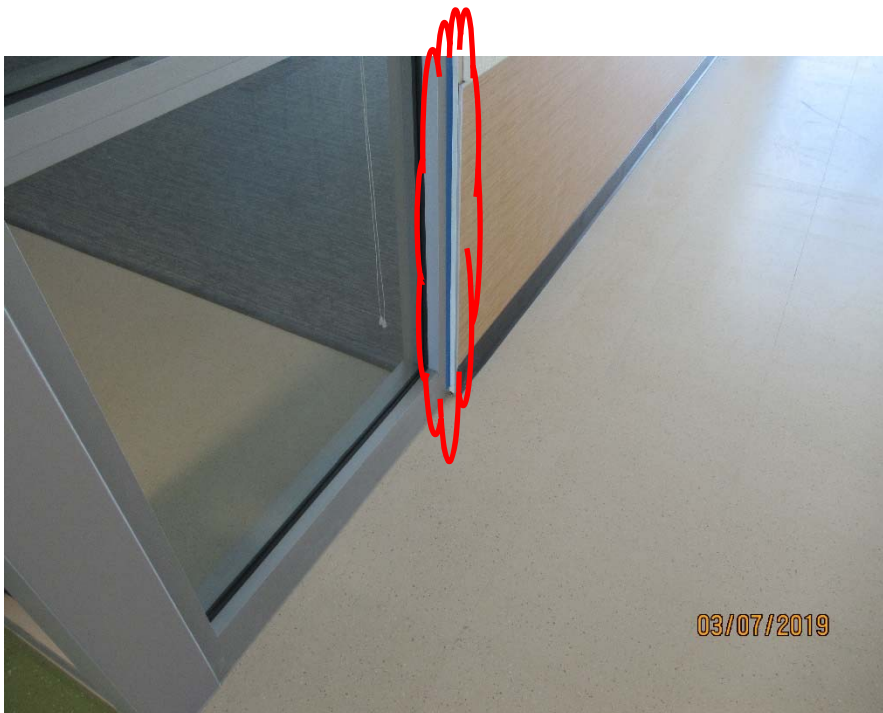
- 11. It appears the contractor has taped off the aluminum frame in preparation of addressing the unfinished edges of wallboard.**

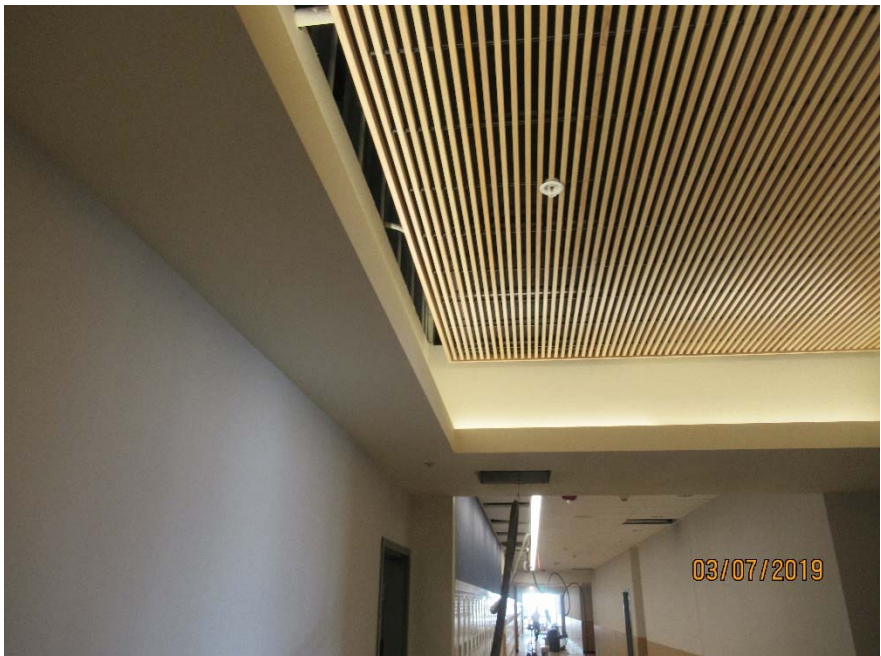
13. It appears the contractor has not yet addressed the soffit issue at the wood slat ceilings.

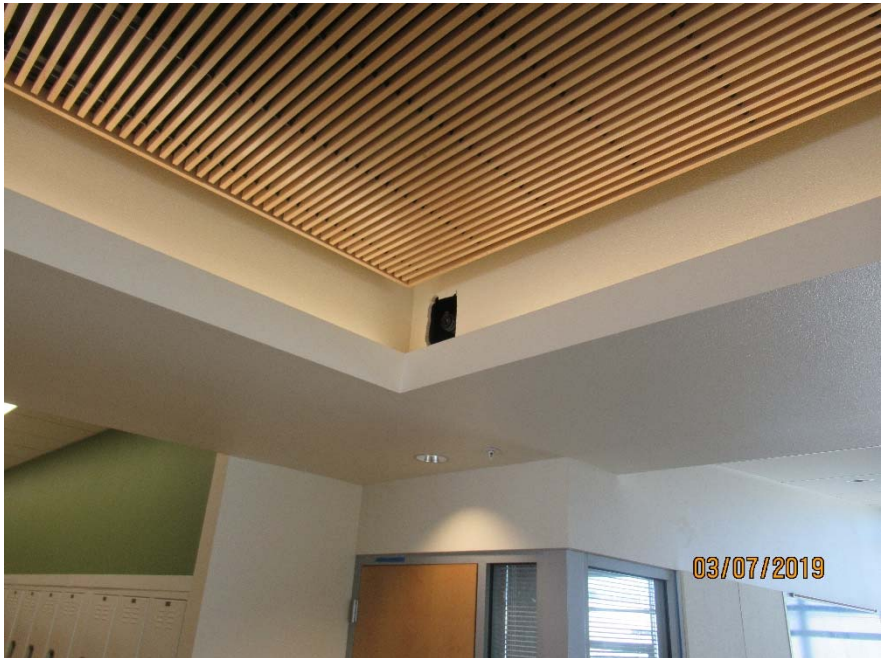
- 14. Appears the contractor has not yet finished repairing wallboard where pipe protrusion was fixed.**

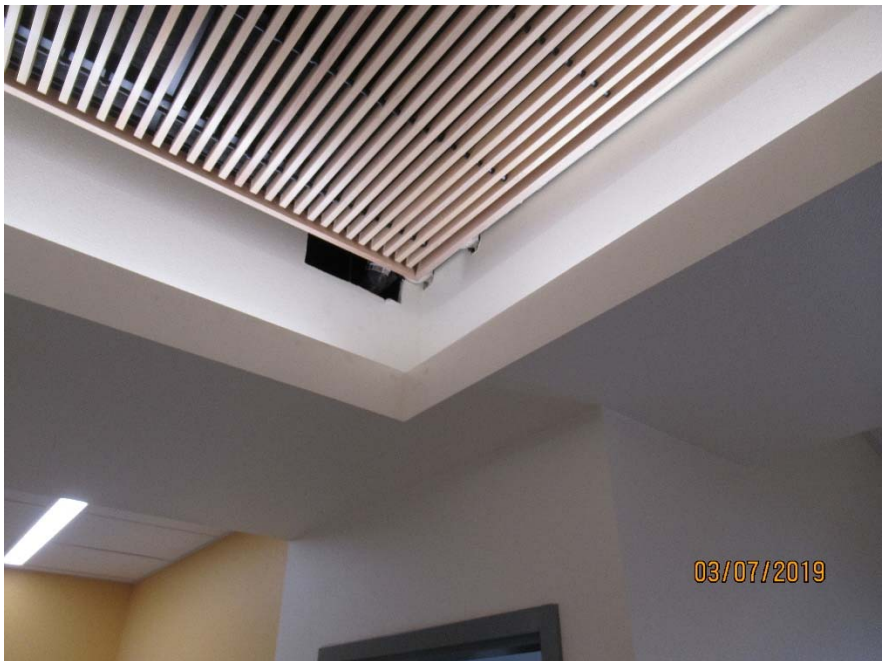
- 15. Appears the contractor has not yet finished repairing wallboard where pipe protrusion was fixed.**

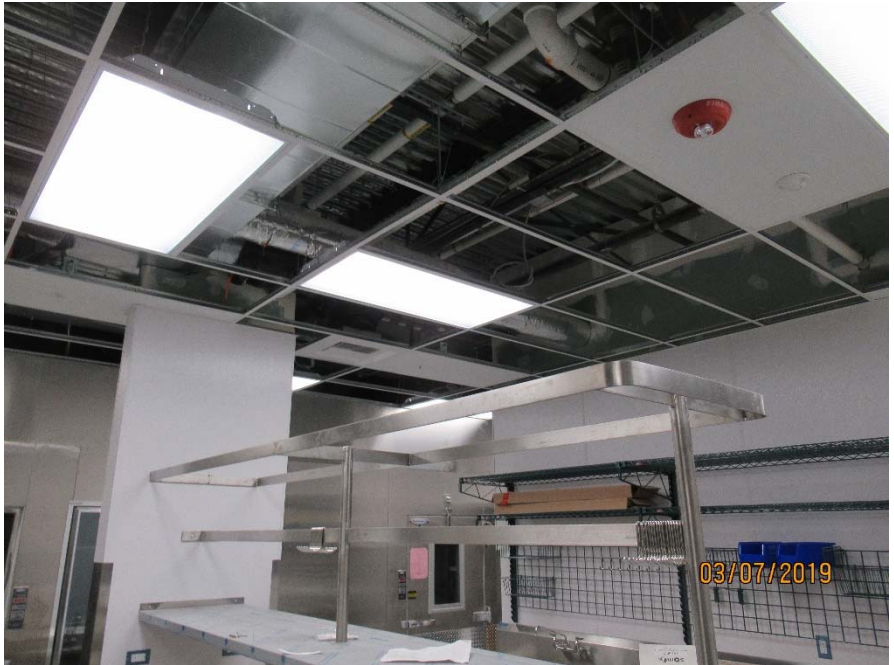
- 16. It appears the Kitchen is nearing ready for drop ceiling installation.**

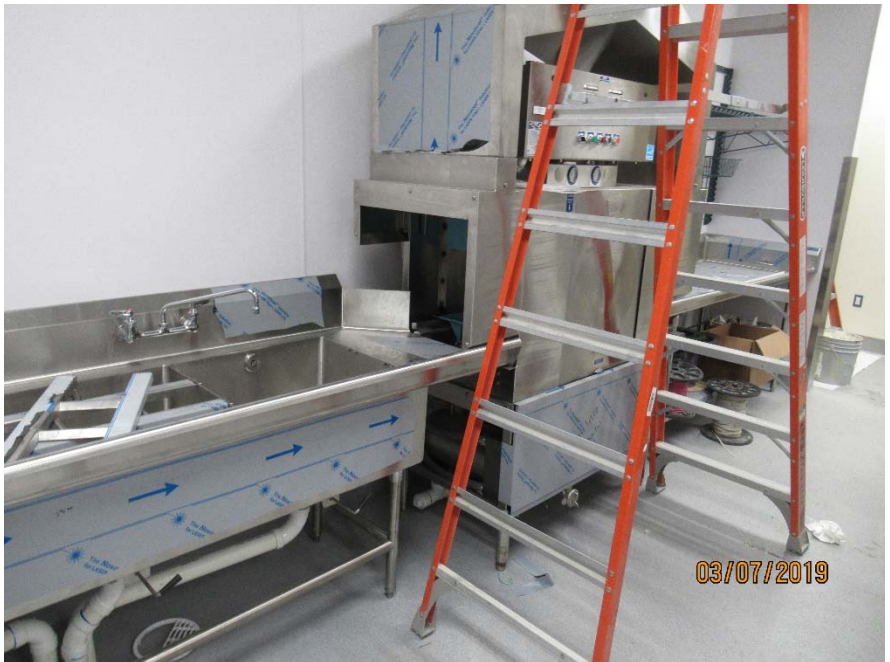
- 17. Appears the dishwasher has been installed, there is still an issue with second power source for booster heater.**

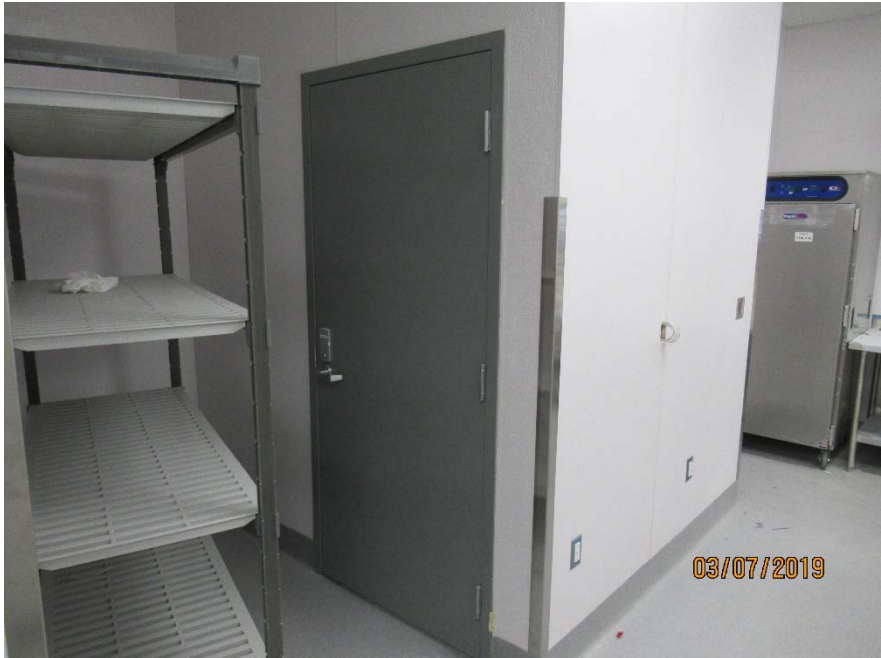
- 18. This Kitchen restroom door needs to be turned around. Contractor still waiting for replacement door.**

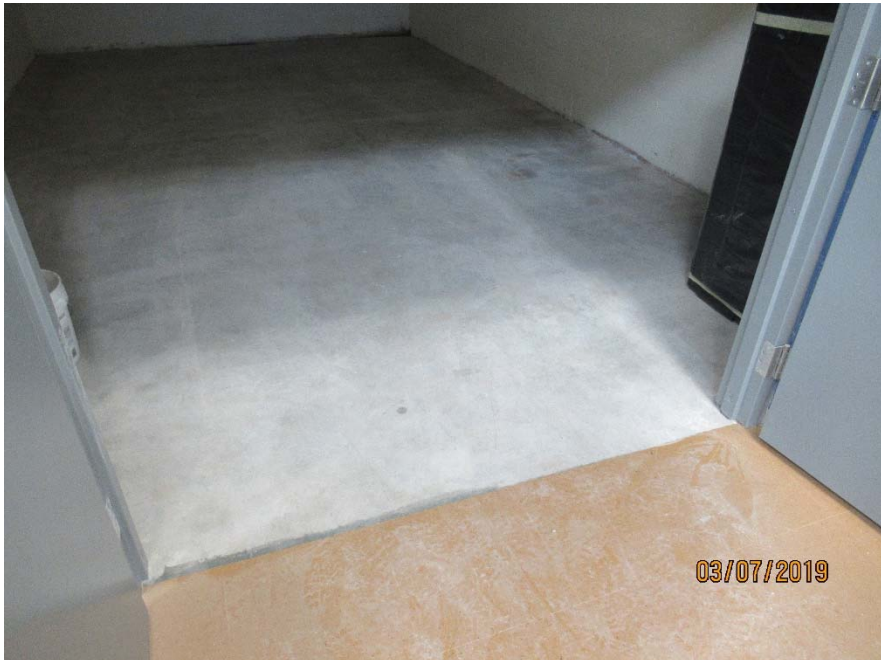
- 19. This is Storage room 139A I believe this is the only concrete floor that has not yet been sealed.**

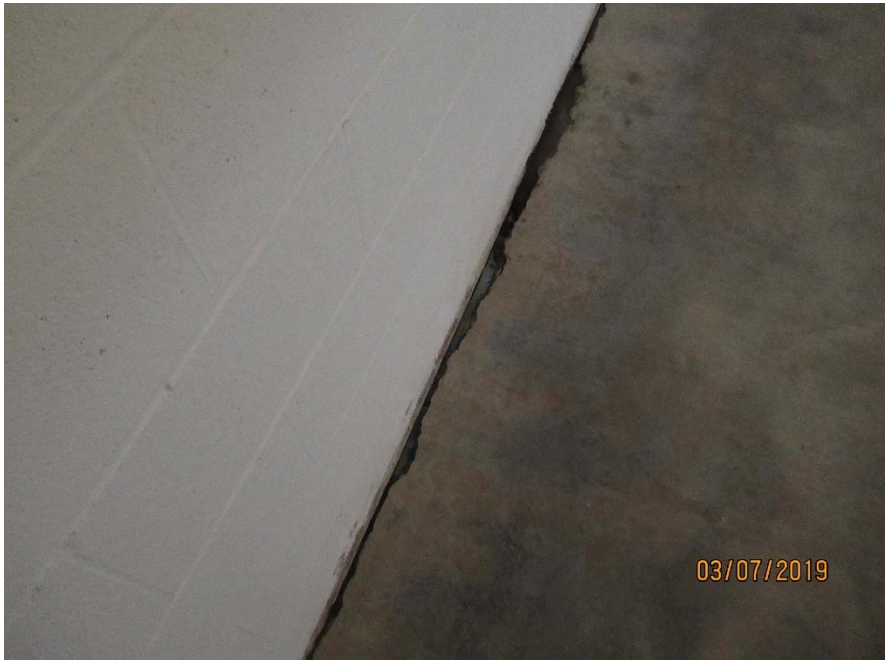
- 20. This is the base of west wall of Storage room 139A. I believe this large gap needs to be repaired then floor can be sealed.**

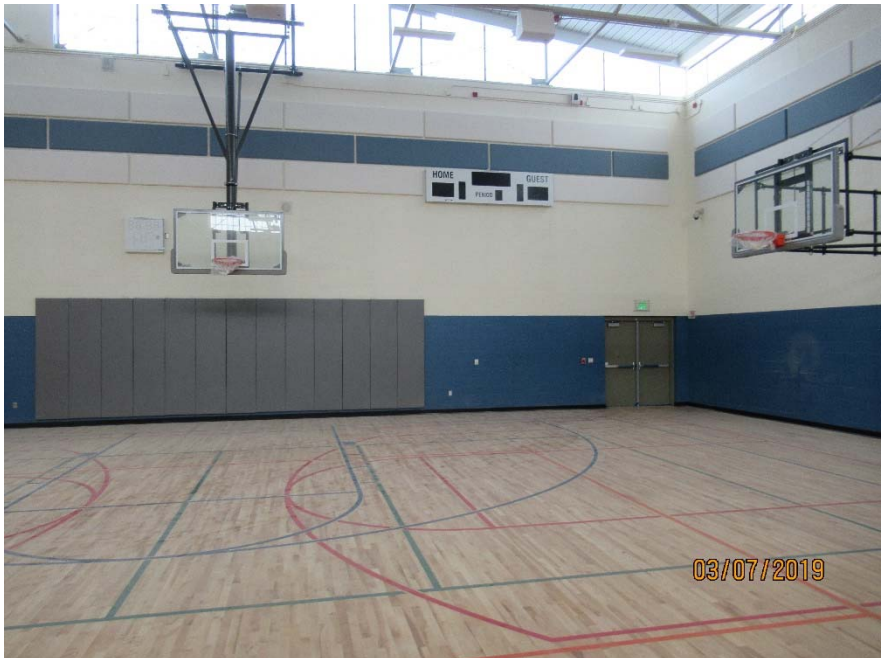
- 21. Contractor has installed shot clocks and score board. There is an outstanding Request for Information concerning low voltage power supplies for them.**
