**Project: PSD: Kamiak Elementary School****Date: April 12, 2018****Weather conditions:**

Discussion with: See Construction Progress Meeting dated 4/12/18**Construction Activities:**

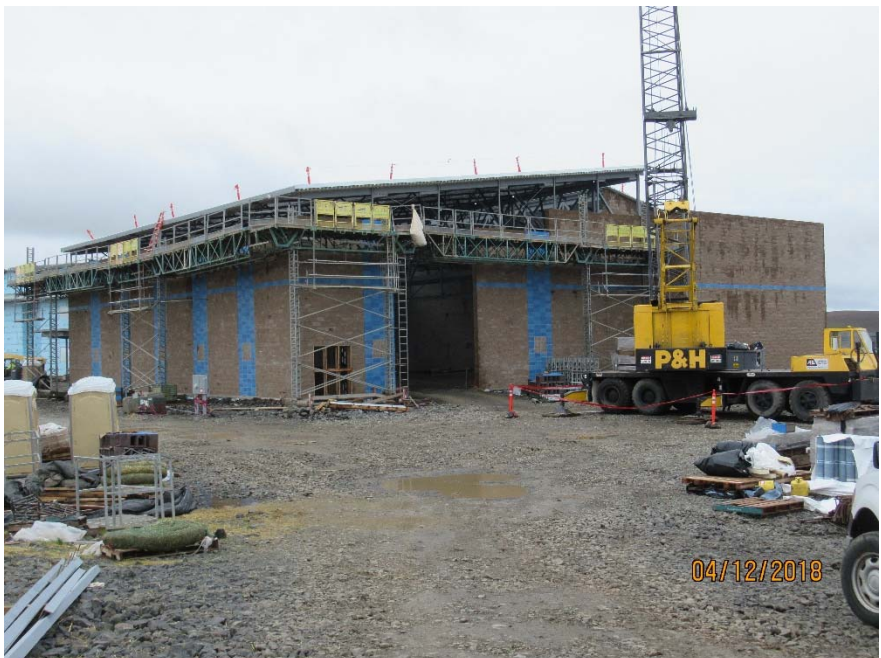
1. View looking south at the Gymnasium. The opening seen is for contractor entrance into the building. This will be closed up once there is no further need for larger equipment access into space.

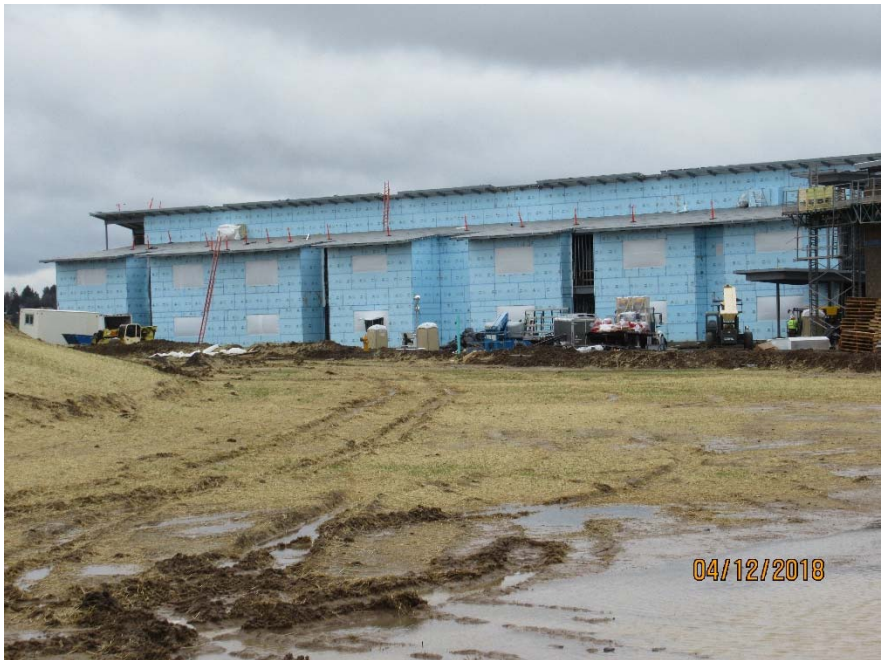
2. Contractor appears to have all the insulation board installed on the east elevation of Area A.

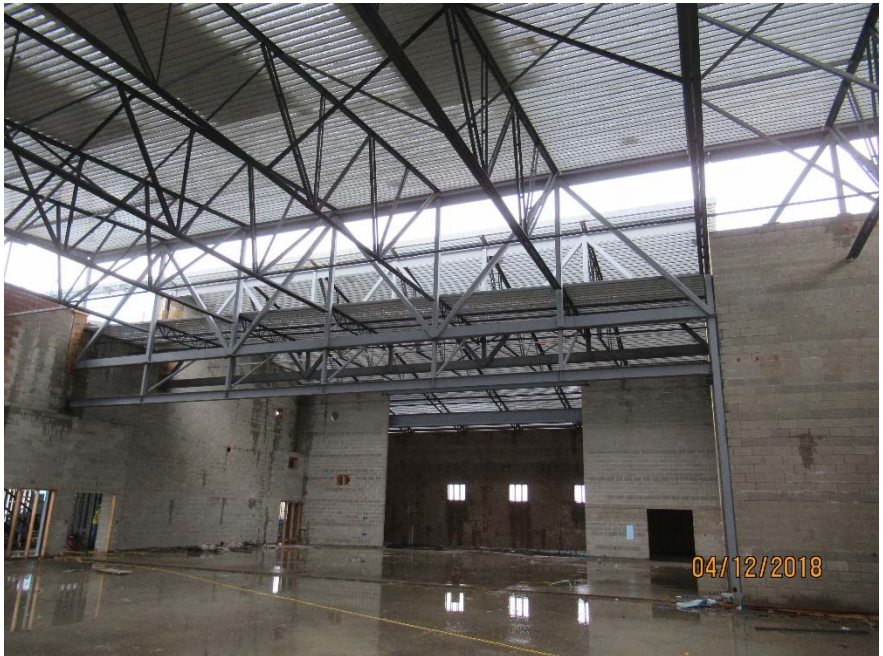
3. View looking west from the Gymnasium space through the Multi-Purpose to Music Classroom.

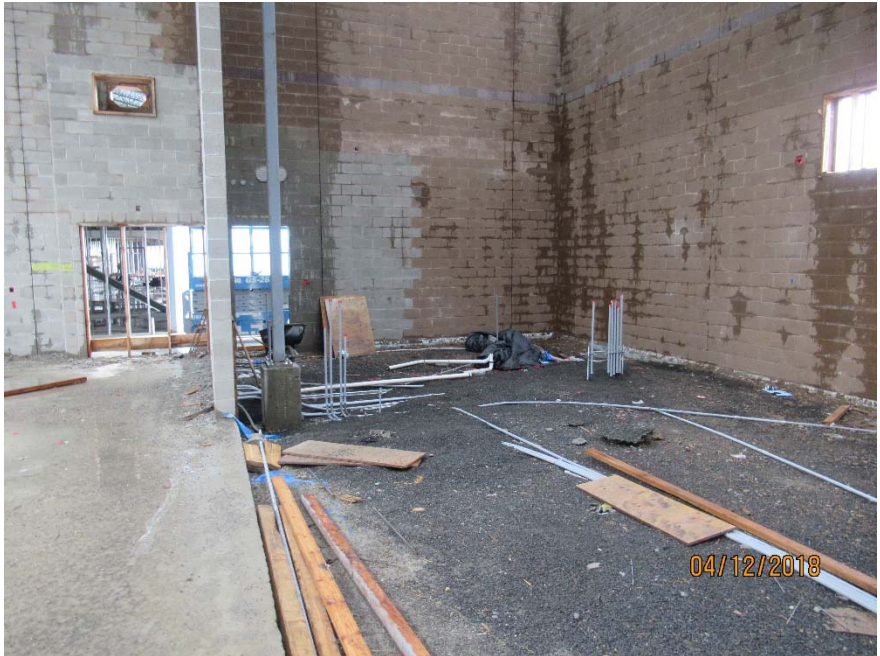
4. **Underground piping and conduits appear to all be installed at Music Classroom.**

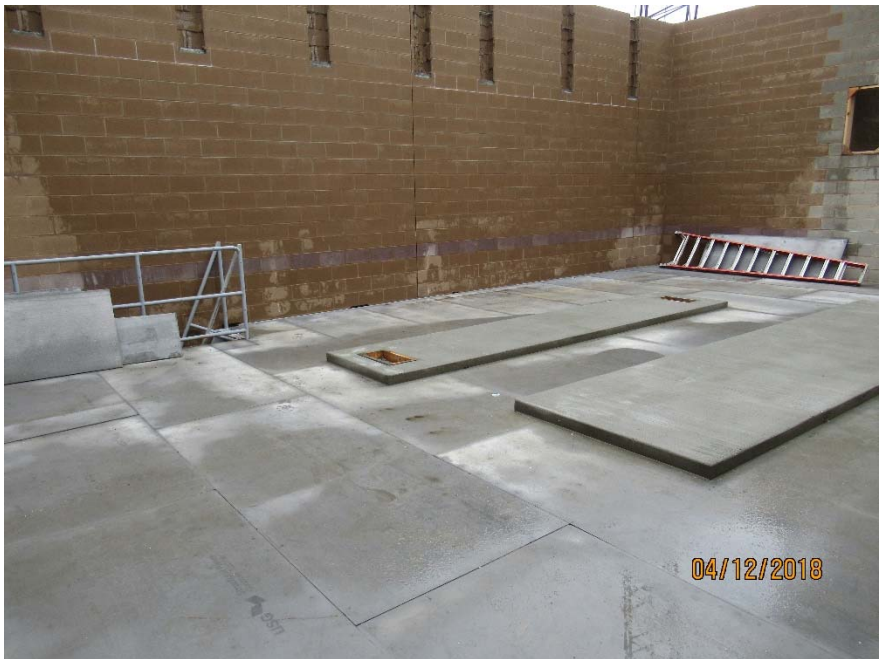
5. **Floor has been installed and housekeeping pads poured in Kitchen Mezzanine. To the left in this photo the stair has also been installed.**

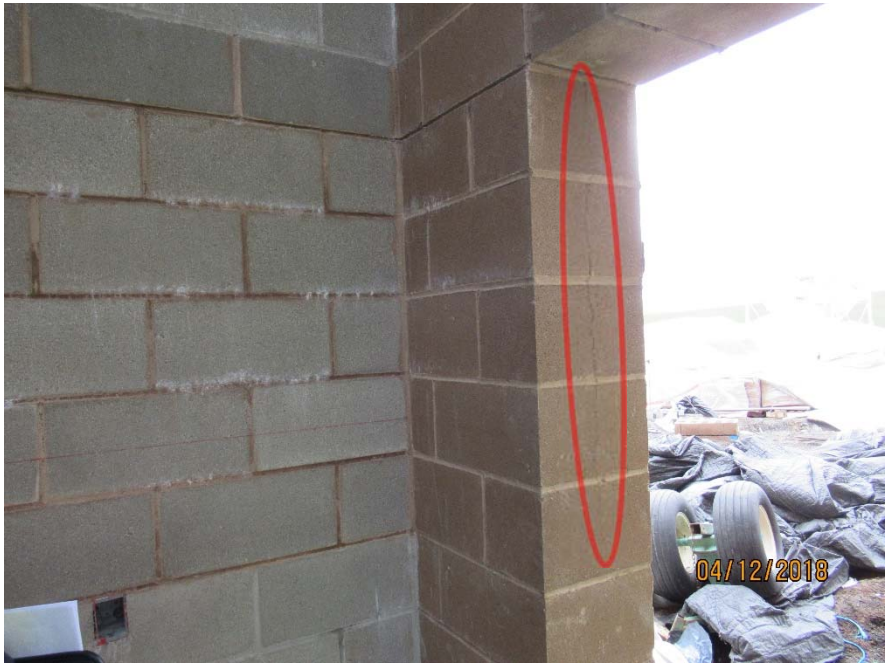
6. Although difficult to see in this photo, there appears to be a crack forming in the west side of the CMU opening for Door 139C.

Deficiencies: I noticed some CMU cracking, shown in photos 6 and 7 above. Architect also took photos for the Structural Engineer to review. Design Team will notify Project Team if there is any structural concern. No other issues noticed at this time.

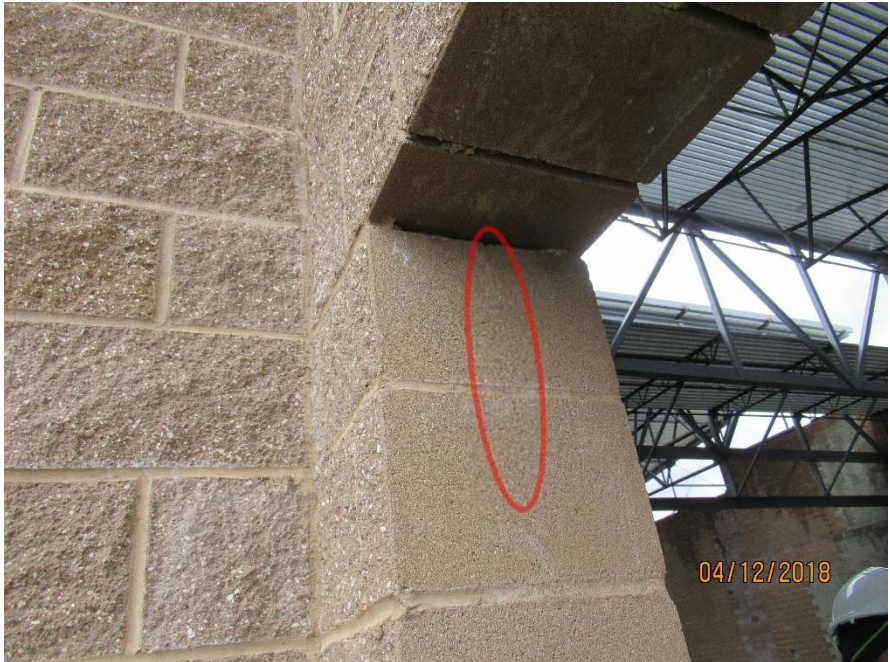
7. There also appears to be a crack forming in the east side of the CMU opening for Door 139C

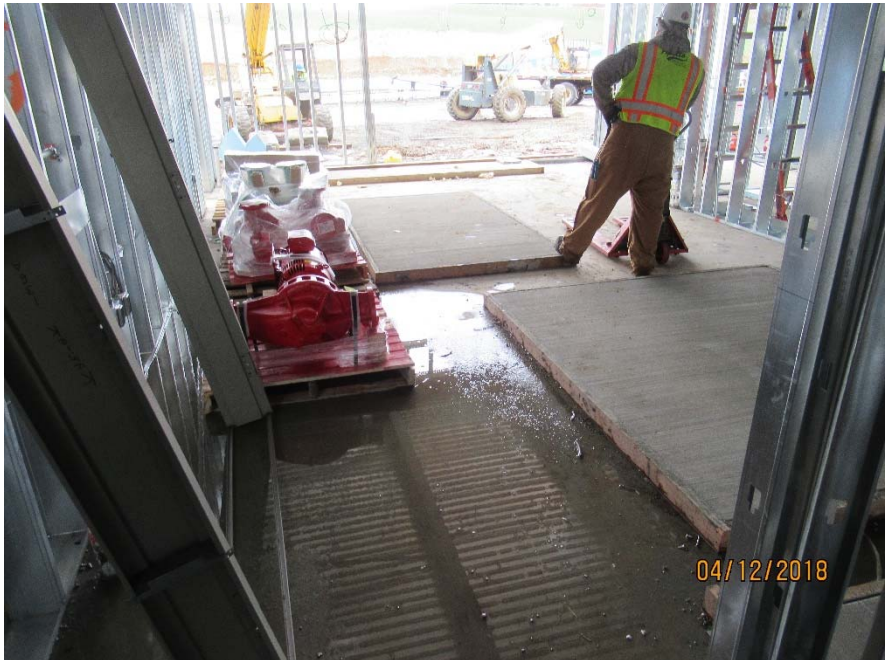
8. Contractor has placed the housekeeping pads for equipment Mechanical Room 136.

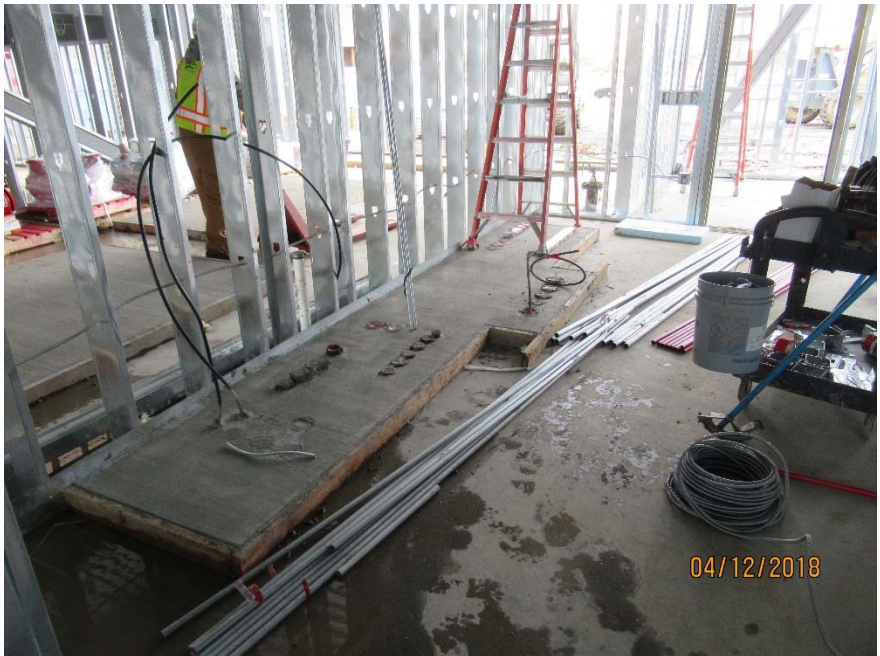
9. Contractor has placed housekeeping pad for equipment in Electrical Room 134.

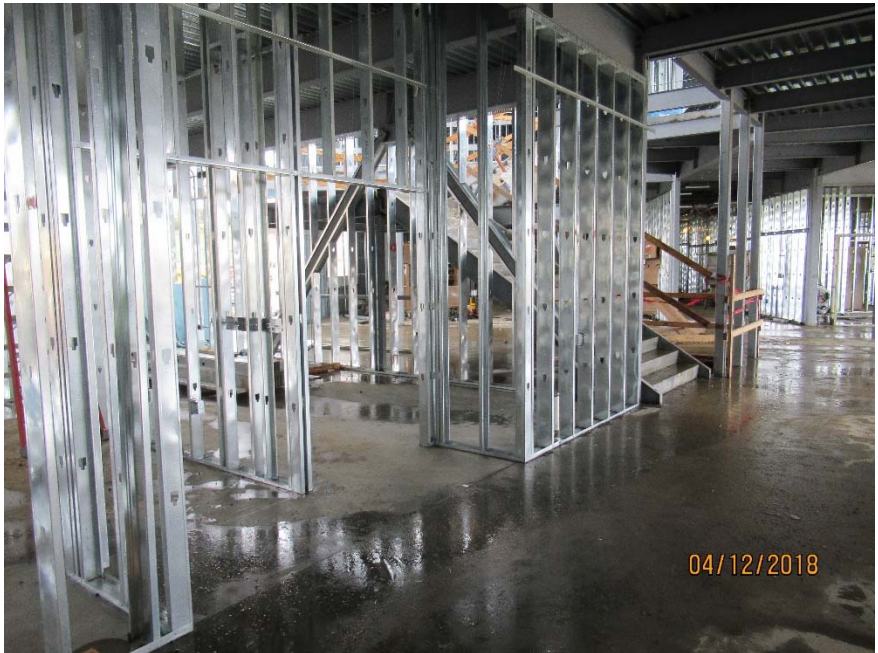
**10. Framing in lower floor
Area B continues.**

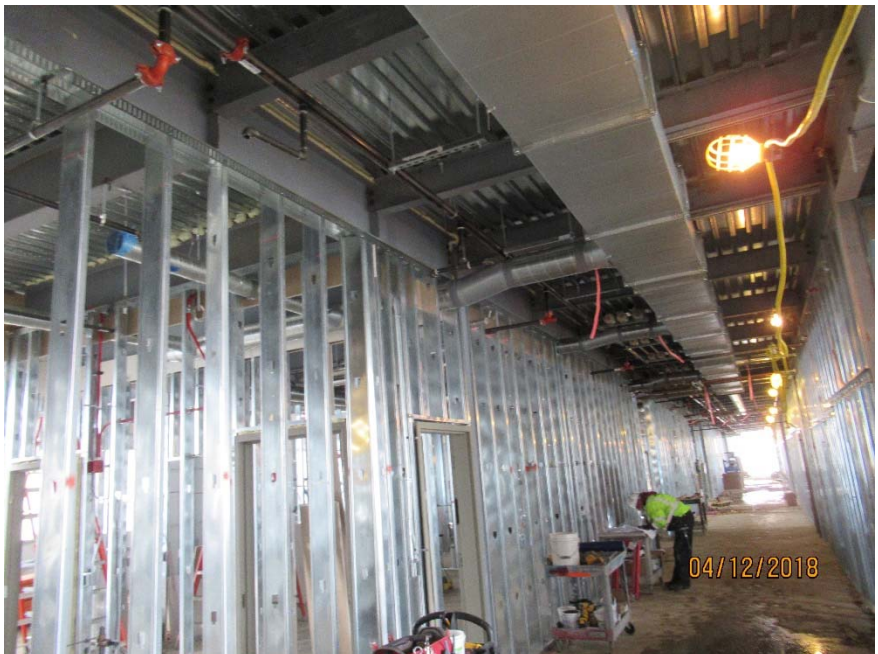
**11. Ductwork, fire
suppression piping,
electrical and plumbing
rough in continues in
lower floor Area A.**

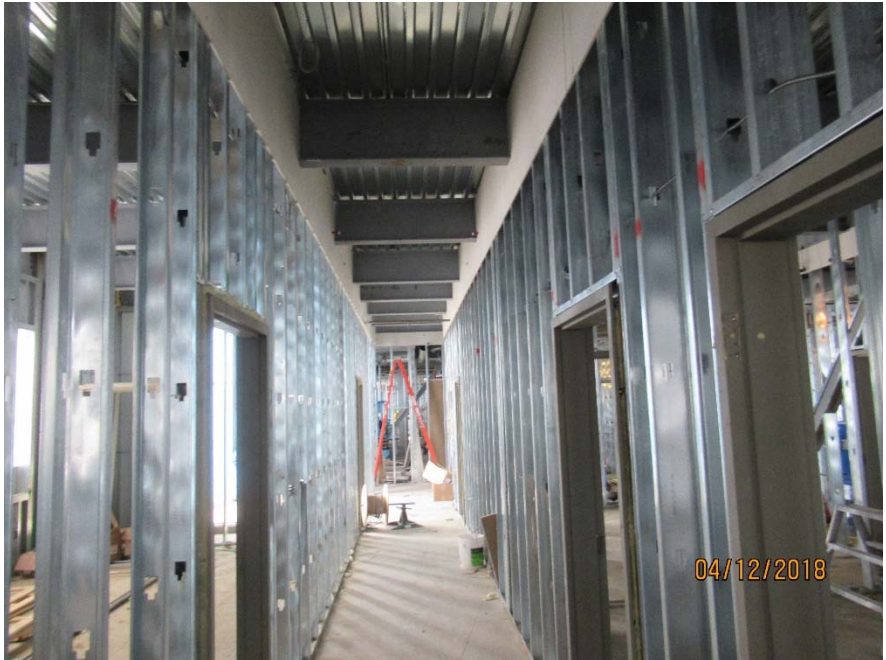
- 12. This view is looking north along Corridor 118A, Conference Room 118G is to the right in this photo.**

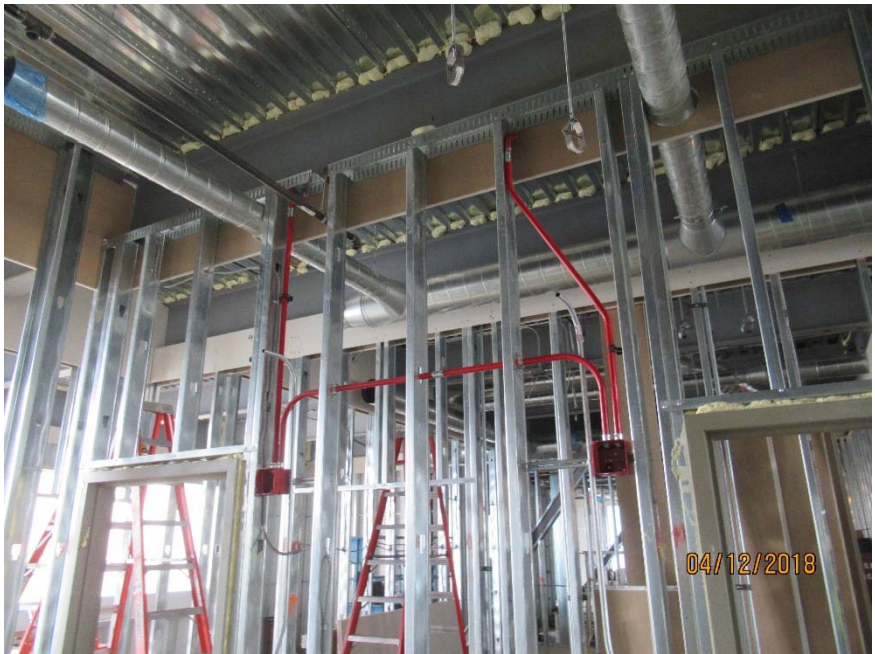
- 13. Contractor has begun installing fire alarm conduit (red).**

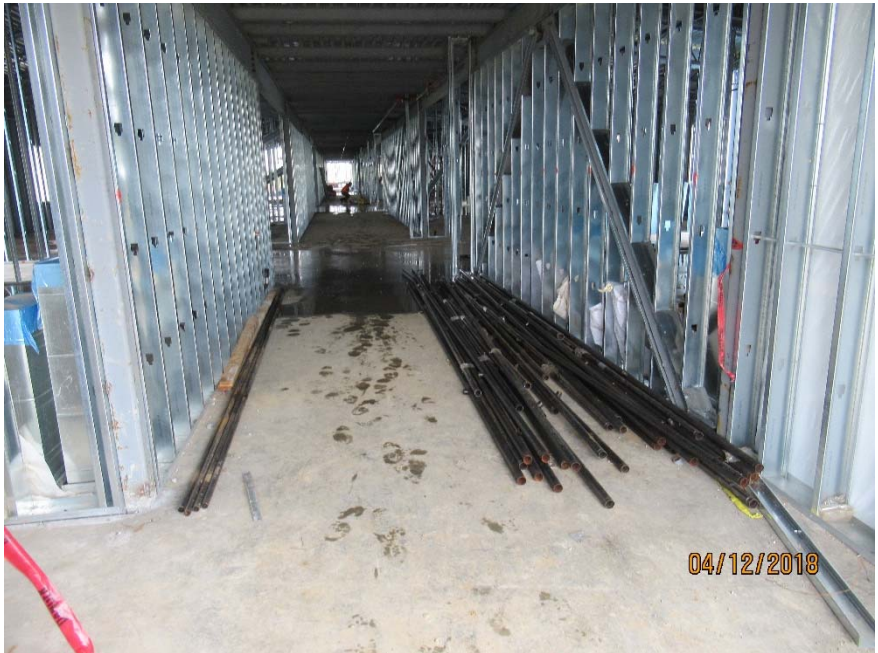
- 14. Upper floor Area A:
Contractor installing fire
suppression waterline
piping.**

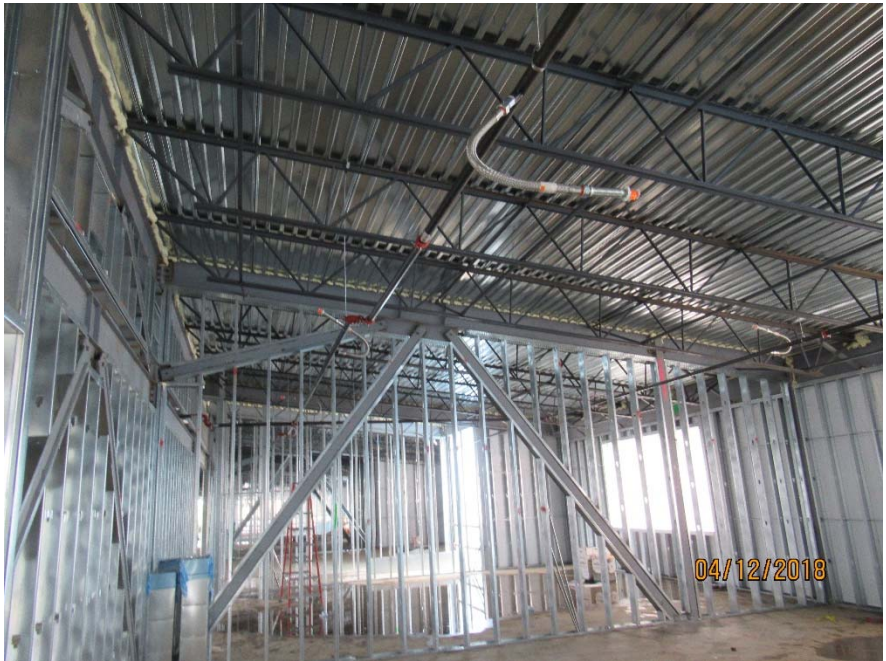
- 15. Upper floor Area A:
Contractor installing fire
suppression waterline
piping.**

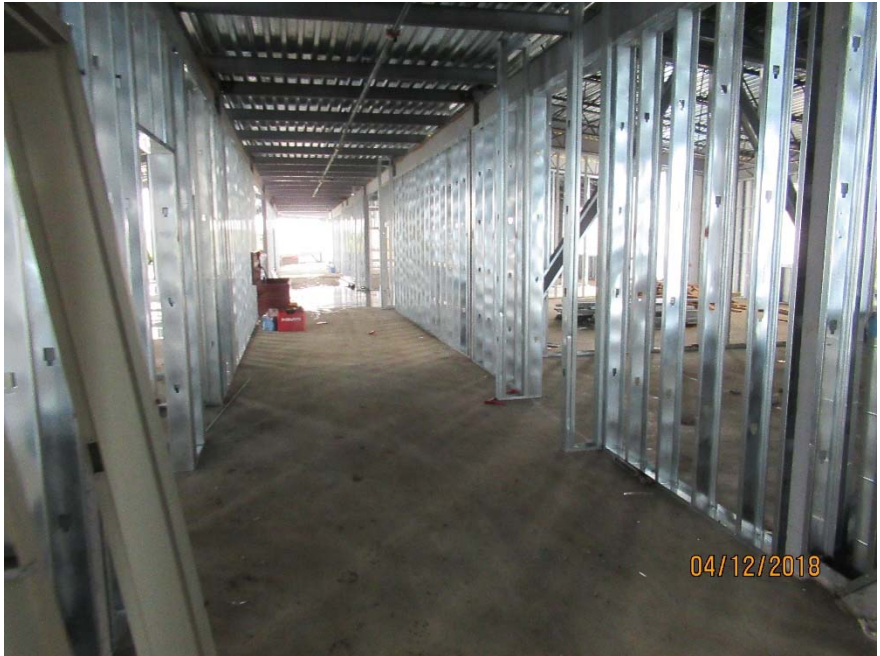
- 16. Upper floor Area A:**
Appears interior wall framing is nearly complete, installation of metal doorframes to begin.

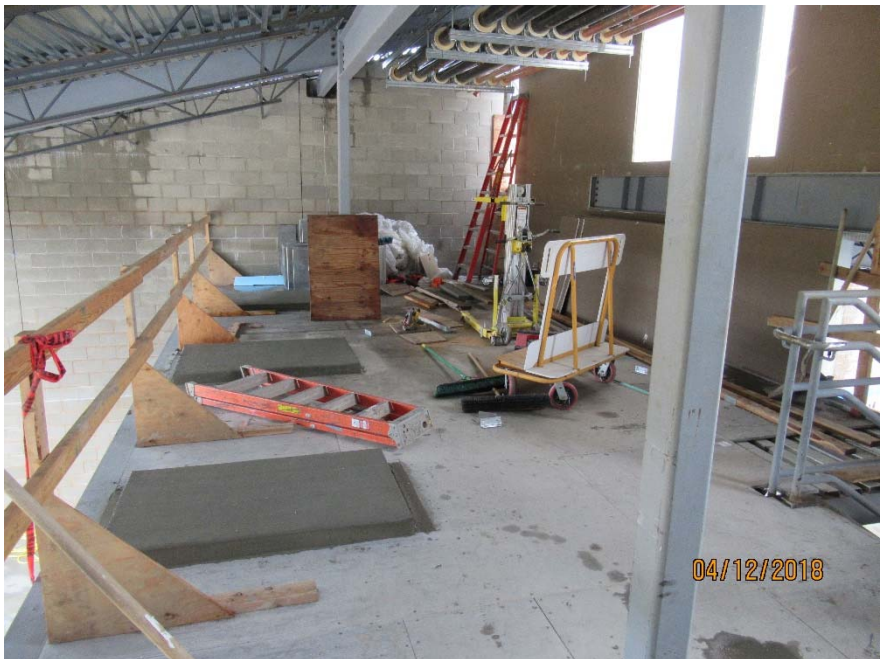
- 17. Contractor has poured housekeeping pads for equipment in Mezzanine in Area B. The Gymnasium is on the other side of the CMU wall in this photo.**

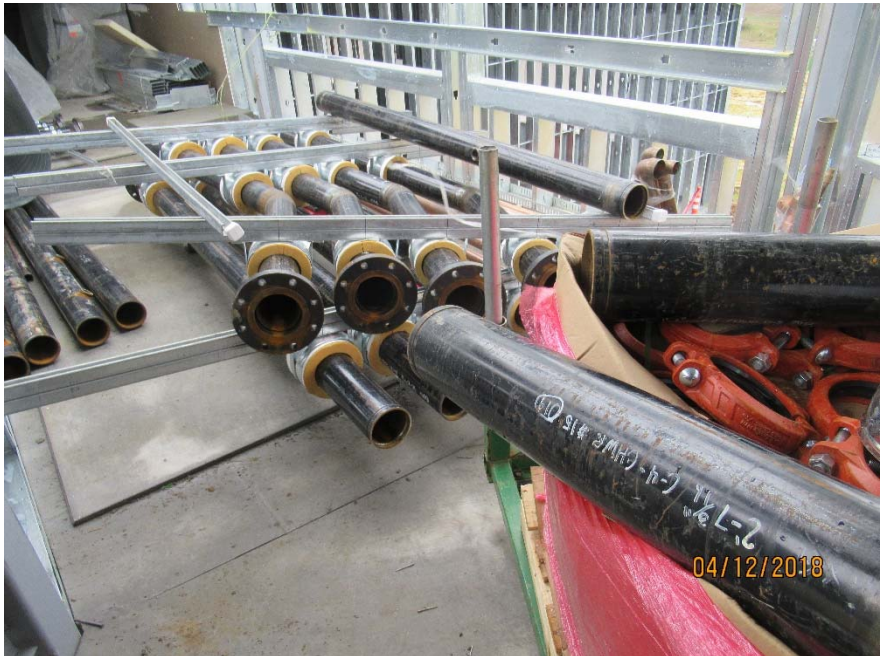
18. Contractor has staged piping in the mezzanine at the juncture of Area A and B.
