**Project: PSD: Kamiak Elementary School****Date: April 19, 2018****Weather conditions:**

Discussion with: See Construction Progress Meeting dated 4/12/18**Construction Activities:**

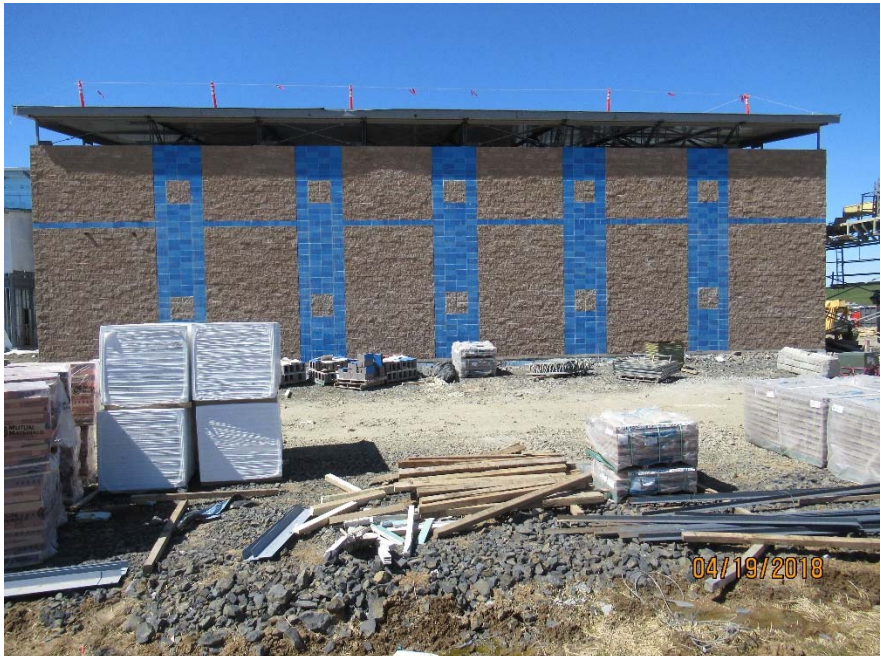
1. East wall of Gymnasium.

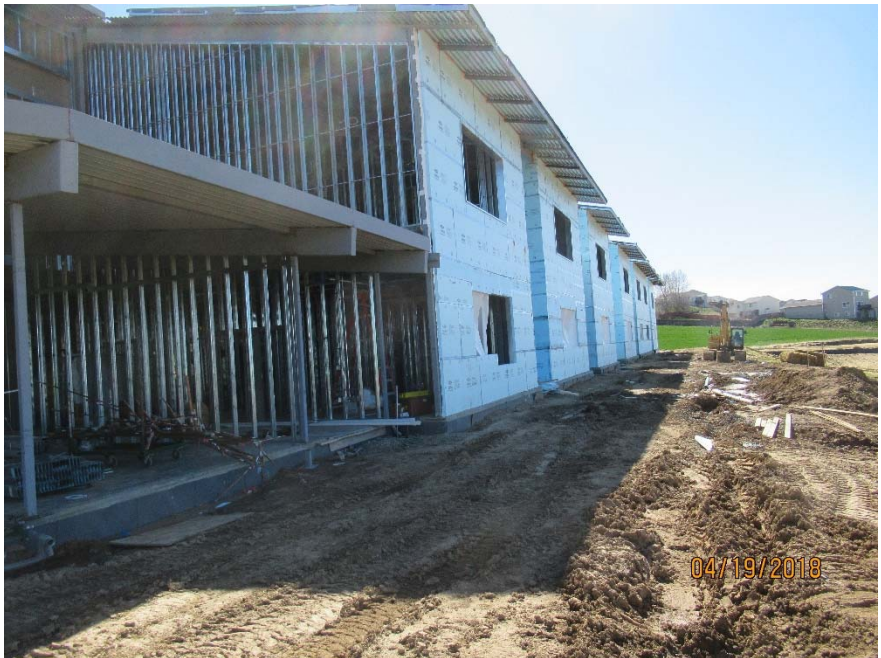
2. **Looking south along the west exterior wall.**
Note: Lower floor area where there is no wall is the Library storefront window wall.

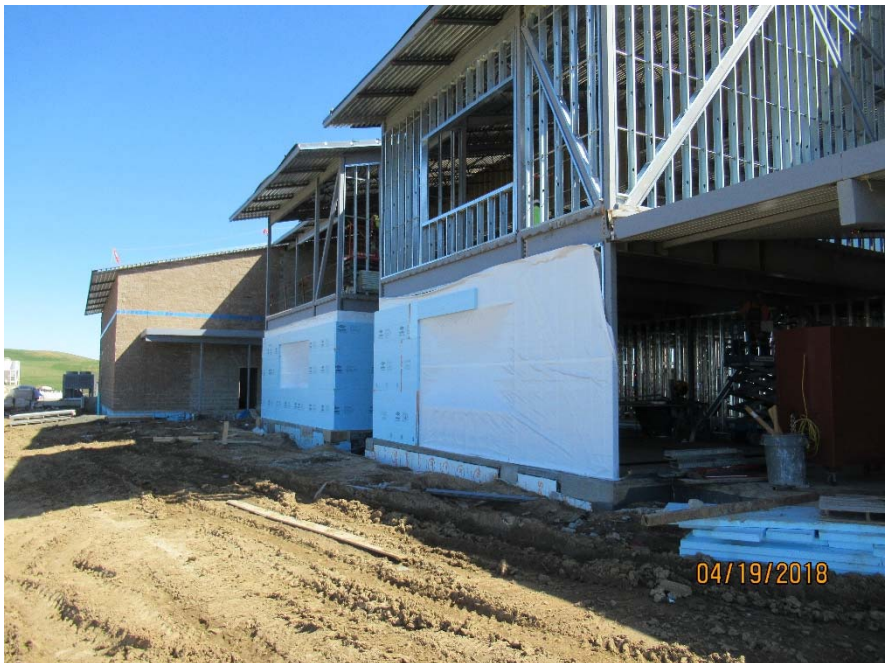
3. **Looking north along the west exterior wall.**
Note: Lower floor area where there is no wall is the Library storefront window wall.

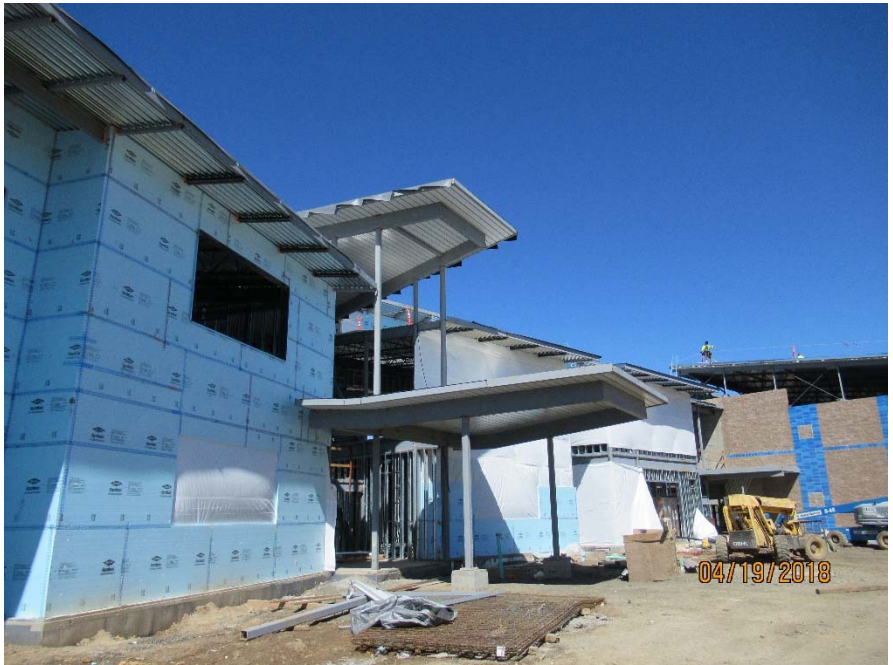
4. **Looking north toward main entrance. Roofs dried in.**

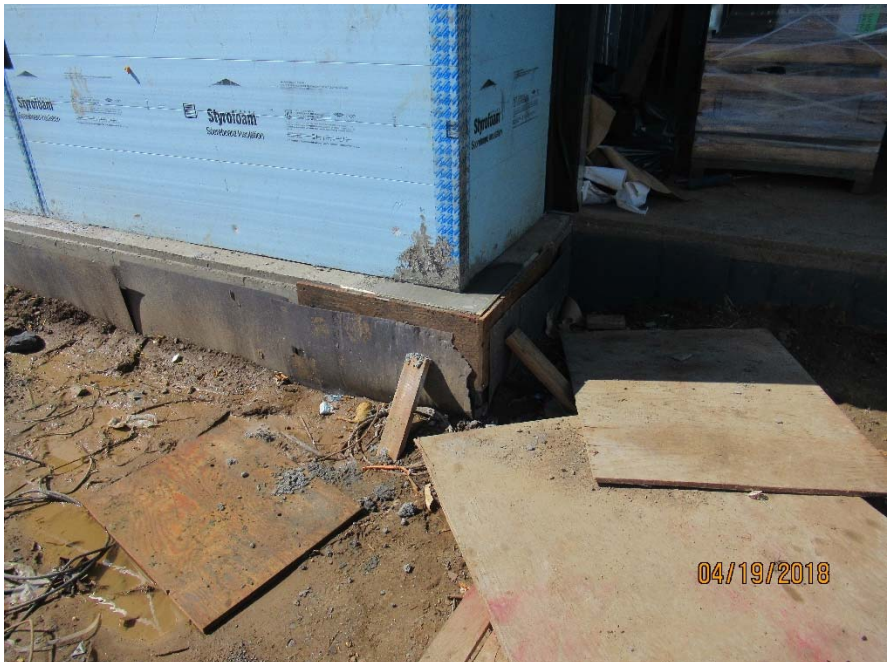
5. **Contractor has replaced cracked pour backs identified earlier on the east side of the building.**

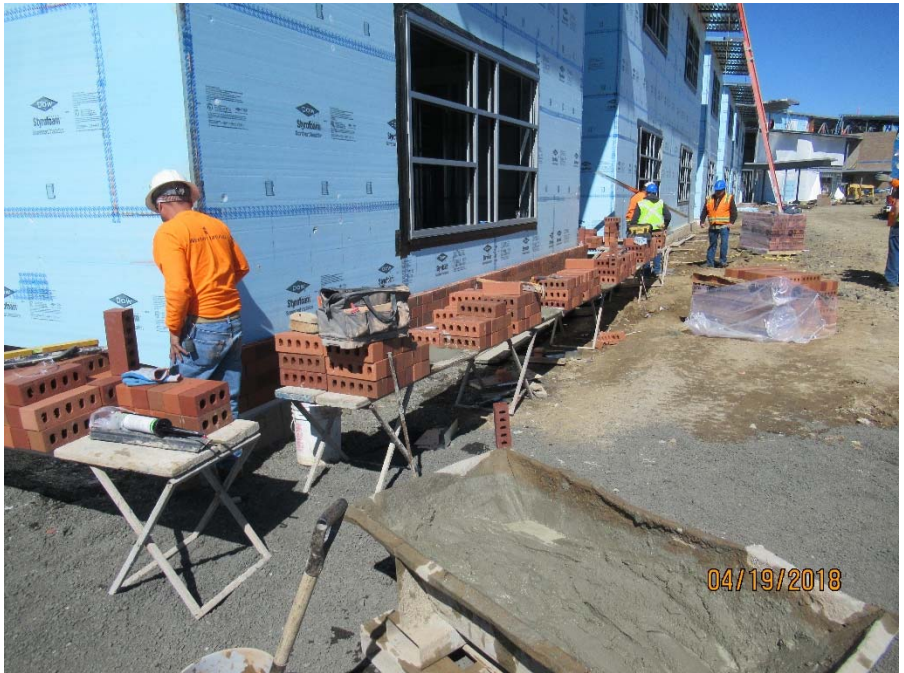
6. **Masons have begun laying up brick veneer on the south end of east exterior wall.**

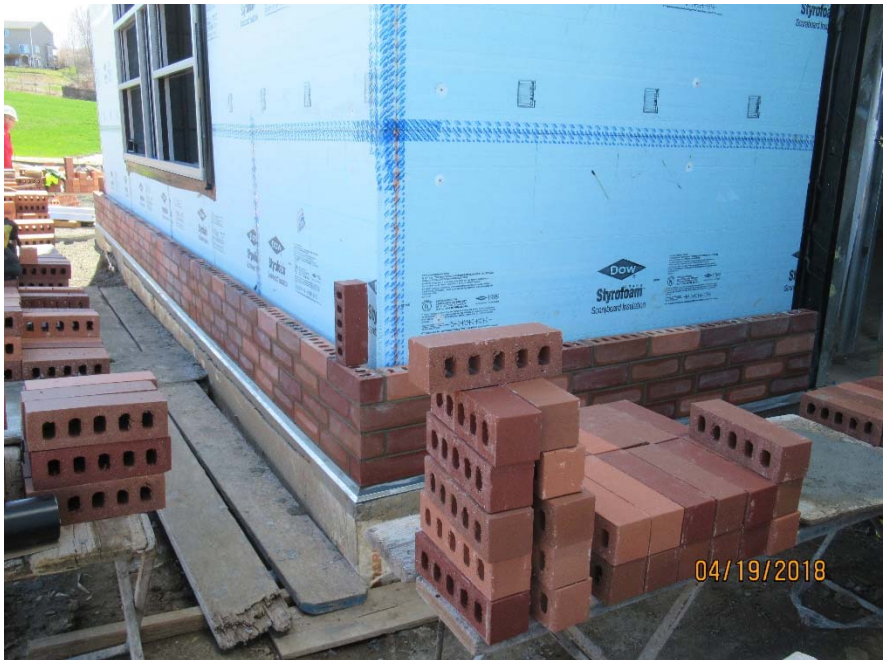
7. **Masons have begun laying up brick veneer.**

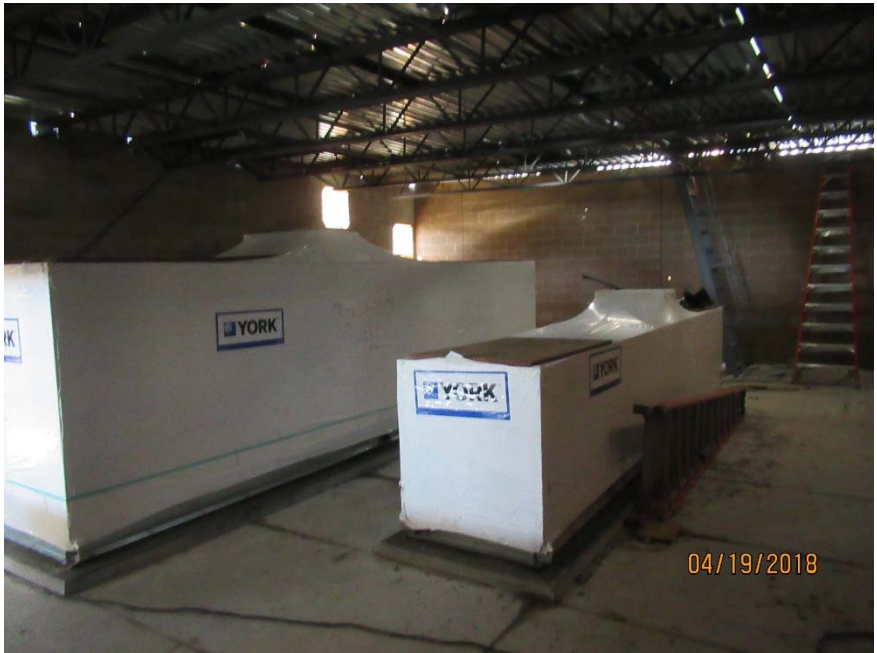
8. **Appears contractor has Air Handling Units AHUs 1, 2 and 3 have been placed in mezzanine above Kitchen. Also note near the back wall the stair to the roof has been installed.**

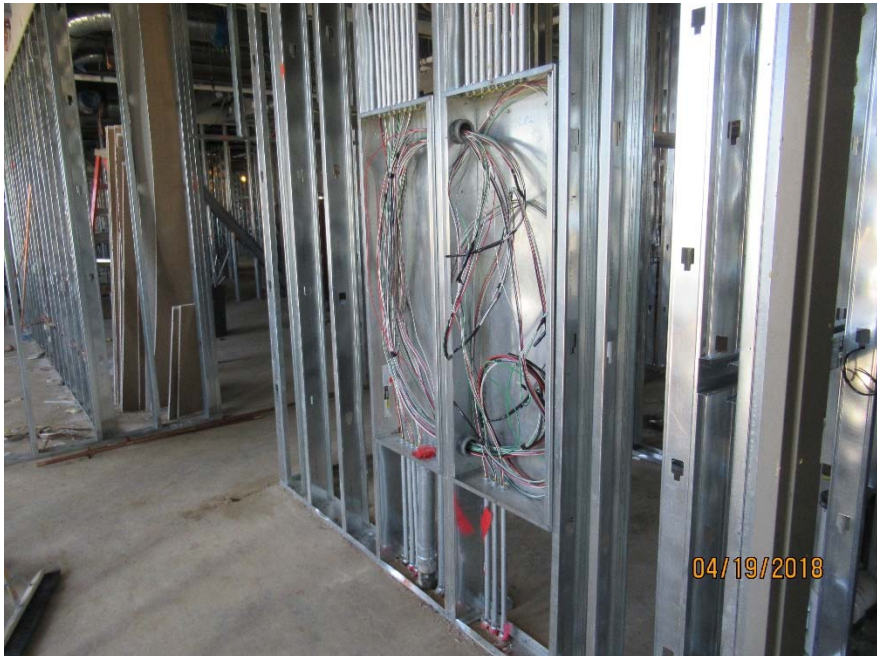
9. **Contractor continues to rough in electrical and install cans for electrical panels.**

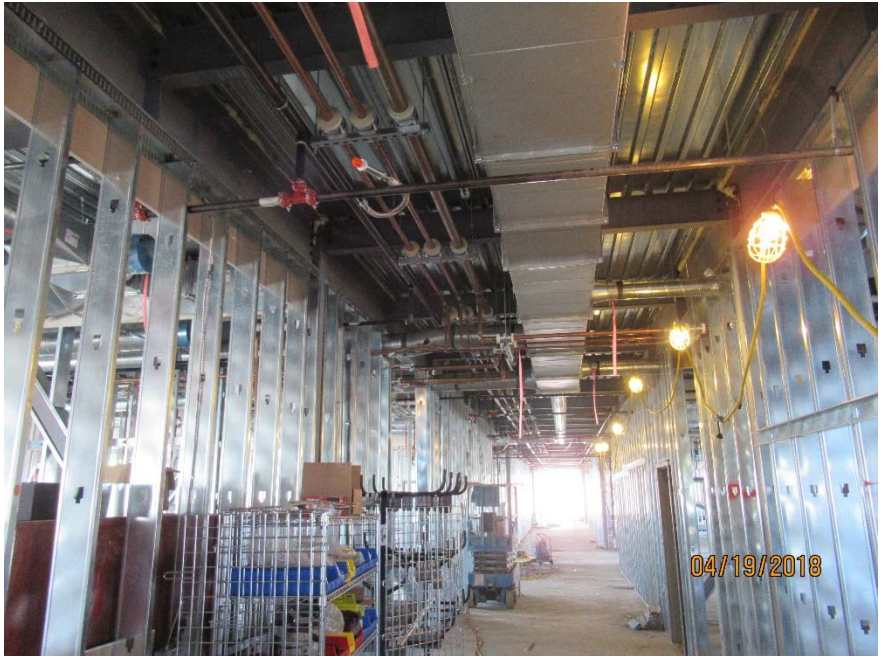
- 10. Rough in of fire piping, water piping, electrical conduits, fire alarm conduits and ductwork continues.**

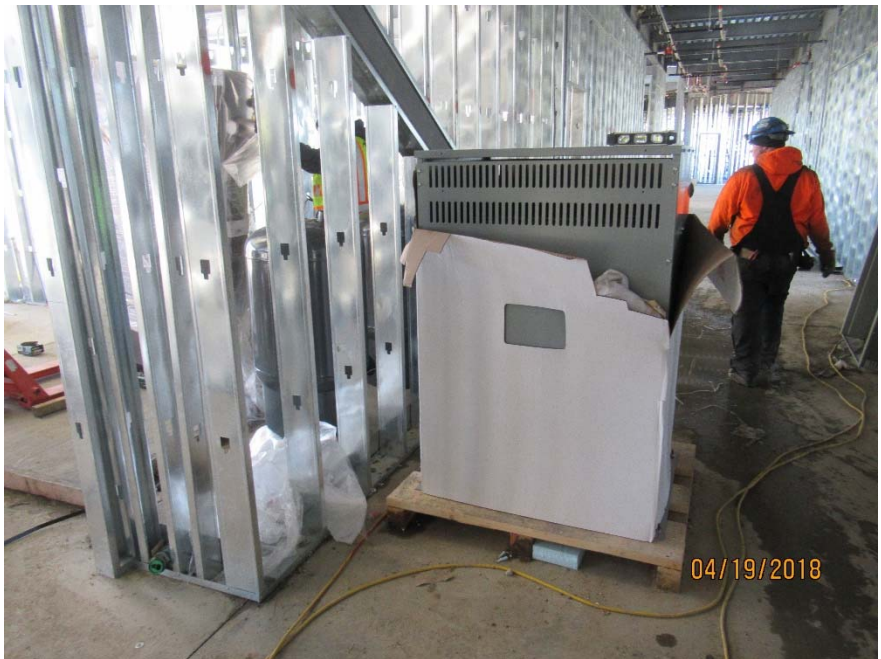
- 11. Contractor has accepted delivery of electrical equipment.**

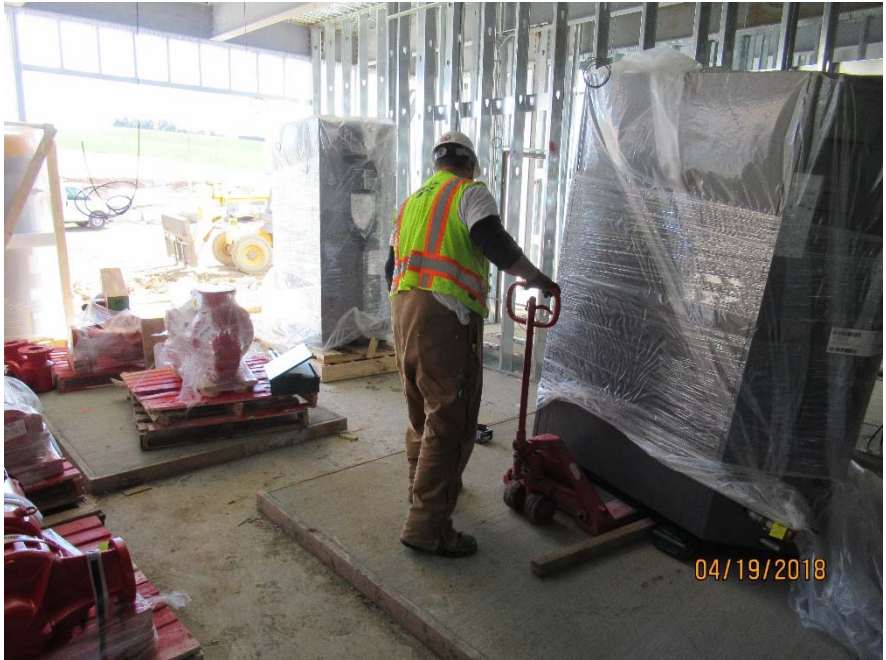
- 12. Appears the contractor is setting one of two boilers.**

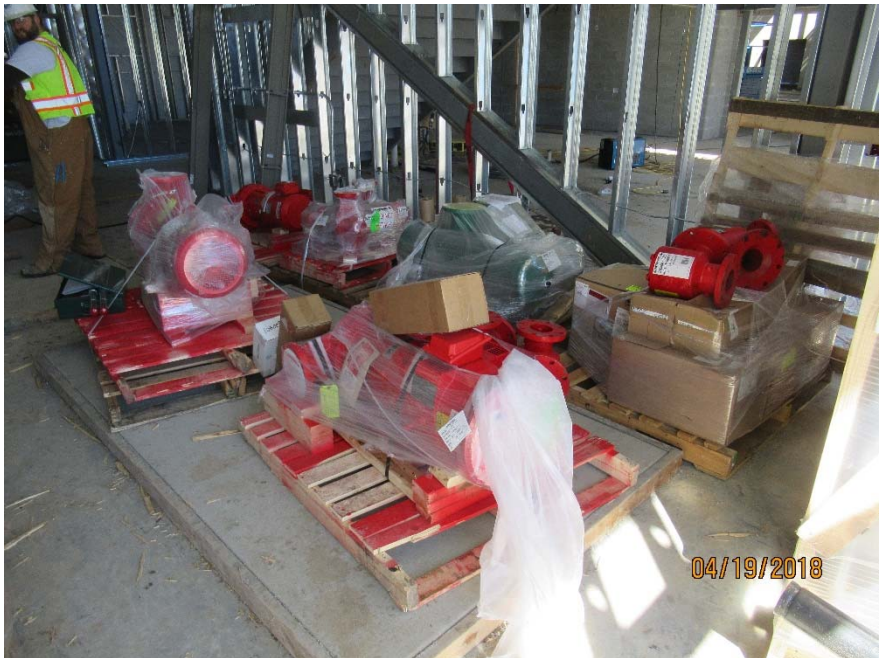
- 13. Contractor has accepted delivery of water pumps.**

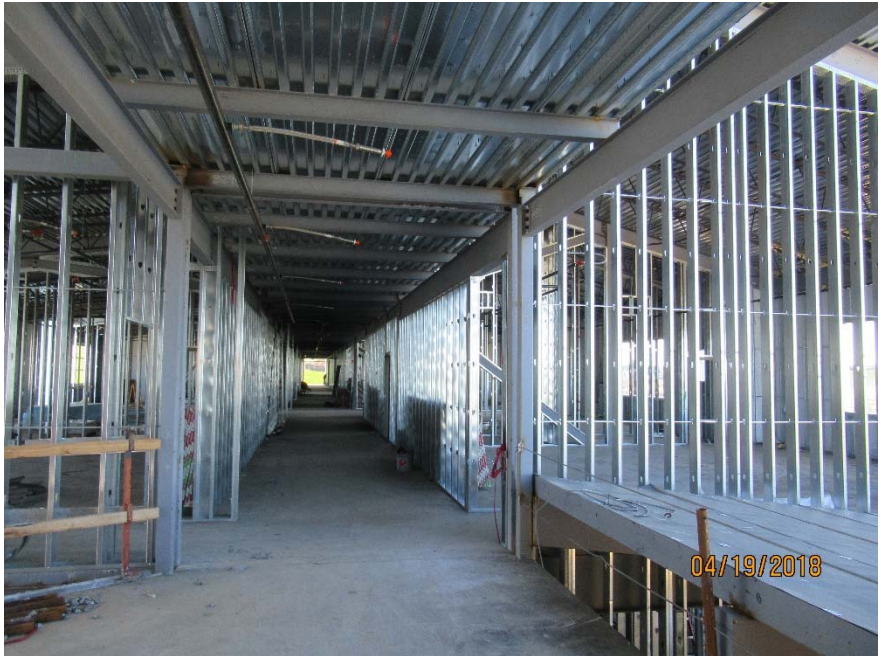
- 14. Upper floor interior wall framing nearly complete.**

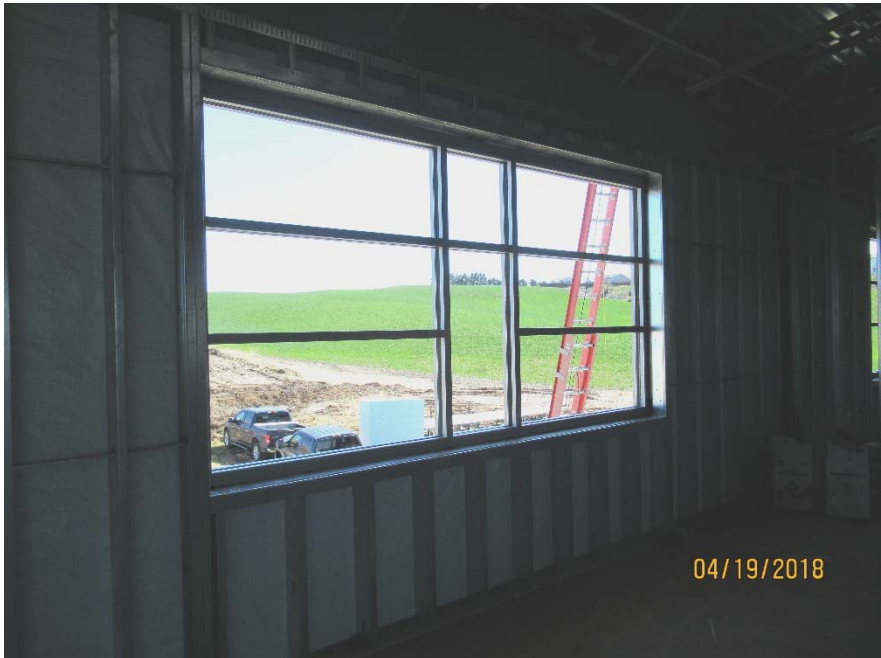
- 15. Contractor has installed the window frames on the east side of the building in Area A.**
