**Project: PSD: Kamiak Elementary School****Date: May 10, 2018****Weather conditions:**

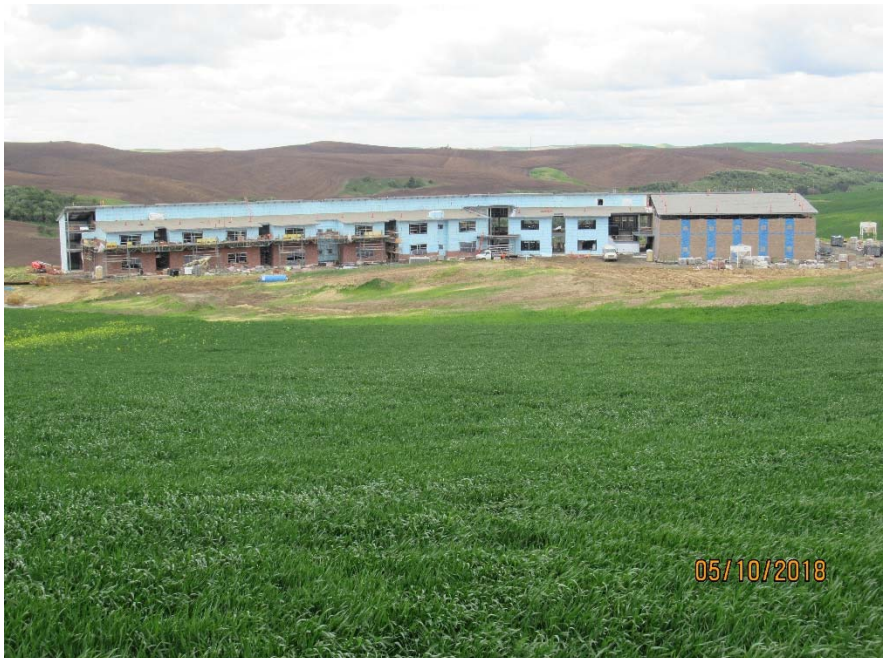
1. View of Kamiak looking west from what will be NW Canyon View Drive.

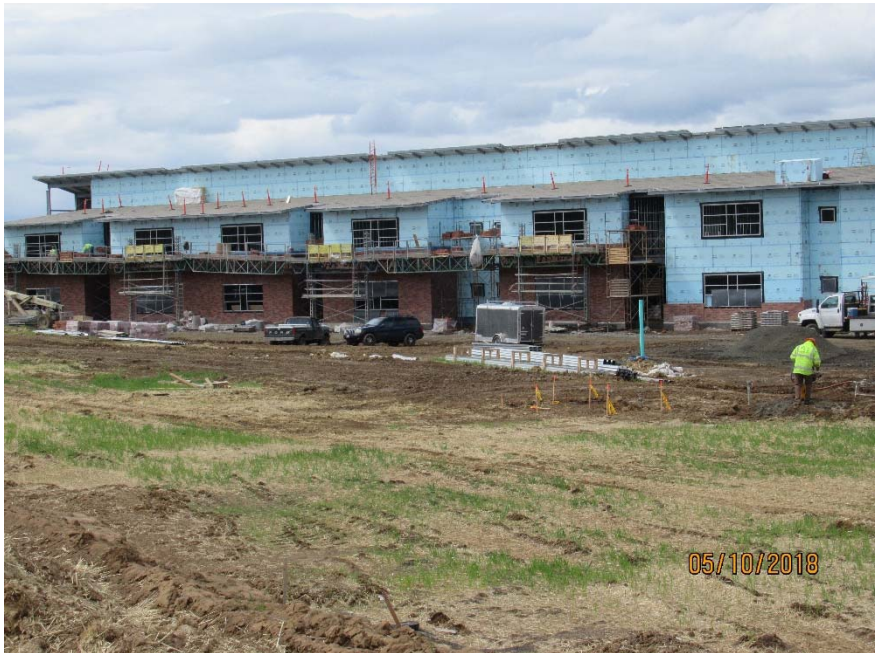
2. **Masons appear to making headway on brick veneer on the east elevation of Area A.**

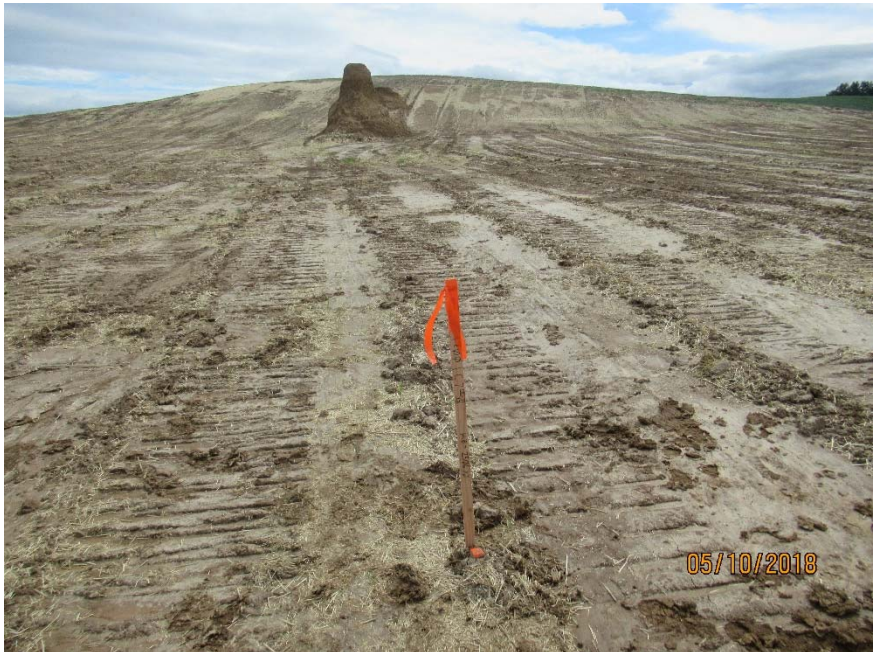
3. **View is looking easterly up what will be the NW Canyon View Drive. The stake is one of four elevations surveyed along the centerline of NW Canyon View Drive as requested by the District. This stake calls for a cut of over 7 feet to subgrade; the next stake is just past the crest of the hill, it shows a cut of over 23 feet to subgrade.**

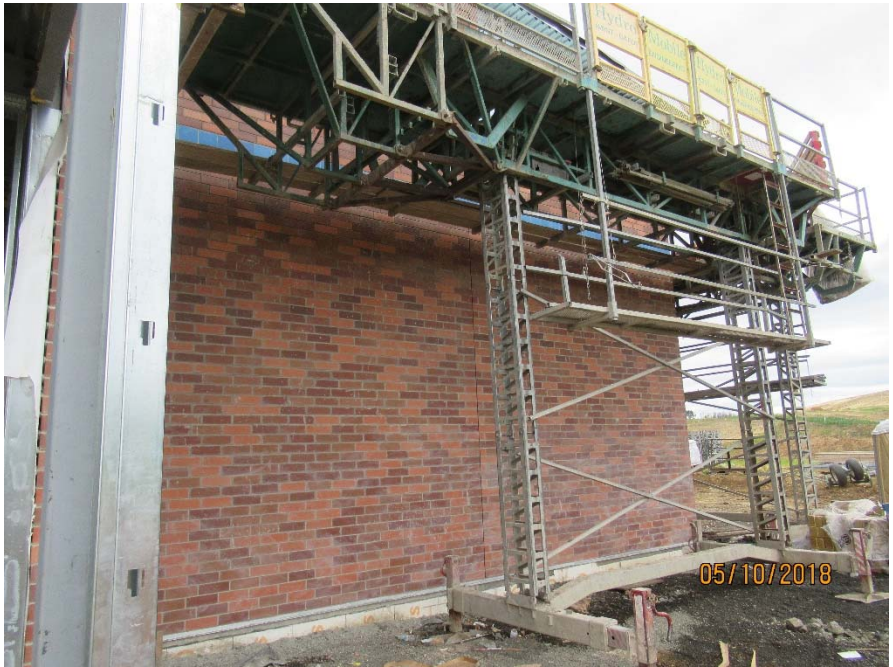
4. Masons continue laying brick veneer. This view is of the south end of the building east of the curtain wall. Although hard to see there is a blue horizontal course near the

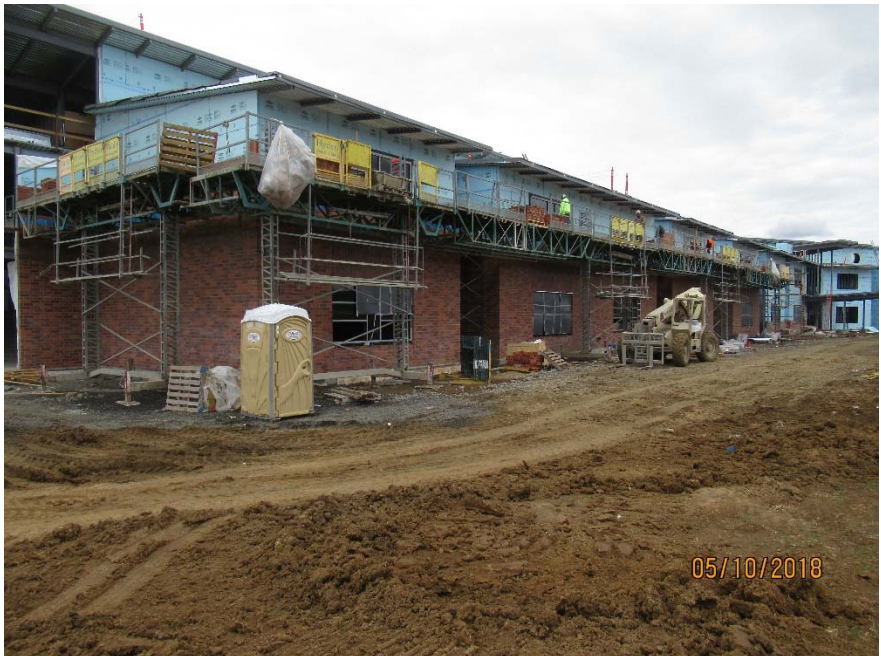
5. View is of the east elevation of Area A. Although impossible to see in this photo, there is basket weave brick between upper and lower windows. See next photo for a better picture.

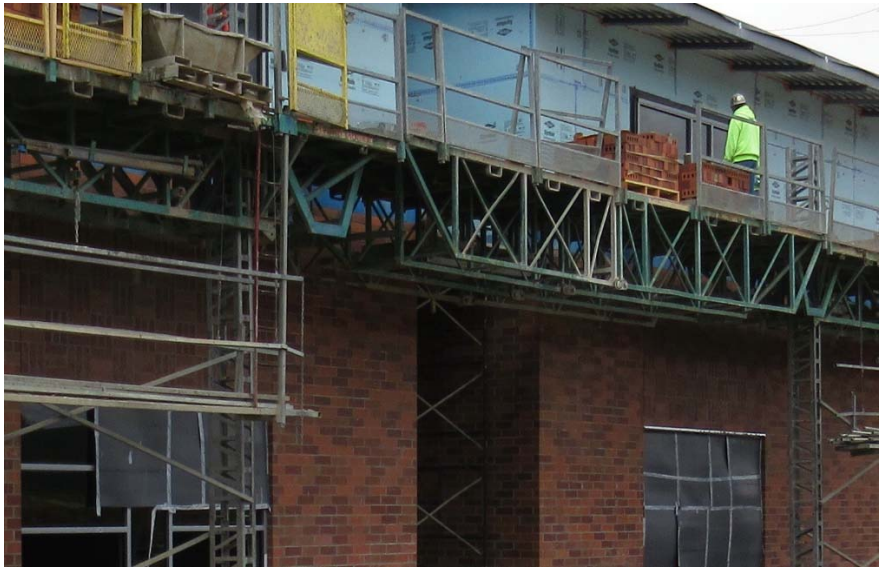
6. Although still difficult to see, there is brick veneer placed in a basket weave just below contractor and above the window.
I will try to get a better picture with my next report.

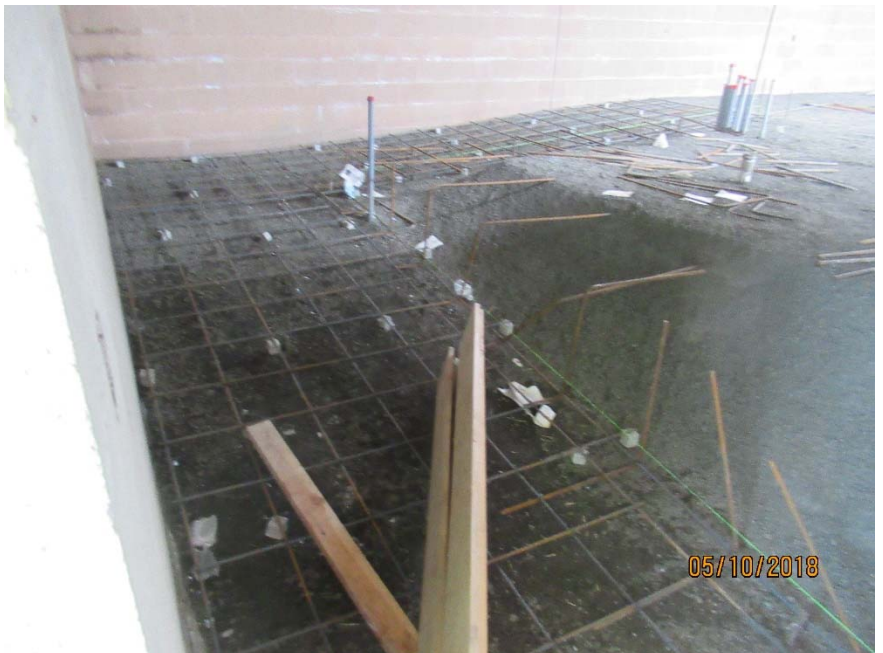
7. Contractor has set reinforcing for the ramp to the stage.

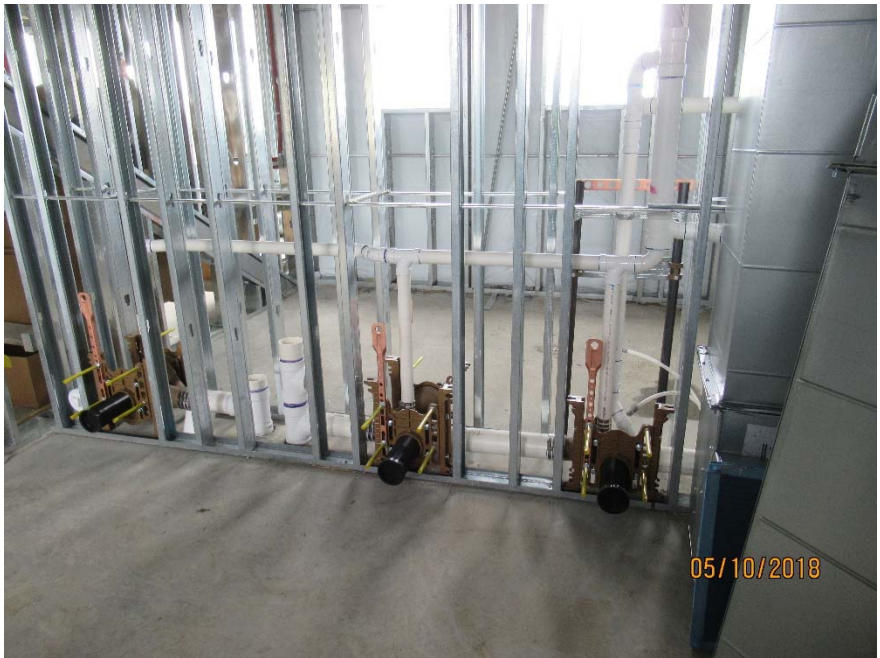
8. **Appears the contractor has installed the toilet carriers and piping for Restrooms 150 and 152.**

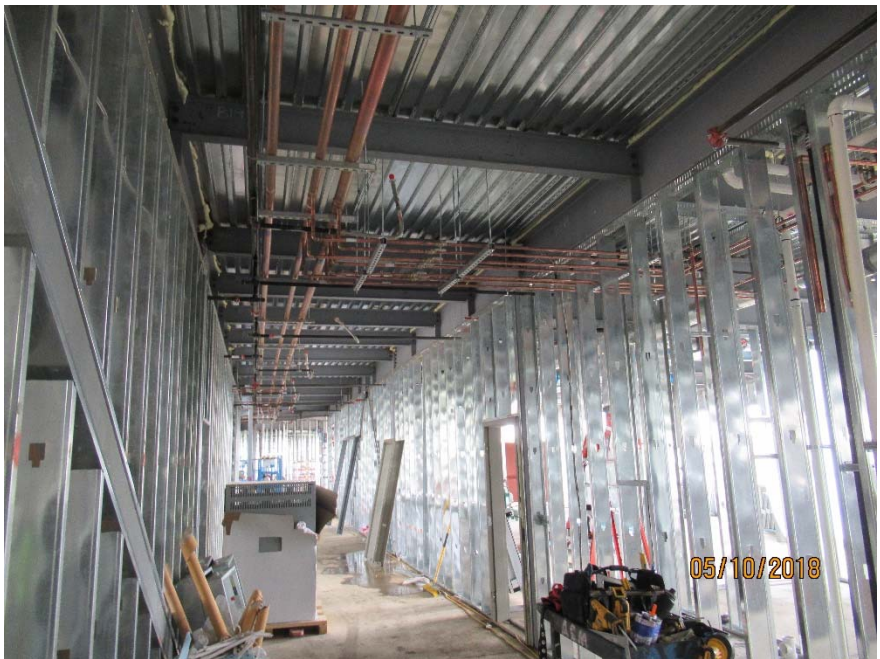
9. **Rough in of Mechanical, Electrical and Plumbing continues on lower floor.**

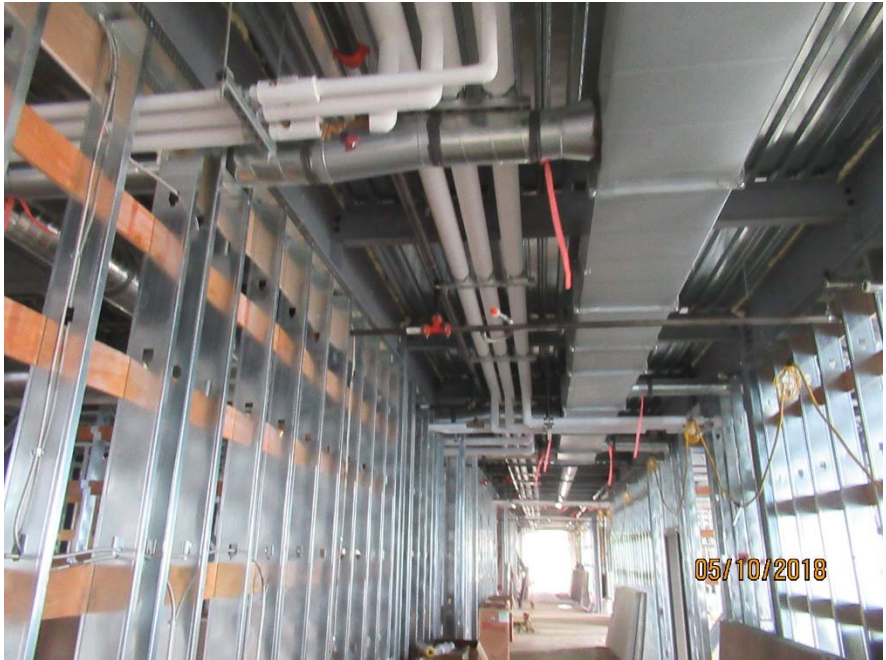
- 10. Appears the contractor is installing pipe insulation on installed piping from the south moving north.**

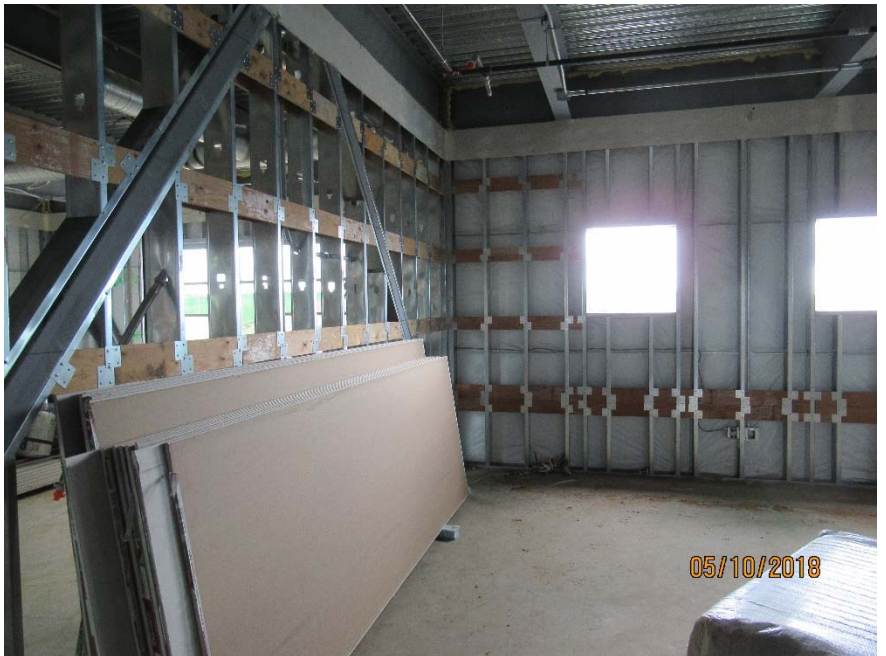
- 11. Contractor has installed backing/blocking in rooms lower floor Area A.**

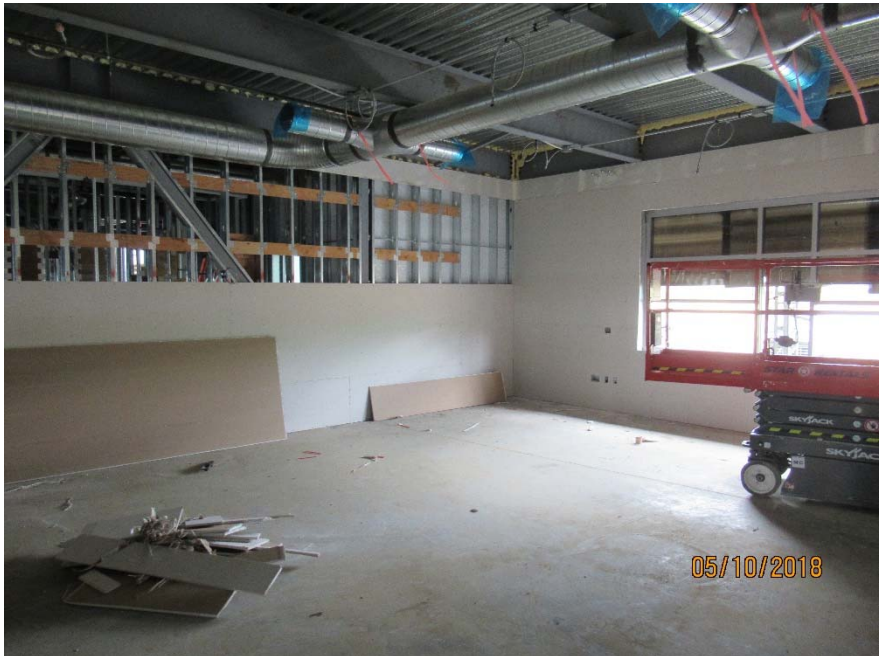
- 12. Appears the contractor has begun installing wallboard in classrooms on the lower floor. Starting on the south end moving north.**

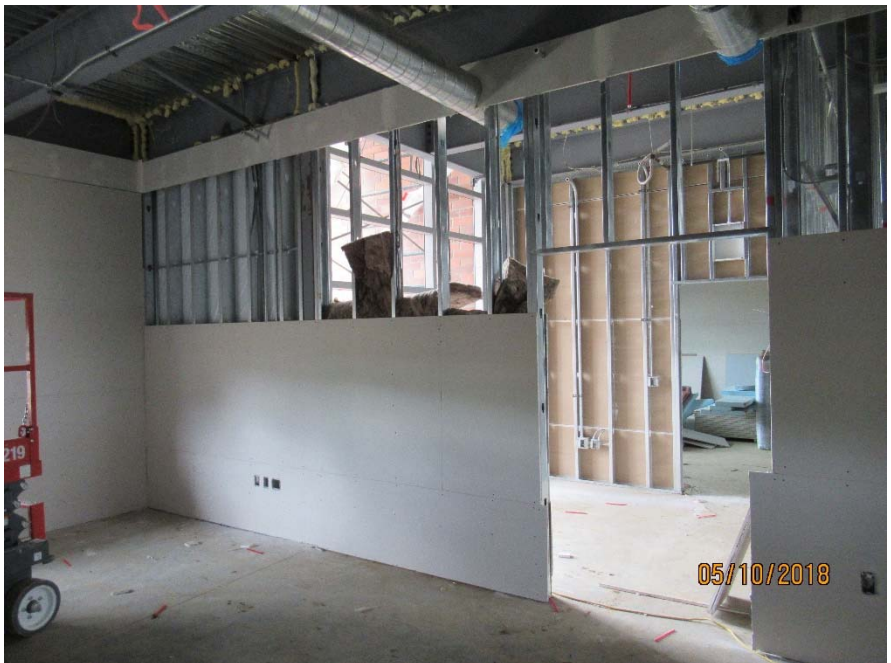
- 13. Appears the contractor has begun installing wallboard in classrooms on the lower floor. Starting on the south end moving north.**

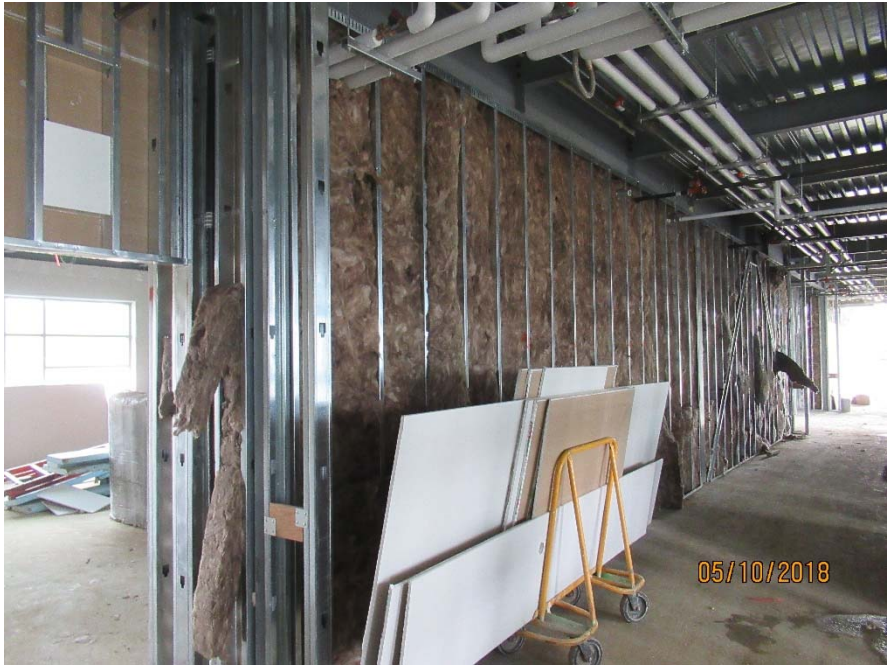
- 14. As one side of walls are wall boarded, the insulator is installing the sound batting in wall cavities between rooms and hall.**

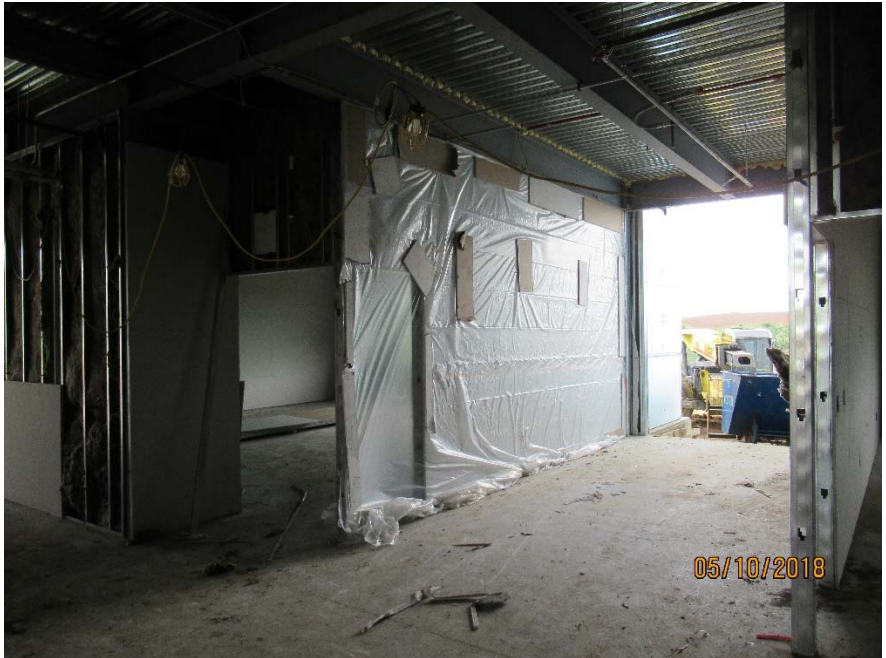
- 15. Contractor has put plastic cover over wallboard to protect it from the weather at breakout space where the curtain wall has not been installed yet.**

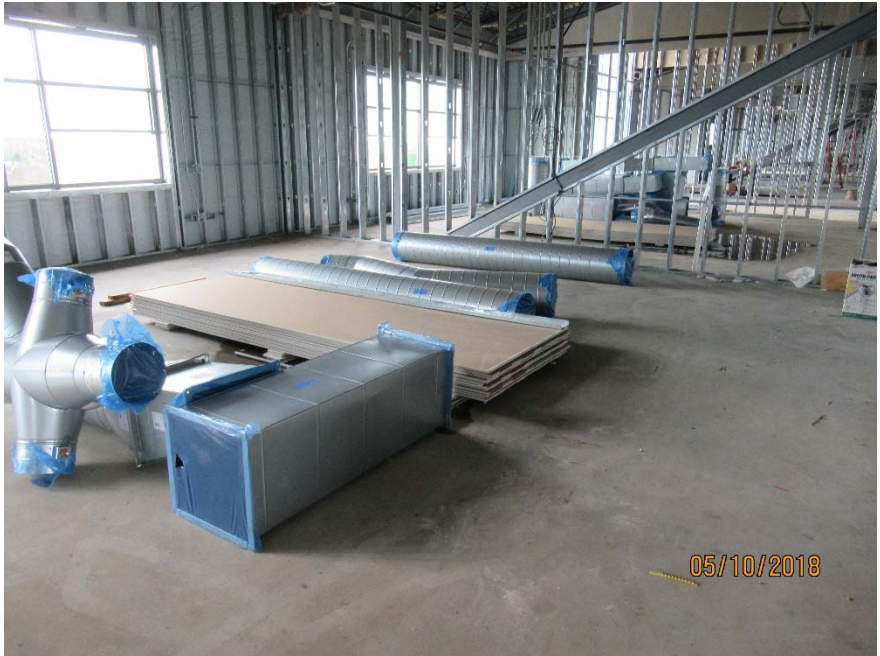
16. Appears the contractor has staged wallboard and prefabricated duct pieces in each room on upper floor of Area A.
