**Project: PSD: Kamiak Elementary School****Date: May 16, 2019****Weather conditions:**

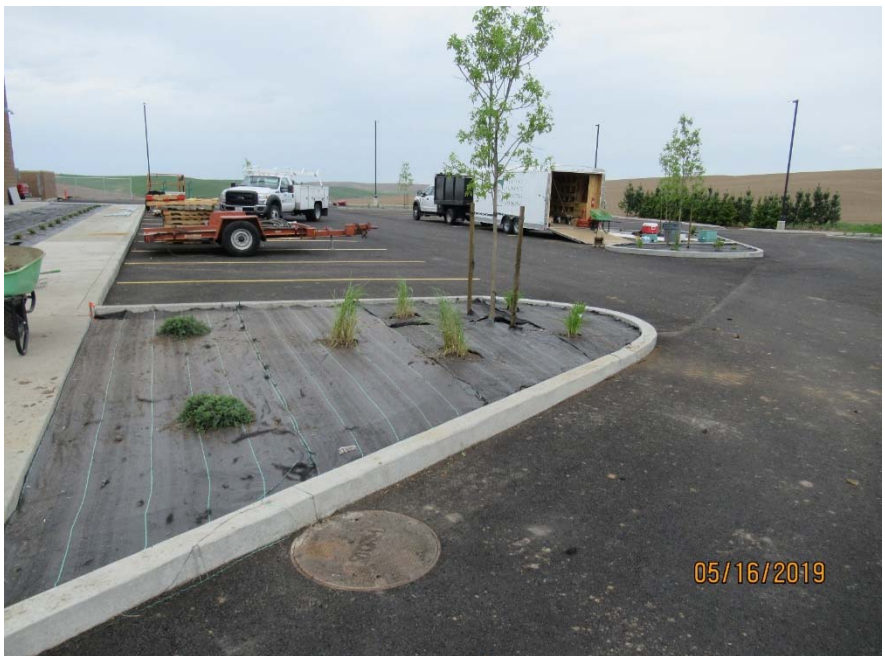
**Discussion with:** See Construction Progress Meeting minutes dated 5/16/19.**Construction Activities:****1. North parking lot:****Landscaper is planting plants and trees.****Note line of trees in the background to the right. These are simply staged there and will be planted around the fence line.**

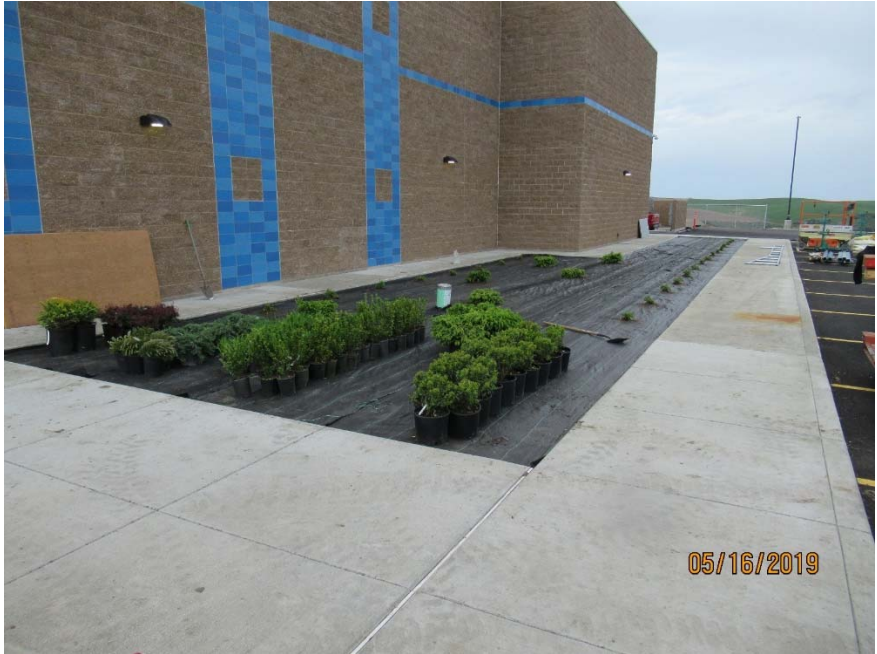
2. **More plants some area planted some staged for planting elsewhere. North of the gymnasium.**

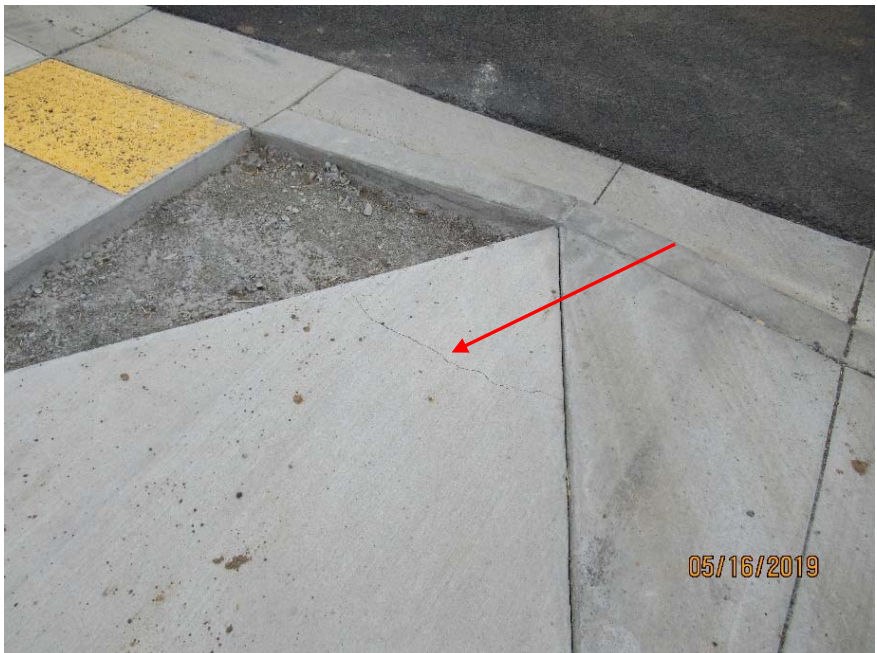
3. **It appears the contractor has cracked another piece of sidewalk since they removed a few pieces because of earlier cracks.**

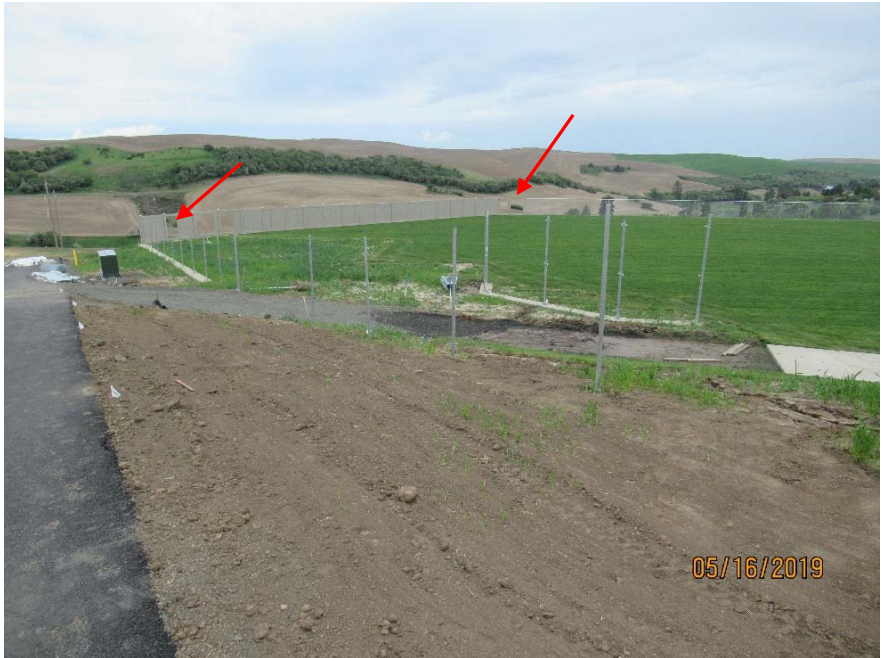
4. There appears to be no headway made at south fence line or the ADA ramp. Also although difficult to see the tan vinyl fence has not yet been repaired.

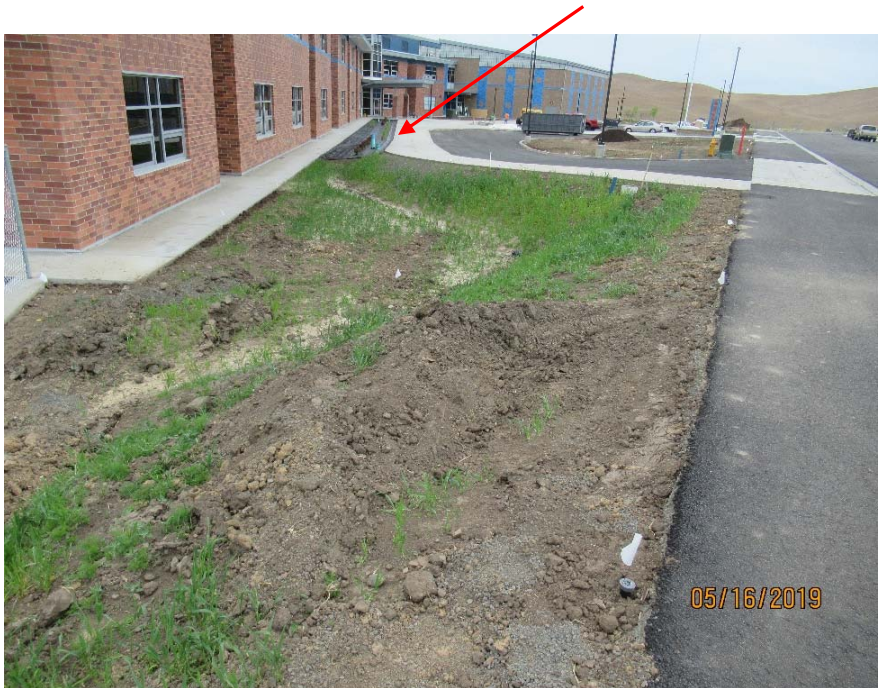
5. Landscaper is working on plantings and lawn areas. Arrow is pointing to a stretch of area near entry to the building where plants have been planted.

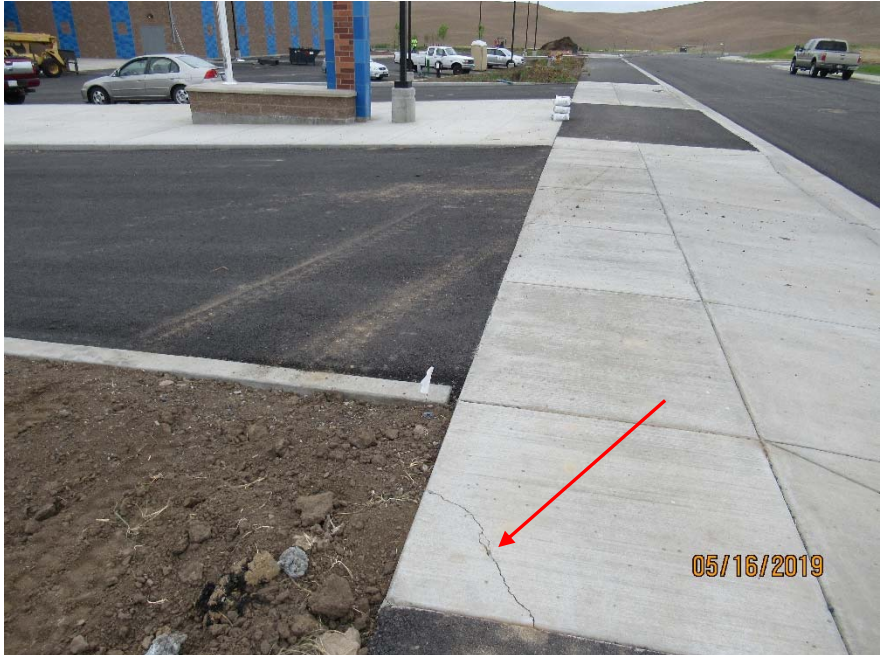
- 6. A crack in the sidewalk.**  
This has been here since before winter. Contractor needs to fix this with other locations where they cracked the sidewalk. See Photo 4.

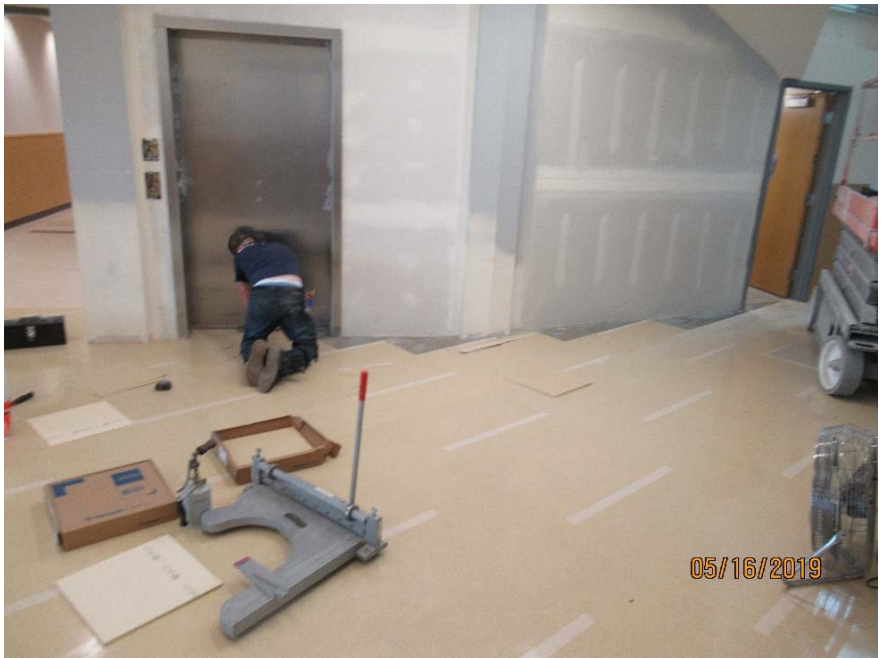
- 7. Contractor installing flooring at elevator entrance area.**

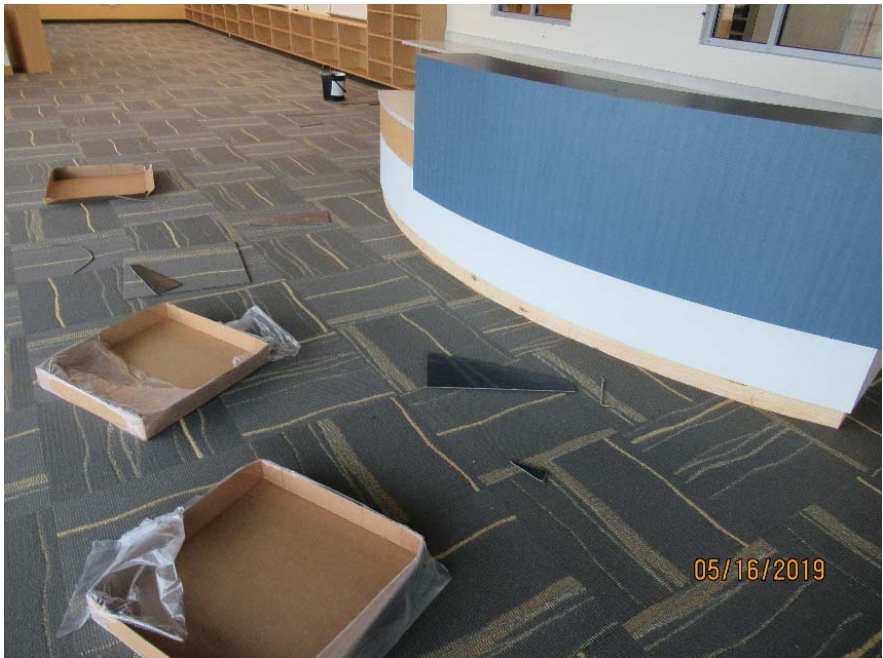
8. Contractor in in the process of installing the carpet in Library that was changed.

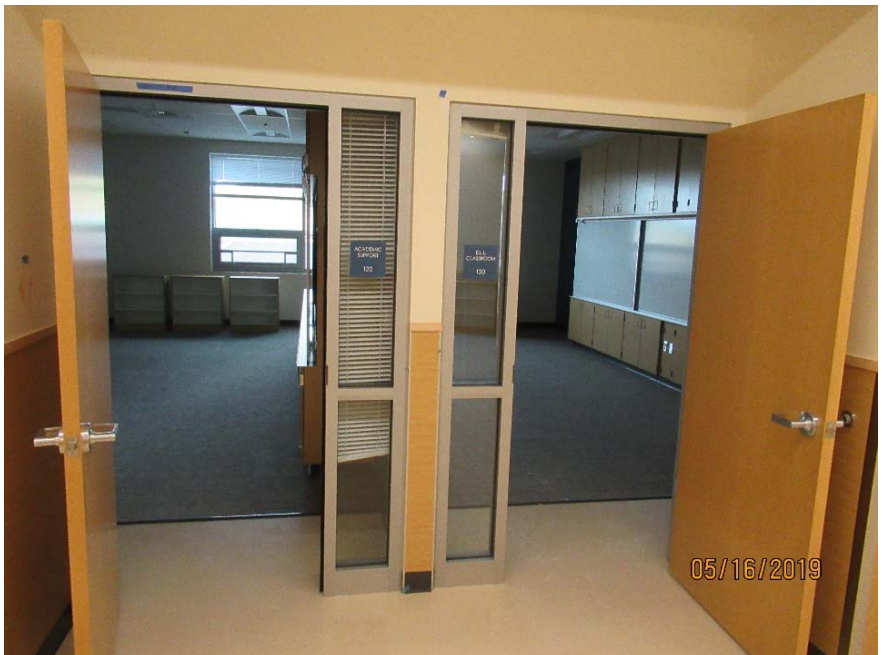
9. Contractor has installed the majority of the room signage. The installation of the blank back panel for locations where signage is installed on glazing has not been installed.

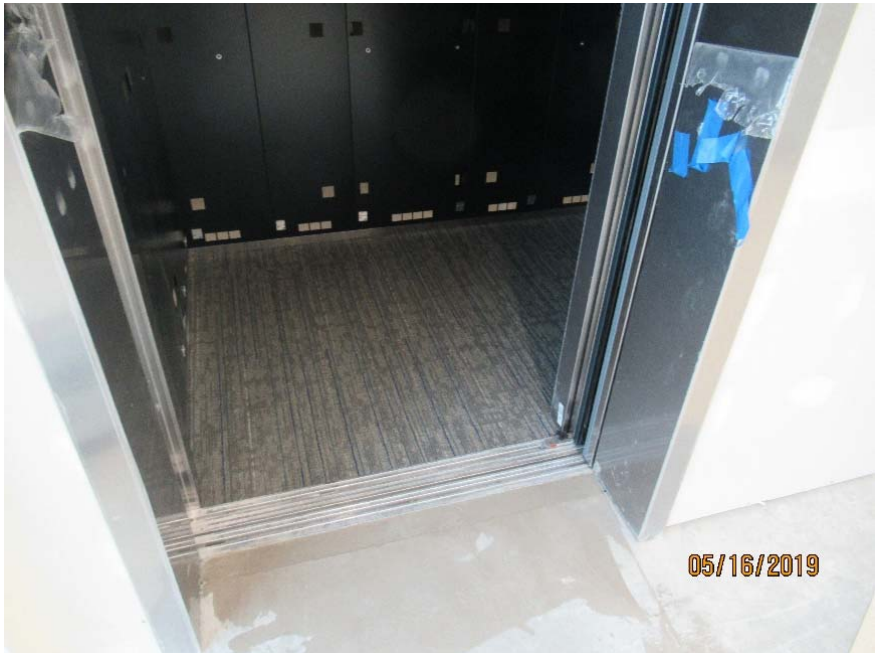
- 10. Carpet has been placed in elevator car.**

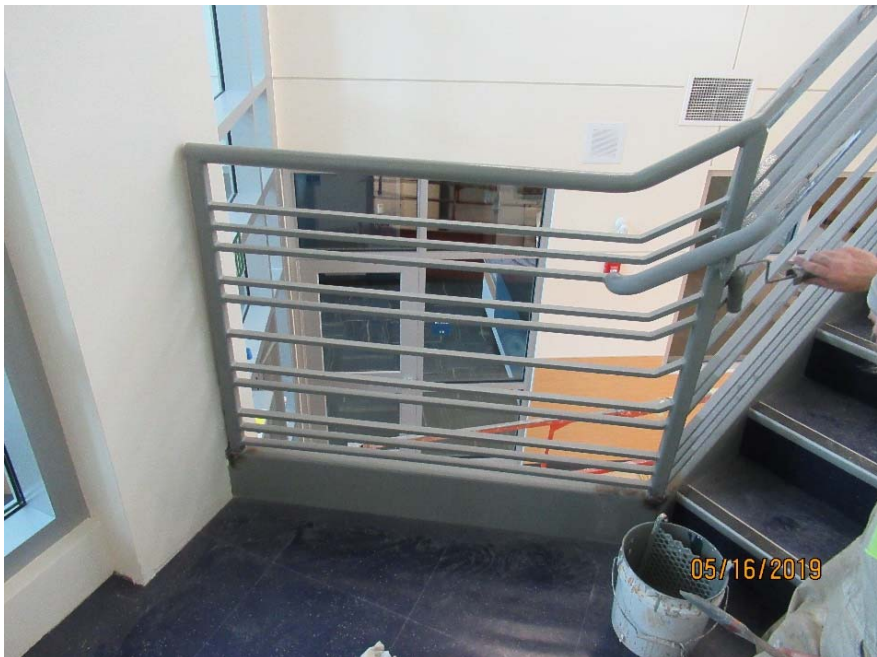
- 11. Painter has begun painting safety railing.**
