**Project: PSD: Kamiak Elementary School****Date: May 23, 2019****Weather conditions:**

**Discussion with:** See Construction Progress Meeting minutes dated 5/23/19.**Construction Activities:**

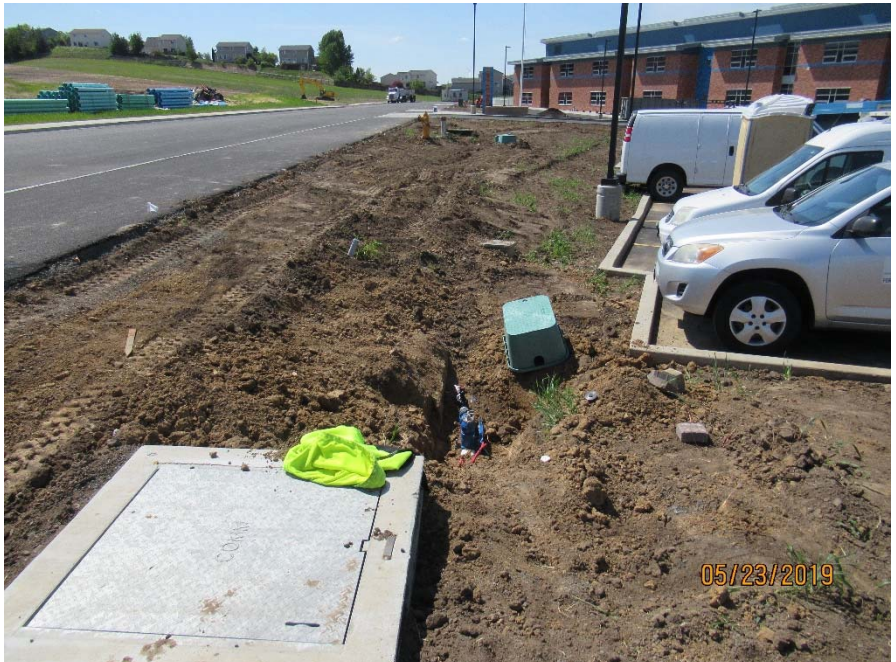
1. Landscaping contractor continues installing sprinkler system. Walker meeting with Curtis Concrete concerning concrete edging not yet installed.

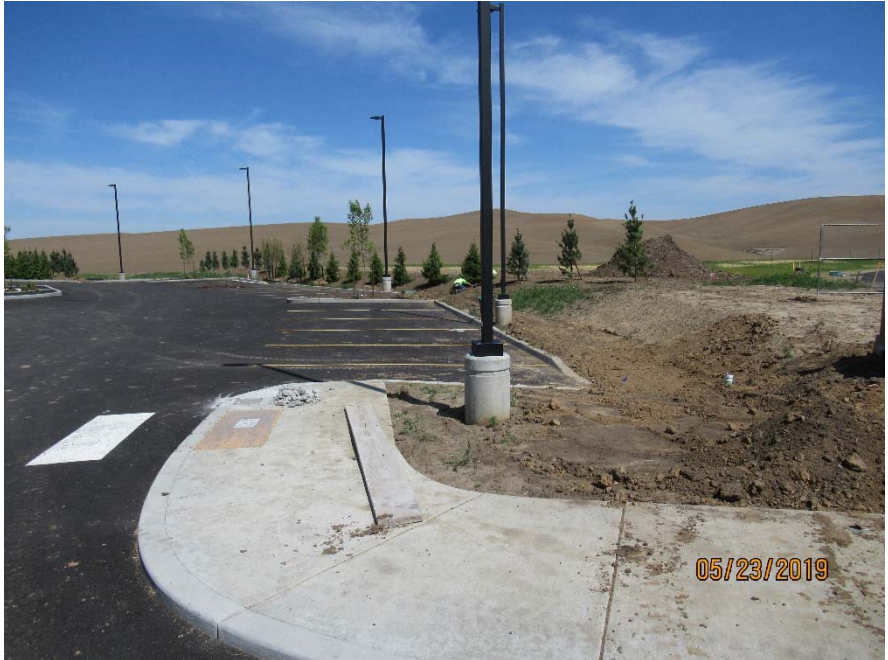
2. Landscaping contractor continues installing trees. Walker meeting with Curtis Concrete concerning concrete edging not yet installed.

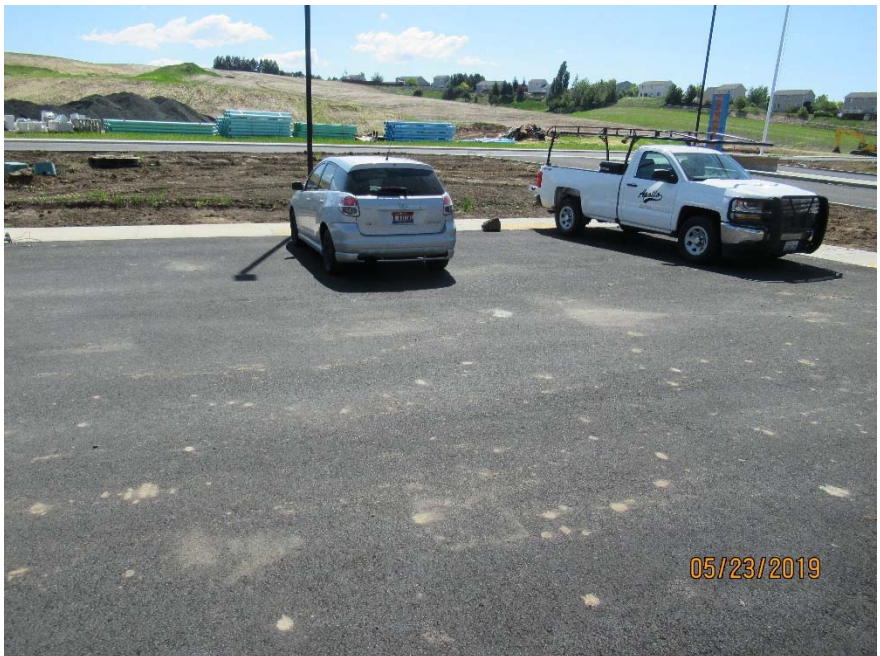
3. Walker needs to schedule the ADA parking area striping as well as signage install.

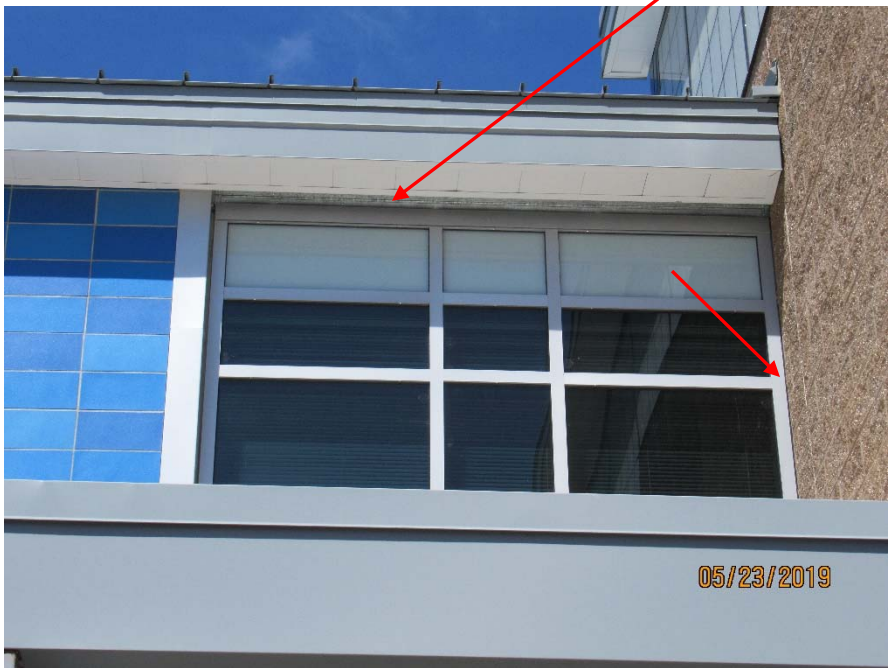
4. I mentioned to the contractor this appears to be metal wall framing exposed to the elements. If not addressed before hand this will show up on the building exterior Punch List. Possible location of air passage.

No indication that the frame has been sealed against the split faced CMU.

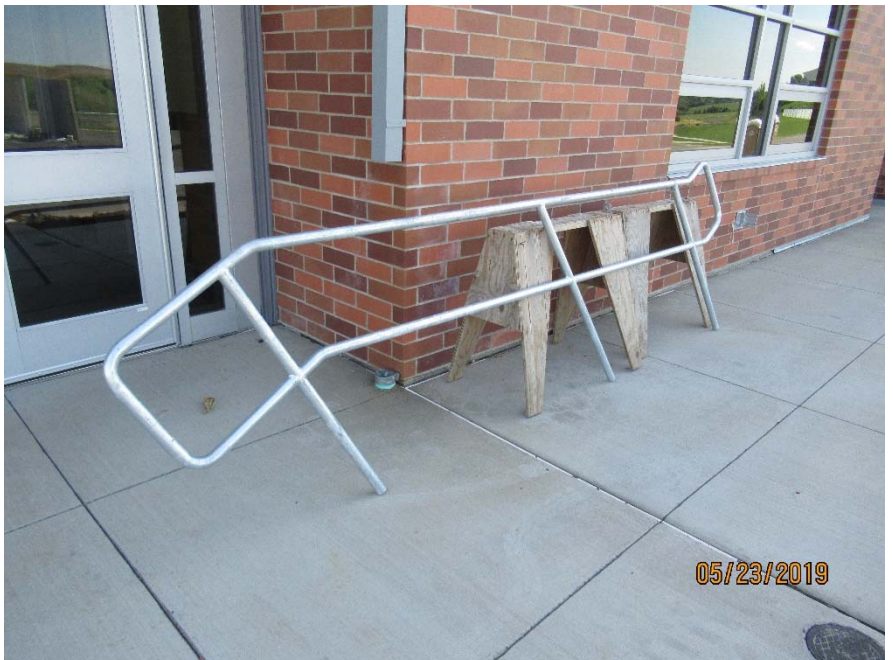
5. Although it appears the contractor has core drilled some of the required holes in the concrete for the install of exterior guard rails at the Library and the Stage exterior doors, they are not finished and not yet installed.

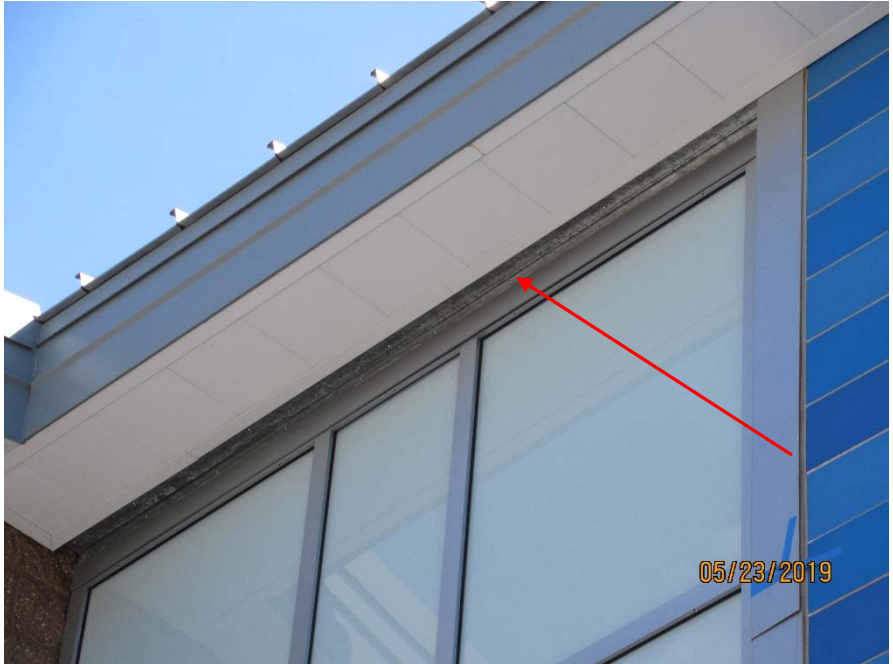
6. I mentioned to the contractor this appears to be metal wall framing exposed to the elements. If not addressed before hand this will show up on the building exterior Punch List. There are a number more locations with this condition. Possible a location of air passage (See below).

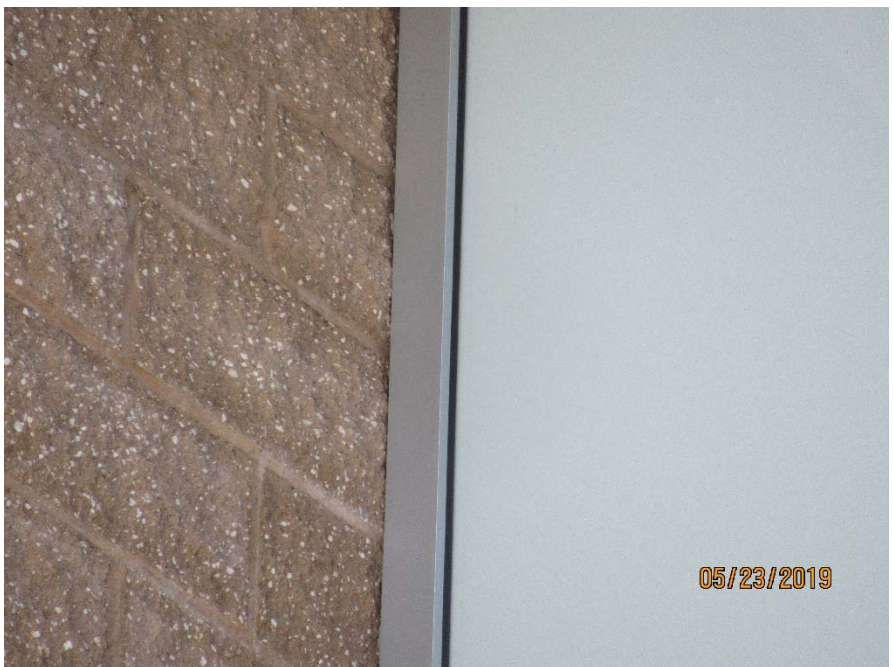
7. This is a photo of the exterior side of Storage room 243, where there is air passing through the area. There appears to be no visual indicator that the contractor has sealed between the CMU and window frame.

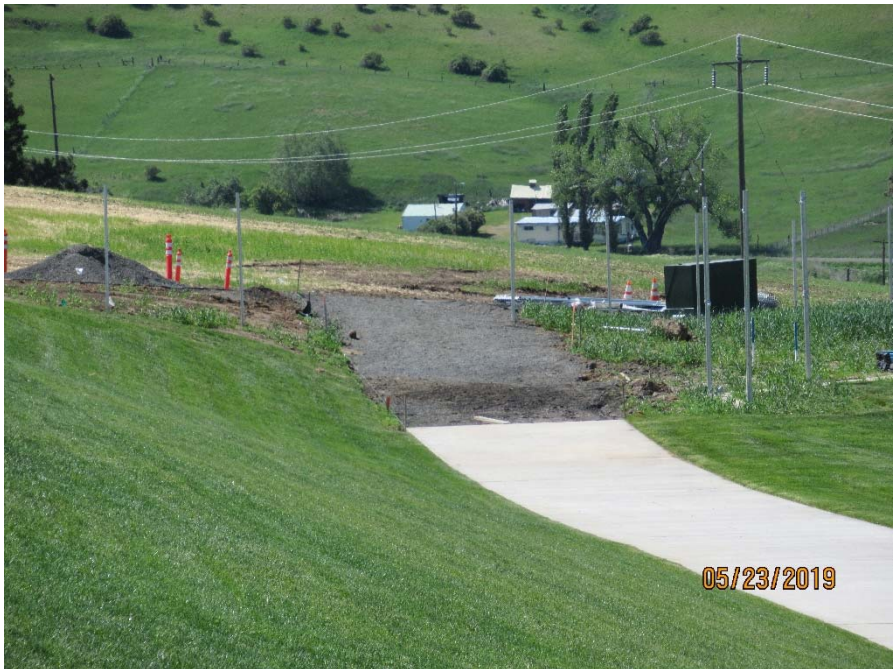
- 8. It appears no progress has been made on ADA ramp. Walker meeting with Curtis Concrete.**

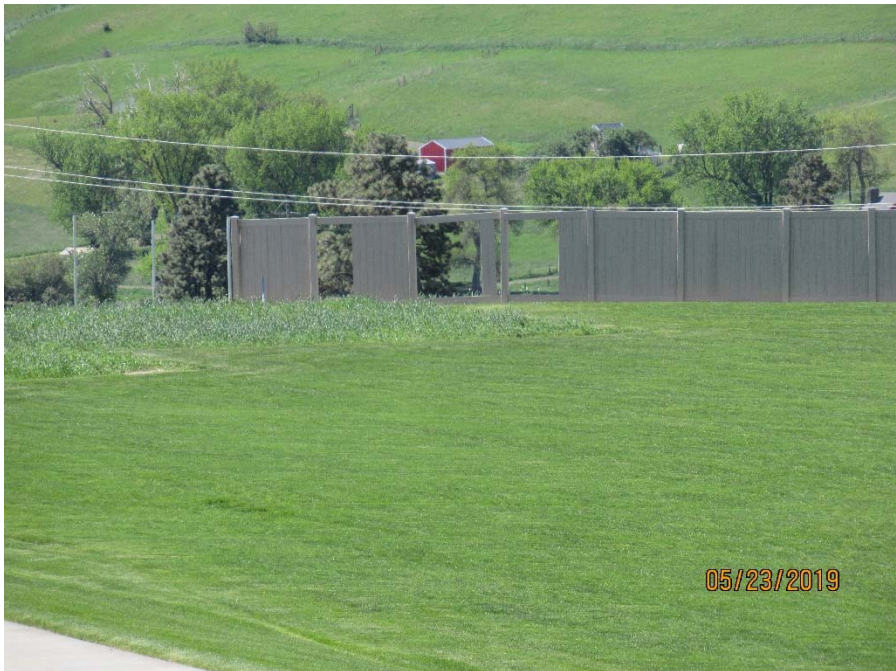
- 9. Fencing contractor expected to be back on site next week Tuesday to continue fence install as well as repair.**

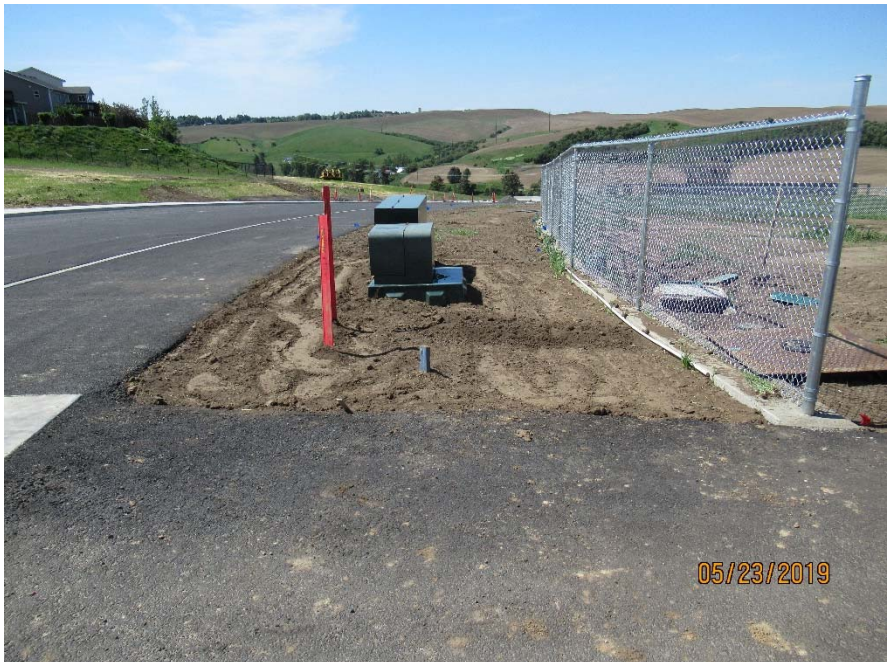
**10. Avista has returned to level installed utility boxes.**

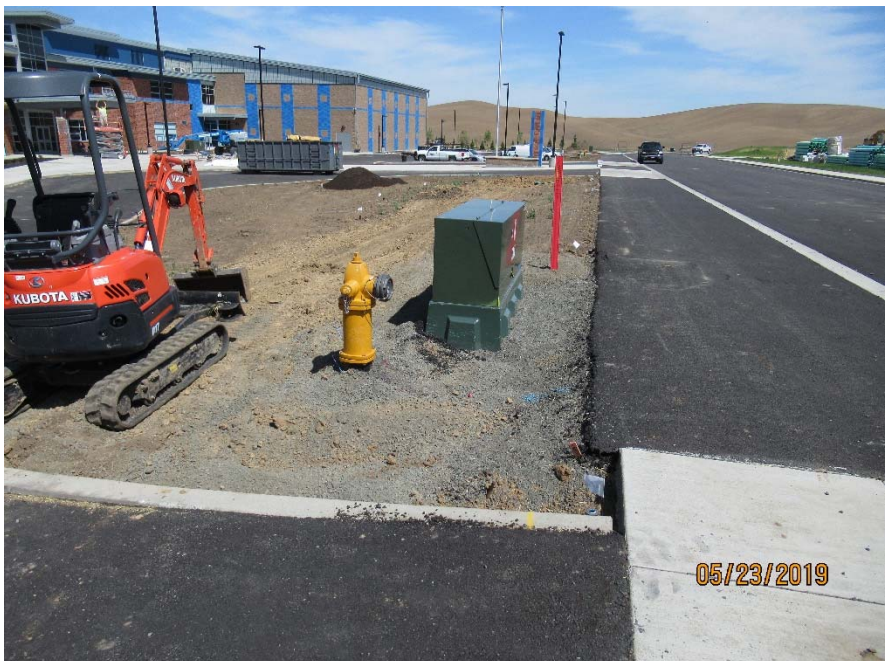
**11. Avista has returned to level installed utility boxes.**

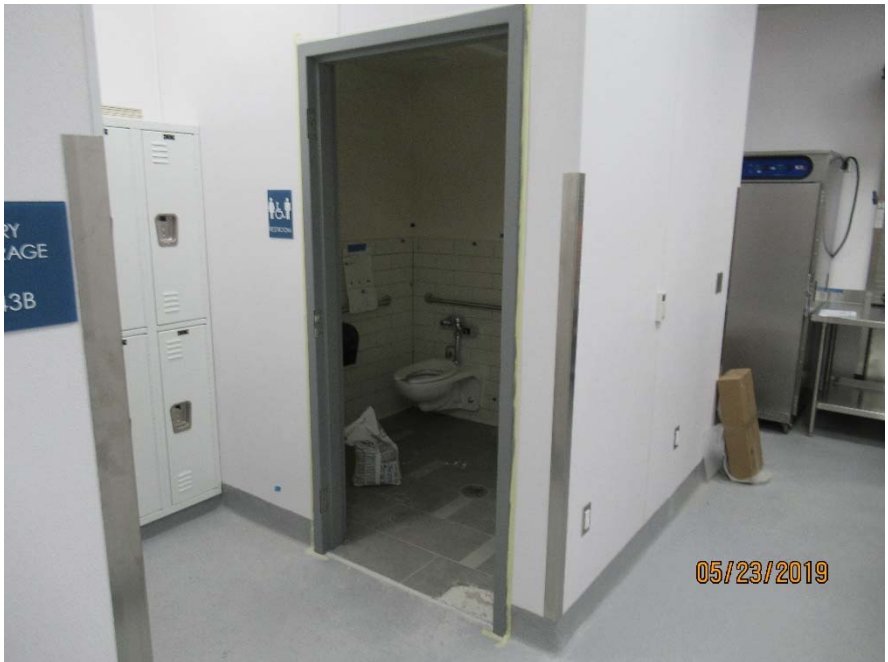
- 12. Contractor has installed the new door frame for the Kitchen bathroom.**

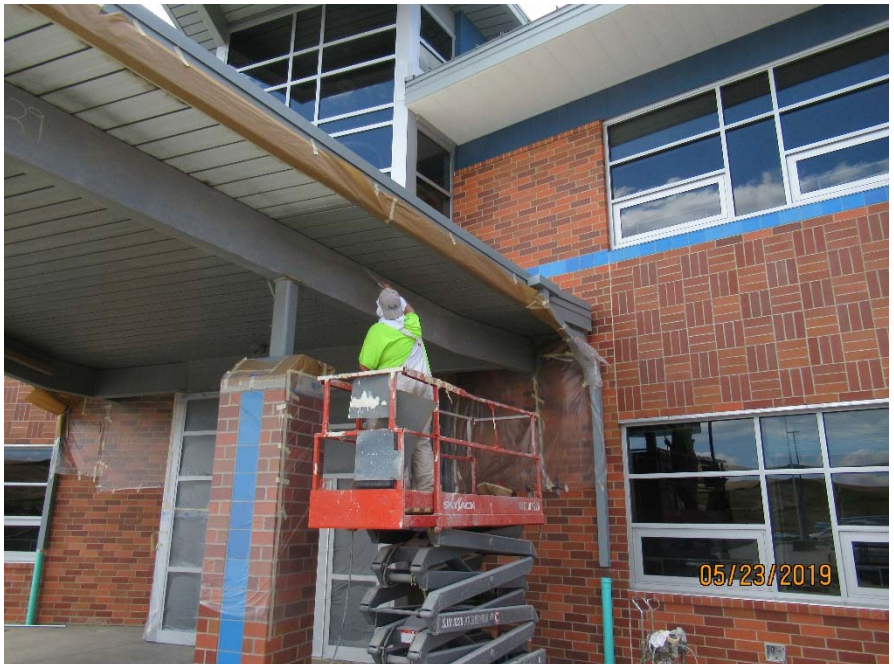
- 13. Painter is painting main entry steel and soffit.**
