**Project: PSD: Kamiak Elementary School****Date: May 3, 2018****Weather conditions:**

**Discussion with:** See Construction Progress Meeting dated 5/3/18**Construction Activities:**

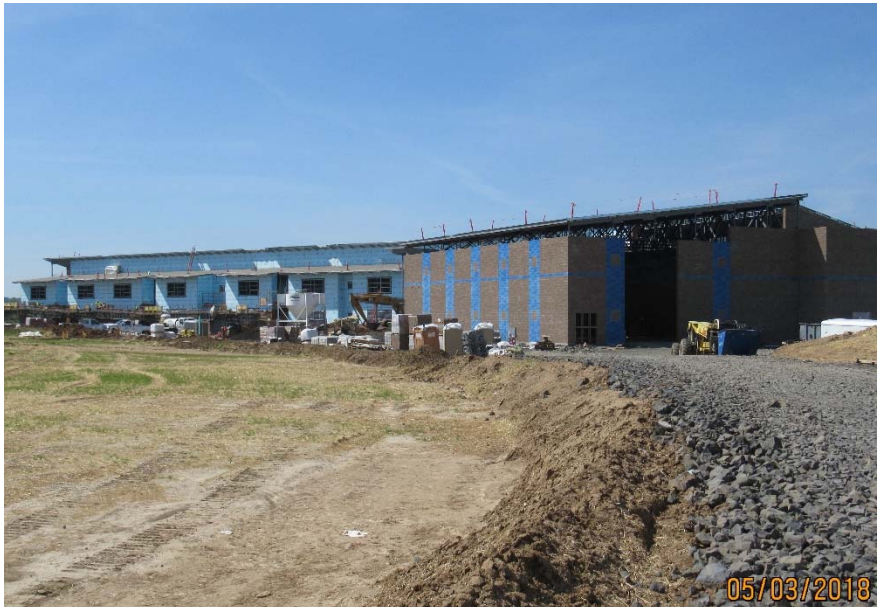
1. View looking south.

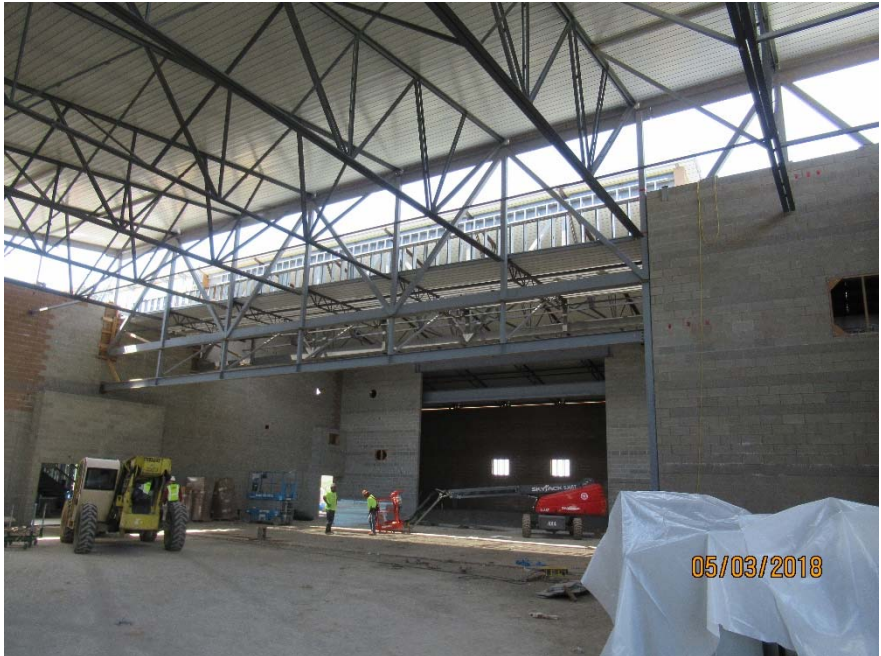
2. Contractor installing the low wall that will be below translucent panels.

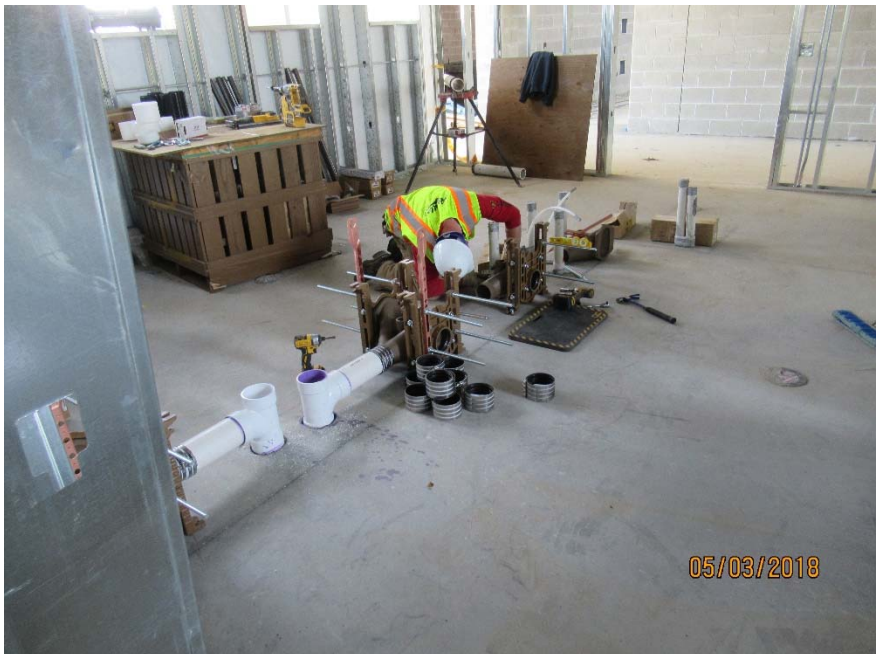
3. Contractor is installing carriers in Restrooms 150 and 152.

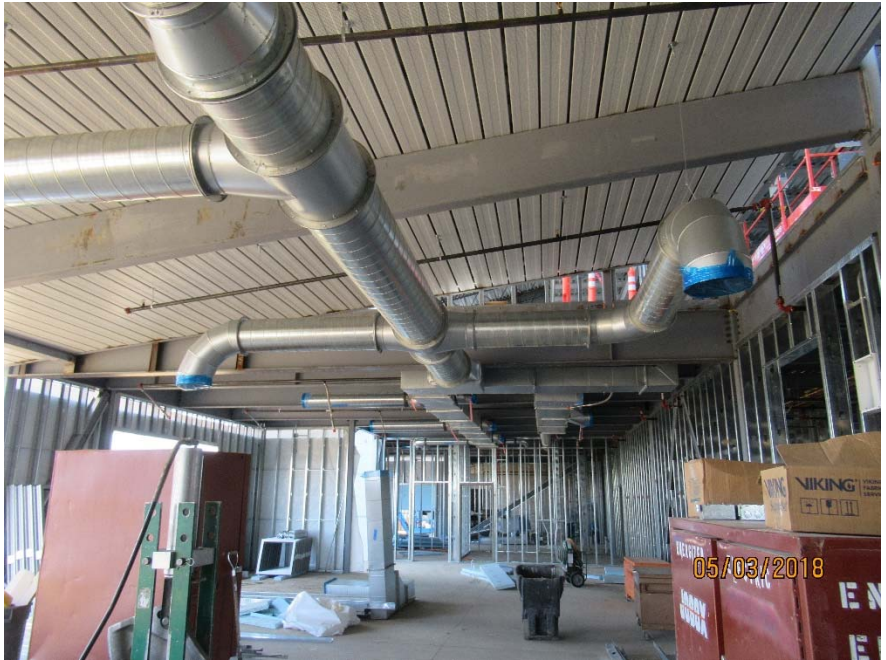
4. Ductwork installation continues. This ductwork is in the Library.

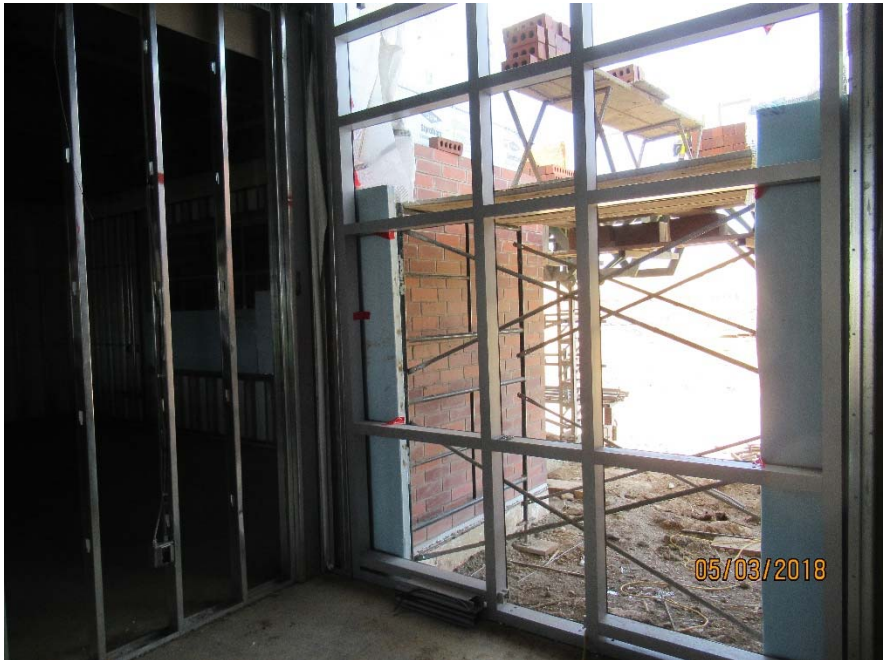
5. Appears the contractor has placed one lower section of curtain wall in Breakout space. It does not appear to be installed but simply staged to see how the brick to frame condition will look.

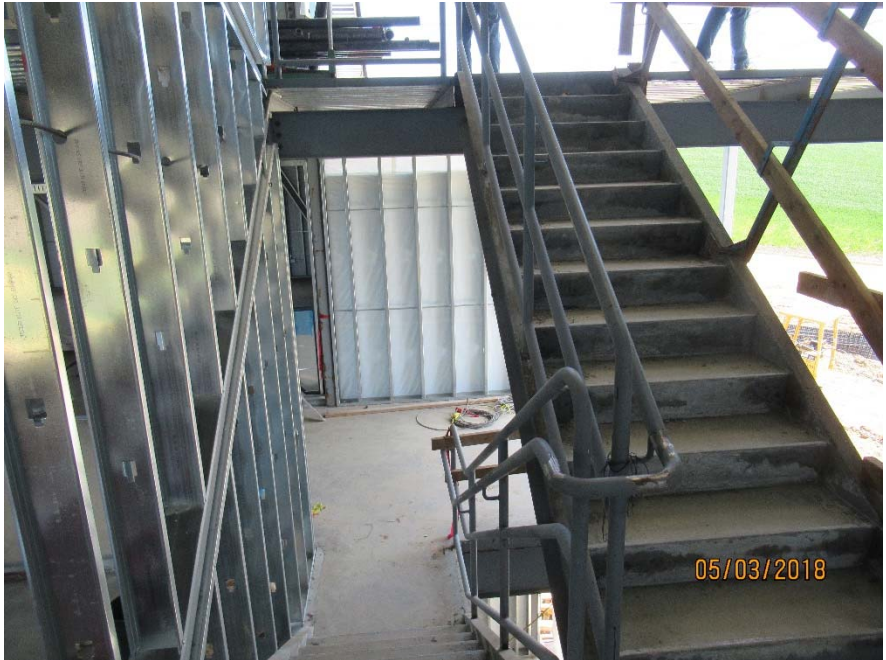
6. **Appears the contractor has installed the hand railing between the second floor and Mezzanine at the south end of the Mezzanine.**

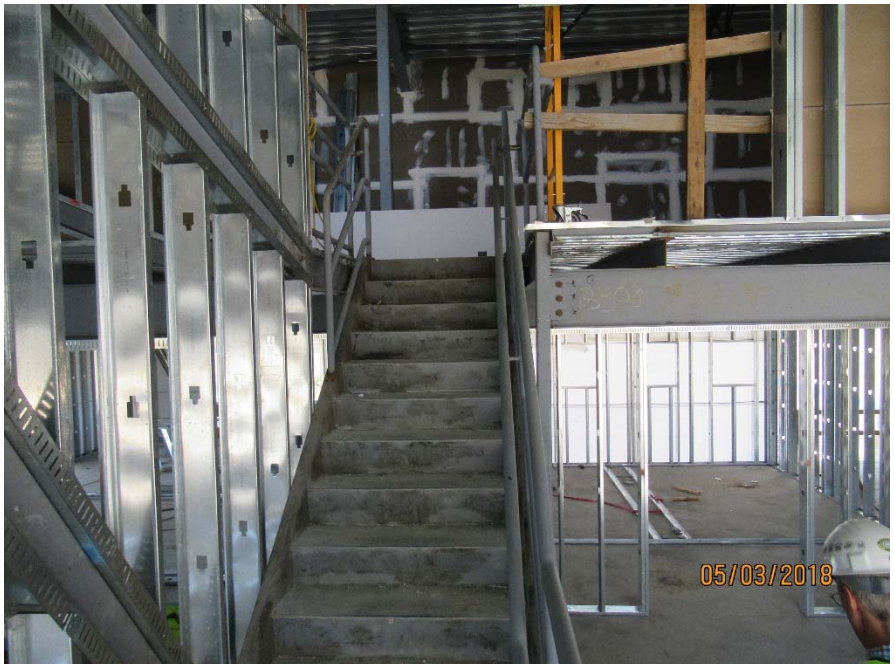
7. **Appears the contractor has installed the hand railing between the second floor and Mezzanine at the north end of the Mezzanine.**

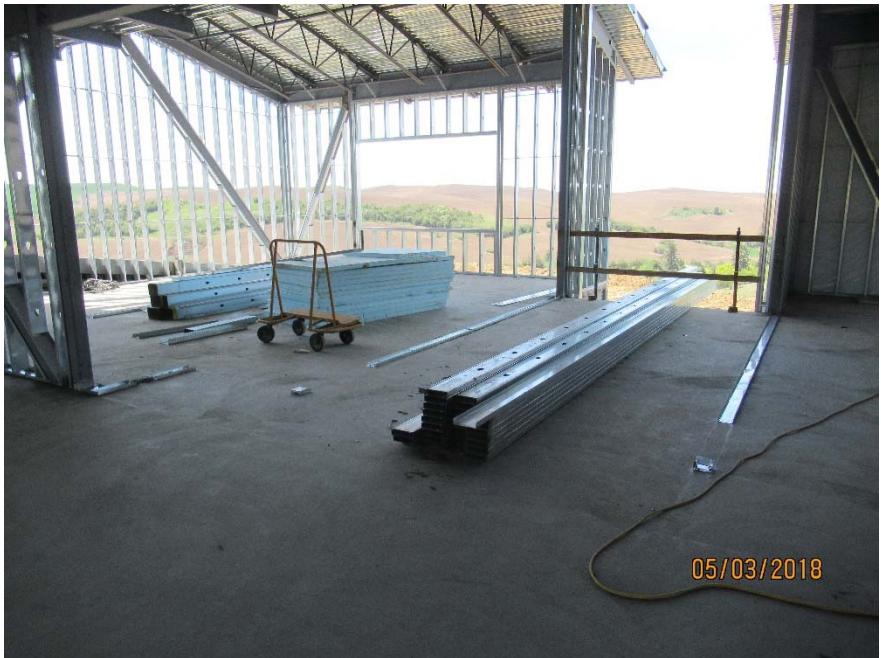
**8. Contractor framing  
Area B upper floor.**

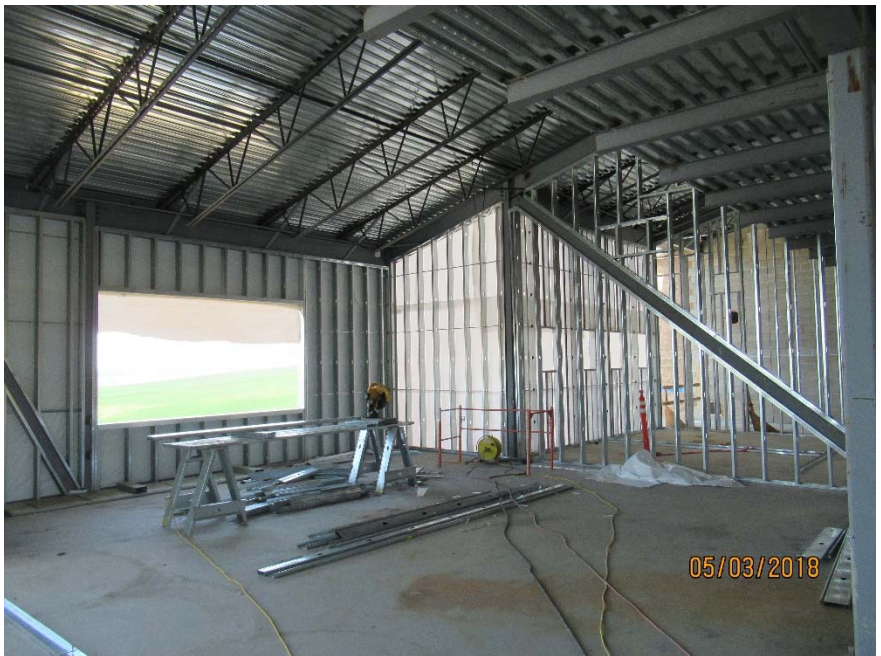
**9. Contractor framing  
Area B upper floor.**

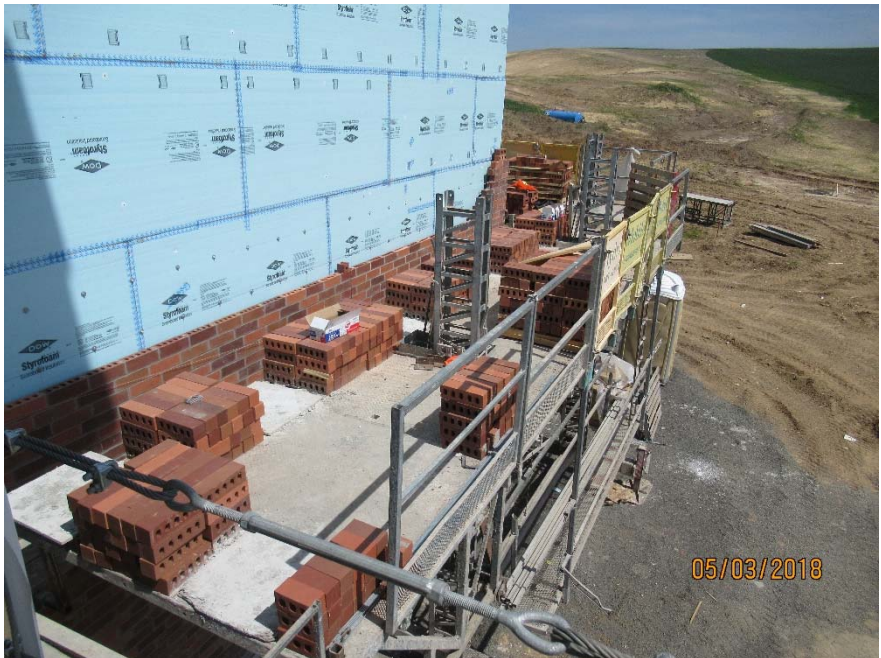
- 10. Contractor continues laying brick veneer at the south end of the building.**

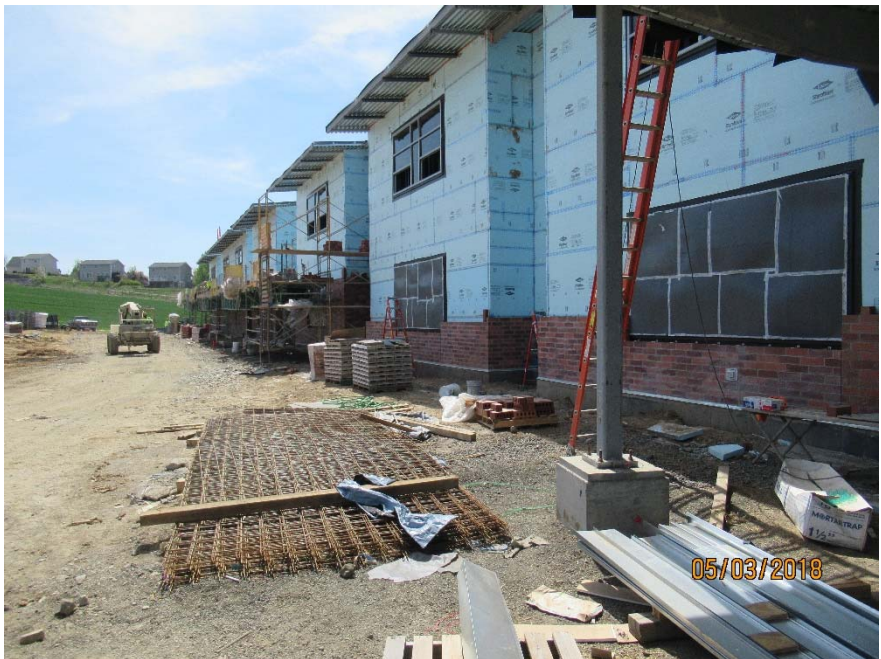
- 11. Contractor continues laying brick veneer at the east elevation of the building.**

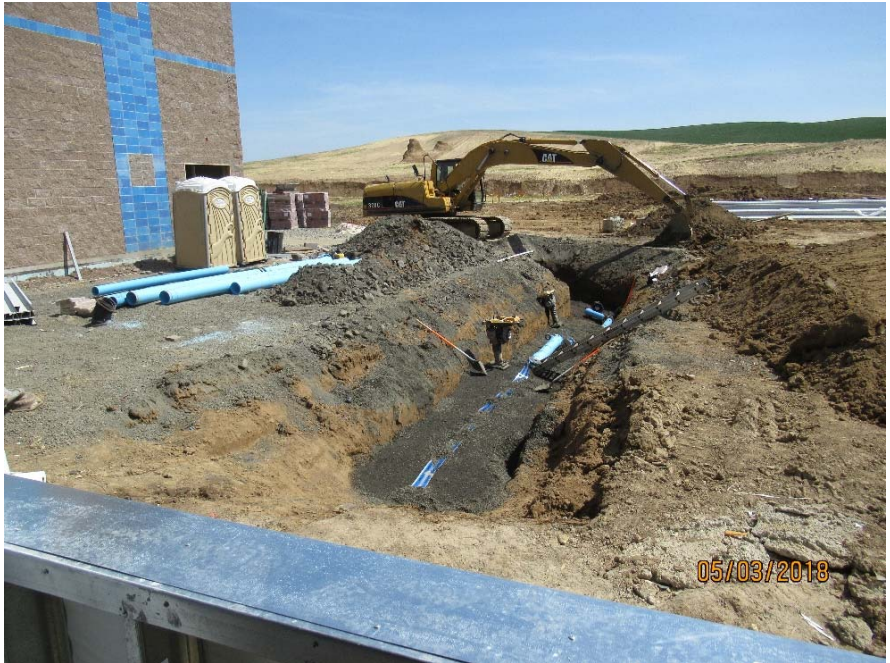
- 12. Contractor is installing water mains on the east side of the building. Has completed the storm piping on east side of building.**

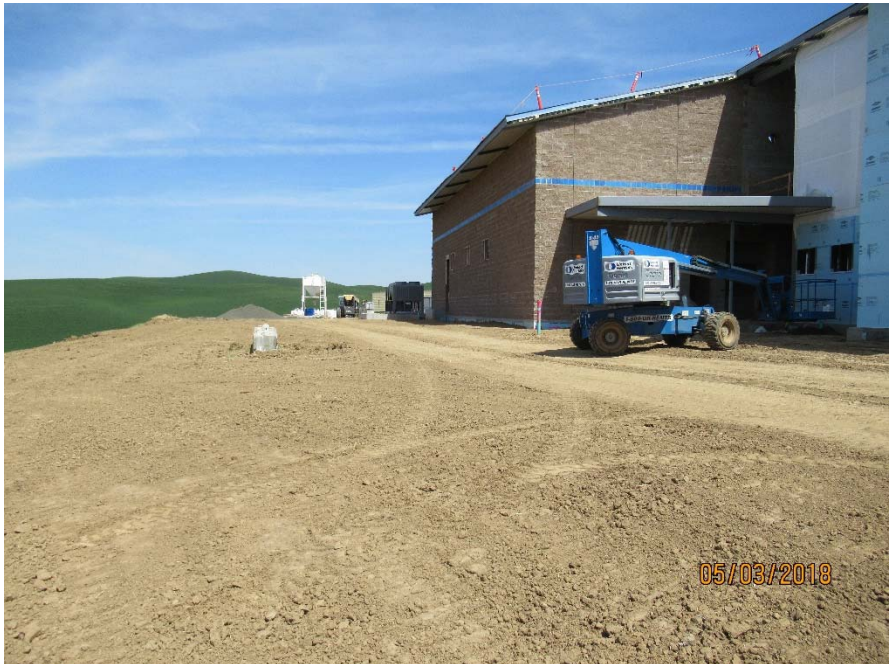
- 13. Contractor has completed the storm piping on west side of building. Contractor has also stripped off the erosion control straw in an effort to dry out the area quicker.**

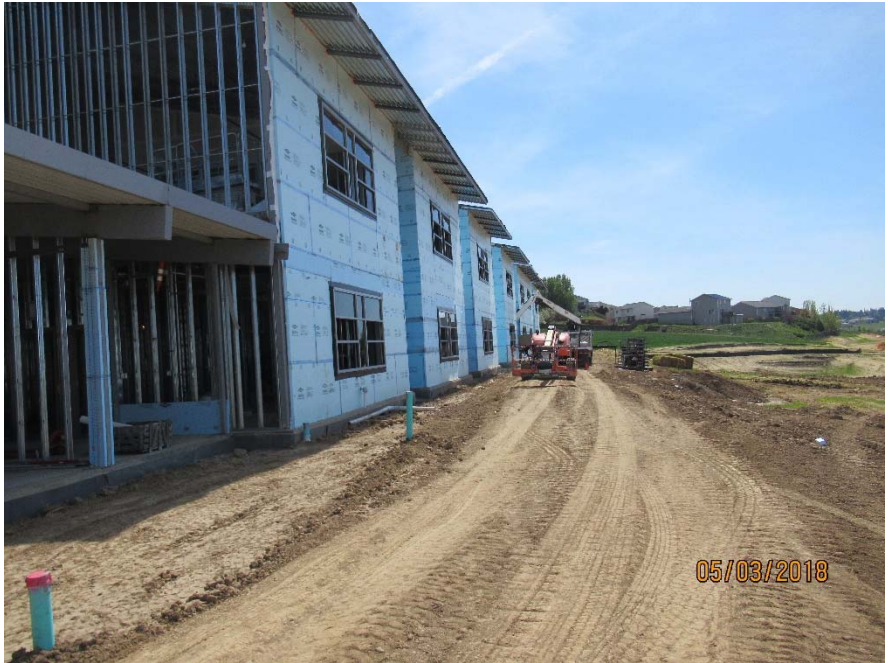
- 14. Appears contractor has installed classroom aluminum window frames and is now installing glass on the west side of Area A.**

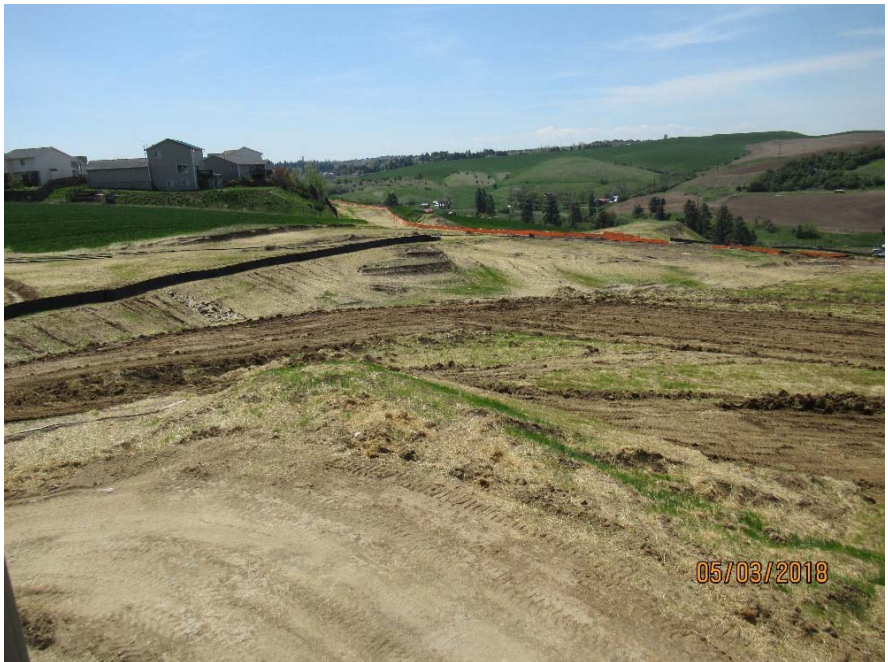
- 15. Appears the contractor has begun stripping the erosion control straw from the lower play field.**

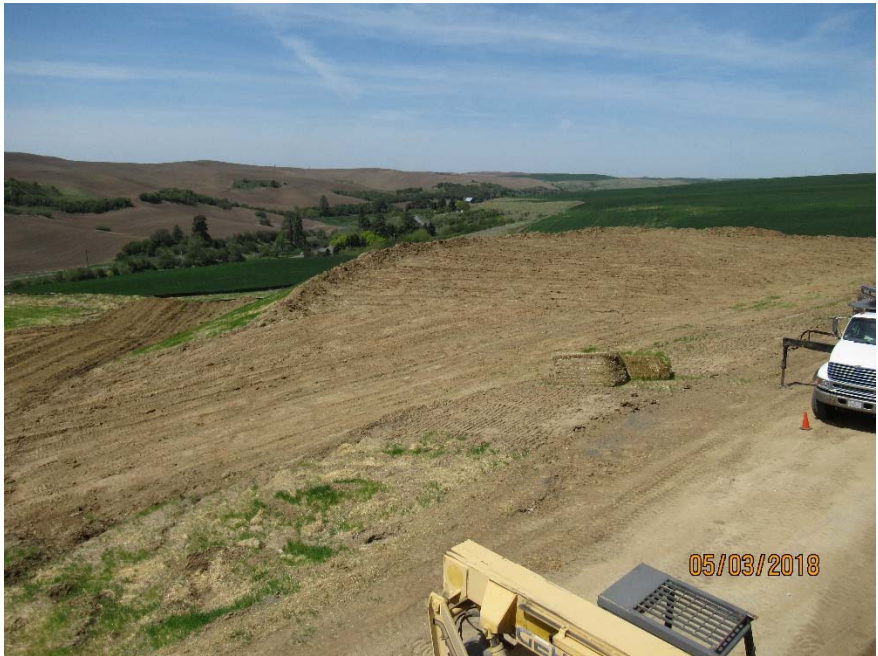
- 16. Appears the contractor has begun stripping the erosion control straw from the upper play field.**
