**Project: PSD: Kamiak Elementary School****Date: May 31, 2018****Weather conditions:**

Discussion with: See Construction Progress Meeting dated 5/31/18**Construction Activities:**

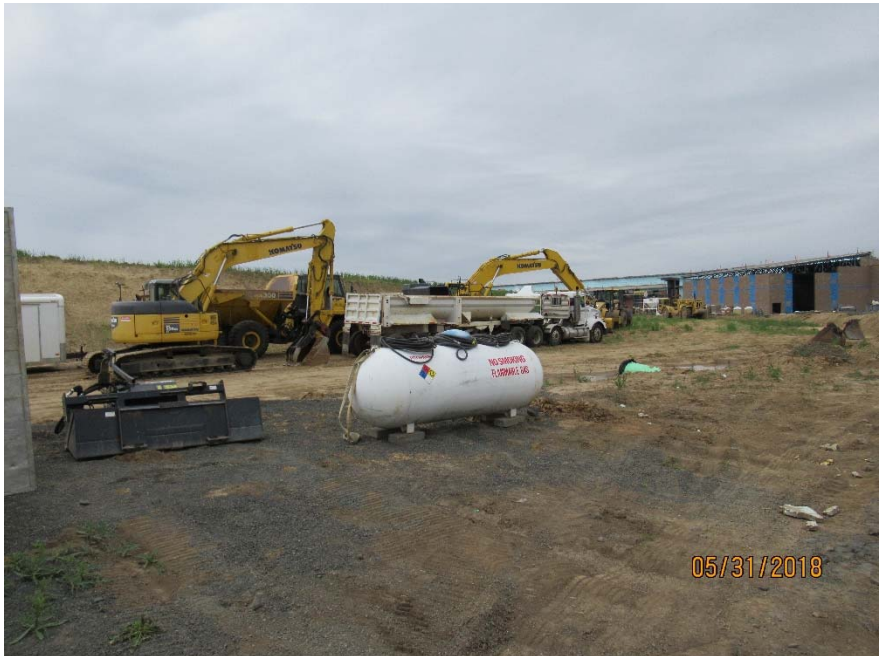
1. It appears the developers (Mader) earthwork contractor (Debco) is remobilizing equipment reading to resume work on NW Terre View Drive.

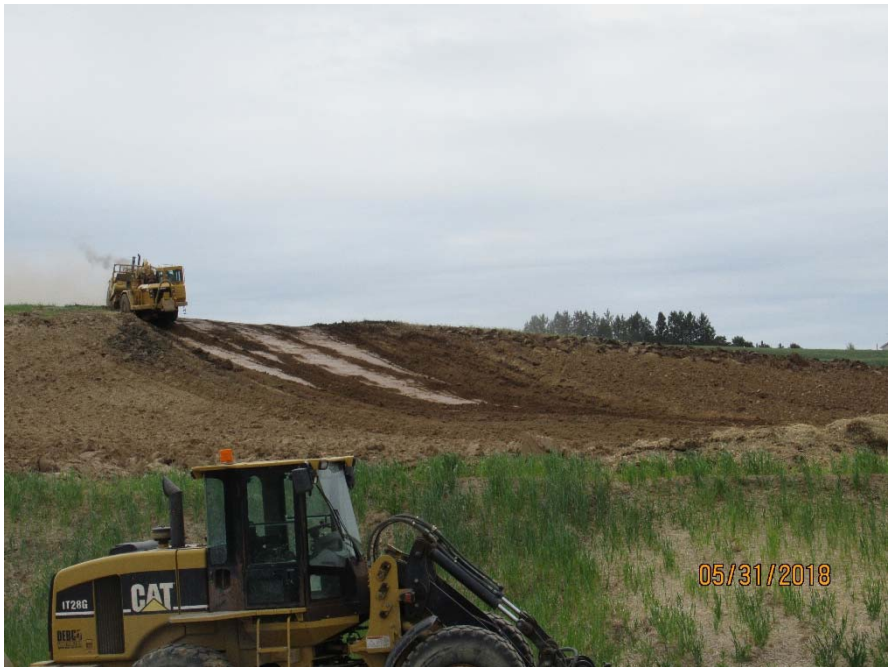
- 2. Motley the Walker**
Construction earthwork contractor has begun moving dirt from the borrow area east of what will be NW Terre View Drive.

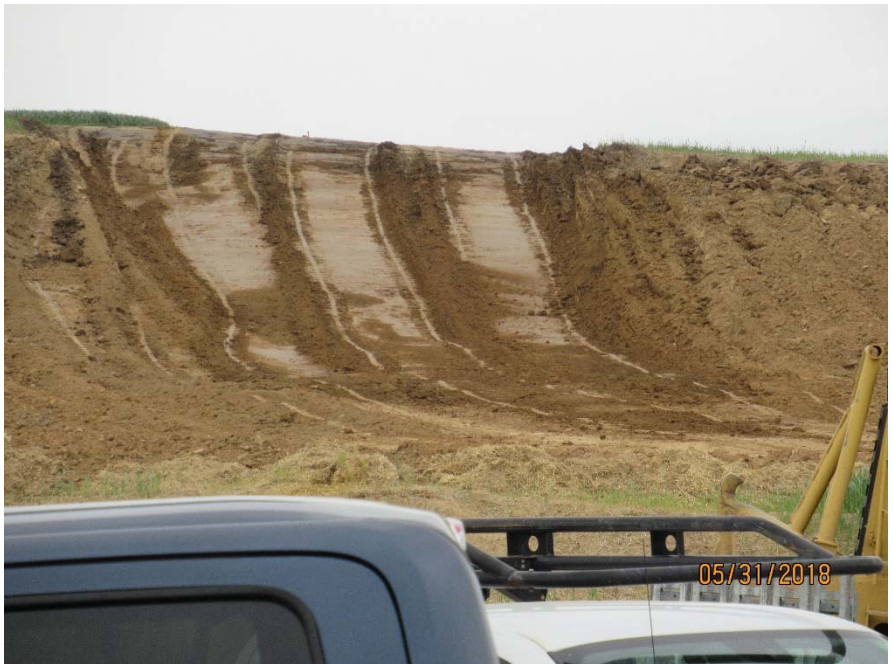
- 3. Motley the Walker**
Construction earthwork contractor has begun moving dirt from the borrow area east of what will be NW Terre View Drive.
Note the contractor is taking material from the top of slope which is reducing the slope of what will be NW Canyon View.

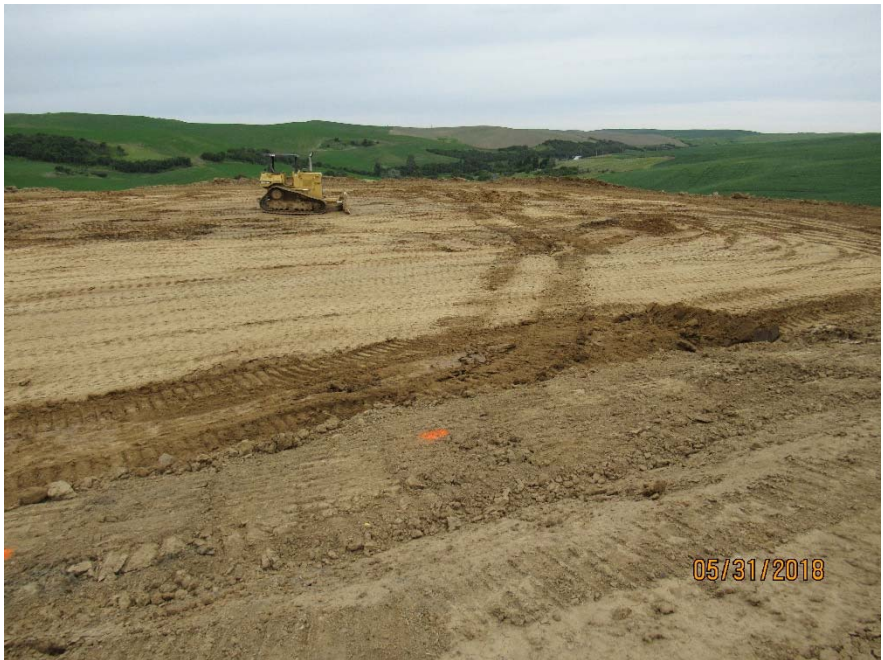
- 4. Motley is depositing material to play areas west of the Kamiak Elementary building. And compacting with a sheeps foot roller.**

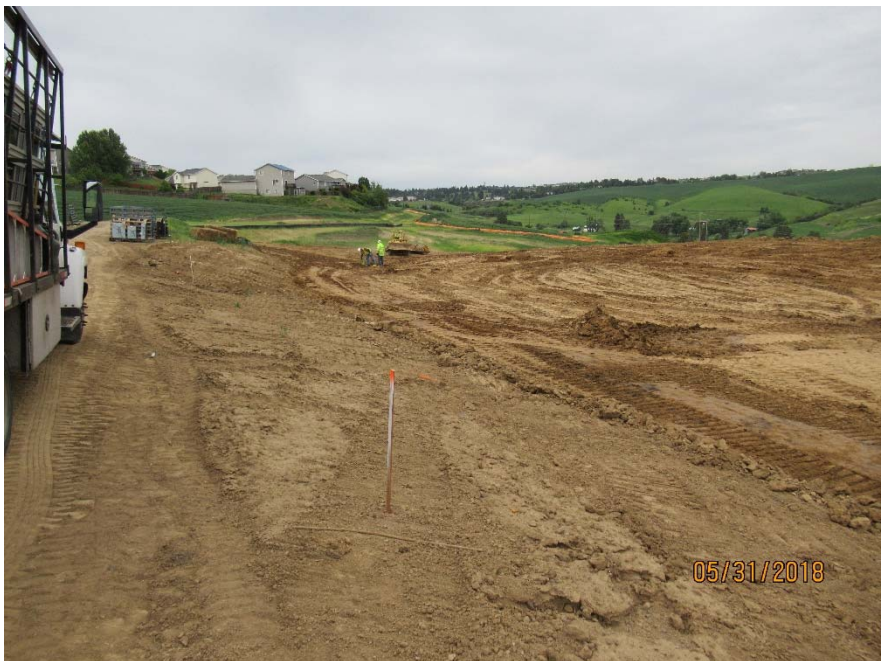
- 5. Motley is depositing material to play areas west of the Kamiak Elementary building.**
Although hard to see in this photo, the person in the green safety jacket is an inspector from GPI, our special inspector. He is testing for proper compaction of material after it is rolled.

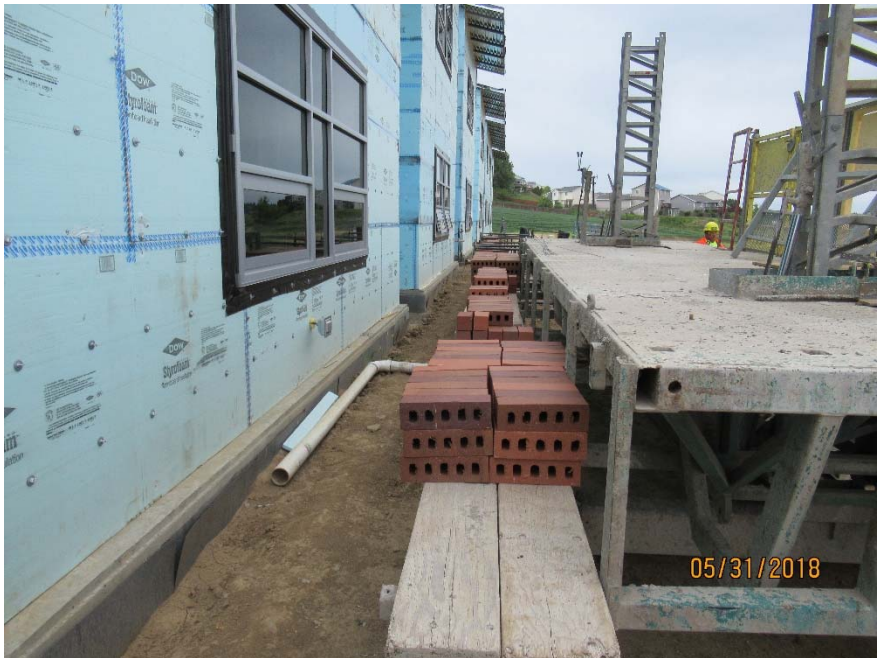
- 6. Masons appear to be staging materials and setting scaffolding to begin laying brick veneer on the west elevation of the building. Beginning at the north end of the classroom wing working south.**

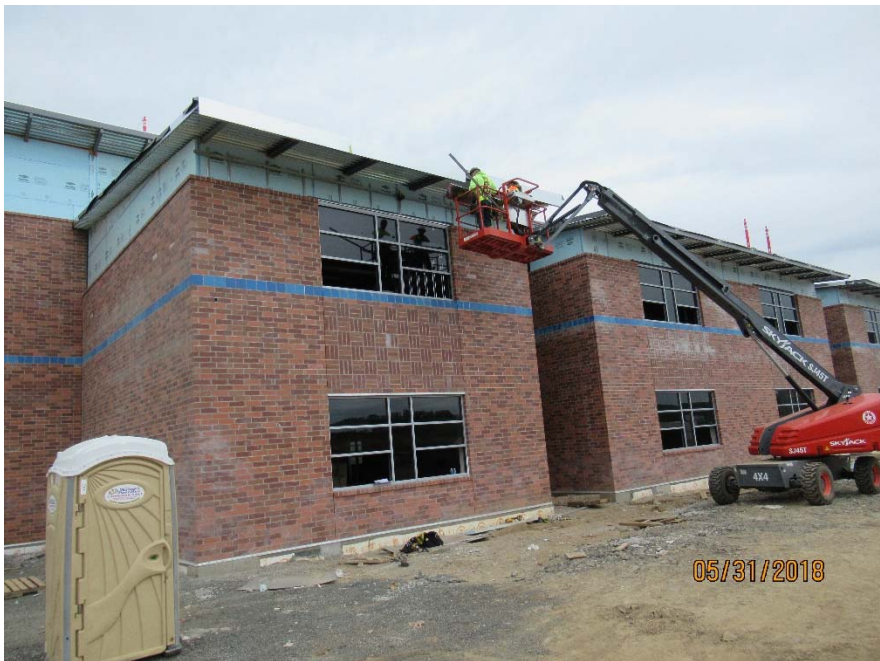
- 7. Brick veneer is complete on the east elevation of the classroom wing. Contractor is now framing for roof fascia.**

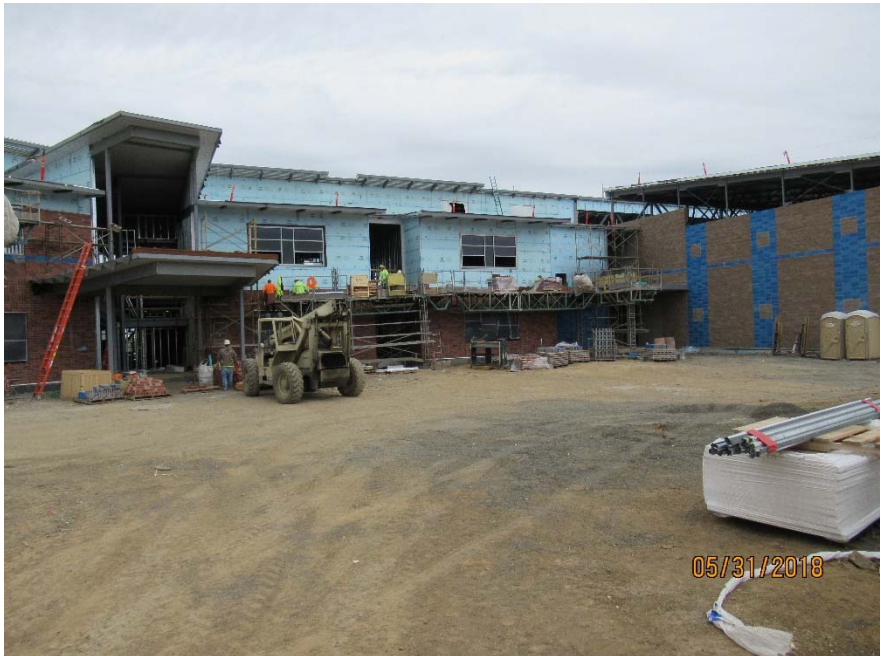
8. Contractor is working on the north side of the main entrance. Once complete with the east elevation they will move to the west elevation.

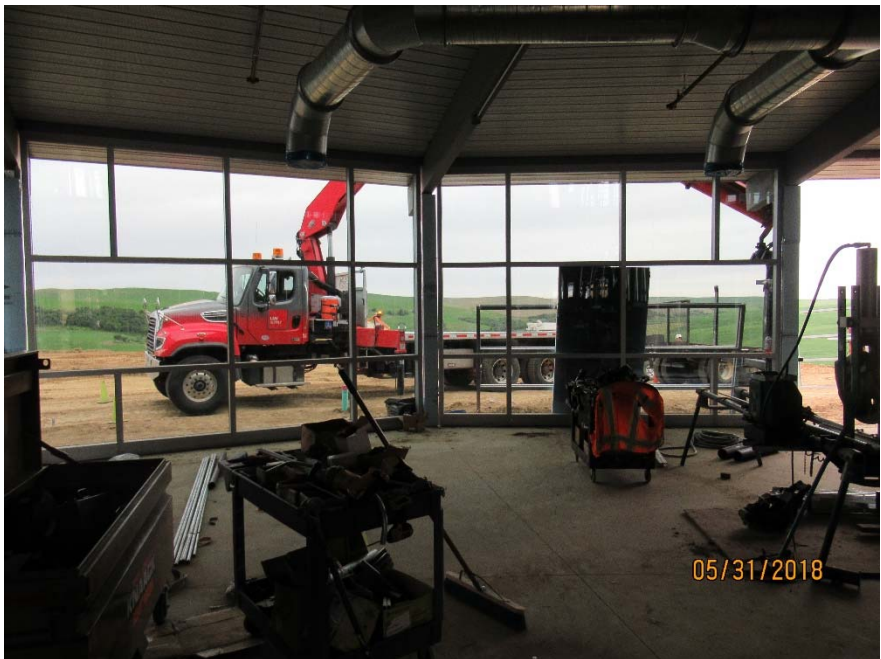
9. The window installer has installed the glazing in the window wall of the Library.

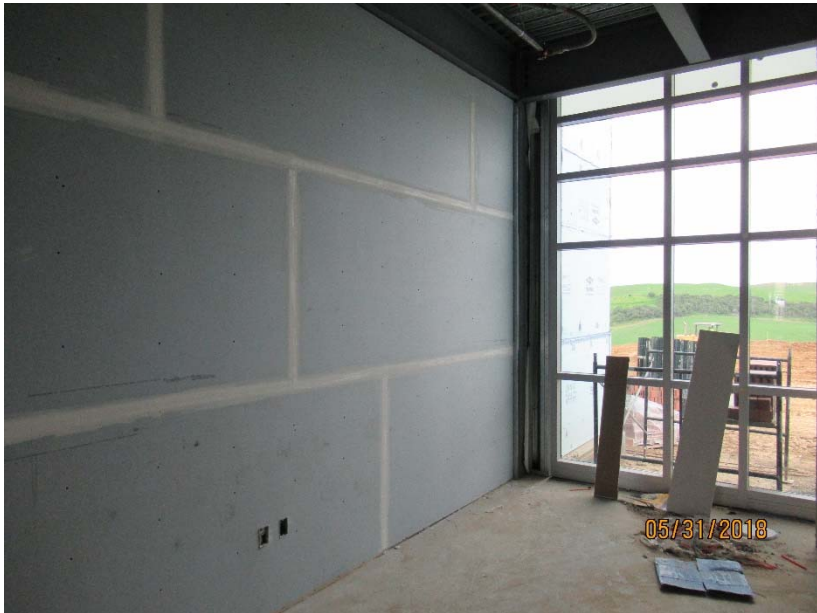
- 10. Contractor has begun taping the wallboard. Working from south end of the building to the north ion the lower floor.**

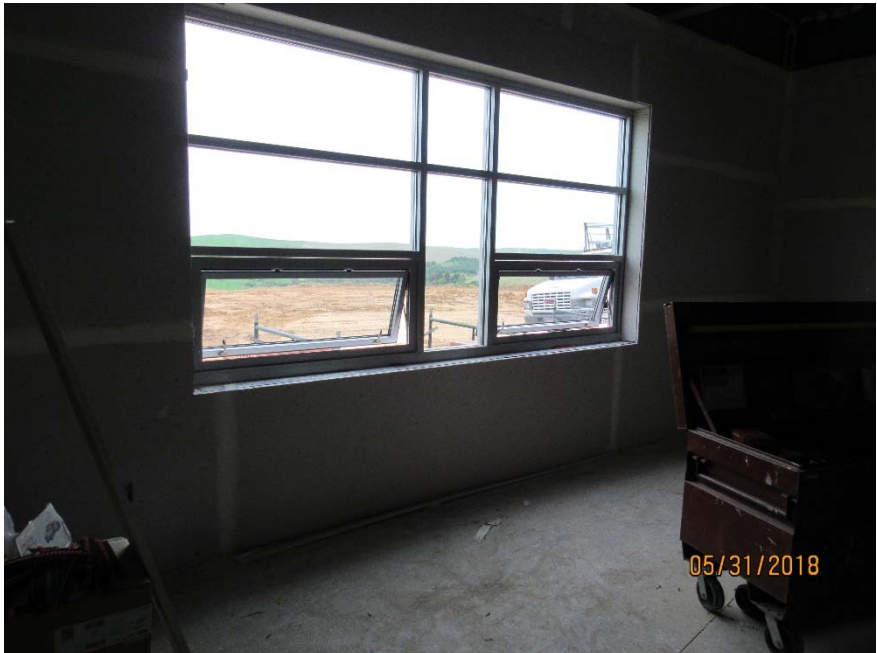
- 11. Window installer has begun installing the operable windows in the classroom wing.**

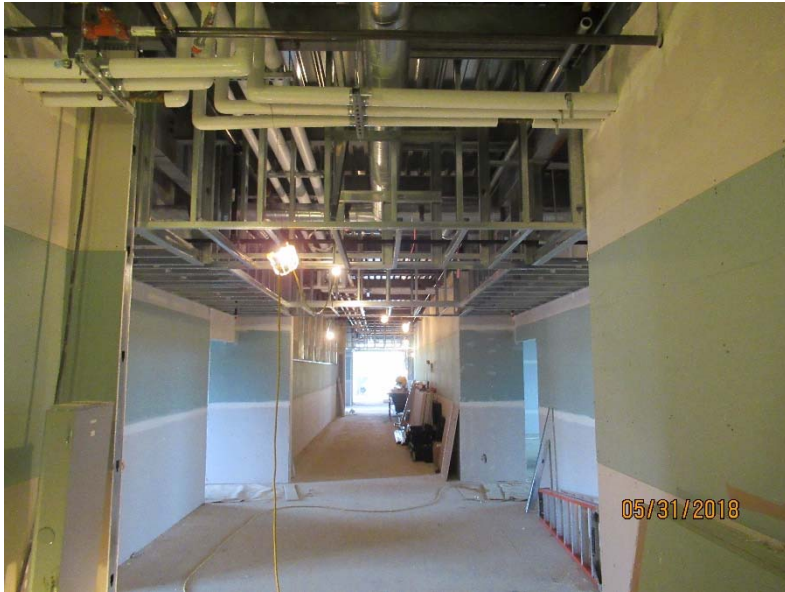
12. Framers continue framing ceiling soffits.

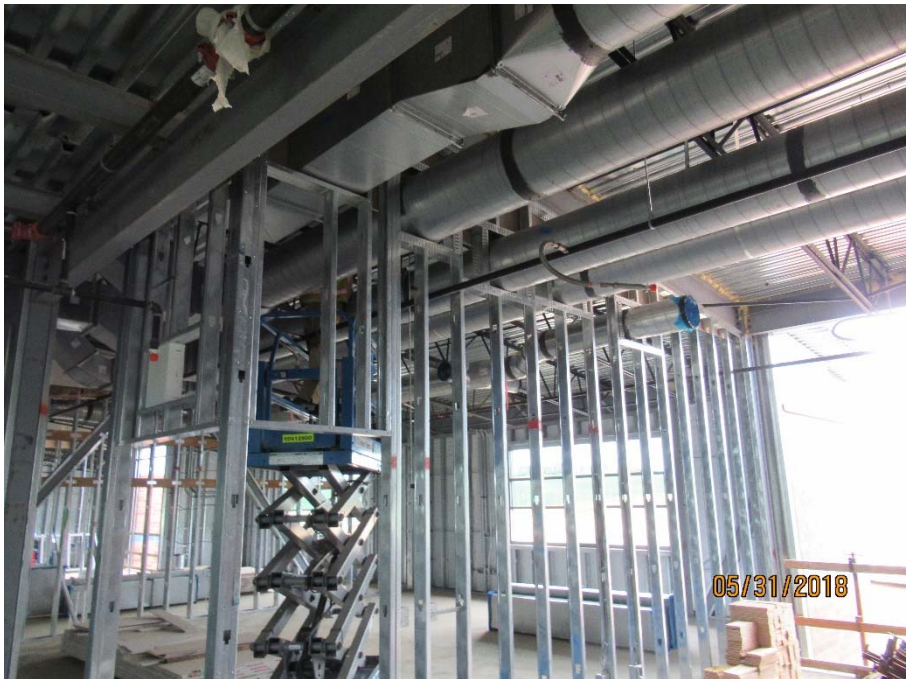
13. Ductwork installation as well as MEP rough in continues.

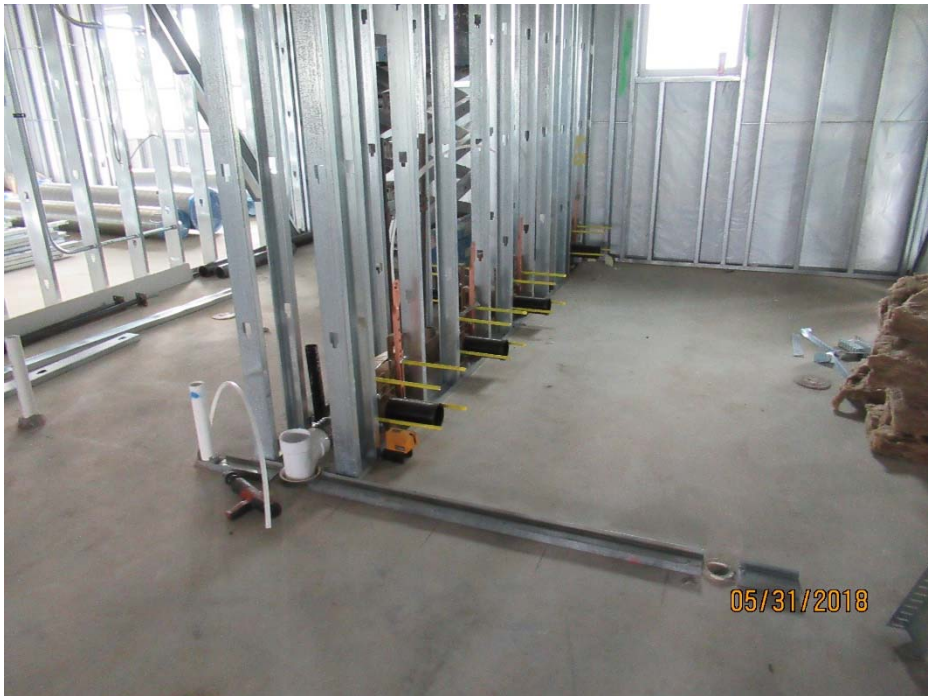
- 14. Framing at the upper floor continues. This is a photo of the upper floor gang bathroom.**

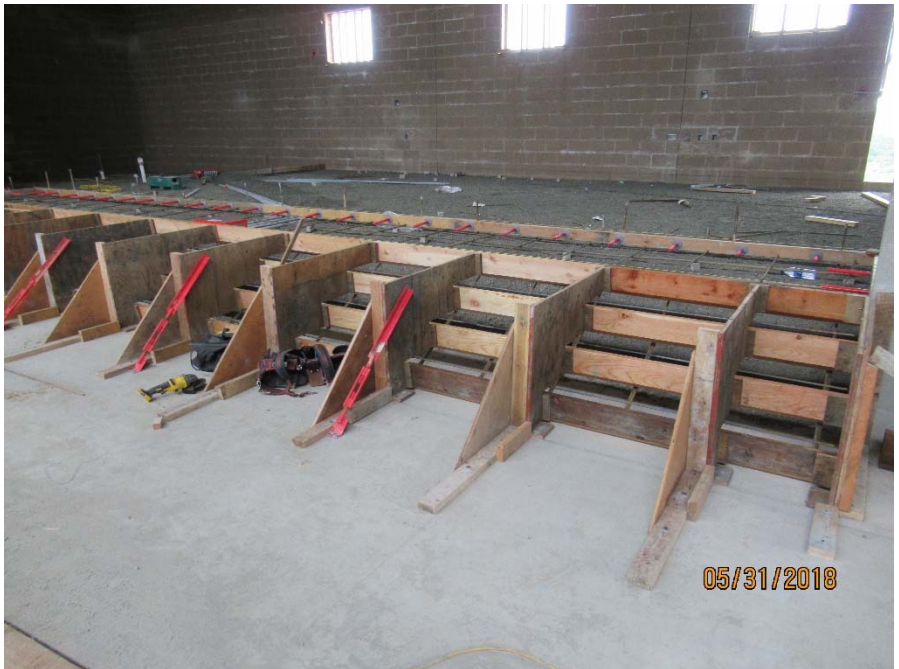
- 15. Contractor has formed the steps at the front of the Stage as well as the ramp to the south of the Stage.**
