**Project: PSD: Kamiak Elementary School****Date: June 21, 2018****Weather conditions:**

Discussion with: See Construction Progress Meeting dated 6/21/18.**Construction Activities:**

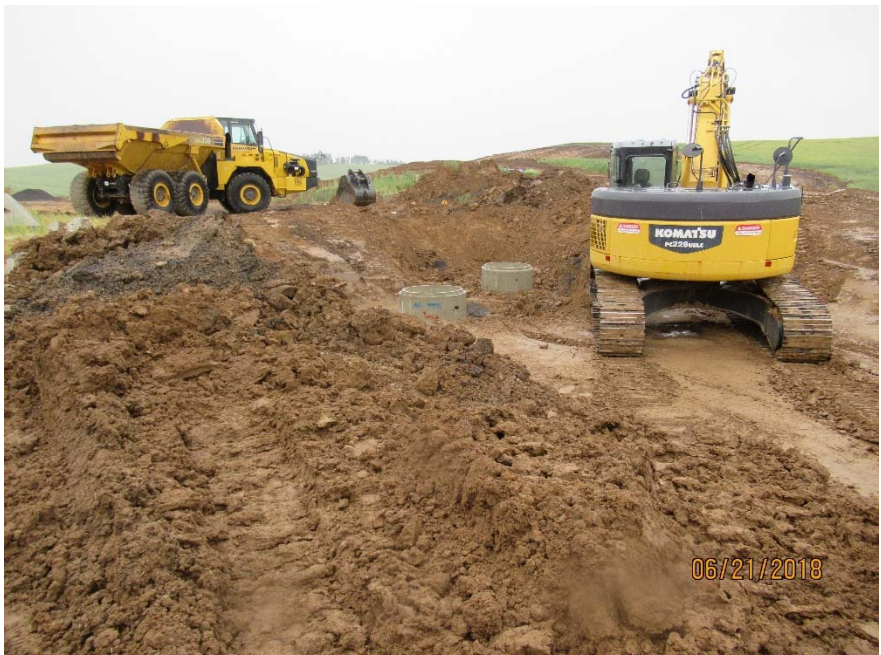
1. It appears the developer's contractor has installed 2 manholes.

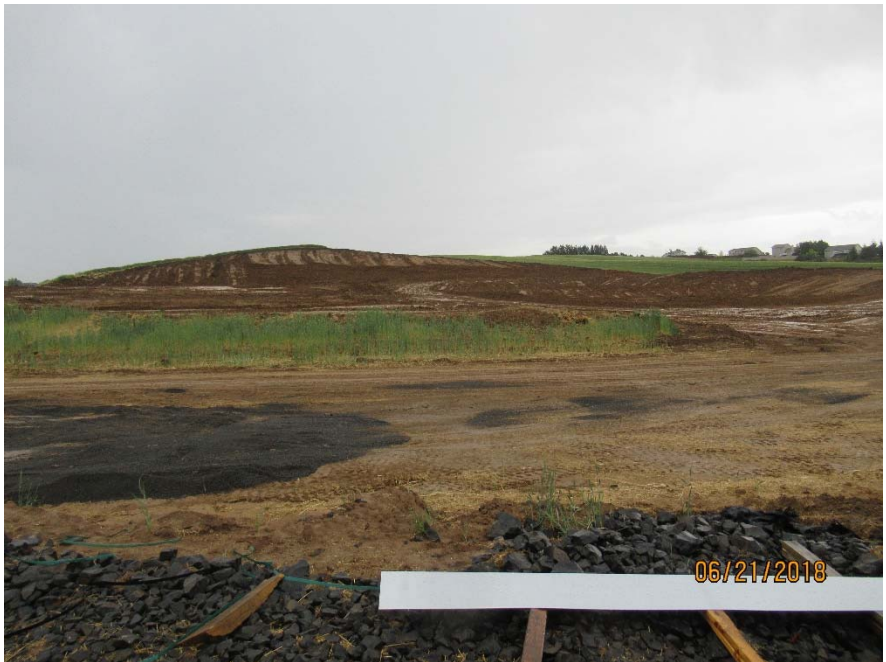
- 2. Earthwork contractor continues to move material from borrow site, pictured here to the playfield west of Kamiak.**

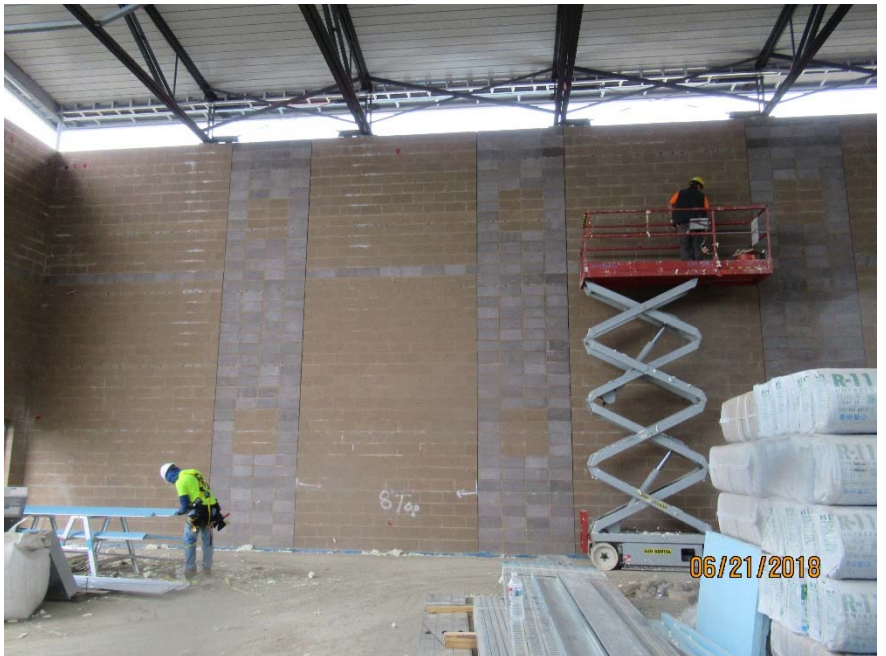
- 3. Insulation contractor injecting insulation in CMU cores.**

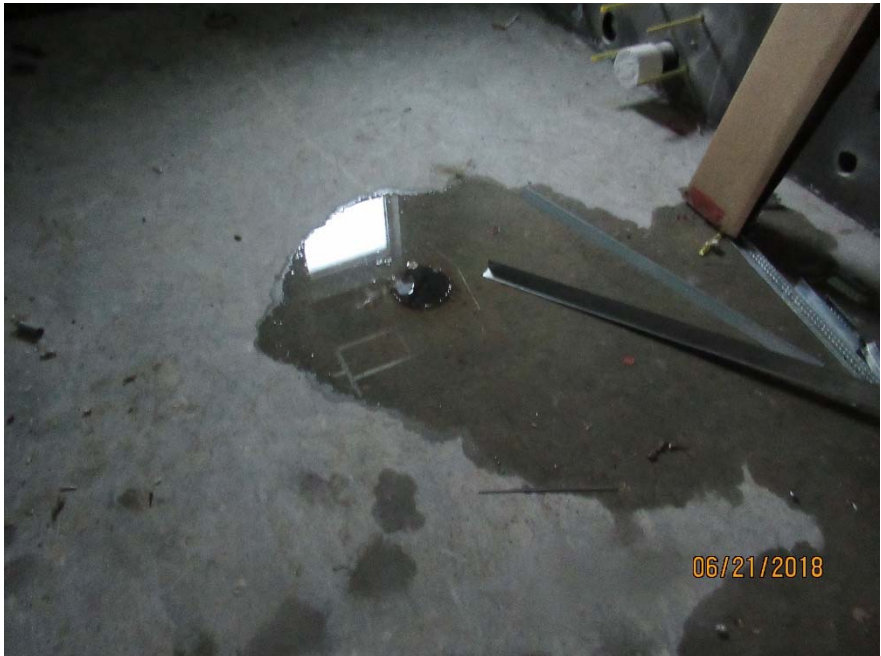
- 4. Appears there is water coming up through floor cleanouts on the lower floor. When asked the contractor states this is from testing the sewer line.**

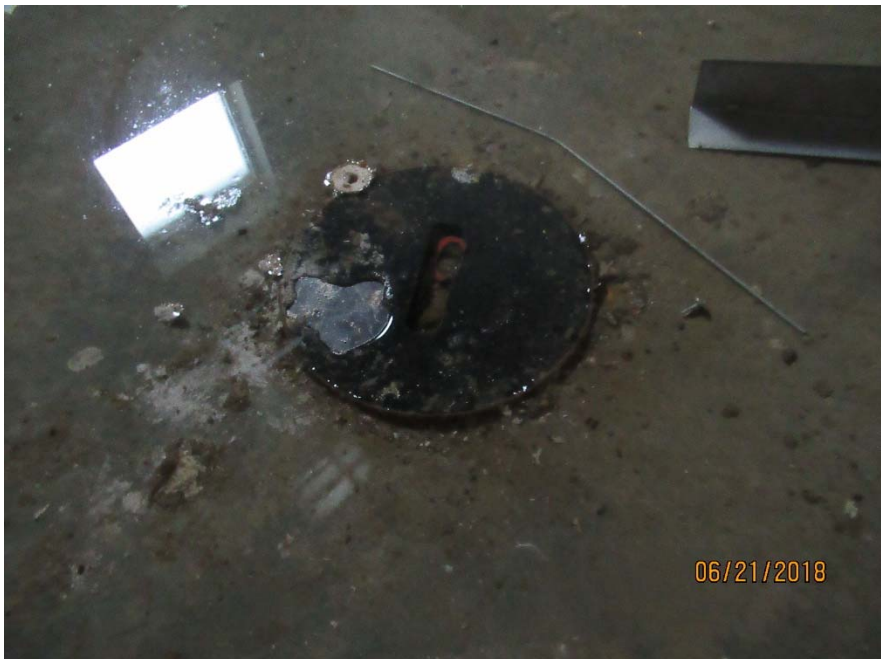
- 5. Appears there is water coming up through floor cleanouts on the lower floor. When asked the contractor states this is from testing the sewer line.**

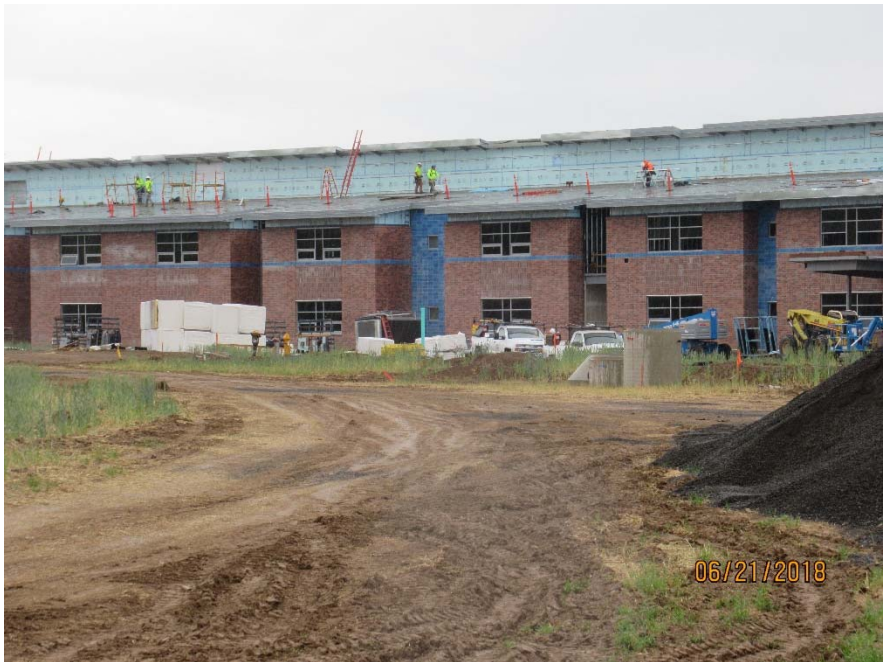
- 6. Roofing contractor appears to be installing flashing on lower roof.**

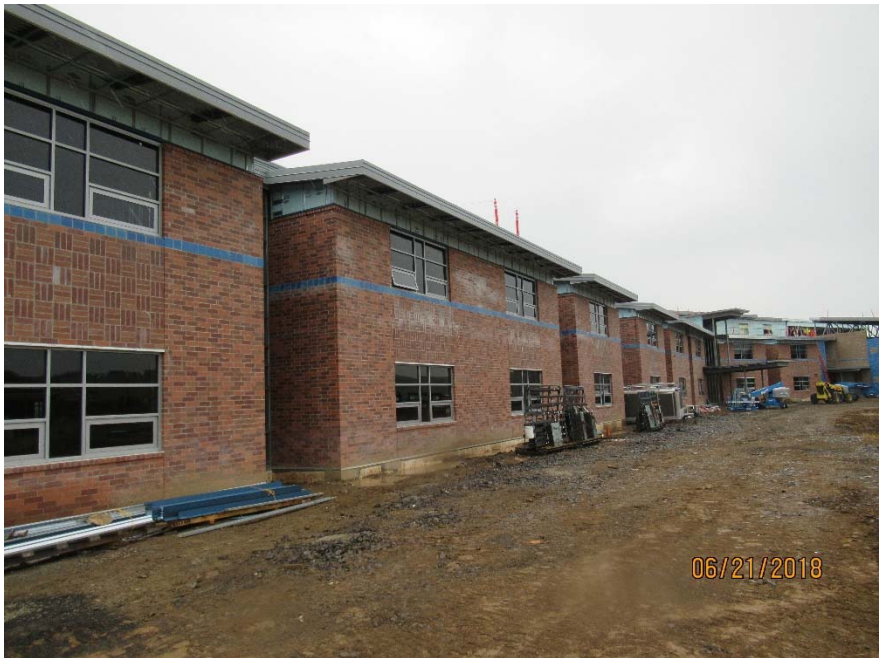
- 7. Appears the contractor has installed the fascia on the east roof edge of Area A.**

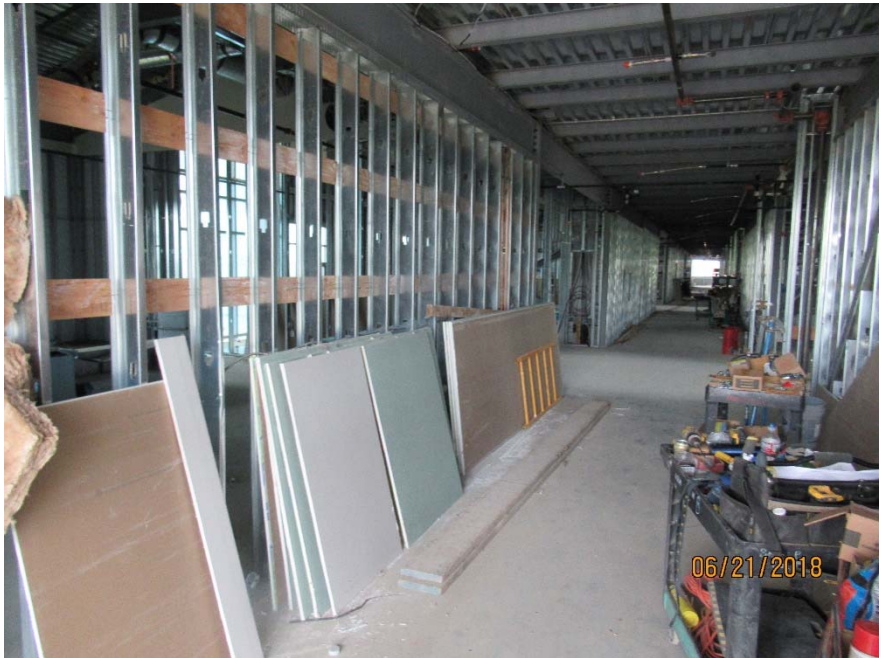
8. Appears the contractor has staged wallboard and will be installing in the next week.

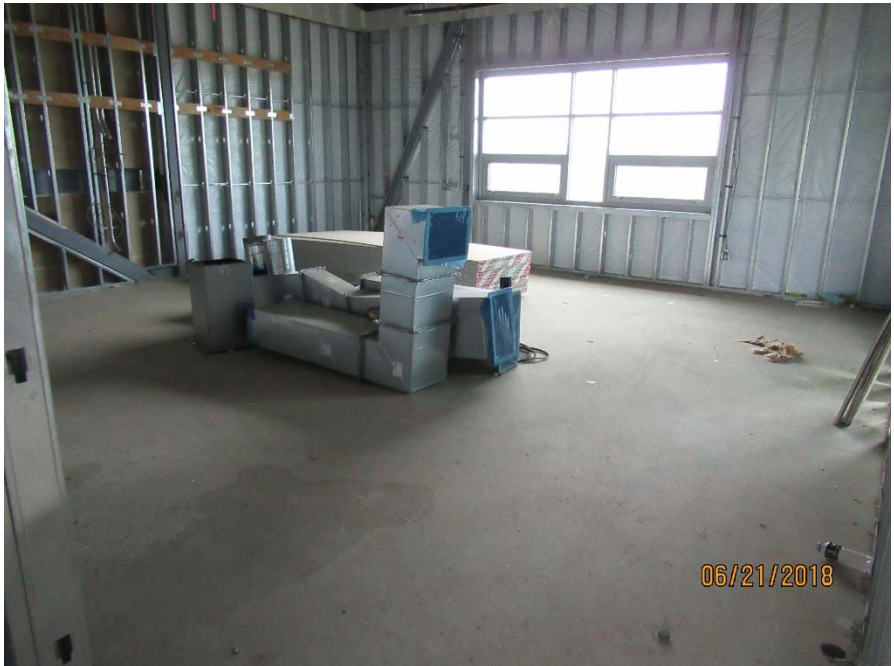
9. Ductwork and wallboard staged in classrooms in Area A upper floor.

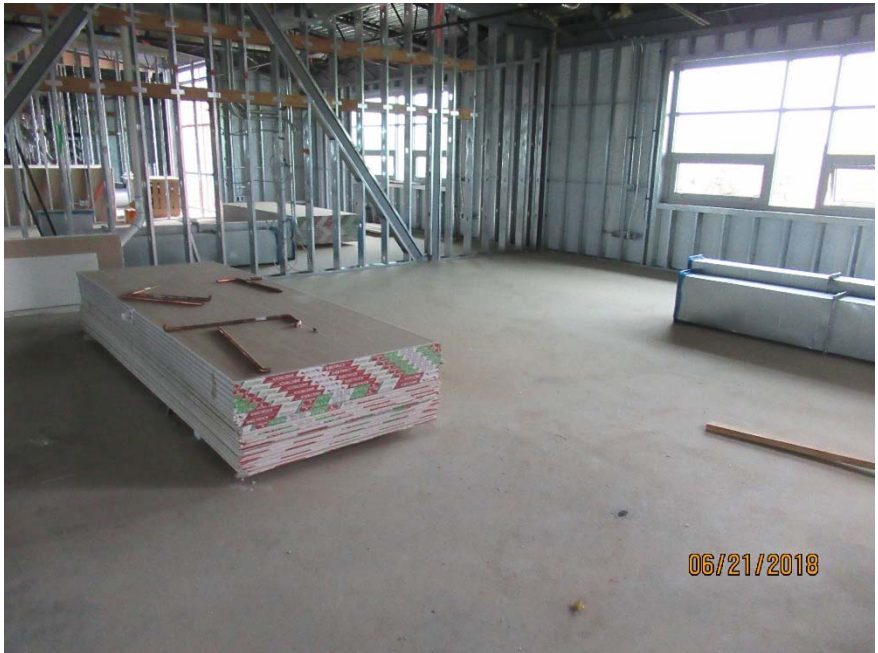
10. Ductwork and wallboard staged in classrooms in Area A upper floor.

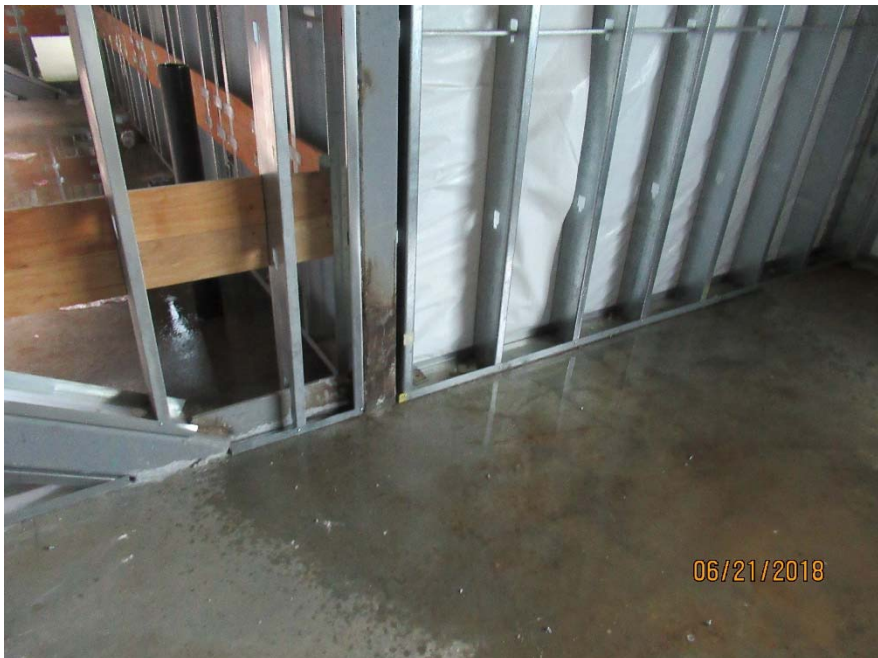
11. There are a number of roof leaks where the wind driven rain gets under the ice and water shield.
