**Project: PSD: Kamiak Elementary School****Date: June 27, 2019****Weather conditions:**

Discussion with: See Construction Progress Meeting minutes dated 6/27/19.**Construction Activities:**

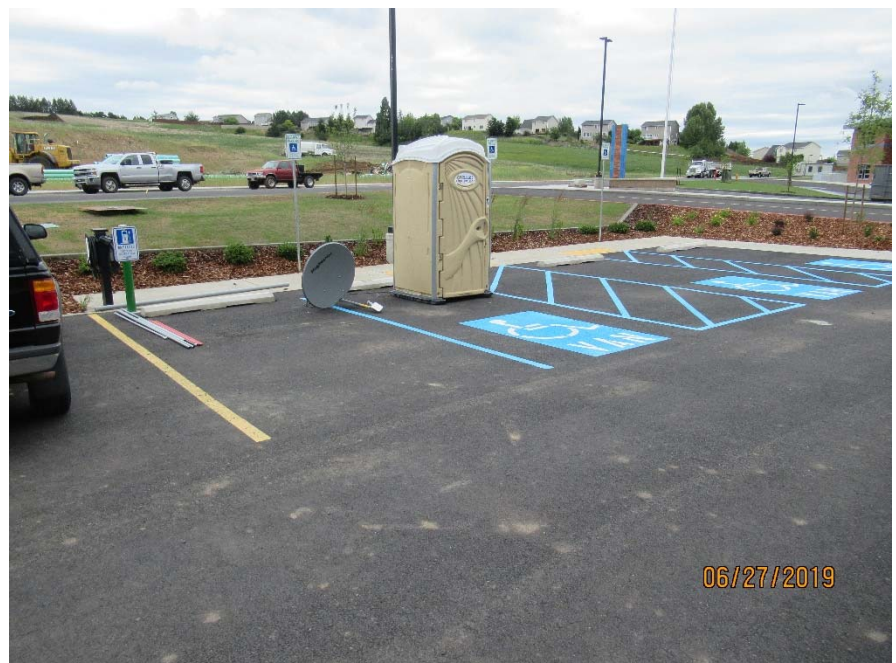
1. The ADA parking slots need to be changed to align with the design documents.

Deficiencies: Appears there is an ADA parking stripping mistake. Contractor needs to finish up inside the building and finish site work.

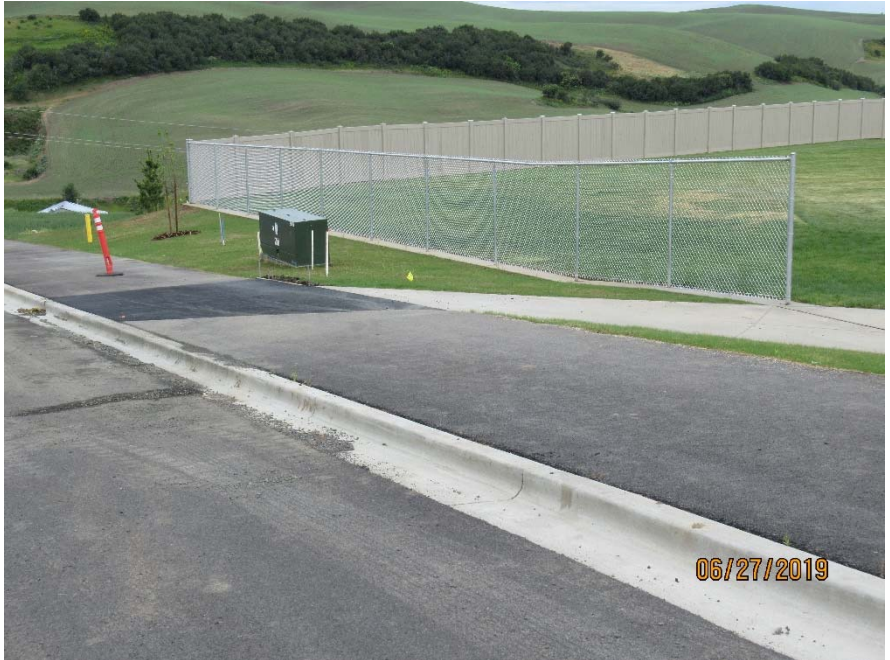
2. It appears the fence contractor has finished the installation of the southwest chain link fence.

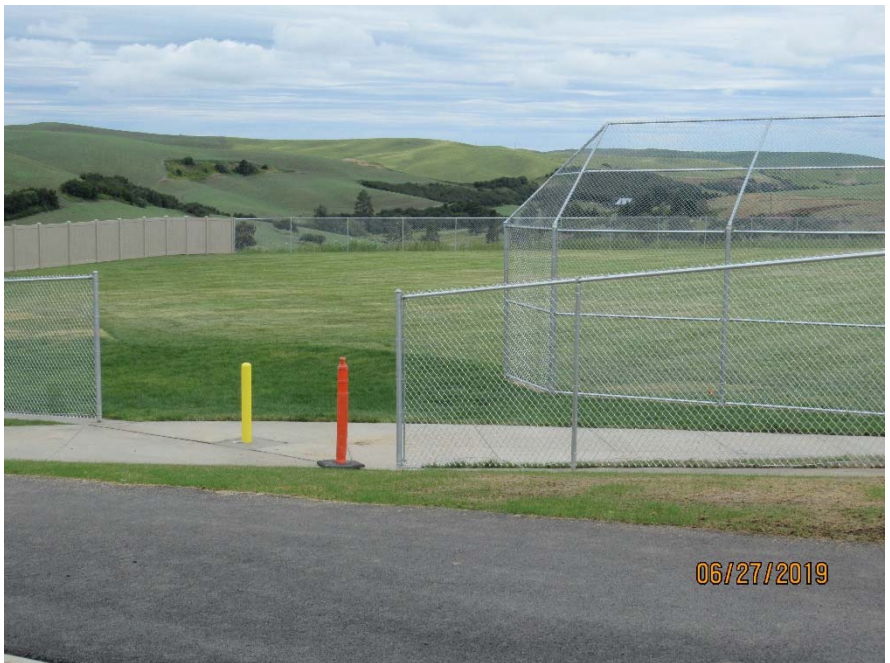
3. It appears the fence contractor has finished the backstop.

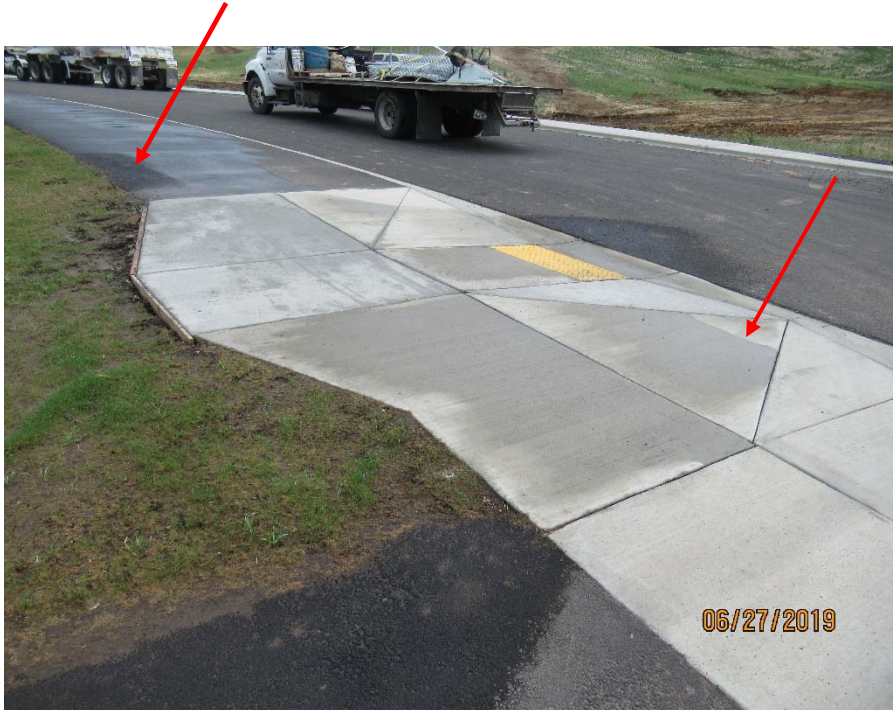
4. The contractor has replaced the portions of the sidewalk that were damaged and removed during construction. With the exception of one piece that was damaged but not removed. The arrow is pointing to a piece of sidewalk that has been cracked for months.

See below photo 11 concerning the arrow pointing to the asphalt path.

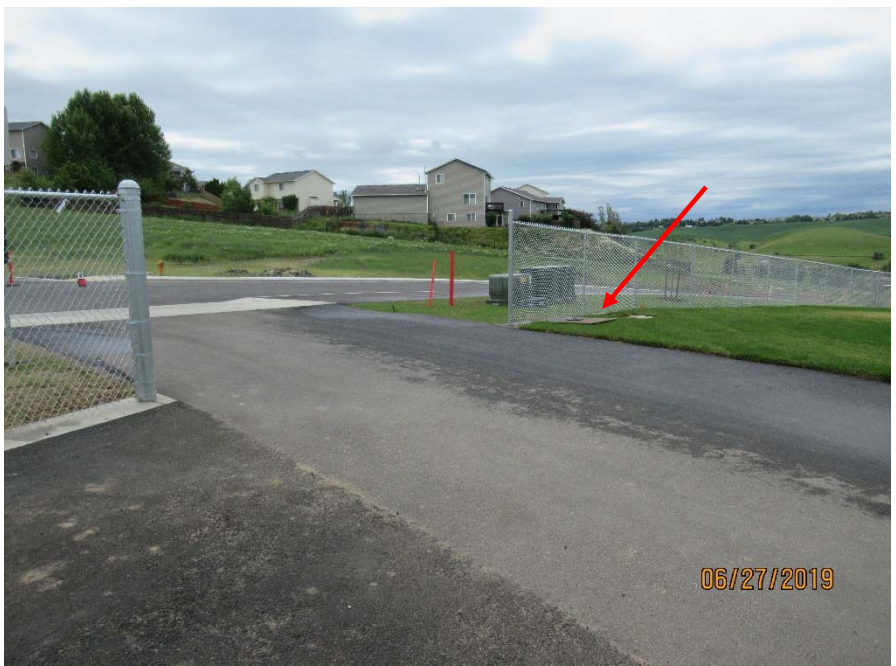
5. The contractor needs to install this gate.

The arrow is pointing to a diamond plate steel cover over the irrigation water meter. See photo 6 below

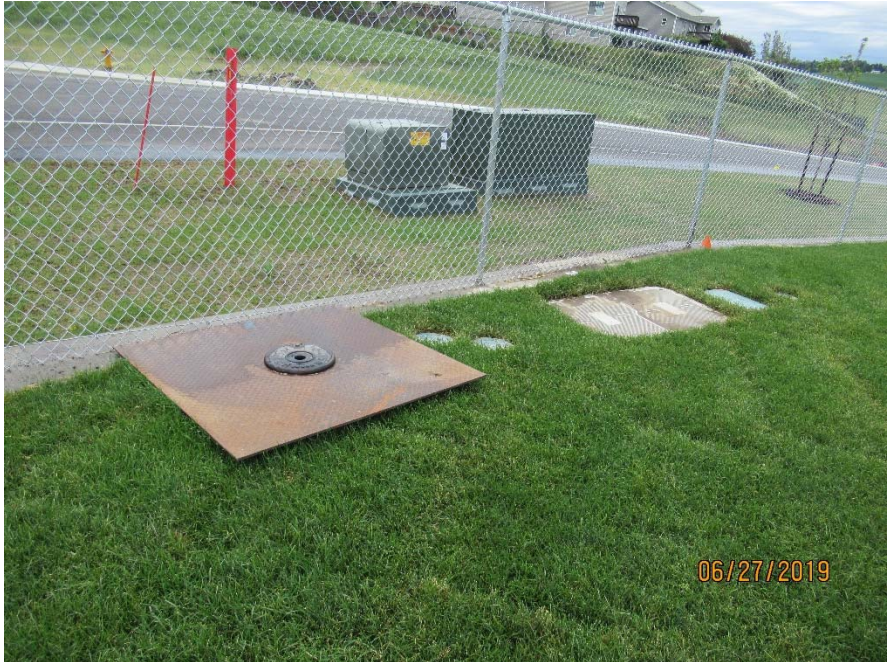
6. This is the Irrigation water meter cover. This is either temporary, or at the very least too high. In its current state it is a safety hazard inside the Kindergarten play area. I have notified the contractor.

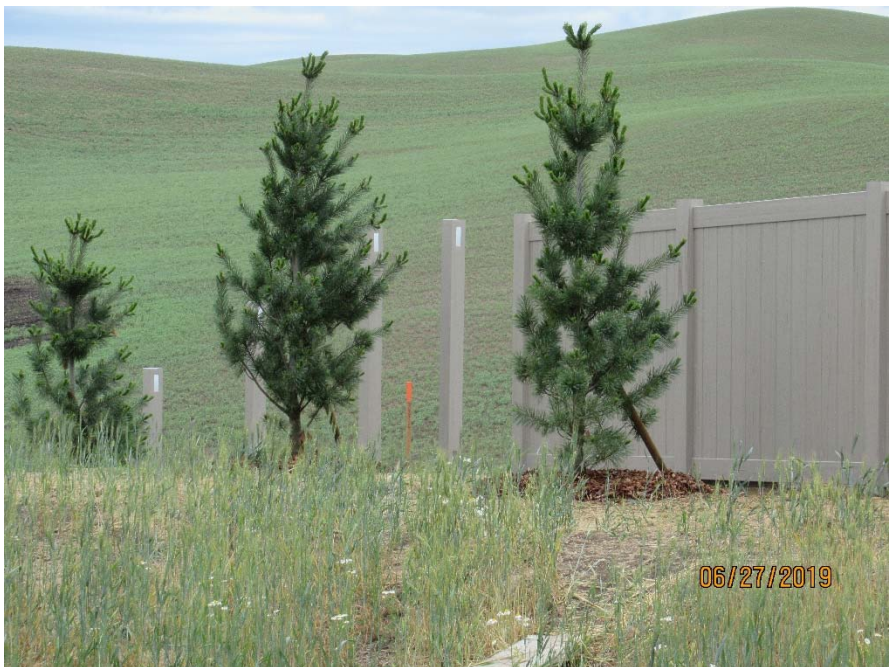
7. The fence contractor has not yet finished the north vinyl fence.

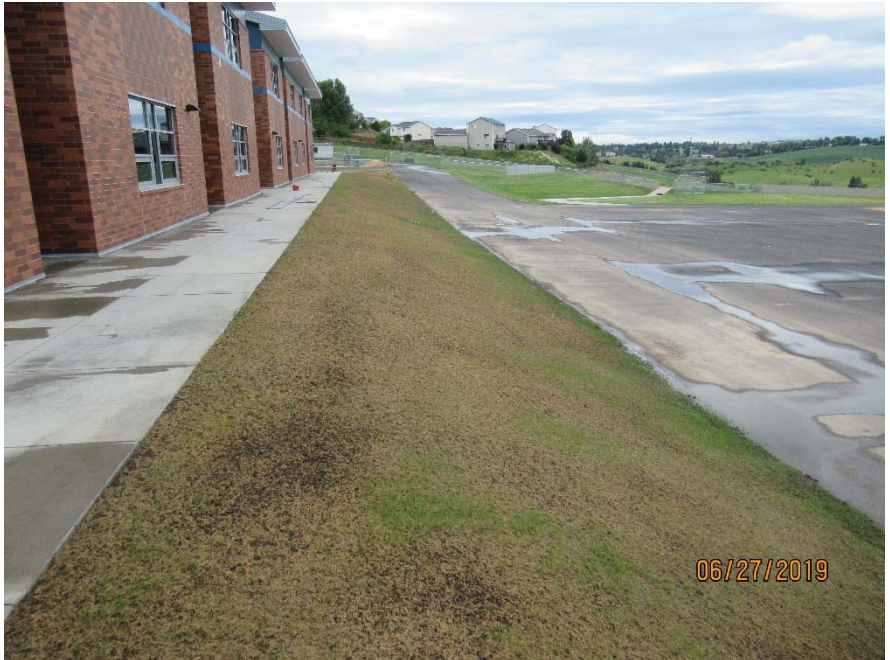
8. It appears the hydroseeded grass area are growing well.

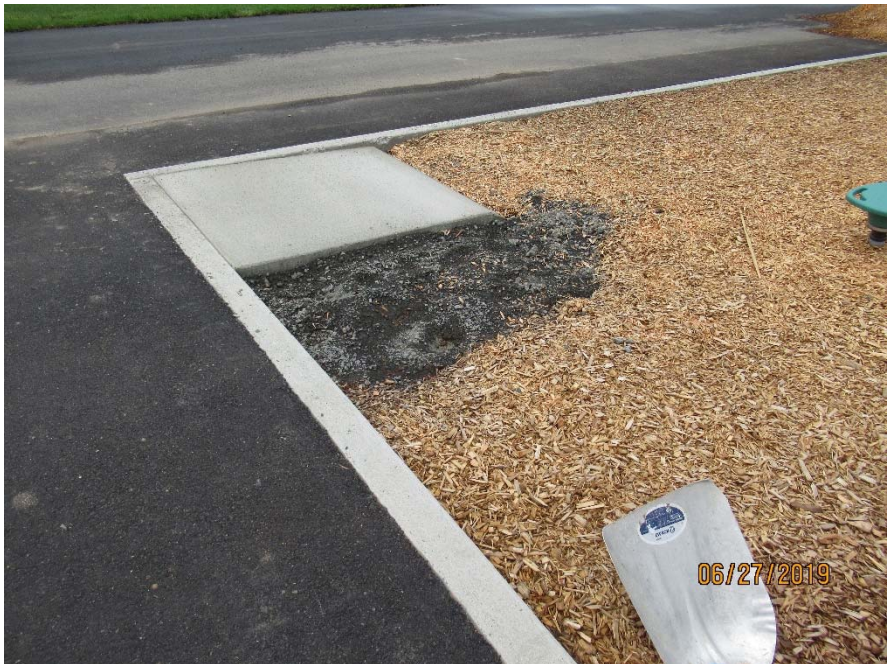
9. The contractor has installed the ADA ramp for both soft fall playground areas.

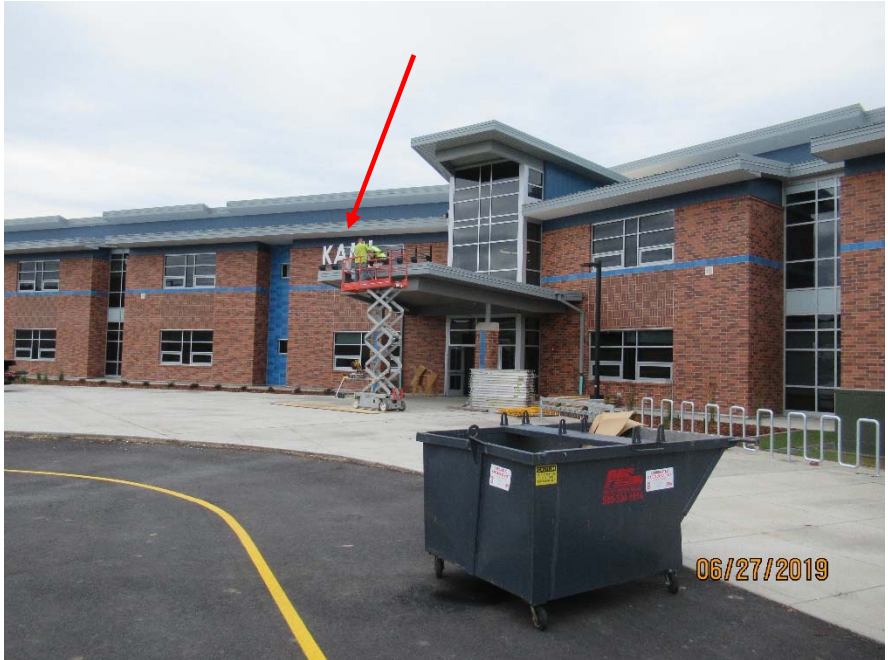
- 10. Contractor has received the building lettering and is currently installing.**

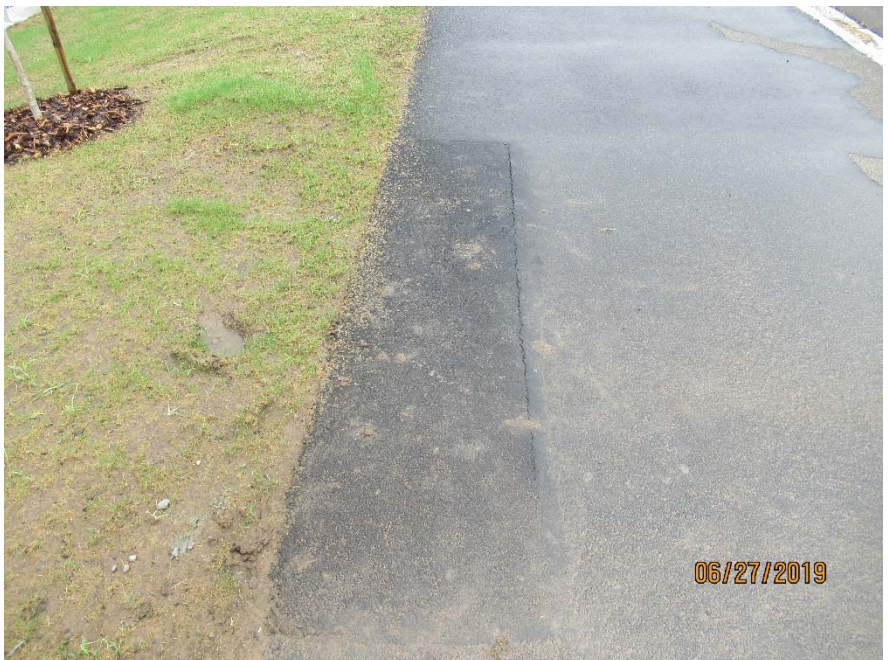
- 11. This asphalt repair was installed last season. It has been pulling away from the rest of the asphalt path since its installation. The contractor has been notified the fix needs to be fixed.**

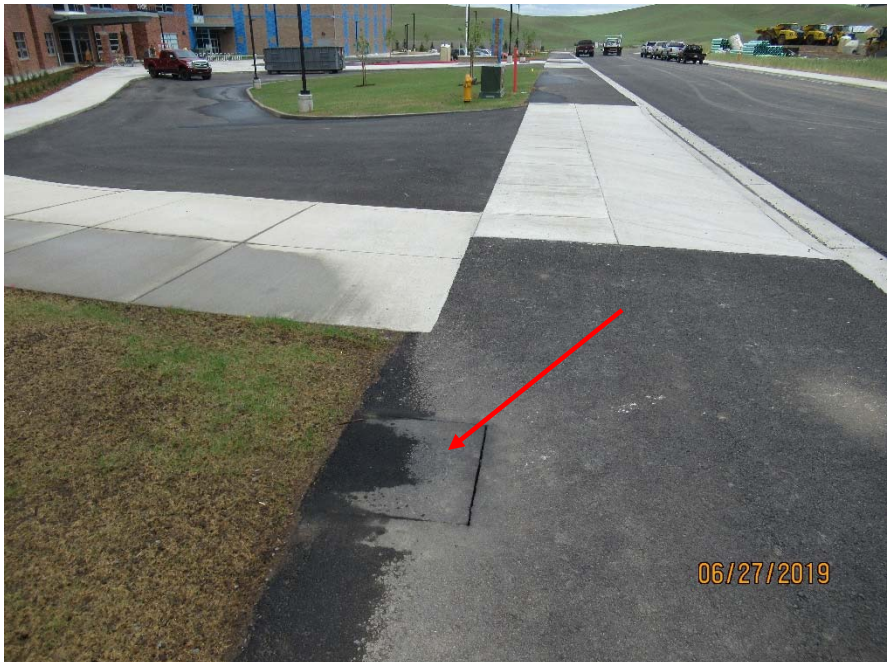
12. This asphalt repair was installed last season. It has been pulling away from the rest of the asphalt path since its installation. The contractor has been notified the fix needs to be fixed.

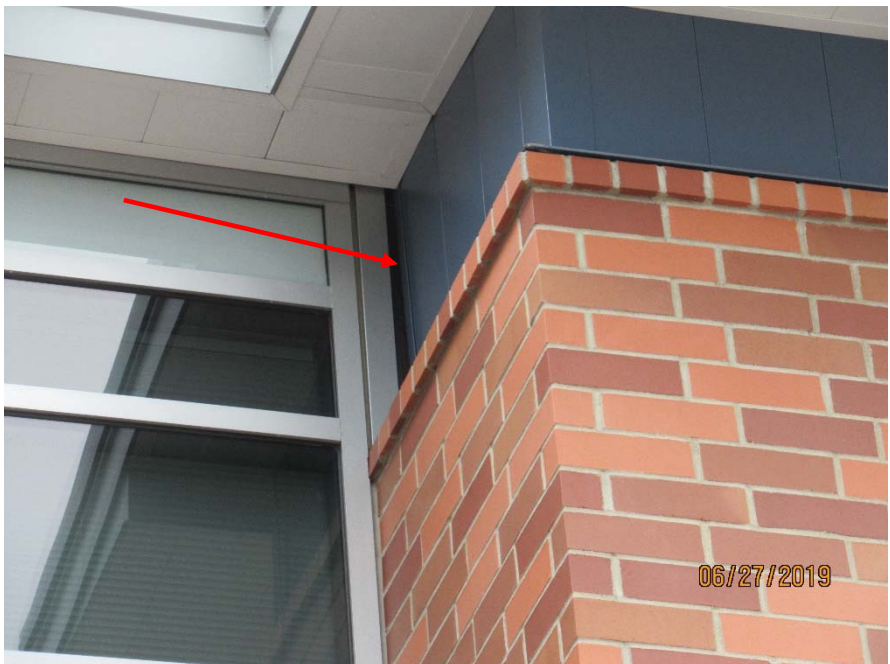
13. The contractor has been notified this area needs to be trimmed out correctly. I am uncertain what the black is, but it does not appear to be sealed properly against weather intrusion.

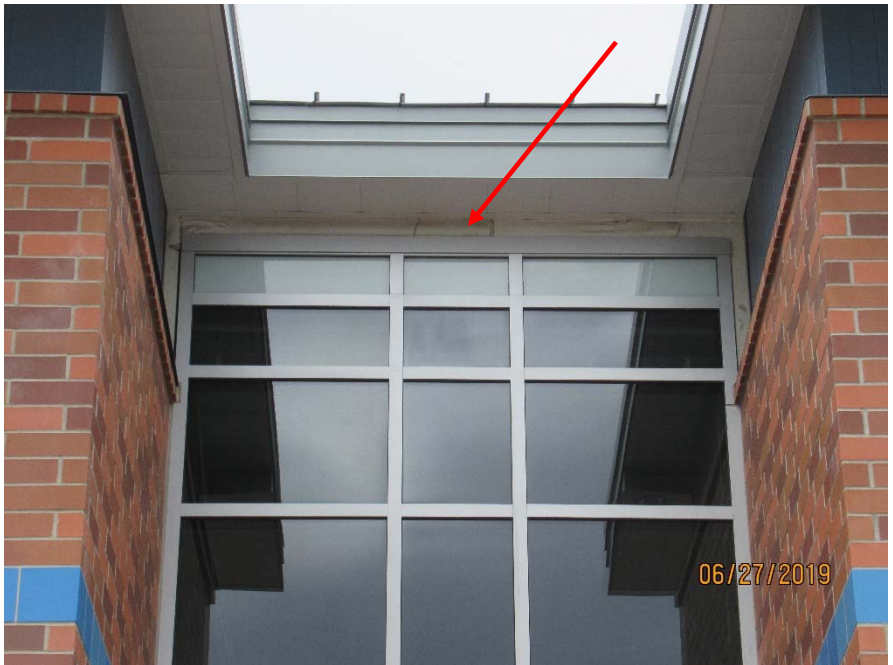
- 14. The contractor has been notified months ago and again today this area needs to be trimmed out correctly. I am uncertain what the white material, it appears to maybe roof membrane. This does not appear to be sealed properly against weather intrusion.**

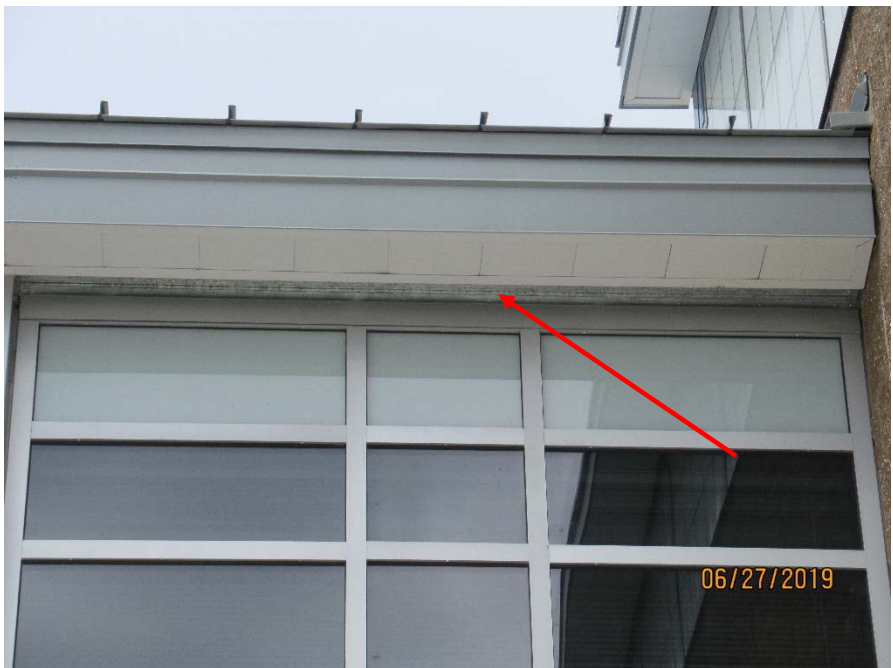
- 15. The contractor has been notified months ago and again today this area needs to be trimmed out correctly. It appears the silver is framing material. This does not appear to be sealed properly against weather intrusion.**

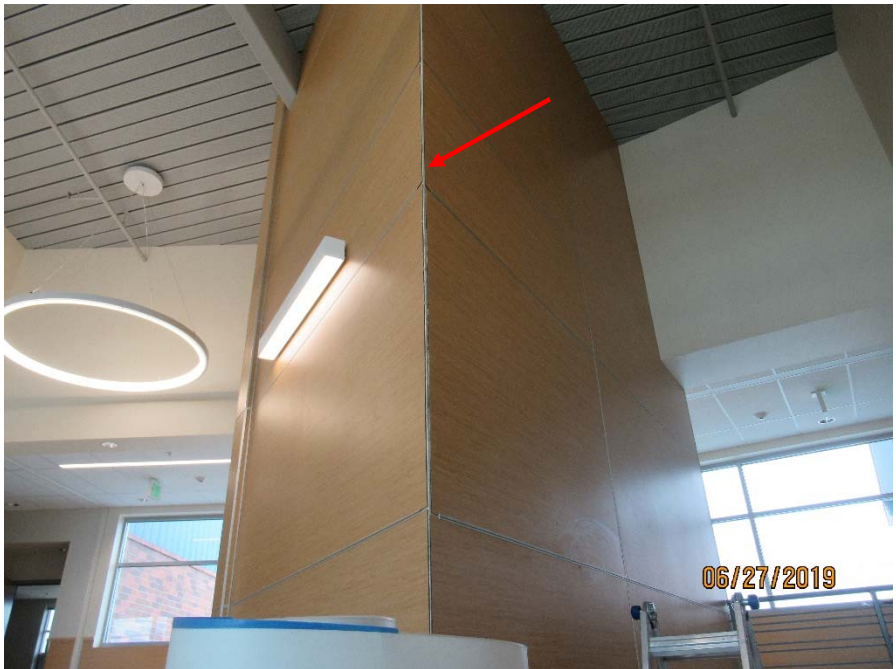
16. With the exception of the acute angle corner, arrow, it appears the FRP paneling has been installed at the main entrance stair well.

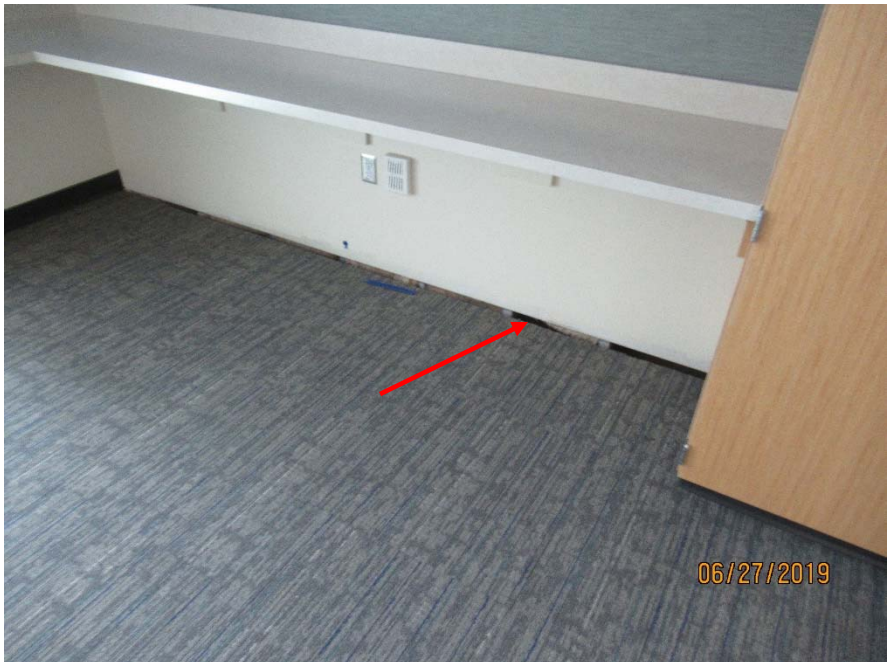
17. Although the contractor has accepted delivery of most of the aluminum angles to be installed at the window frames at the Breakout spaces. This was forgotten, I mentioned to contractor and was informed it is being made now and will be installed once it arrives on site. The blue tape denotes this issue is on the Punch List.

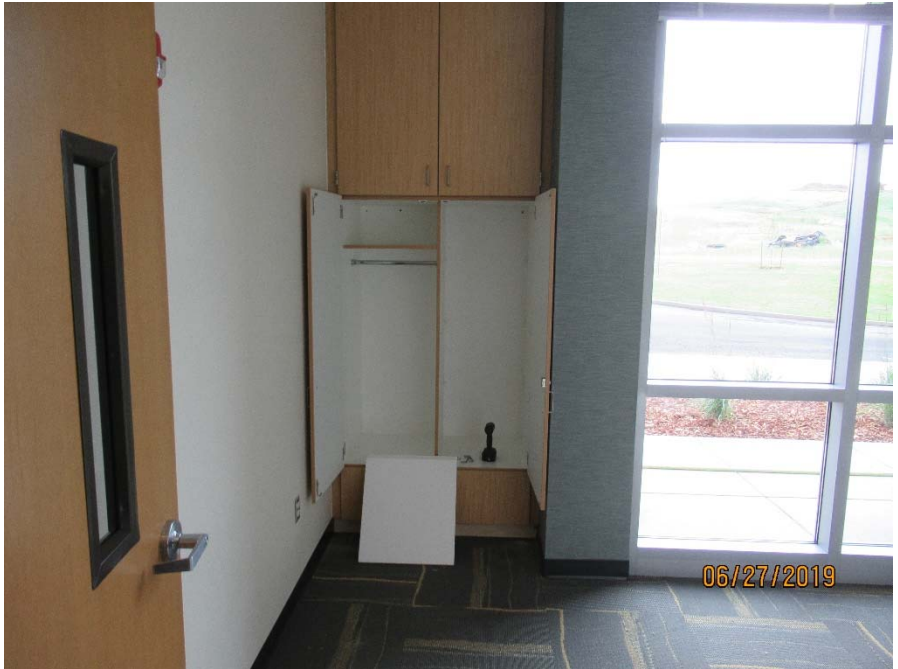
18. The contractor is installing the tall cabinet in room 118J.
