**Project: PSD: Kamiak Elementary School****Date: June 28, 2018****Weather conditions:**

Discussion with: See Construction Progress Meeting dated 6/28/18.**Construction Activities:**

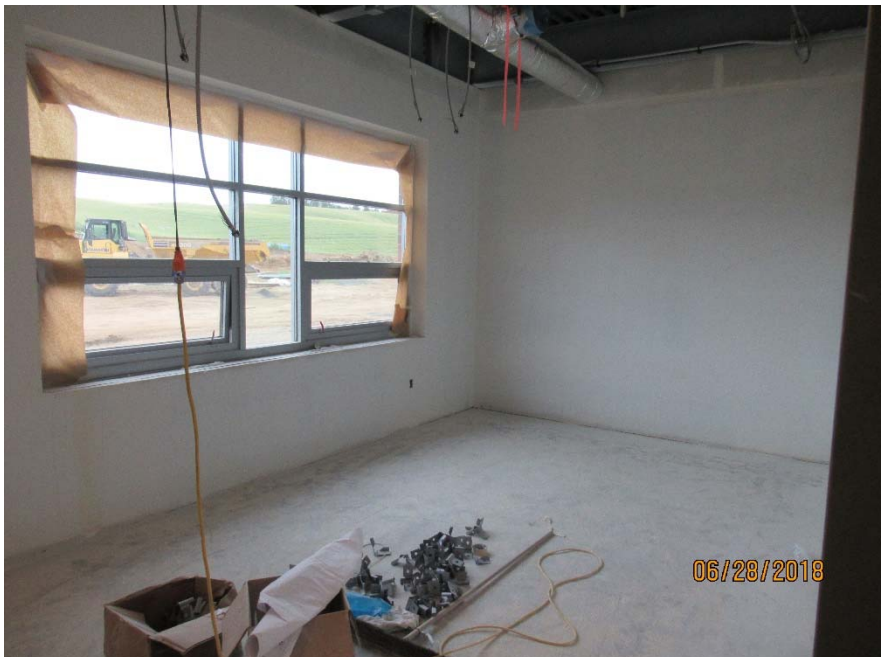
1. This is Administrative Conference Room 118G. Appears contractor has finished taping wallboard and has applied primer.

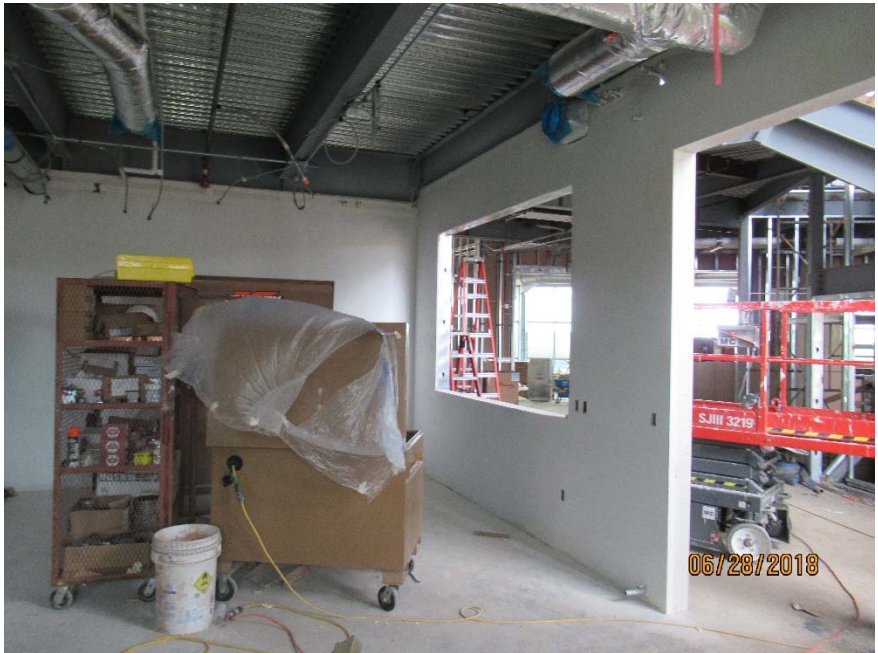
2. This is Reception Room 118 looking at what will be aluminum storefront window to the left and the Reception entry to the right. Appears contractor has finished taping wallboard and has applied primer.

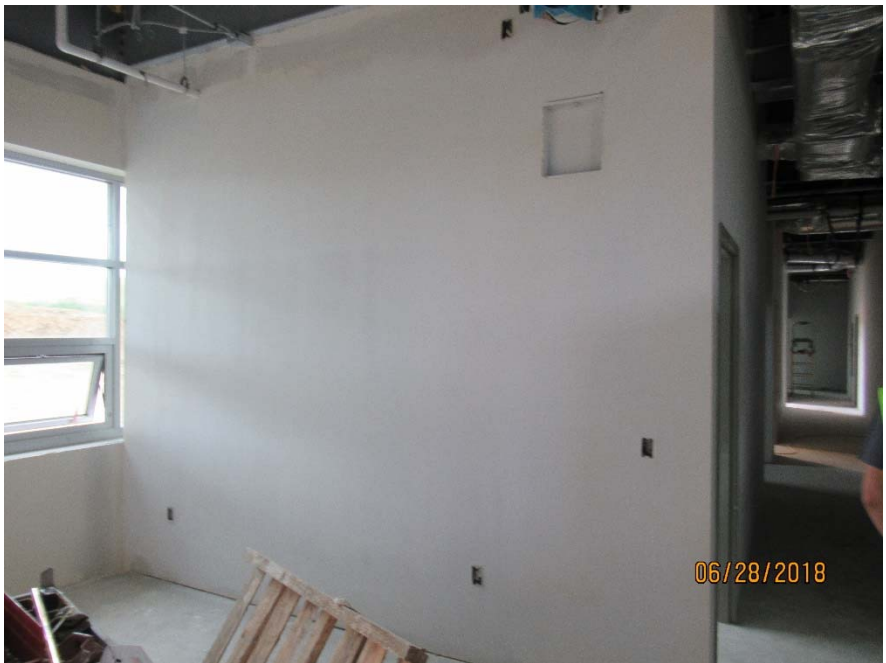
3. This is Reception Room 118 to the right of the photo is looking down Corridor 118A.

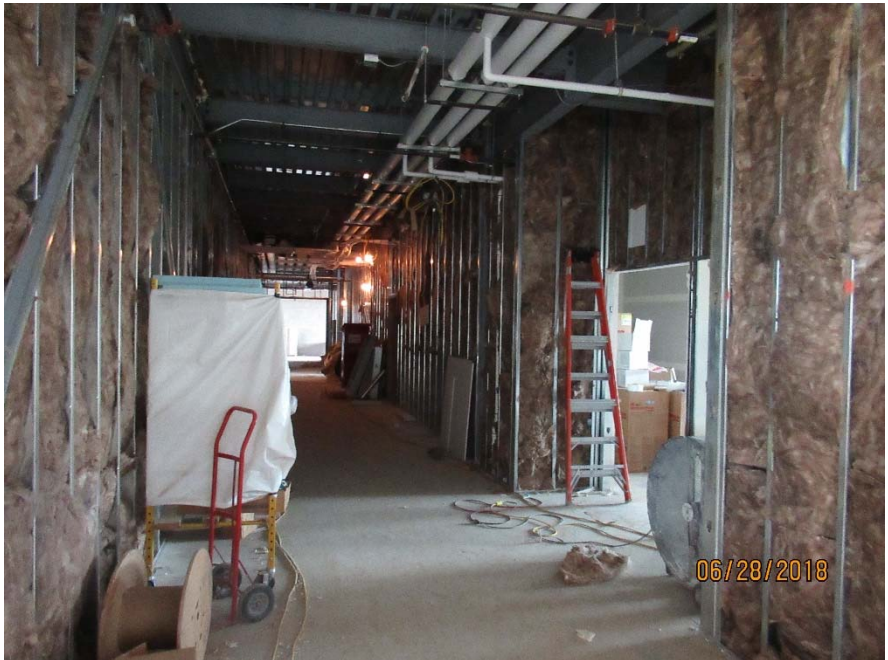
- 4. Area B lower level sound batt insulation installation under way.**

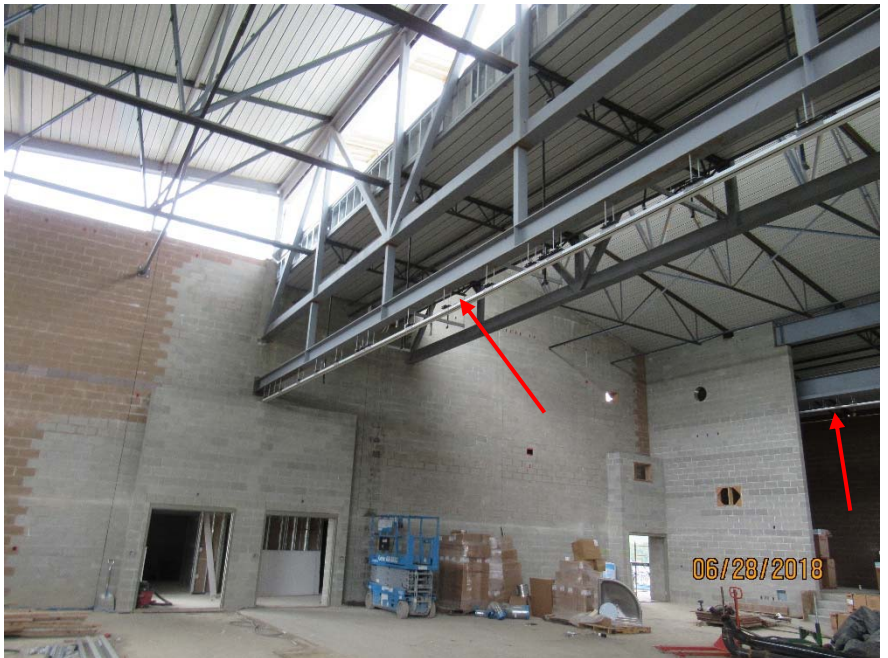
- 5. Although difficult to see the tracks for the Gymnasium/Multi-Purpose folding partition wall as well as the Multi/Purpose/Stage folding partition wall have been installed.**

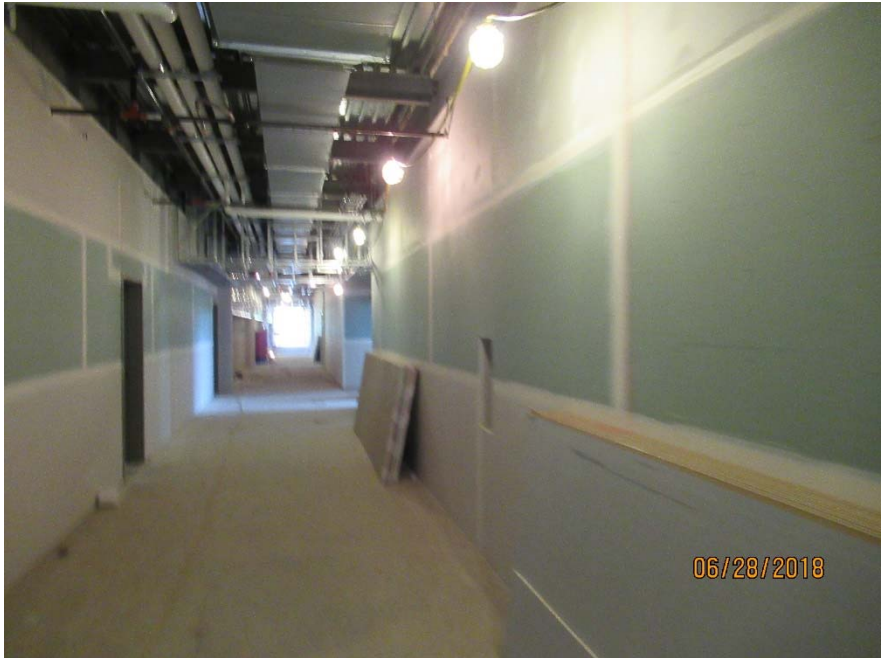
- 6. Area A lower level: It appears the wallboard has all been installed with the exception of at the hallway soffits and above the lockers.**

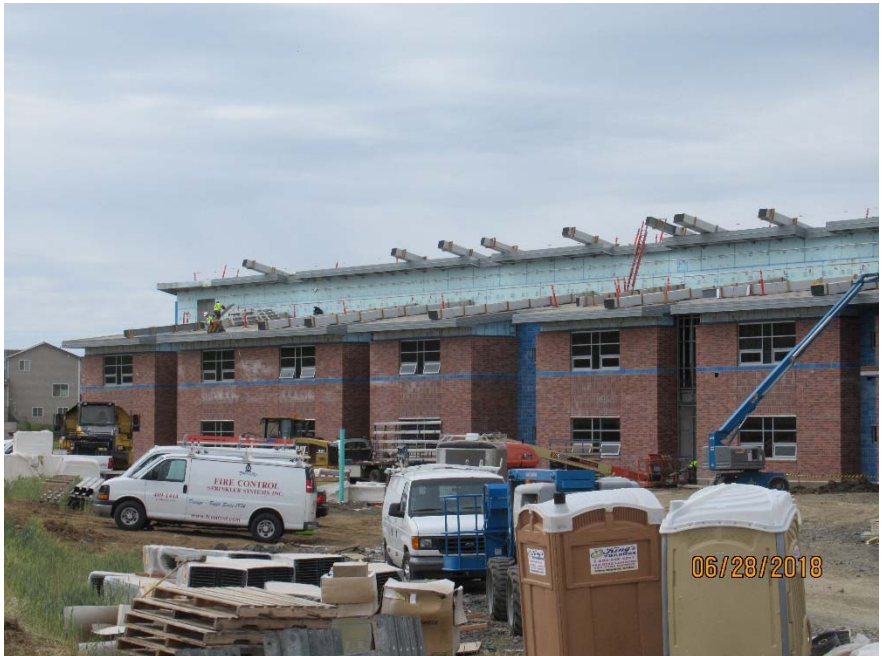
- 7. Appears the roofers have loaded the roof with metal roofing.**

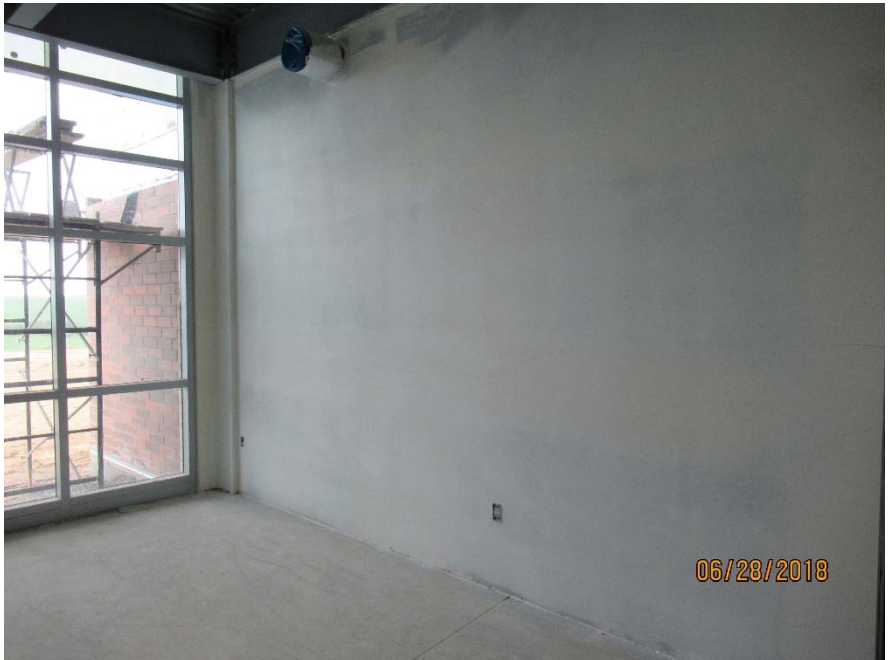
- 8. Appears portions of Area A walls have been prime painted.**

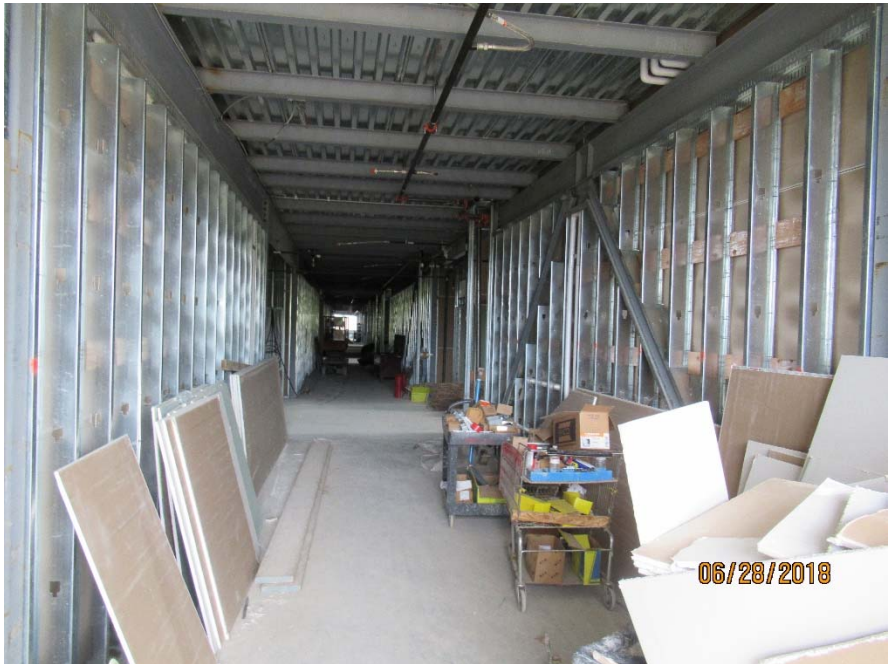
- 9. Area A upper floor some rooms are wall boarded.**

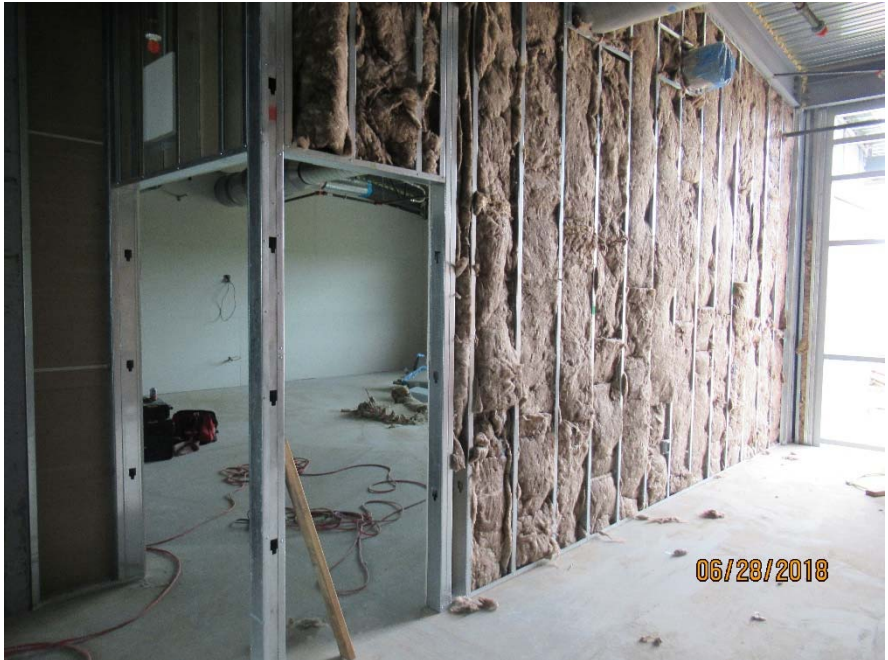
- 10. Area A upper floor southern area some rooms are wall boarded and ductwork installed. Sound batt insulation installation underway.**

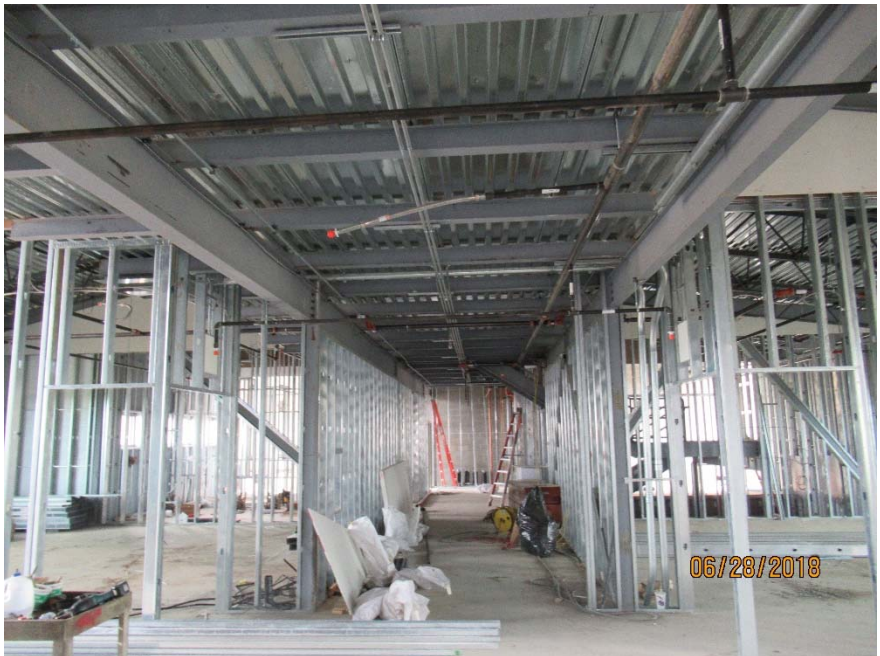
- 11. Area B upper level. It appears much of the wall framing has been completed. Appears much of the fire sprinkler piping has also been installed.**

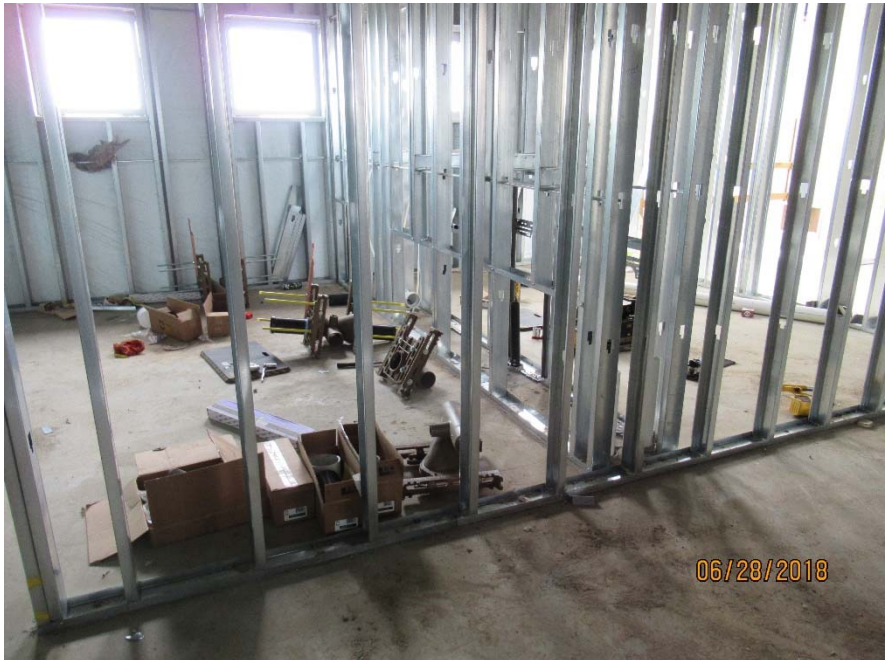
- 12. Area B upper level Gang restrooms 239 and 241 toilet carriers are staged but not yet set.**

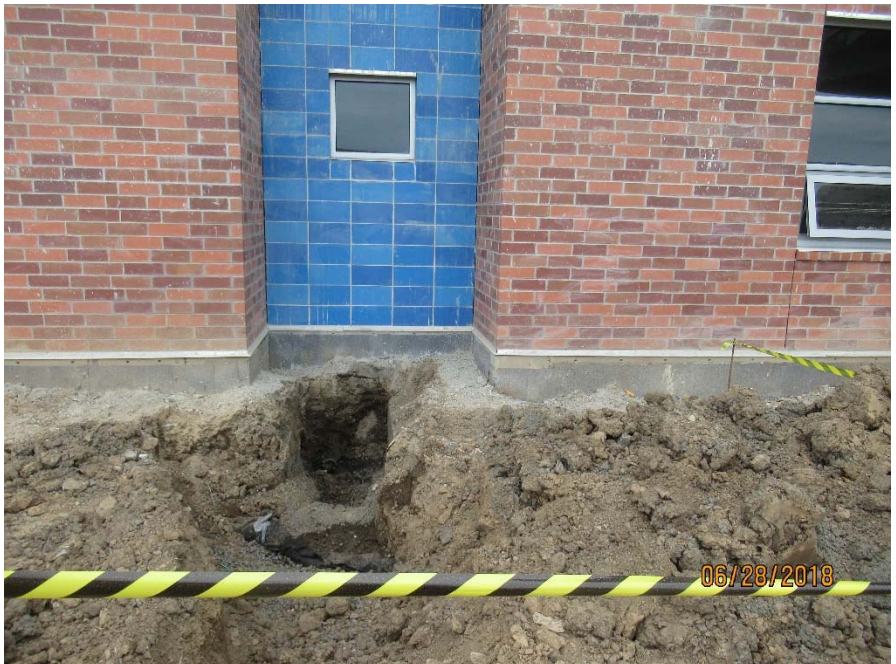
- 13. Appears the contractor has day lighted utility pipe.**

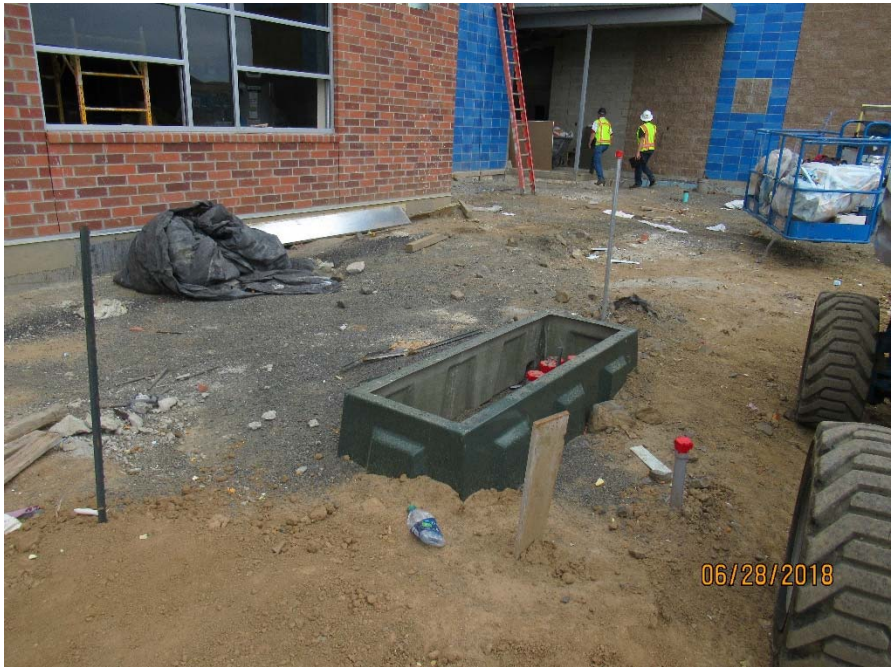
- 14. Appears the contractor has installed the box where the transformer pad will be placed.**

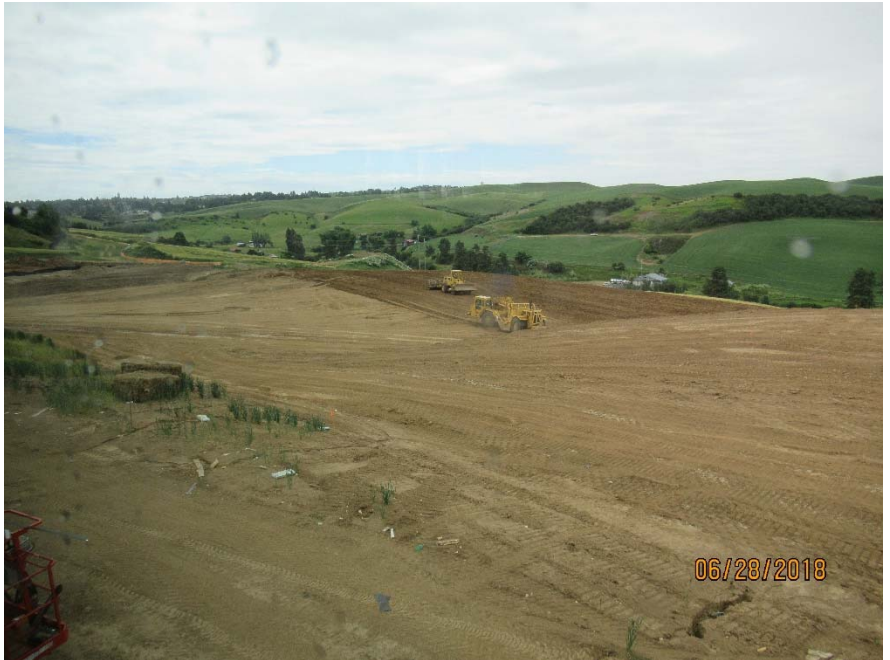
- 15. Mader continues placement of dirt at southern (lower) playfield. We have approximately 9 feet to go to get to proper subgrade elevation.**

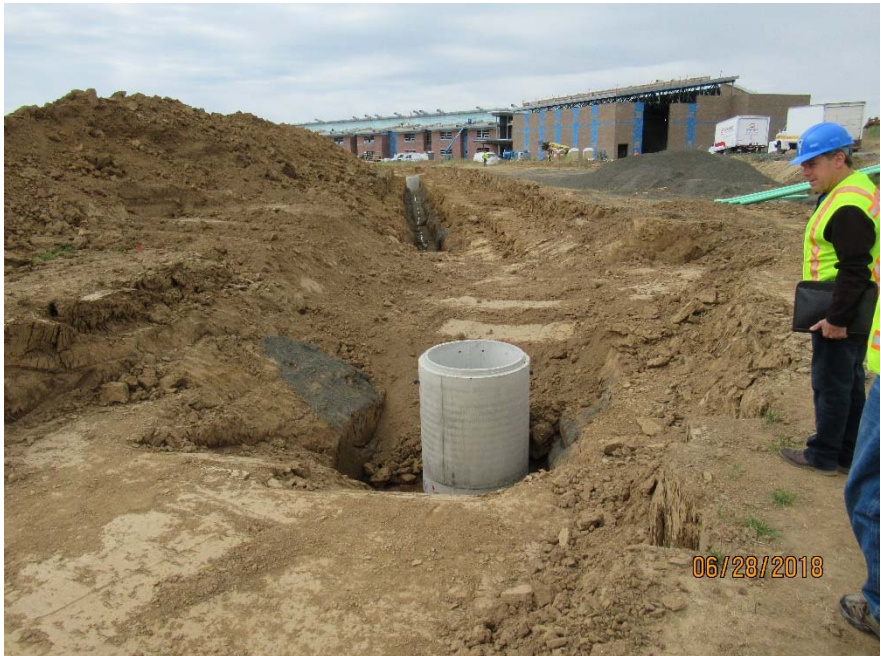
16. It appears Debco has begun placement Man Holes in what will be Terre View Drive.

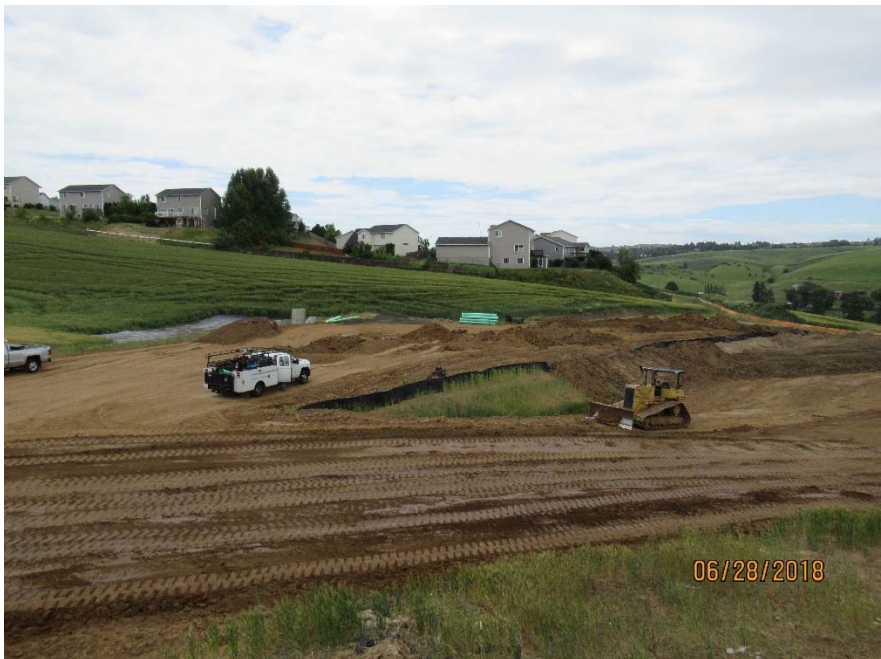
17. It appears Debco has begun placement Man Holes in what will be Terre View Drive.
