**Project: PSD: Kamiak Elementary School****Date: June 6, 2019****Weather conditions:**

**Discussion with:** See Construction Progress Meeting minutes dated 6/6/19.**Construction Activities:**

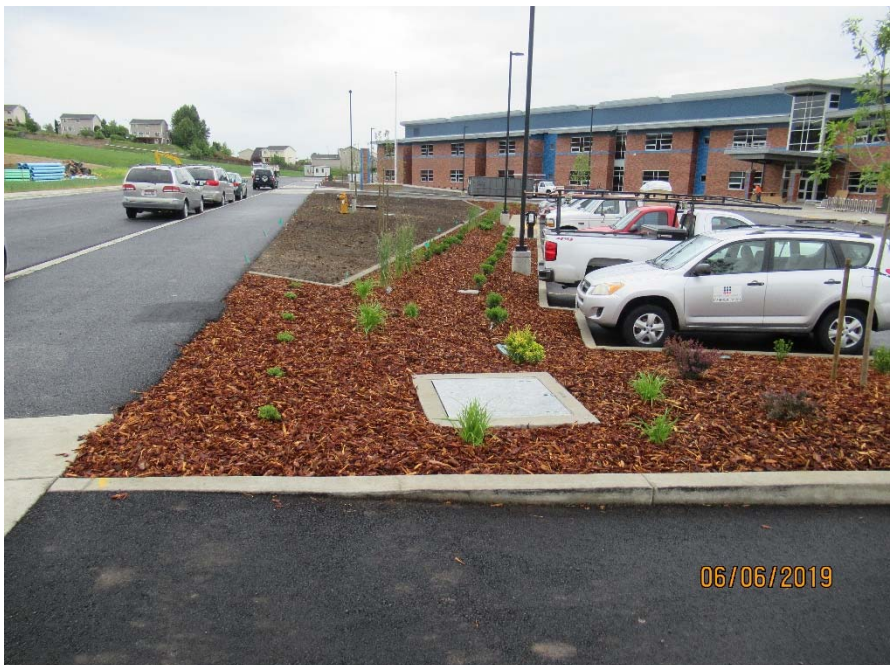
1. Landscaper continues to install plantings, irrigation and bark.

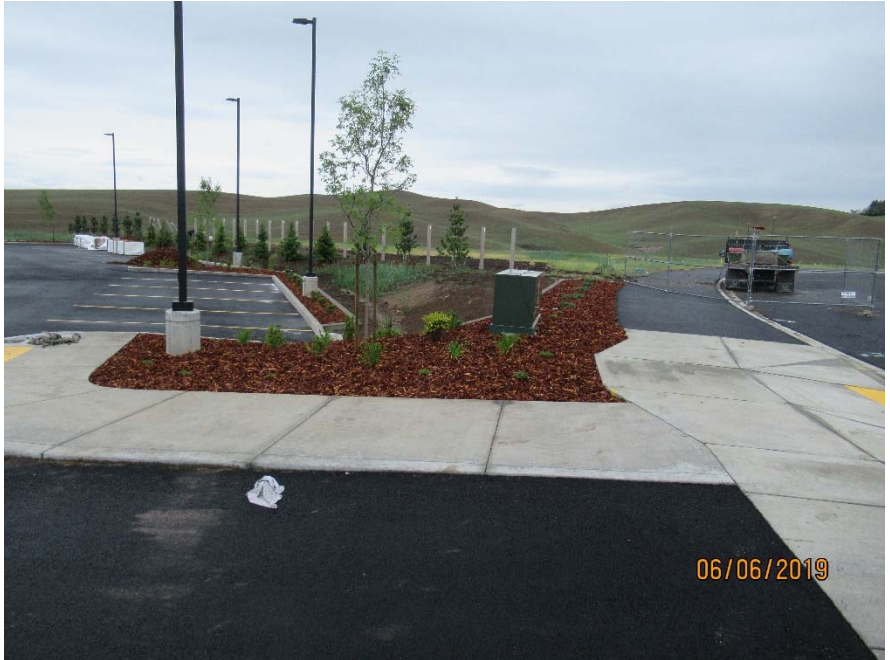
2. **Landscaper continues to install plantings, irrigation and bark.**

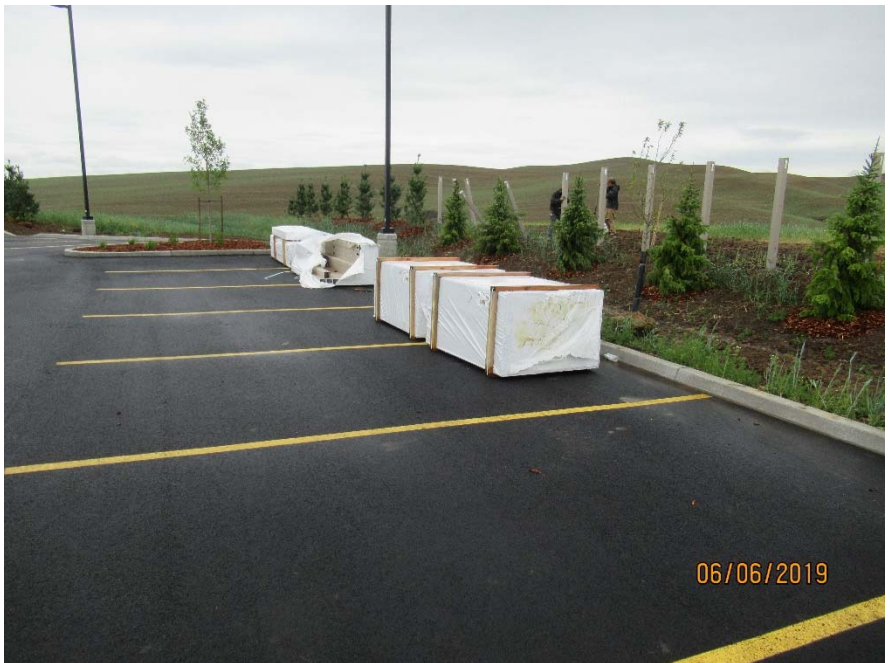
3. **Fence contractor is installing the north property line vinyl fence.**

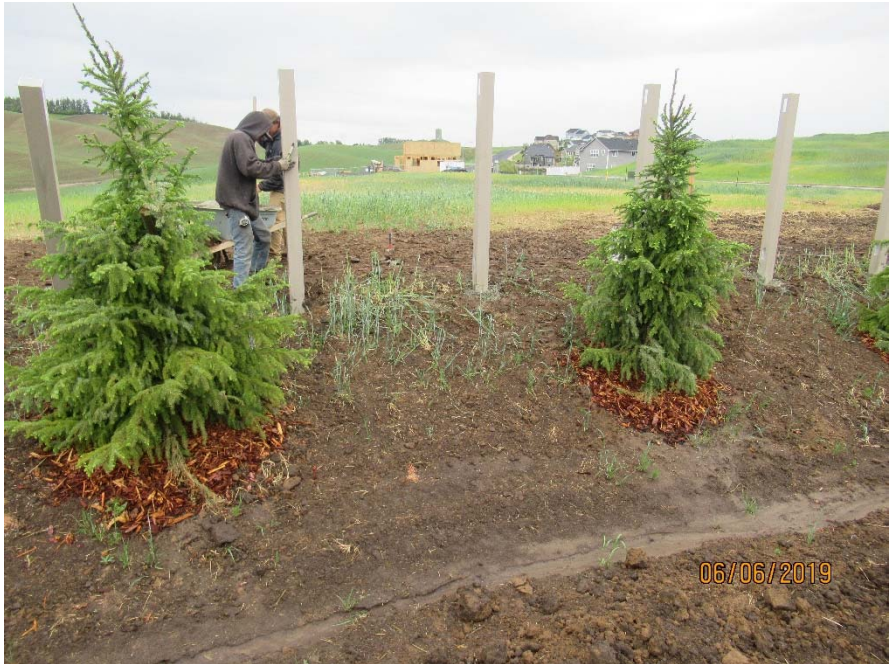
- 4. Fence contractor setting fence posts in concrete.**

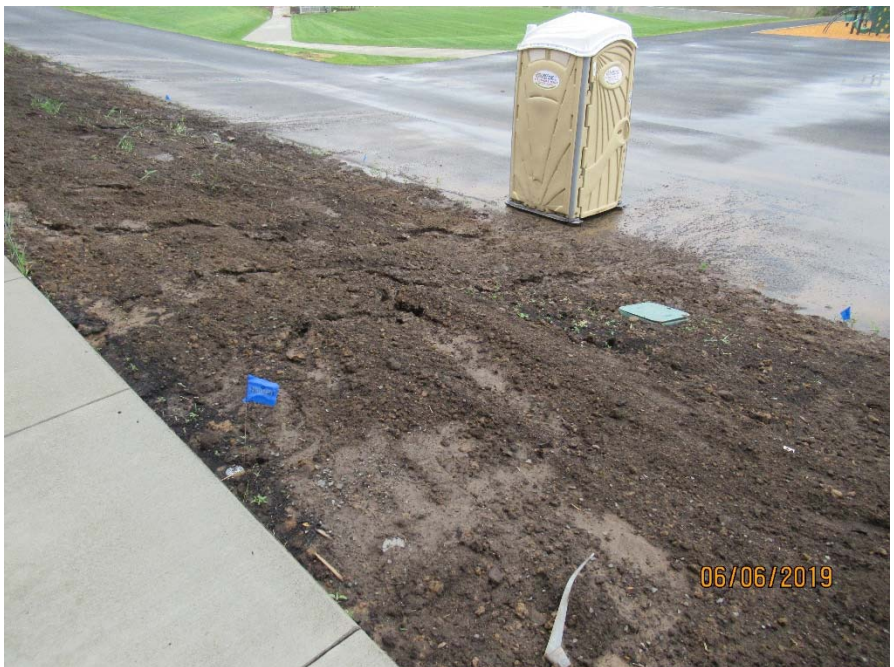
- 5. It appears the last rain event has caused some erosion onto asphalt play area and access road. Landscaper will put soil back in place before hydroseeding.**

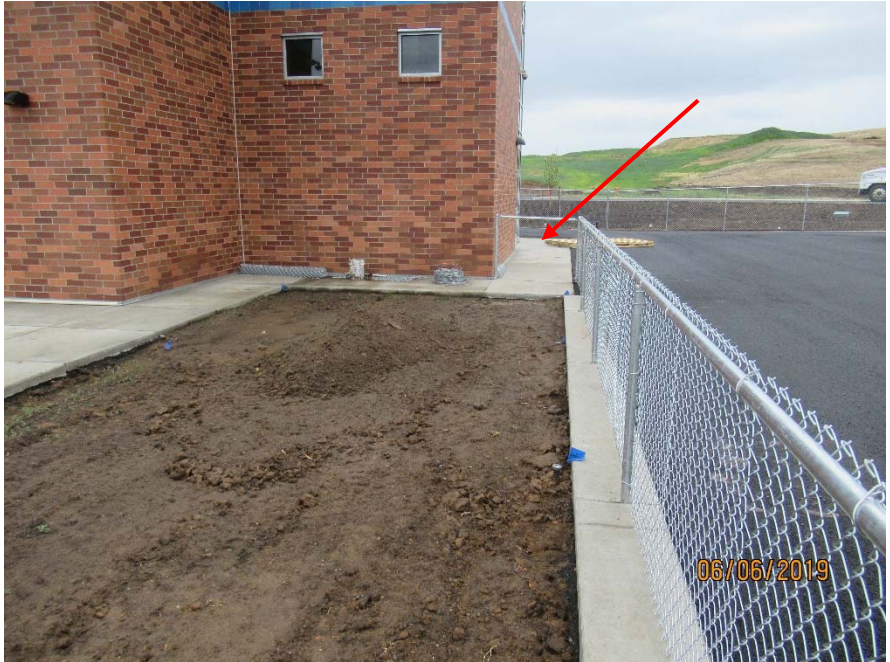
- 6. Fence contractor has placed fence frame for this enclosure fence piece.**

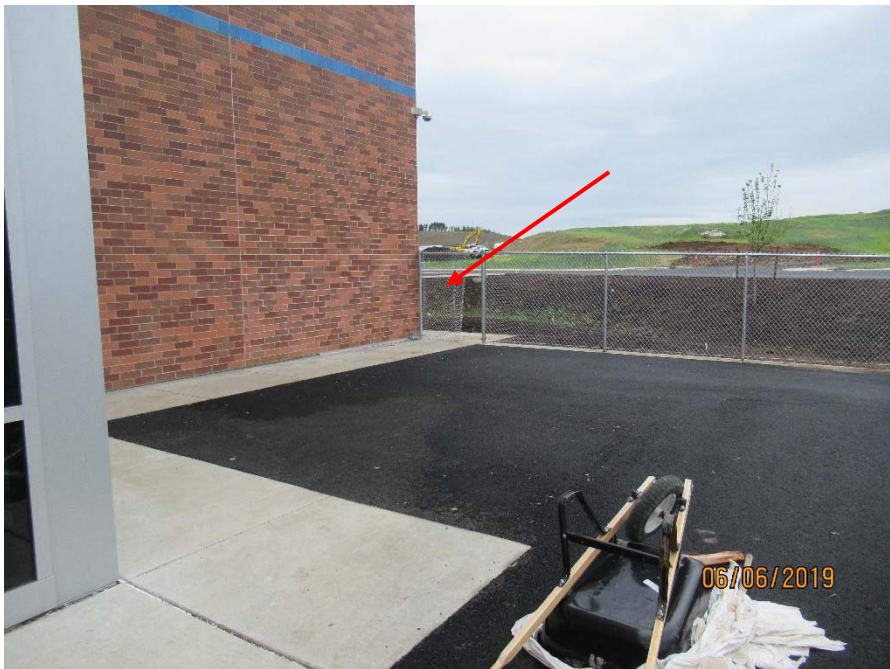
- 7. Fence contractor has placed fence frame and begun stringing fence for this enclosure fence piece.**

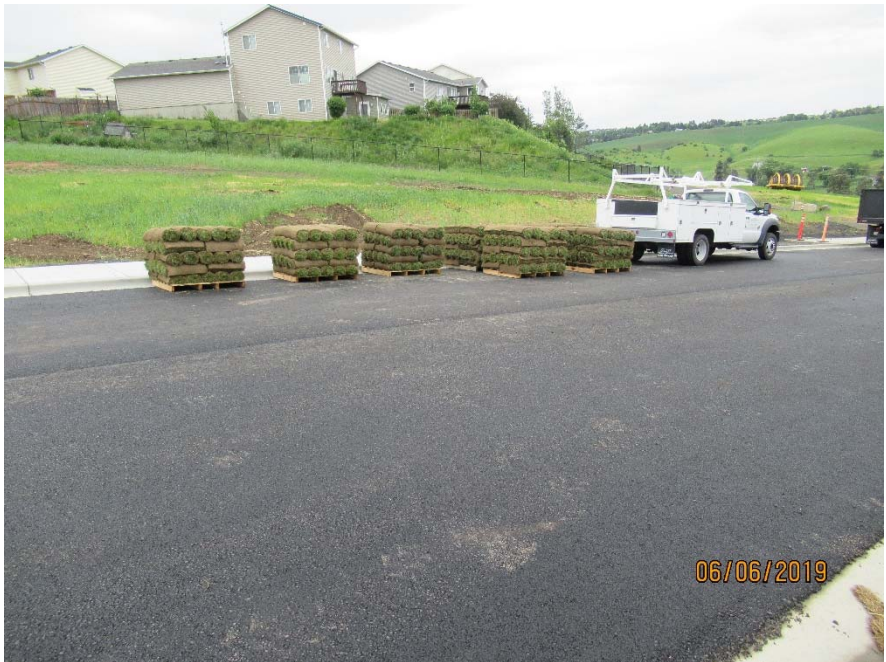
- 8. Landscaper has accepted delivery of sod for the remaining areas that are to receive sod.**

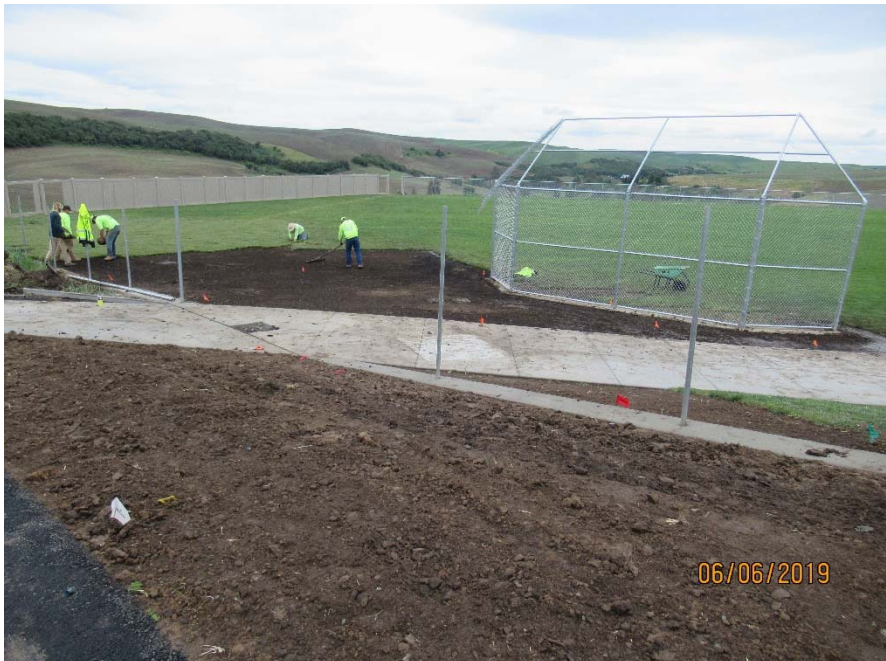
- 9. Landscaper installing sod at lower play field.**

**It appears the fence contractor has framed the top of the back stop. The fabric has not yet been installed.**

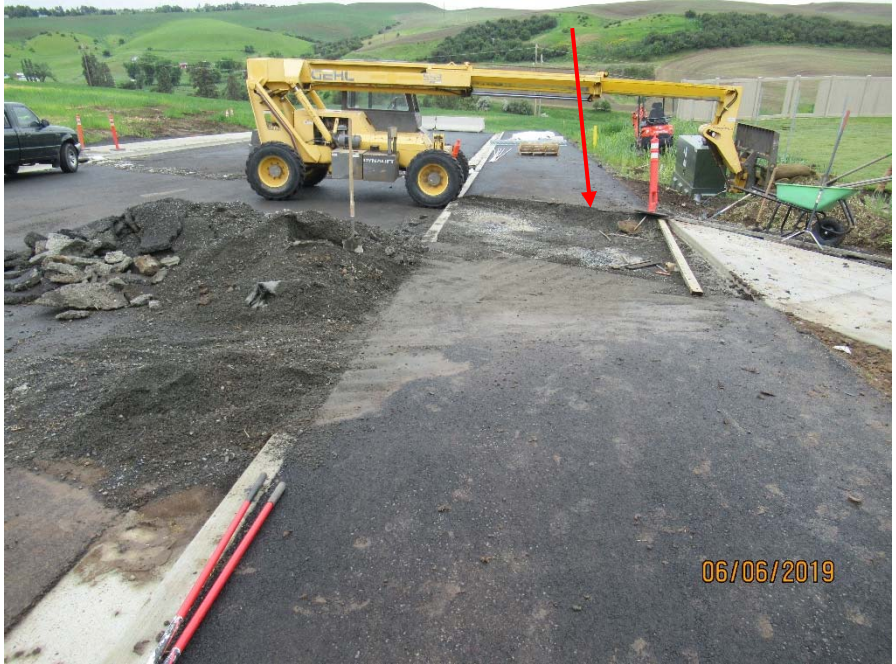
- 10. The contractor that placed the sloped (south) portion of the ADA access walk damaged the asphalt path. They have removed that portion of the asphalt. Upon review I noticed not enough of the asphalt has been removed. I informed the contractor.**

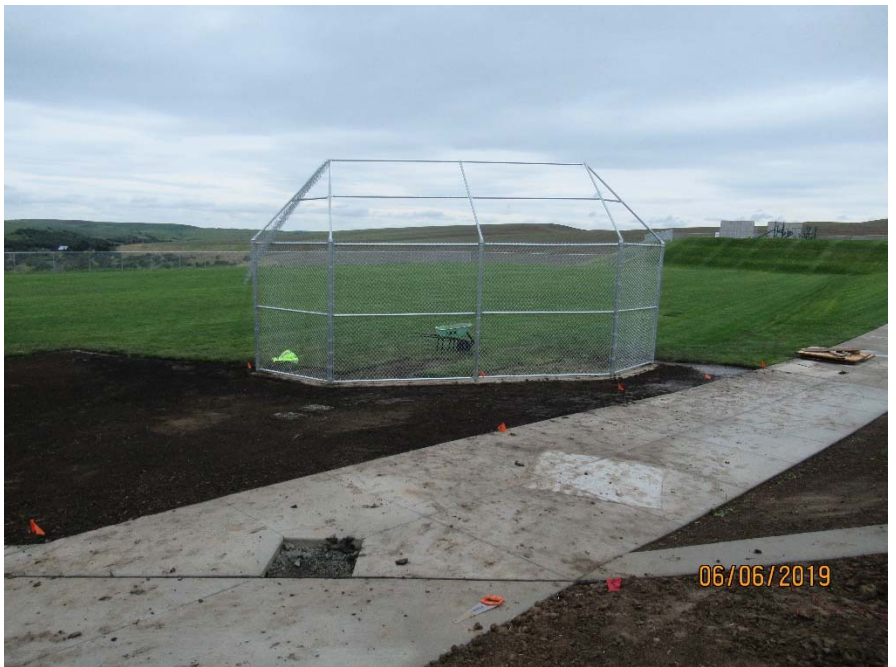
- 11. As mentioned above the sloped (south) portion of ADA access sidewalk has been placed.**

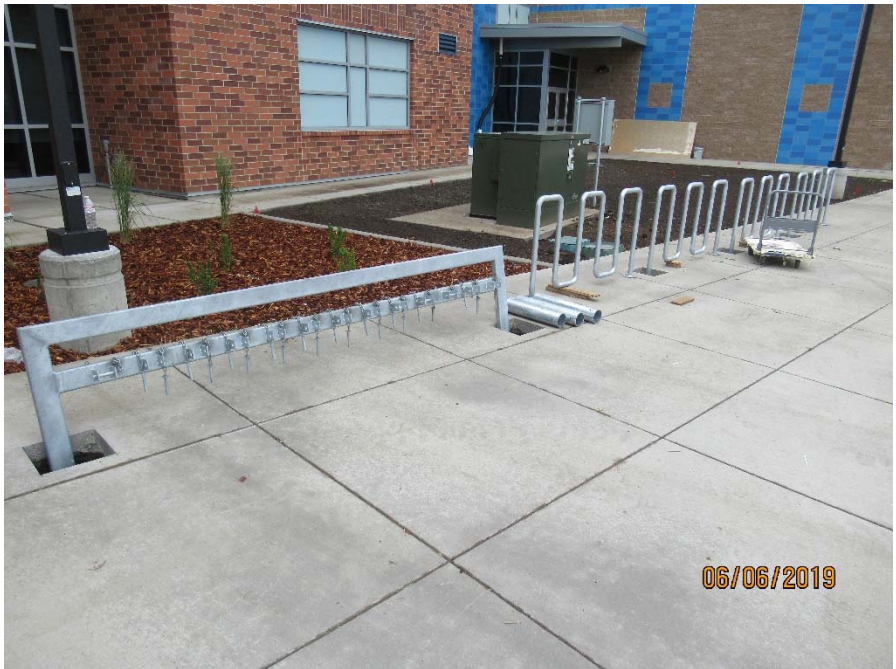
- 12. Contractor has set the bike racks, still need to place the concrete.**

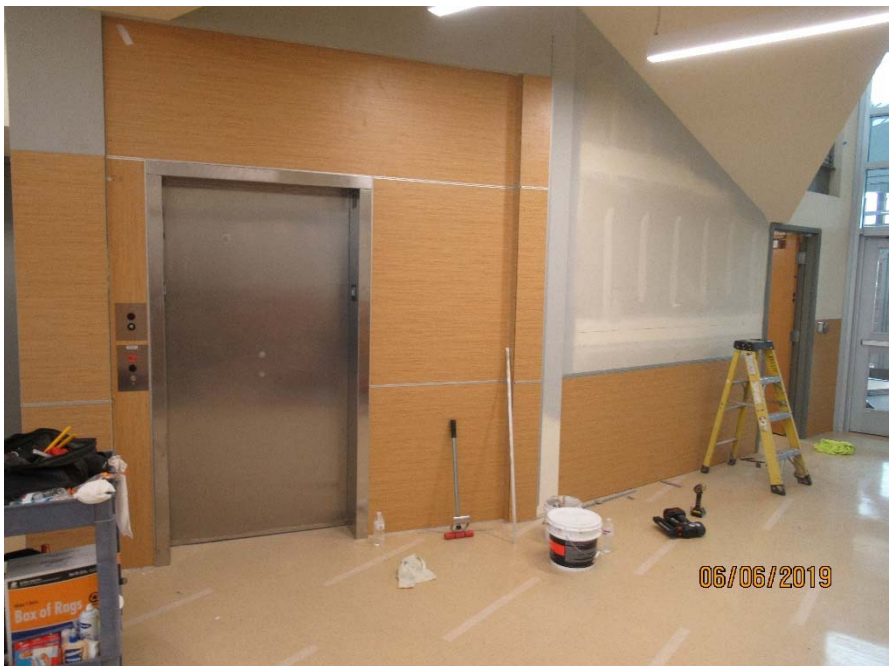
- 13. Contractor has begun installation of the FRP paneling at the elevator shaft.**

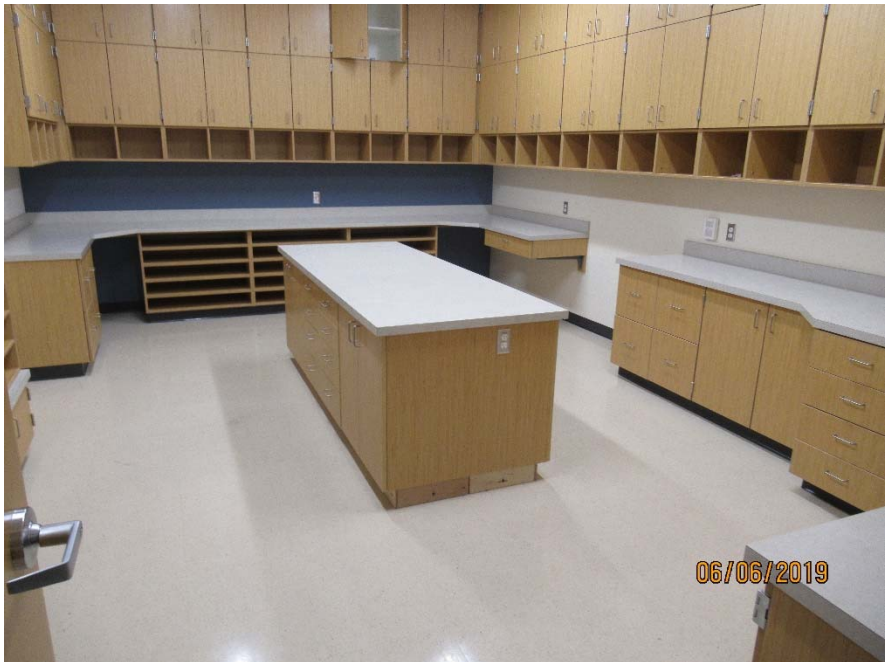
- 14. Contractor has installed the island work station along with the electrical outlets in Staff Workroom 118M.**

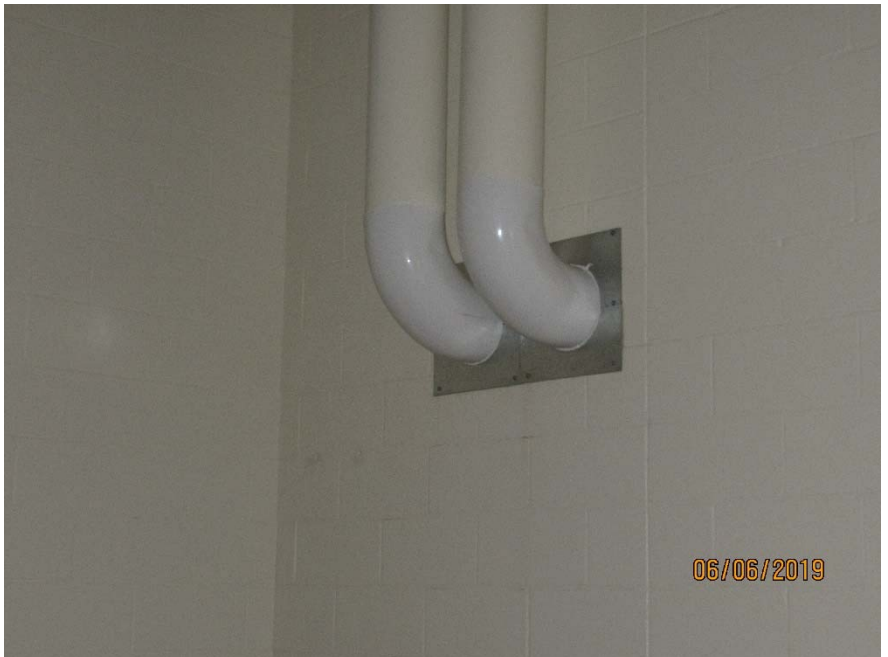
- 15. Contractor has sealed around the chiller piping in Storage room 139A.**
