**Project: PSD: Kamiak Elementary School****Date: June 7, 2018****Weather conditions:**

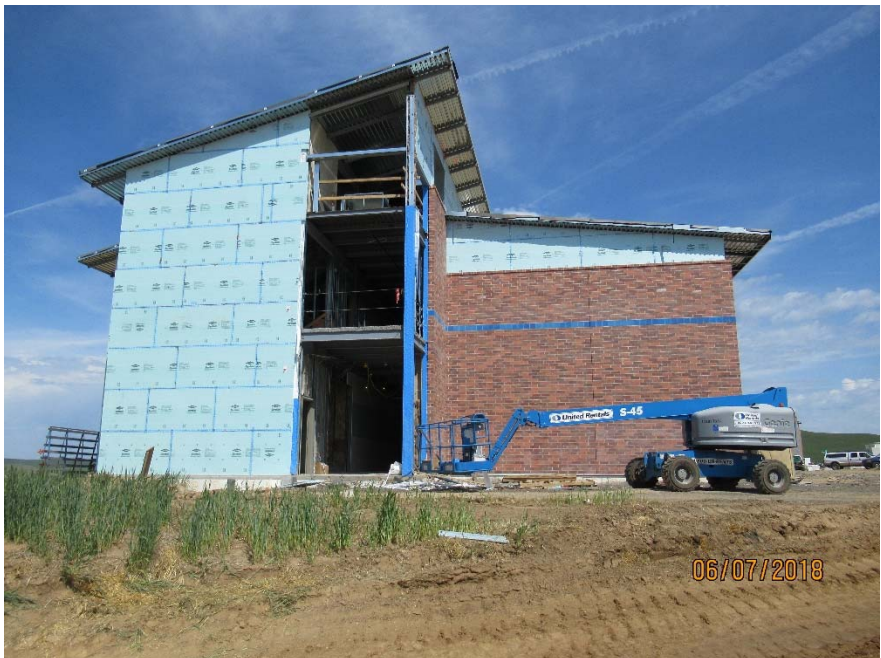
1. South elevation looking north.

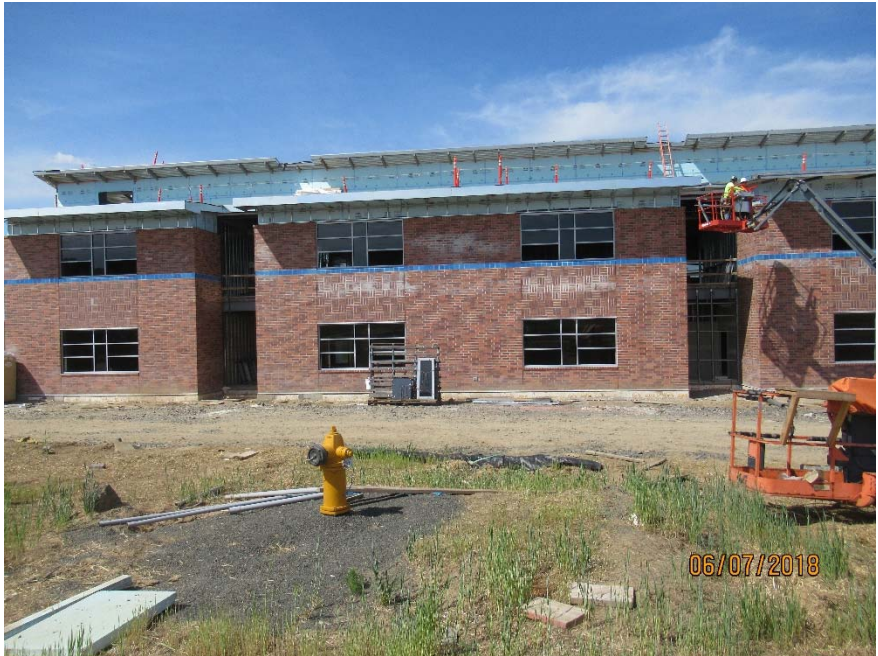
- 2. East elevation near south end of the classroom wing.
Between grid lines B and E.**

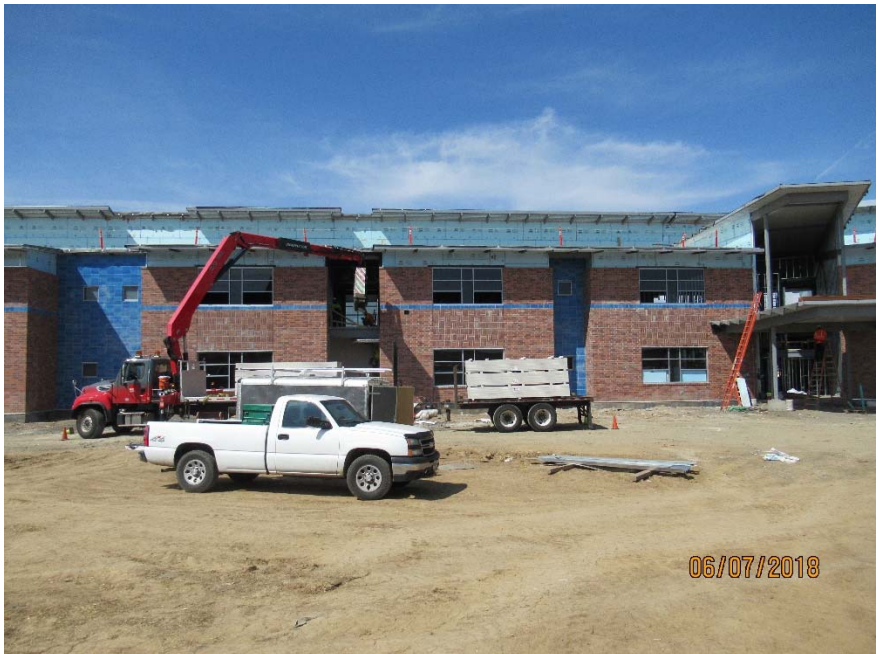
- 3. East elevation middle of the classroom wing. Between grid lines G and M.**

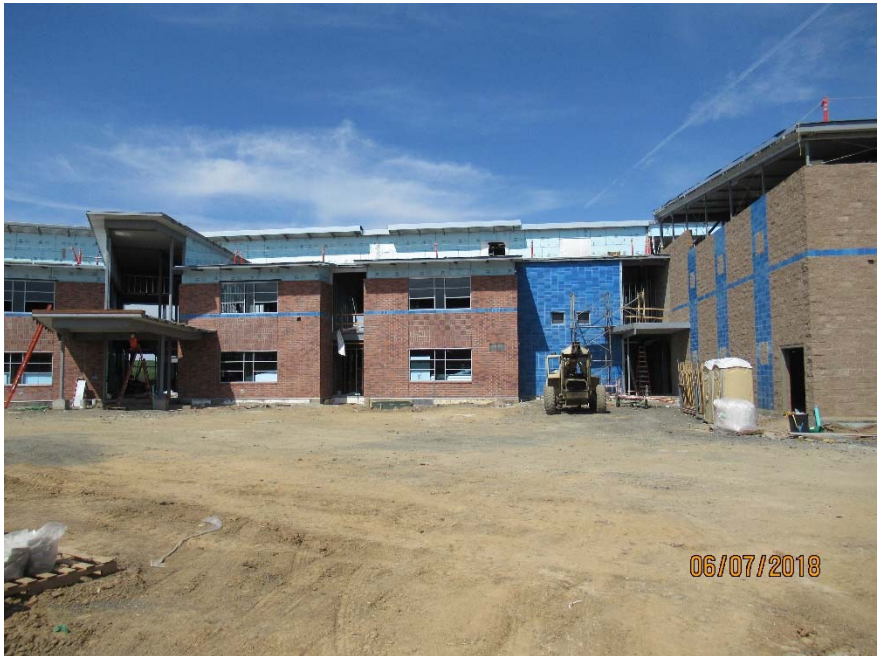
- 4. East elevation north end of the classroom wing. Between grid lines M and T.**

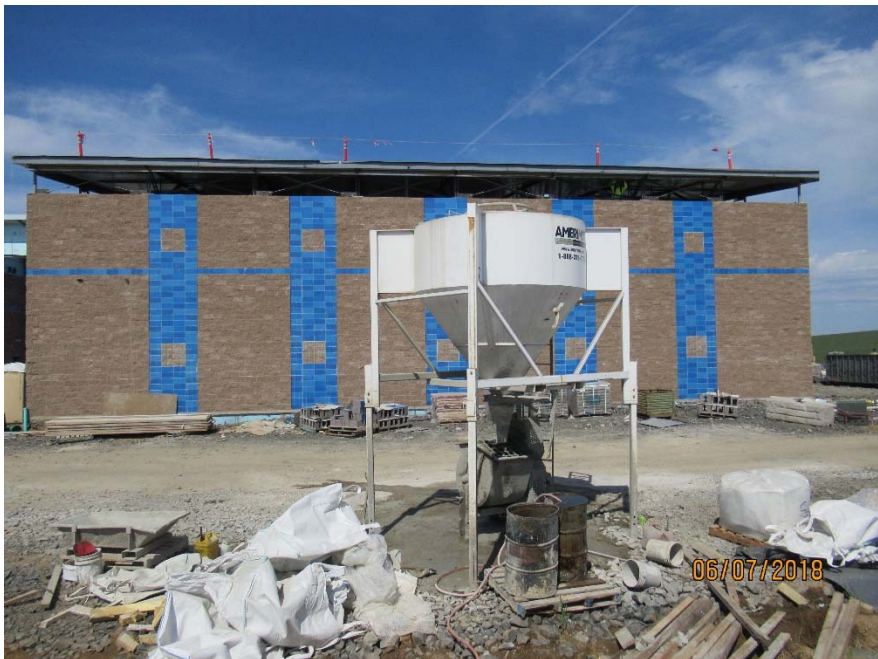
- 5. East elevation of gymnasium. Between grid lines T and U.5.**

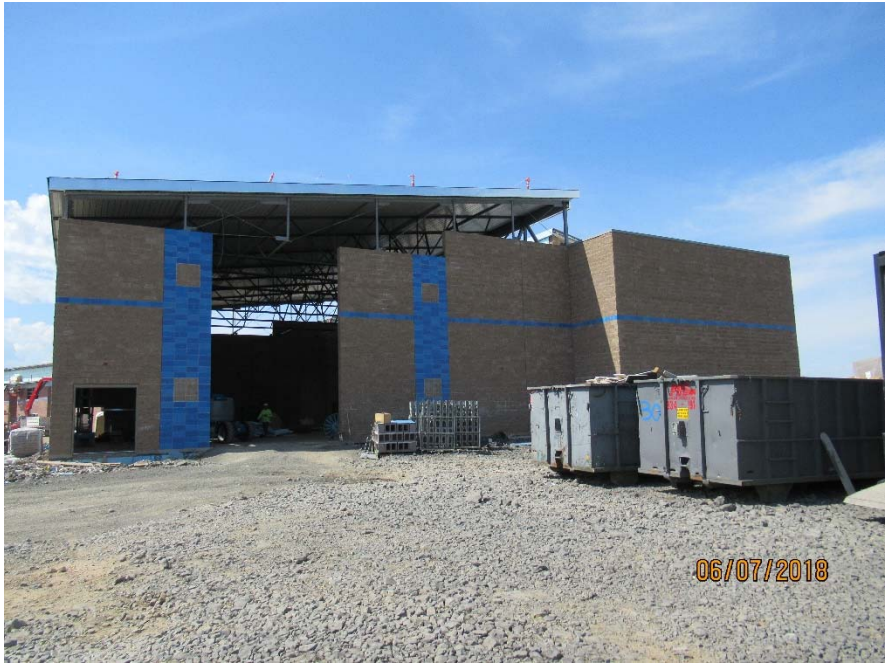
**6. North elevation of
gymnasium looking south.**

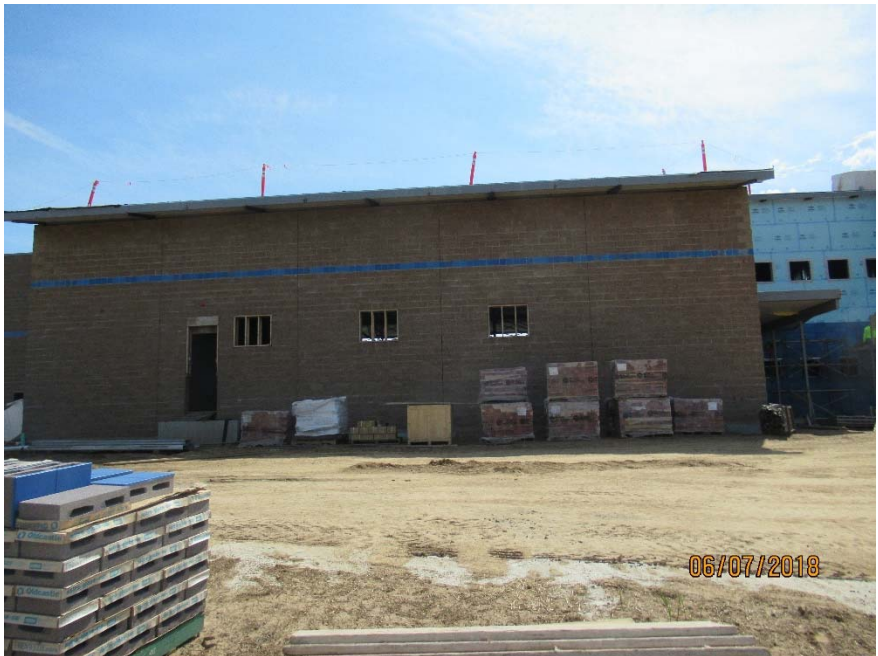
**7. West elevation of Stage.
Between grid lines U and T.**

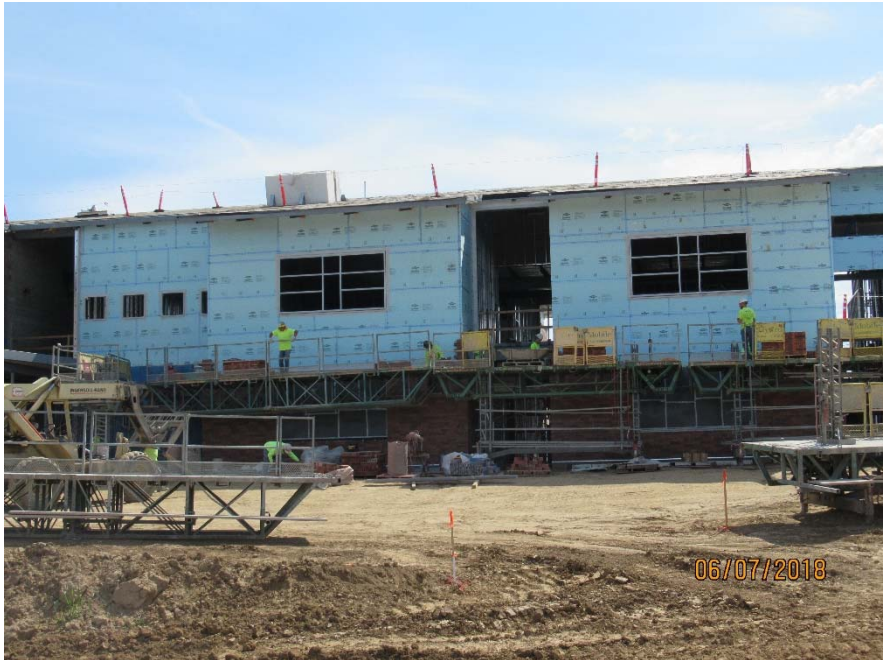
8. **West elevation of north end of classroom wing. Between grid lines S and O.**

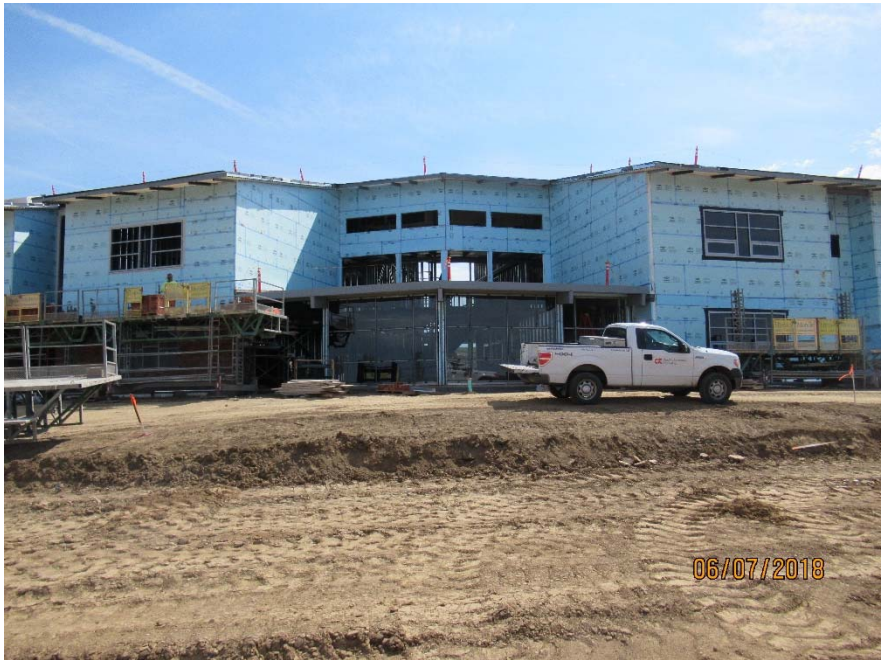
9. **West elevation of middle of classroom wing, Library is in the middle. Between grid lines P and L.**

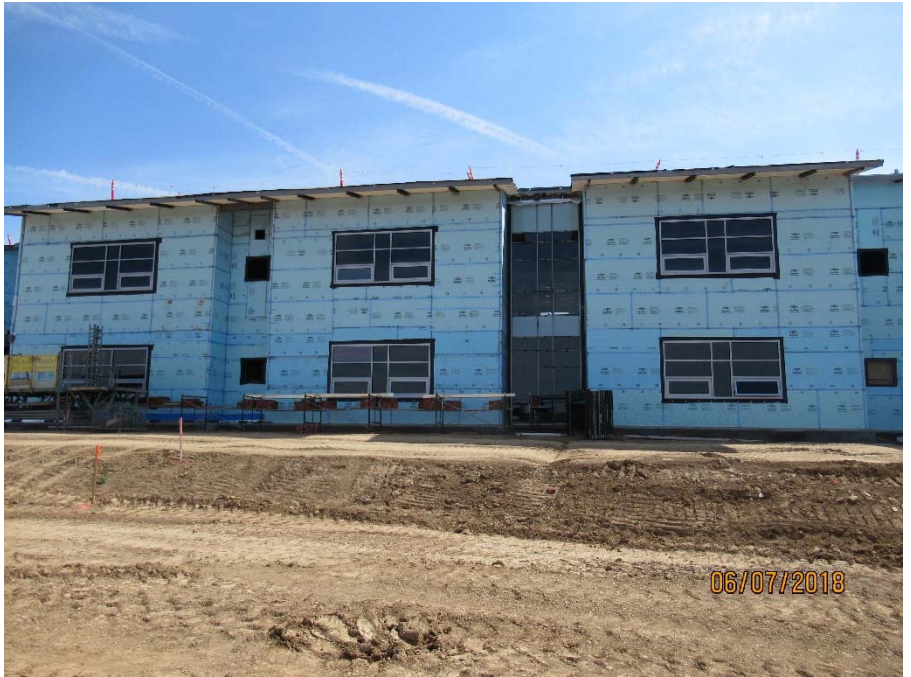
10. West elevation middle of classroom wing. Between grid lines M and H.

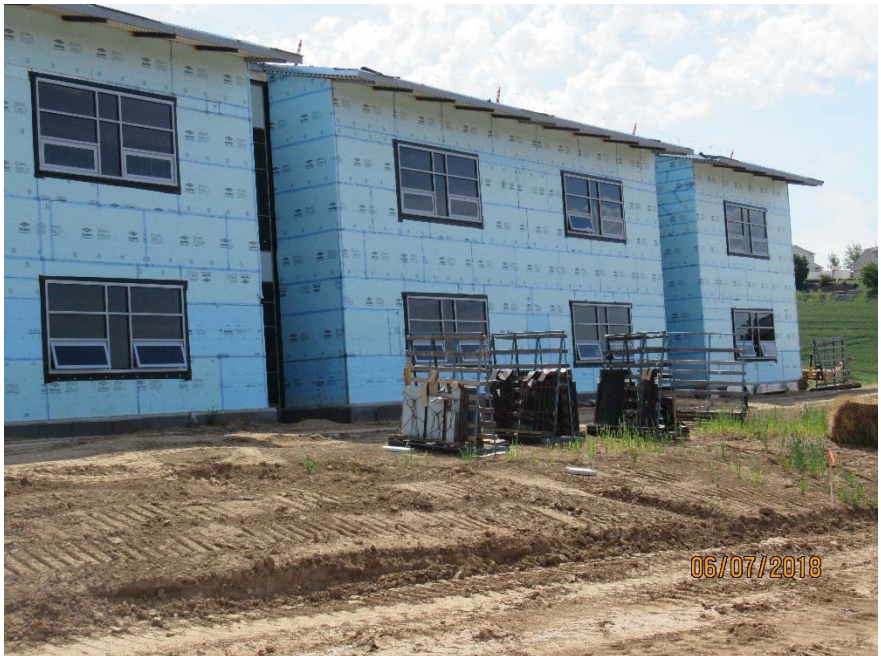
11. West elevation south end of classroom wing. Between grid lines B and G.

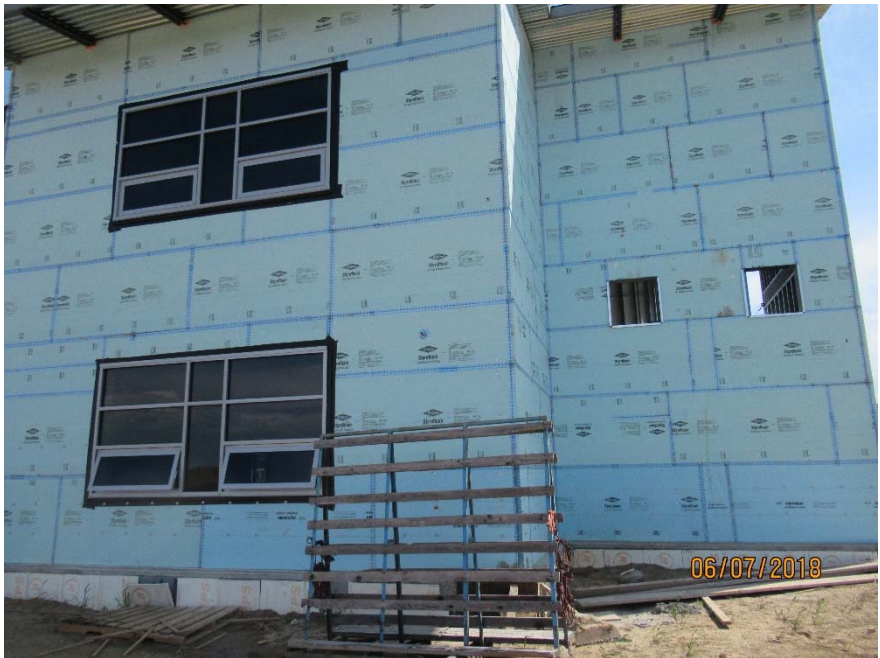
- 12. West elevation south end of classroom wing. Between grid lines C.5 and A.**

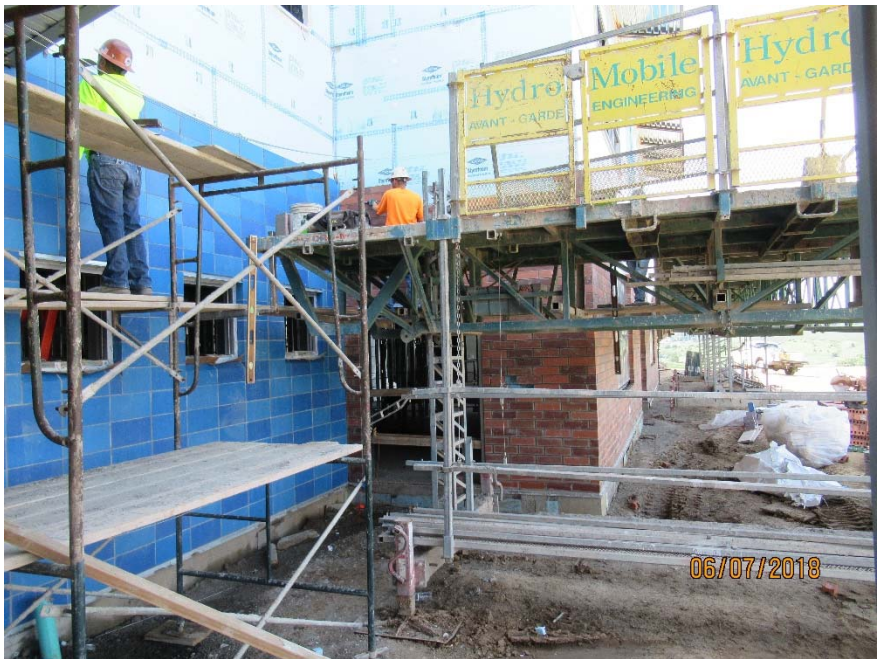
- 13. The masons have moved to the west elevation of the building at the north end working to the south.**

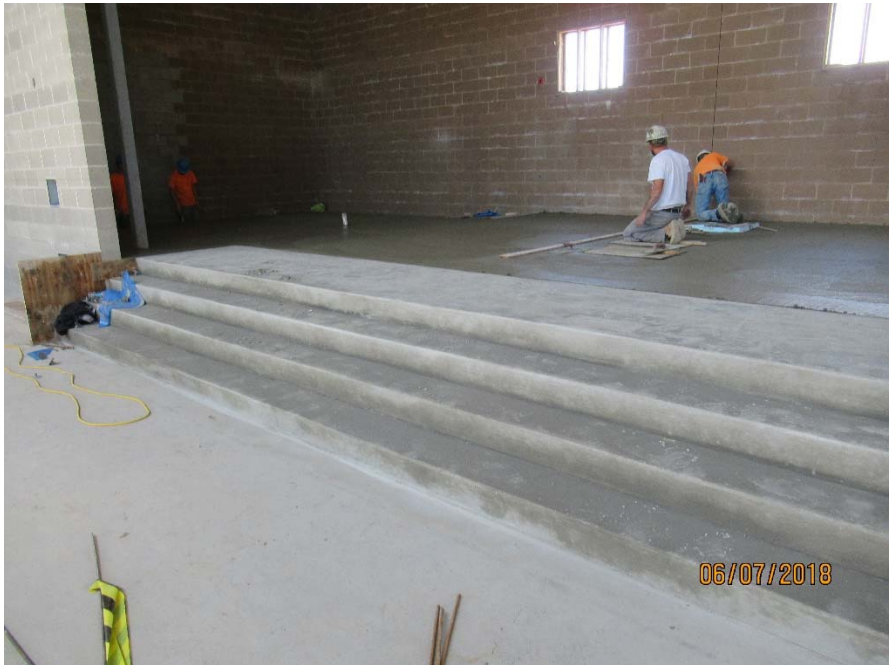
- 14. Contractor has placed the Stage stairs, ramp and today placed the Stage concrete slab.**

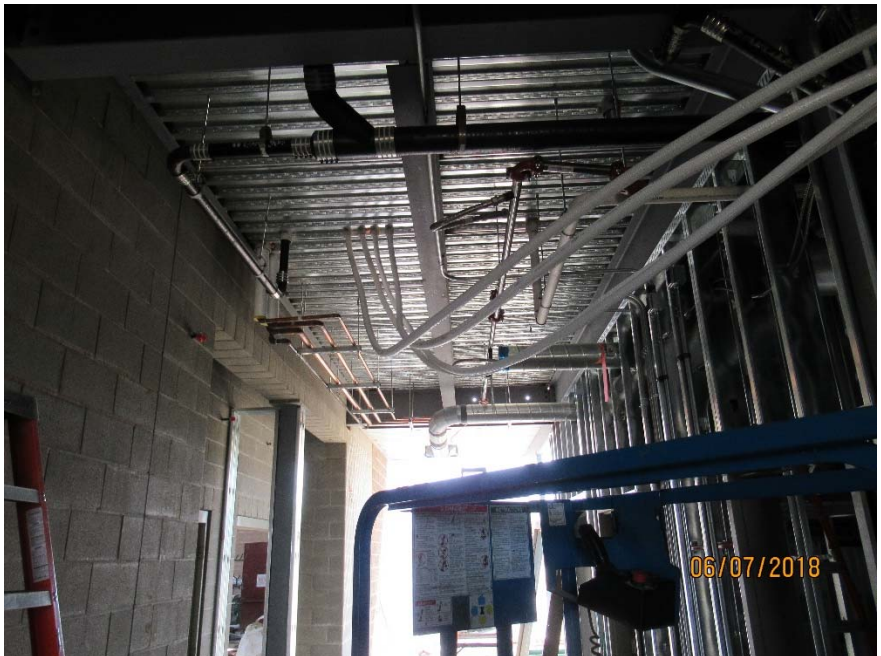
- 15. Appears the contractor is installing the hydronic piping lines.**

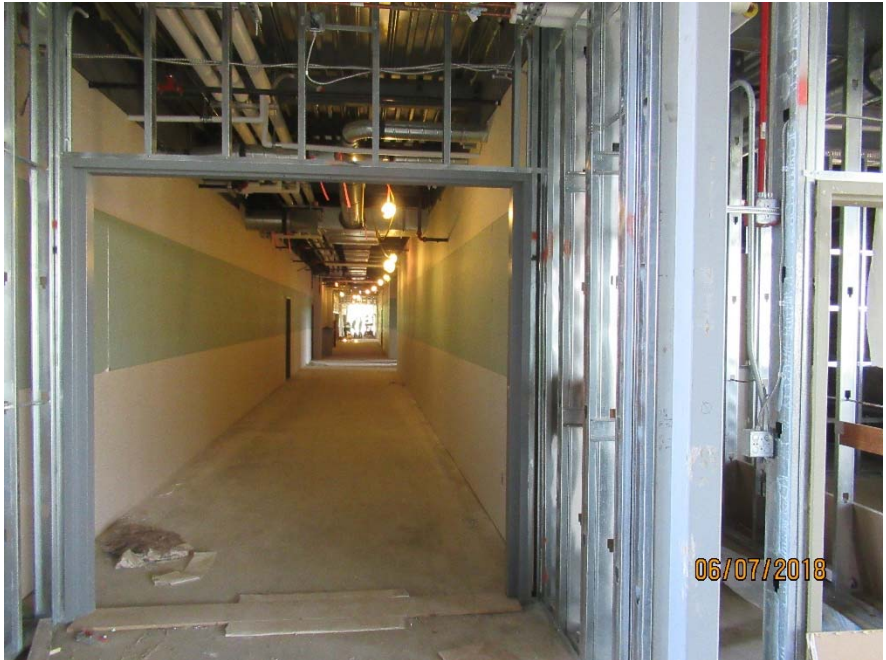
- 16. Wallboard installation appears nearly done in Area A first level with the exception of soffits. Taping is underway.**

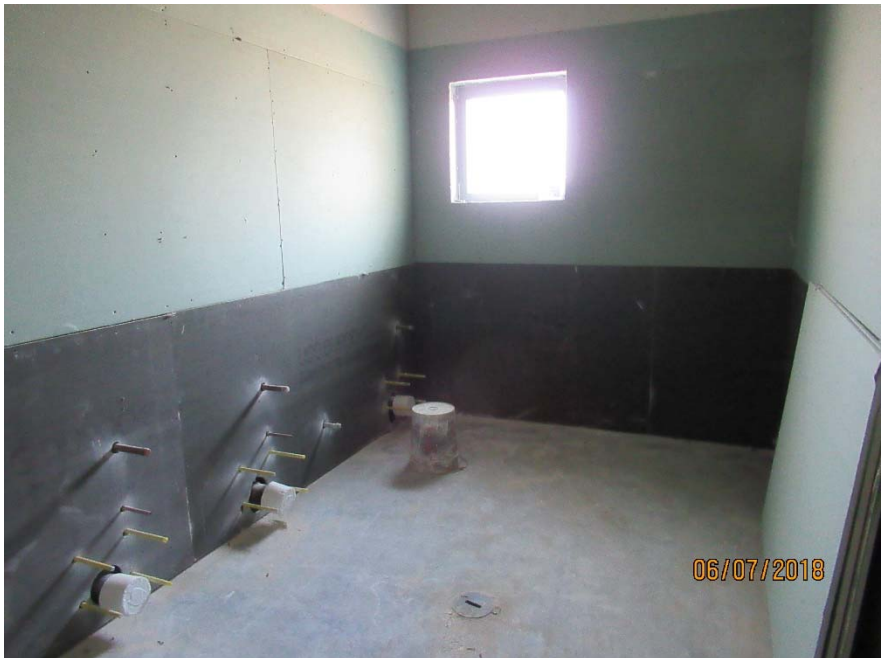
- 17. Wallboard installed in toilet rooms. Darker wallboard is the backing for ceramic tile.**

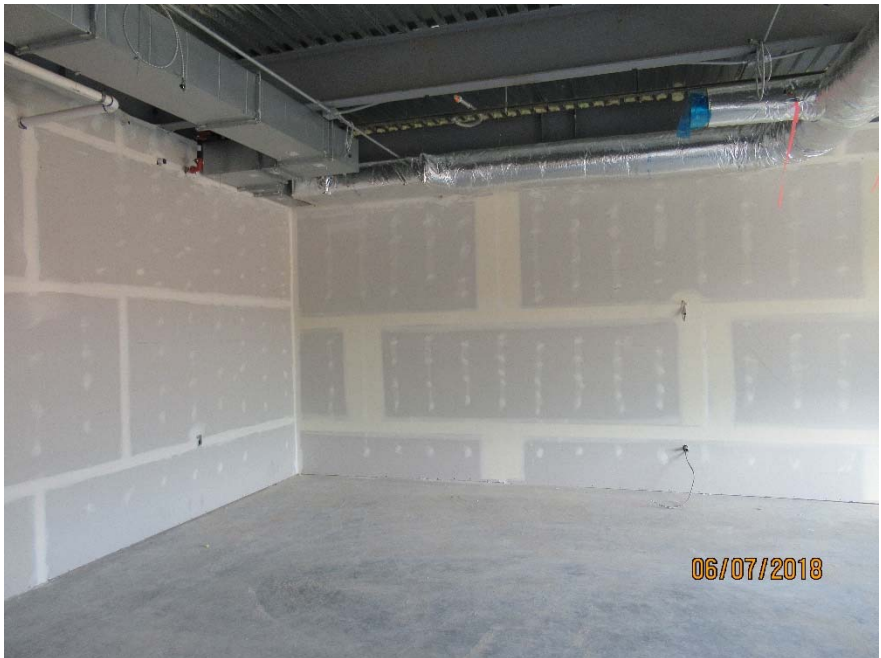
**18. Area A lower floor:
Wallboard taping in
progress.**

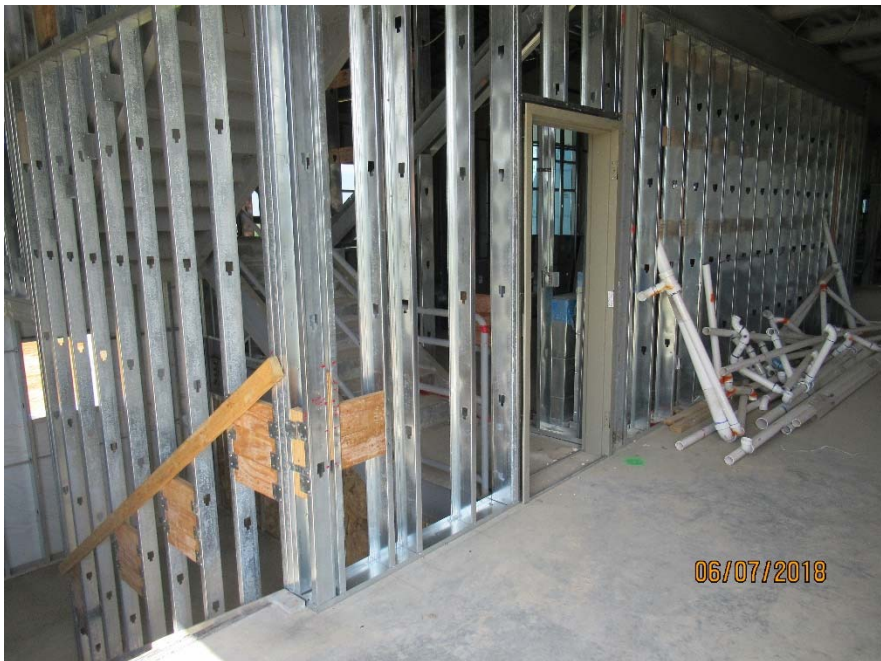
**19. Area A upper floor. It
appears wall framing is
complete, backing/blocking
installation appears
complete. Preassembled
plumbing has been
delivered.**

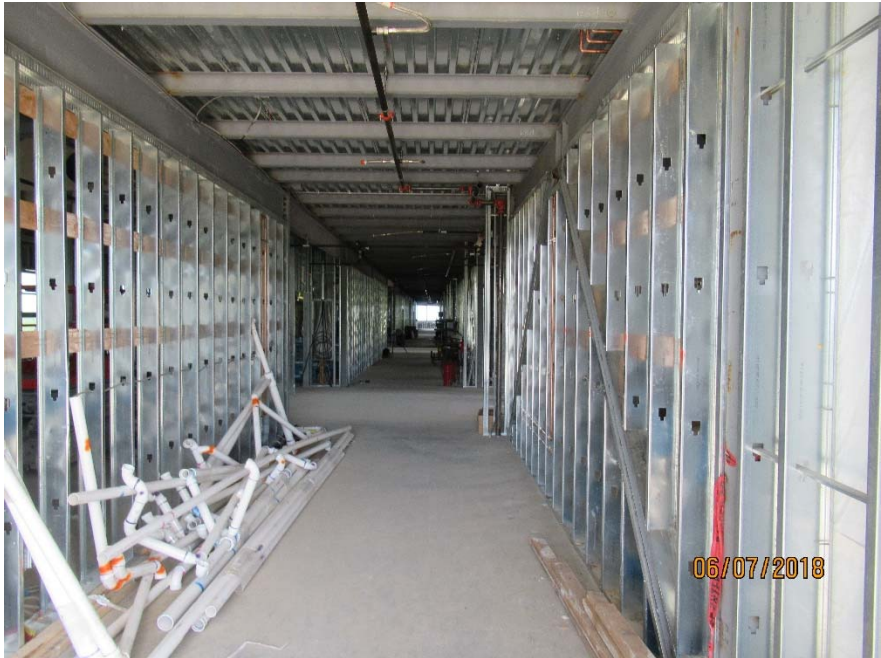
20. Area A upper floor. It appears wall framing is complete, backing/blocking installation appears complete. Preassembled plumbing has been delivered.

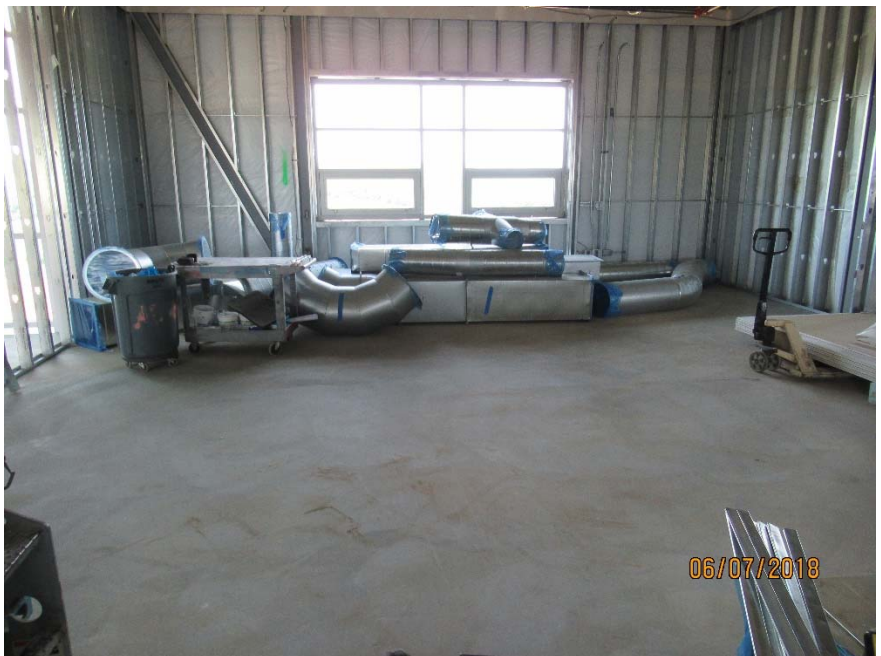
21. Area A upper floor. It appears wall framing is complete, backing/blocking installation appears complete. Preassembled ductwork has been delivered.

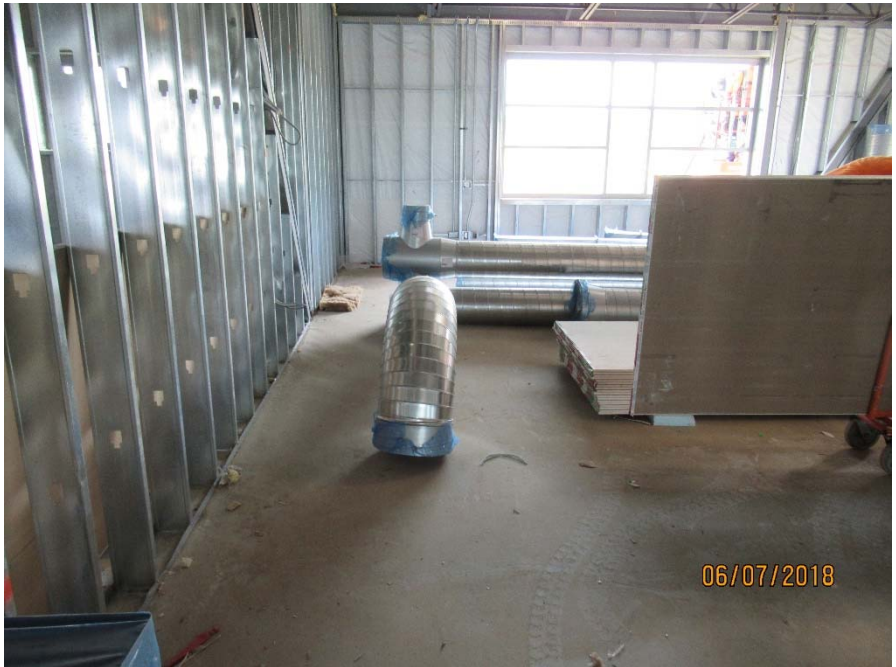
22. Area A upper floor. It appears wall framing is complete, backing/blocking installation appears complete. Preassembled ductwork has been delivered.

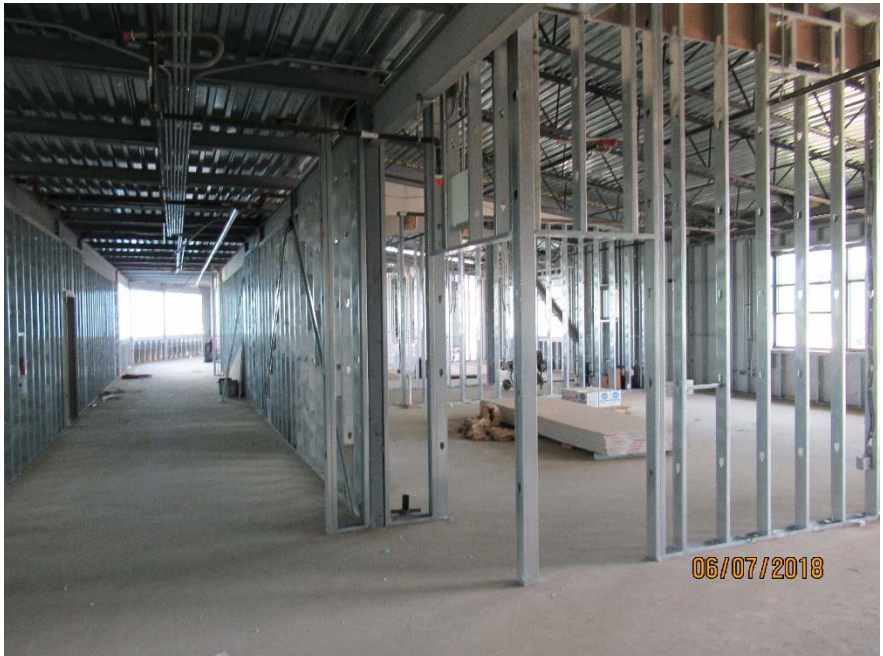
23. Area A upper floor looking south.

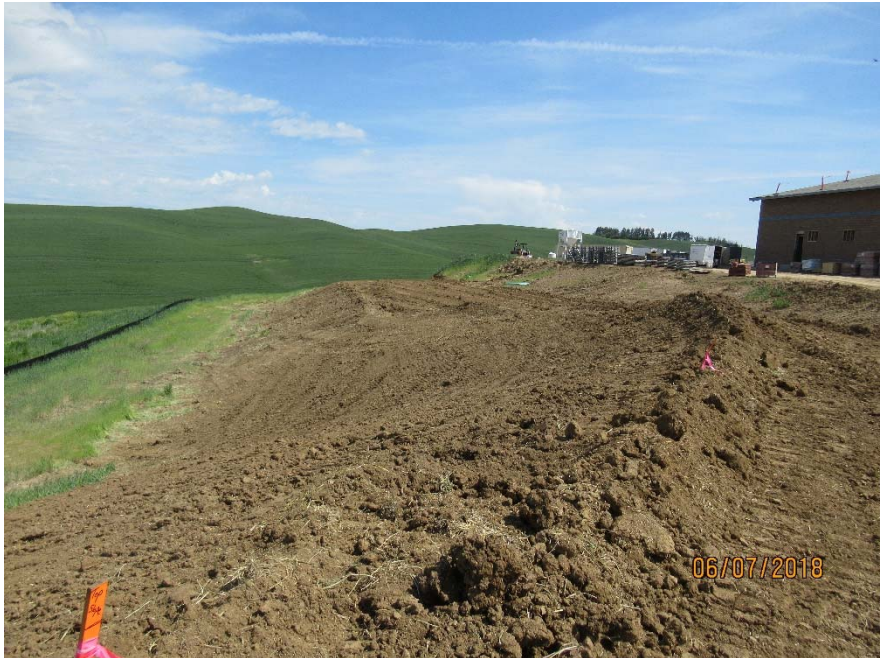
24. Contractor appears to be fine grading slopes west of the gymnasium.

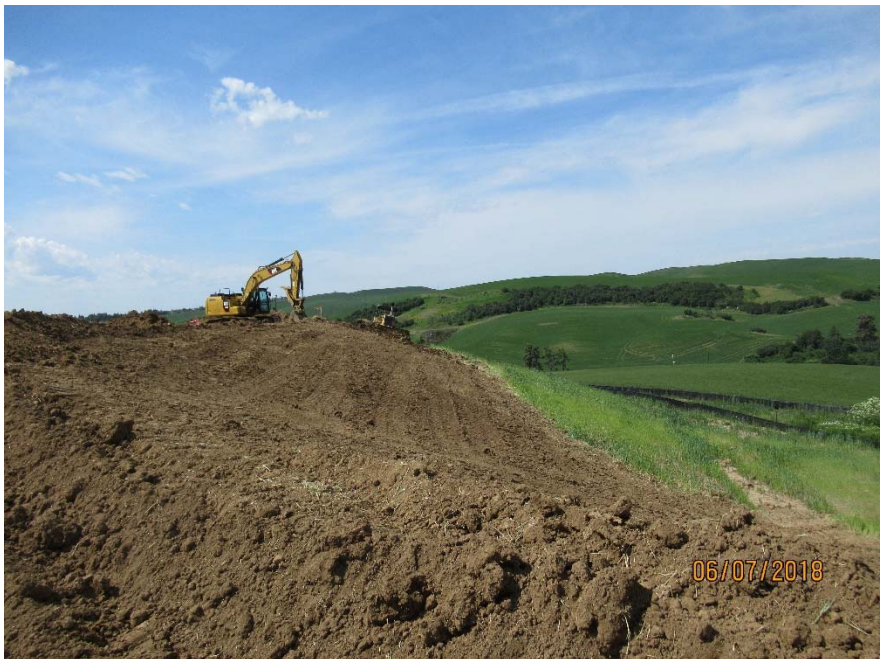
25. Contractor appears to be fine grading slopes west of the upper play field.

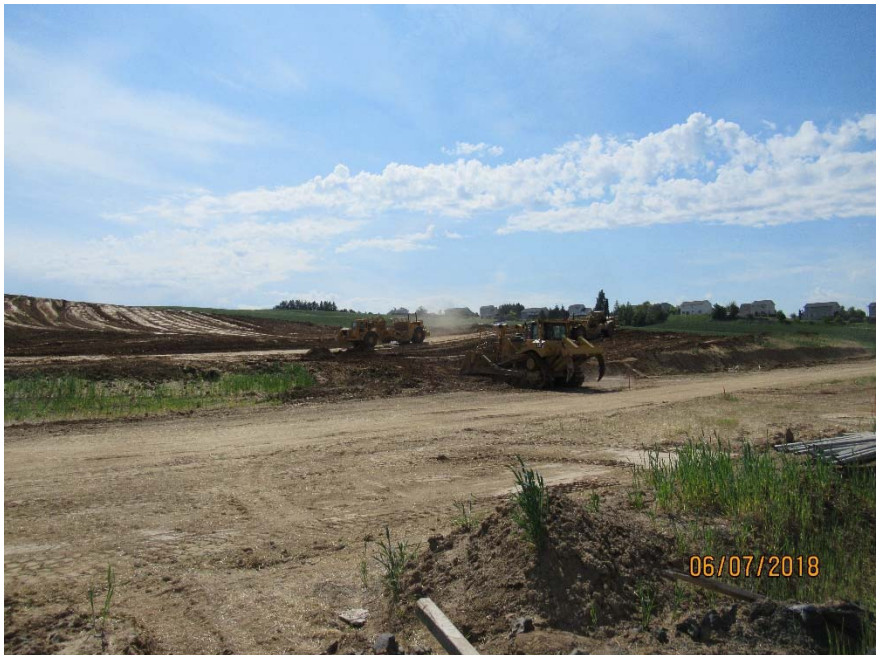
- 26. Contractor continues taking dirt from borrow area and depositing on east play fields.**

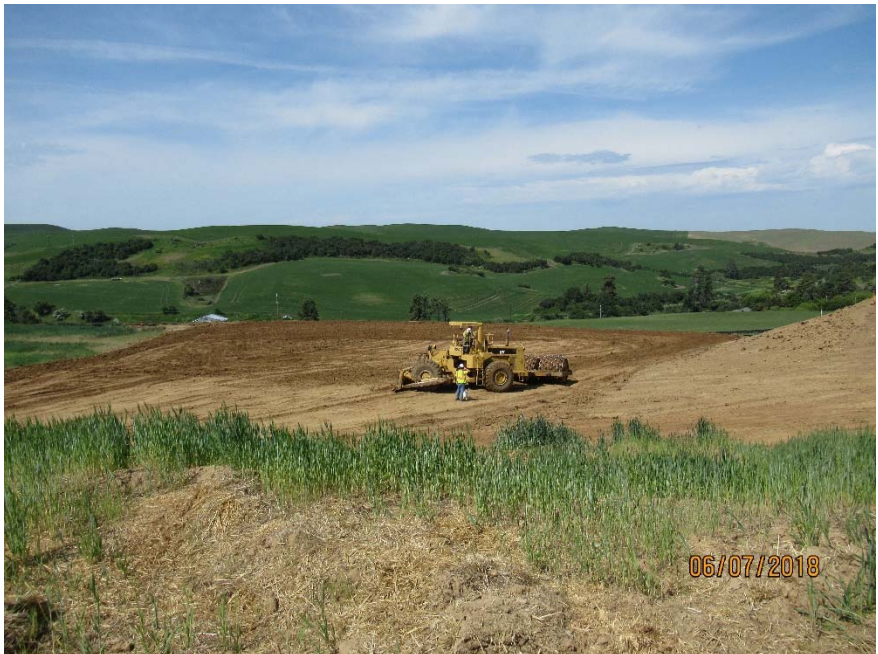
- 27. Contractor is using sheep's foot roller to compact borrow site dirt placed on play fields. Photo shows GPI technician testing compaction.**
