**Project: PSD: Kamiak Elementary School****Date: July 19, 2018****Weather conditions:**

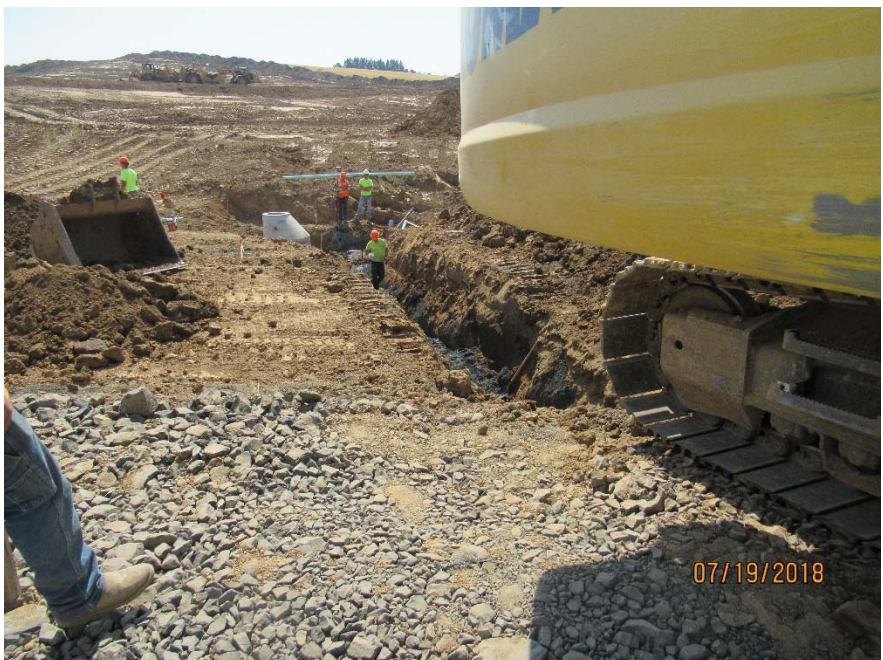
1. Appears Debco is installing a sewer branch line north of the school.

Per meeting with DebCo today, the school sewer line will be hooked up on Friday 7/20/18. It will be inspected the following Monday or Tuesday. Although the placement of this piping will cut off access for Walker on Friday, it will be back open on Monday.

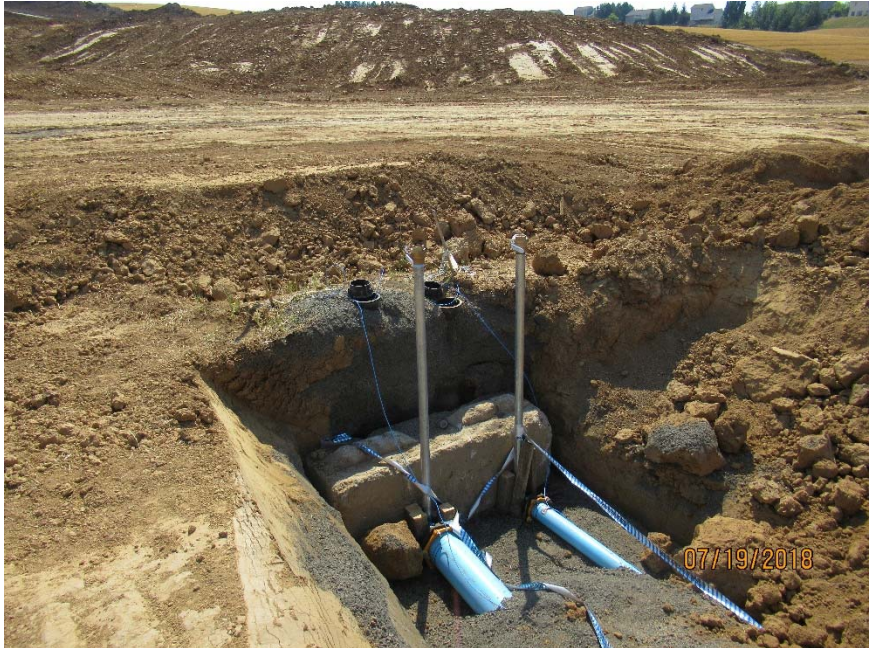
2. It appears Debco has hooked up the Fire Line as well as domestic water to Kamiak. The line will be inspected Monday or Tuesday next week. I believe this is the east side of NW TerreView Drive.

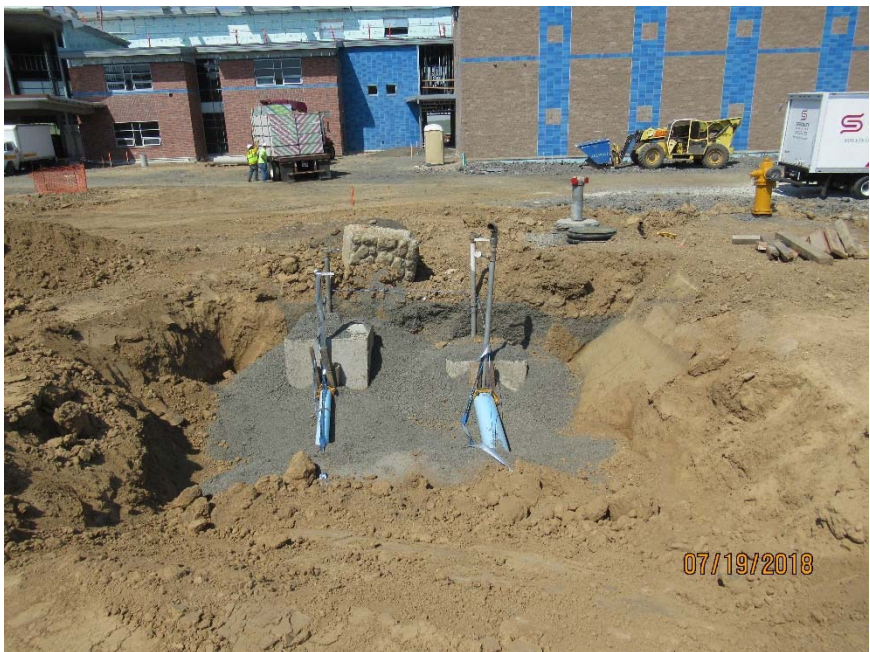
3. It appears Debco has hooked up the Fire Line as well as domestic water to Kamiak. The line will be inspected Monday or Tuesday next week. This photo is the west side of NW Terre View Drive.

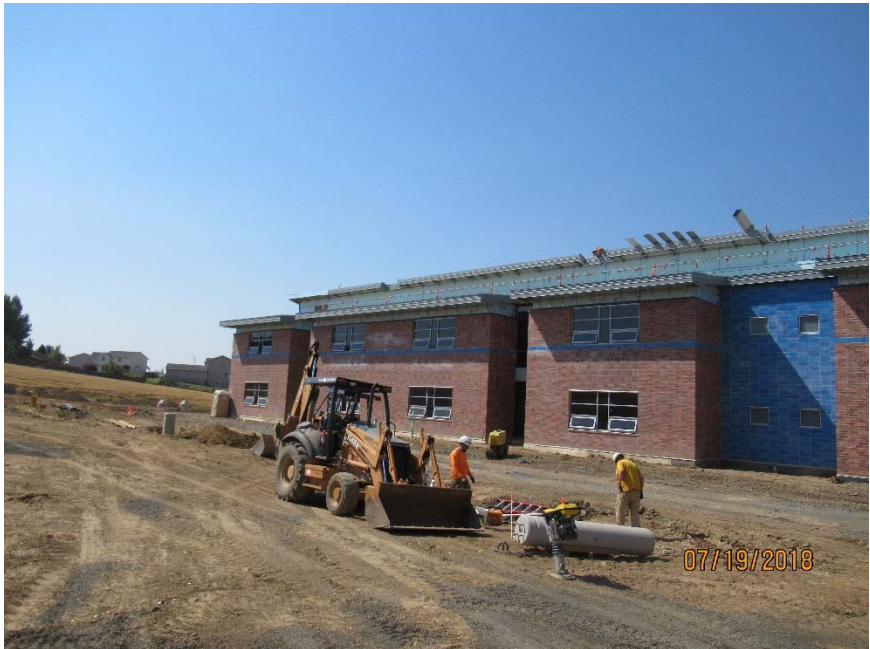
4. **Appears the electricians are setting the light standards in the east side of school.**

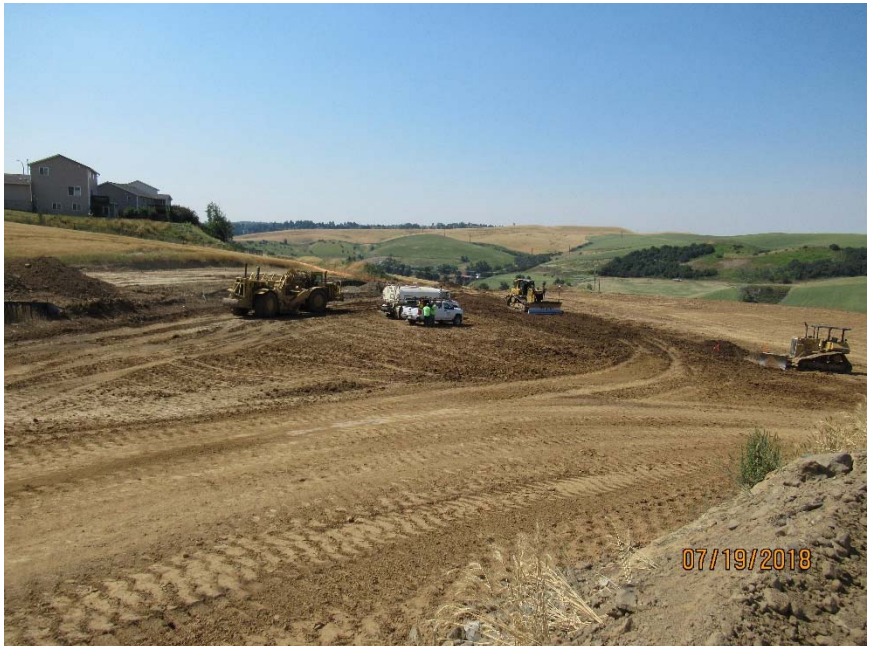
5. **Motley is at or very near subgrade at lower play field. There are still areas around upper playfield and between upper and lower play fields that need fill. There is still the area directly south of the school that needs to be built up. Appears we are about 2 weeks away from finishing the mass grading and borrow from developer's site.**

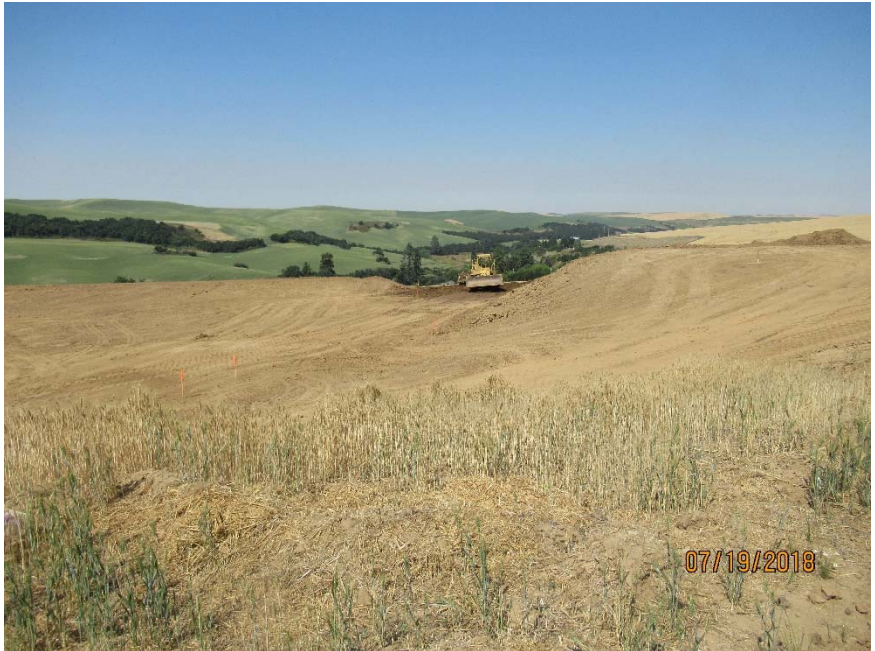
**6. Motley sheeps foot
compacting area between
upper and lower playfields.**

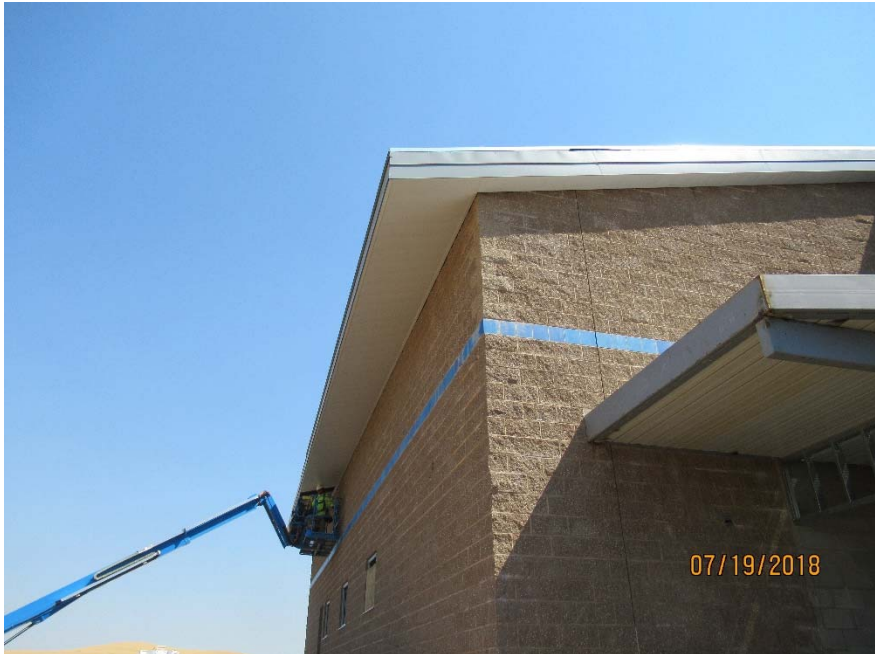
**7. Contractor installing soffit at
gymnasium.**

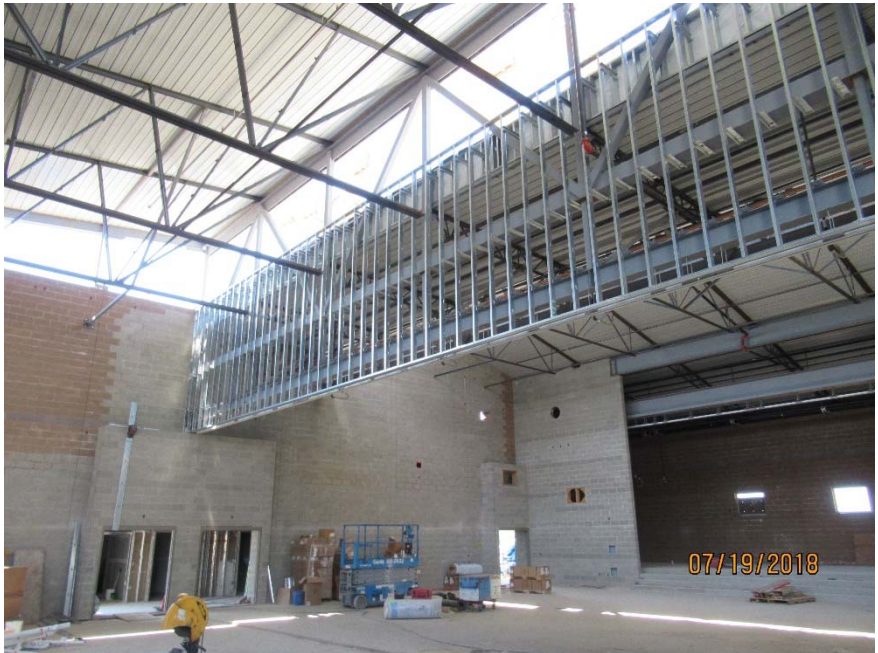
8. Contractor has infilled studs at high wall between Gymnasium and Multi-Purpose room.

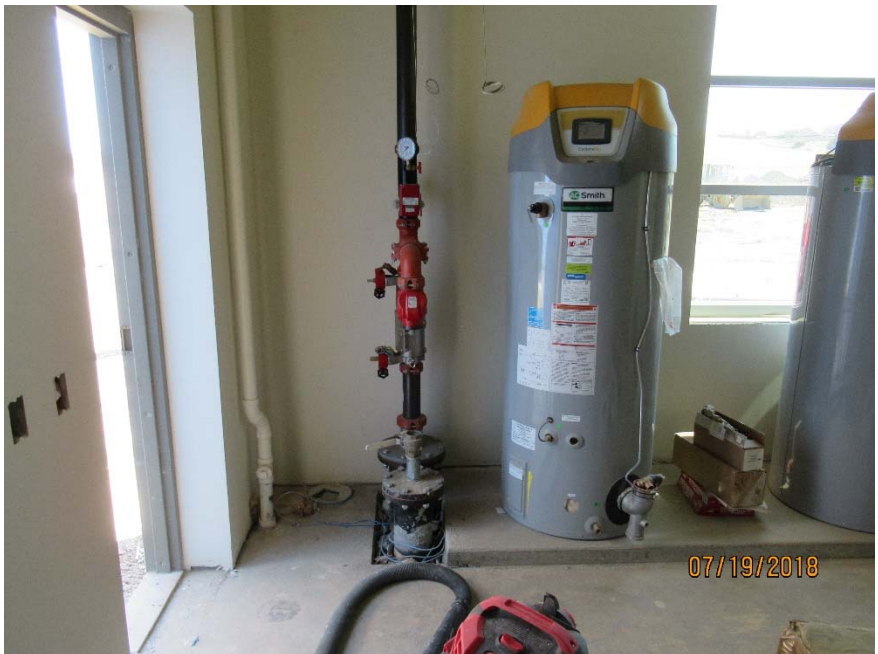
9. Appears the contractor has the fire line ready for water.

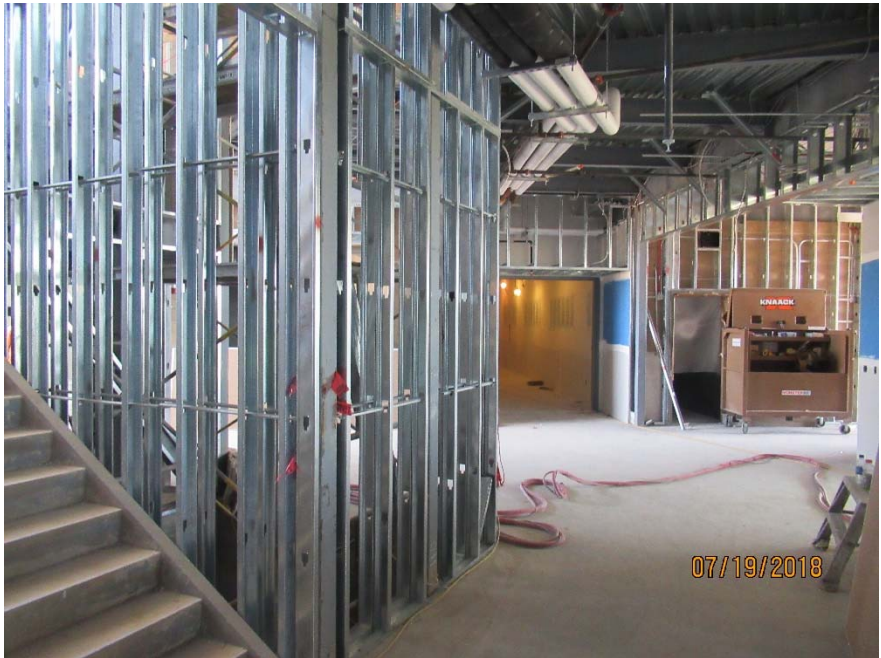
- 10. Appears main entry area nearly ready to be closed up with wall finishes.**

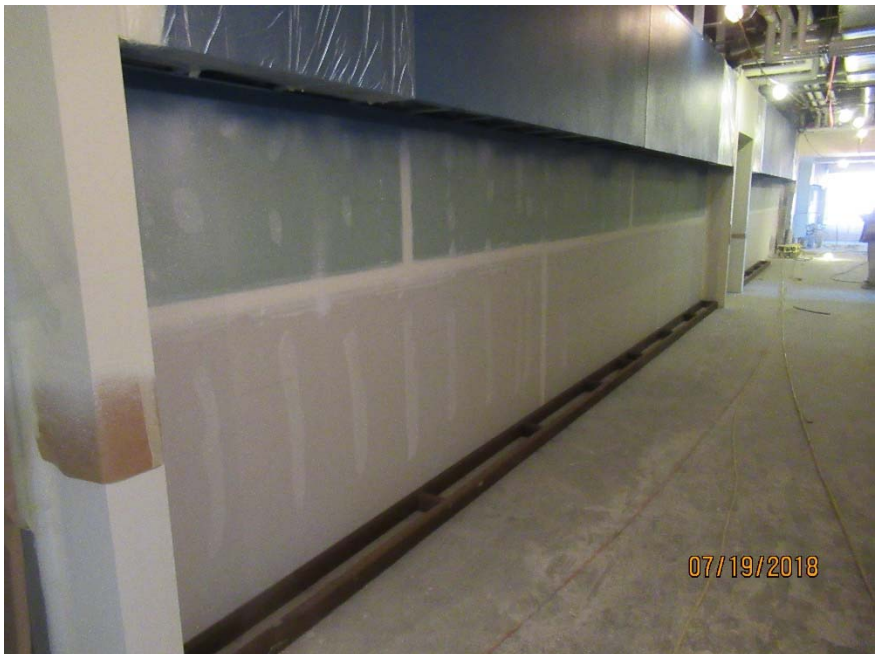
- 11. Contractor has painted the Area A lower level Corridor. Also appears the locker bases have been placed.**

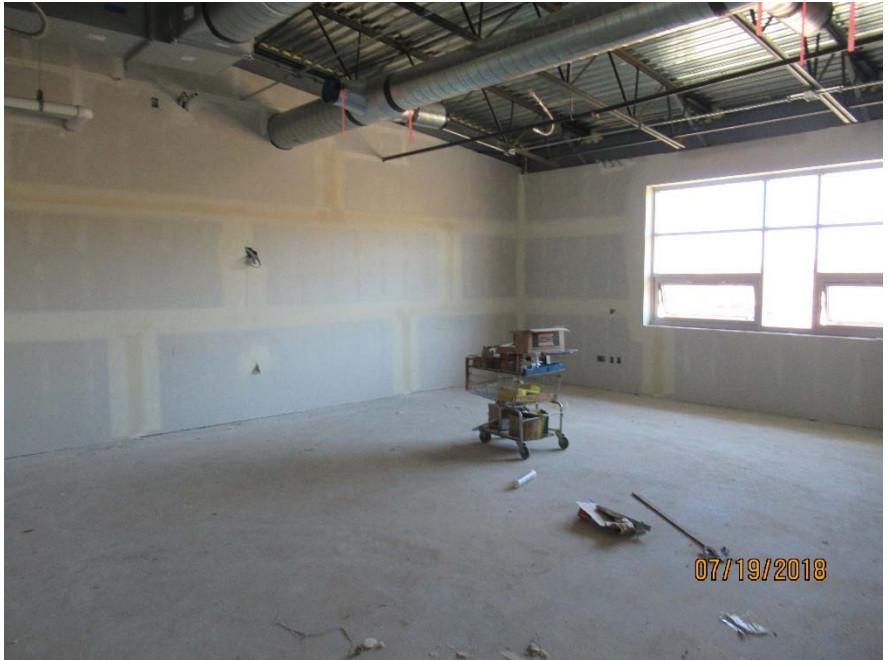
- 12. Appears contractor has applied joint compound in classrooms Area A upper level.**

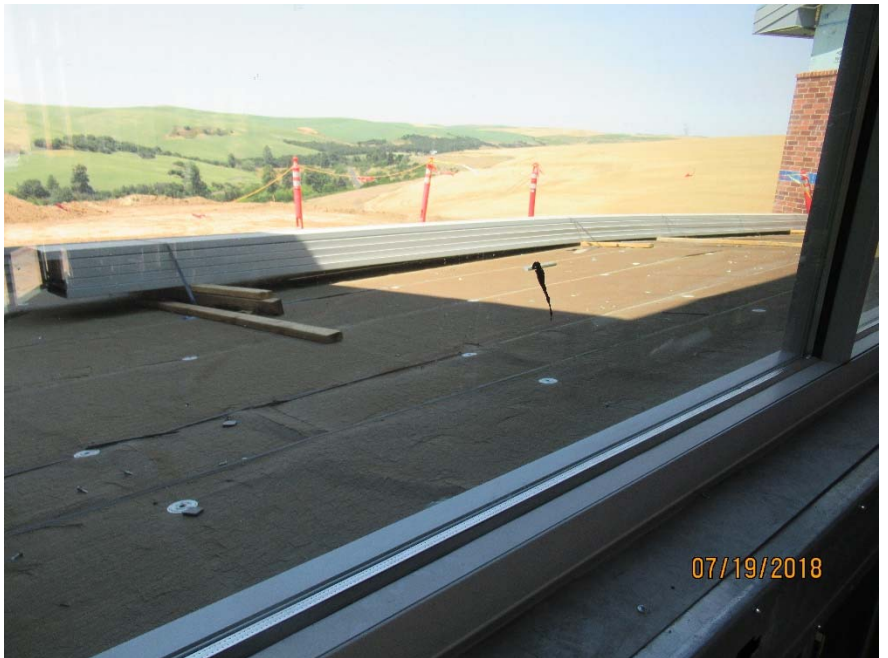
- 13. Roofer has staged the metal roofing on the Library roof.**

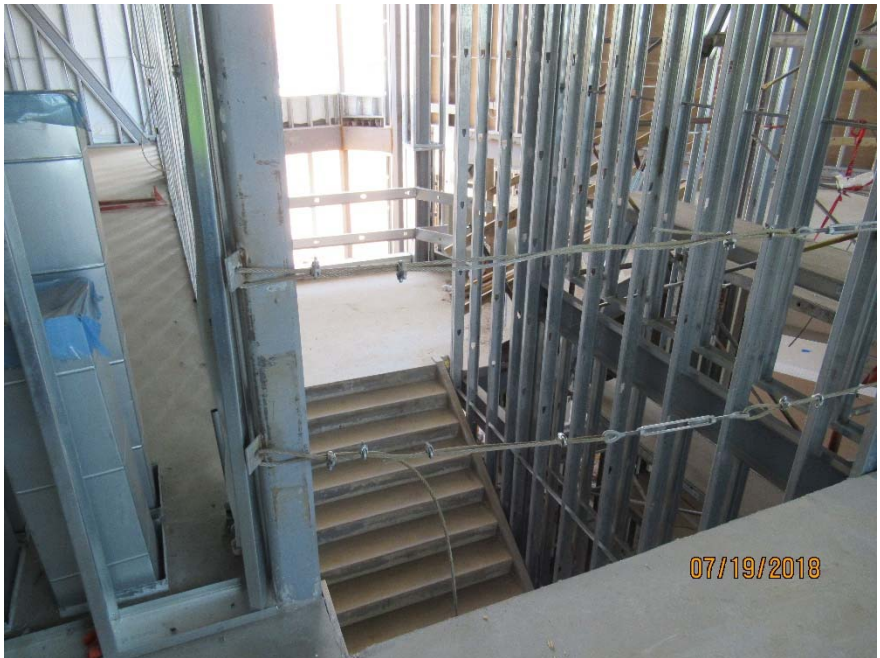
14. Looking down main entry stair.

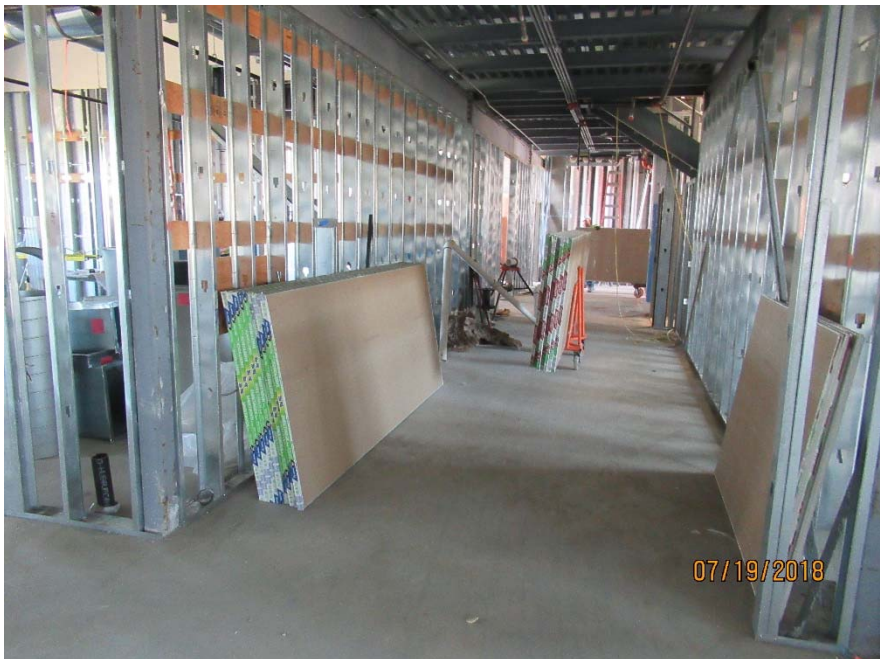
15. Contractor has staged wallboard for upper level.
