**Project: PSD: Kamiak Elementary School****Date: August 2, 2018****Weather conditions:**

Discussion with: See Construction Progress Meeting dated 7/19/18.**Construction Activities:**

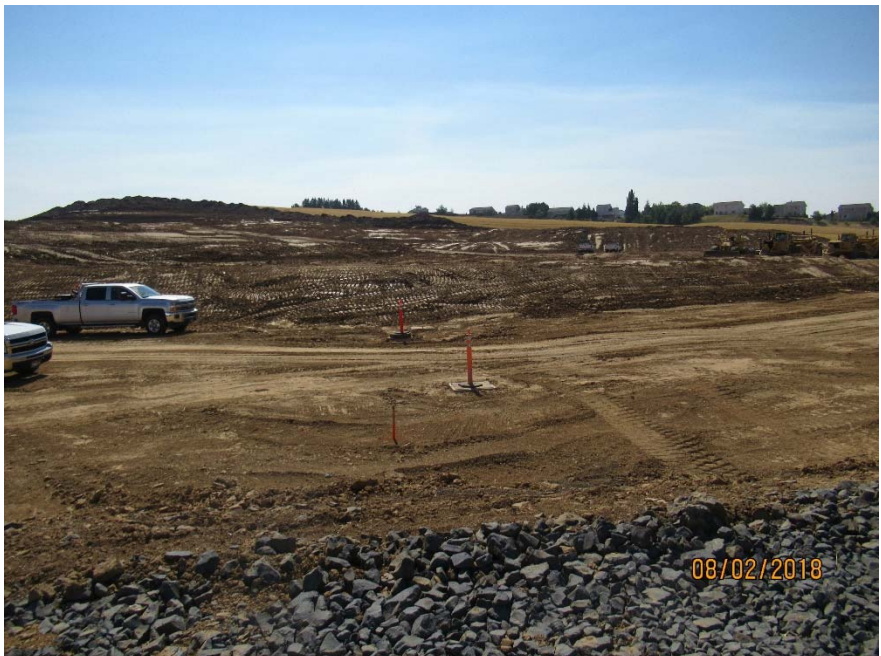
1. It appears Motley is nearly done with getting dirt from the borrow site.

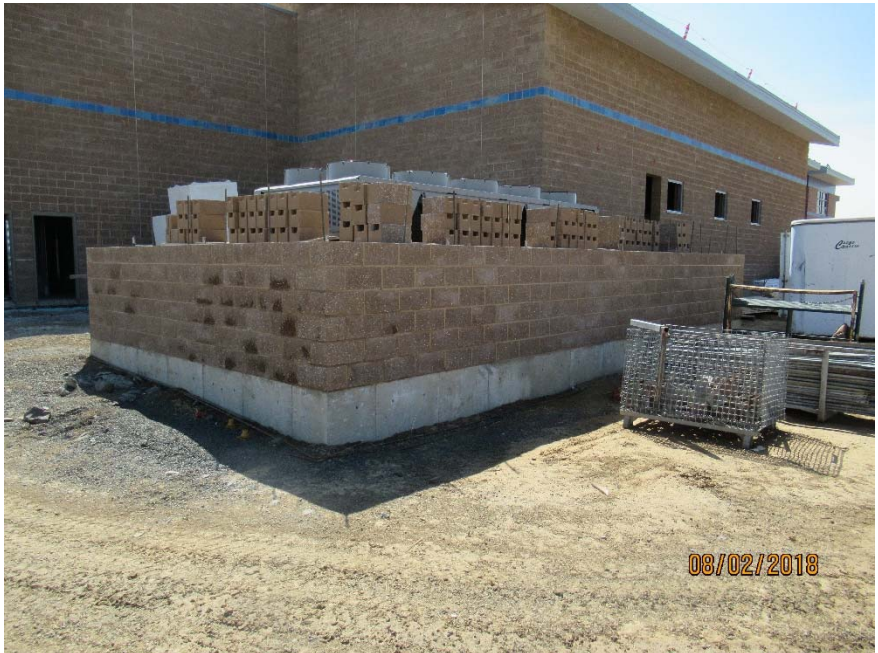
2. **Appears the mason has begun building the screen wall at the chiller.**

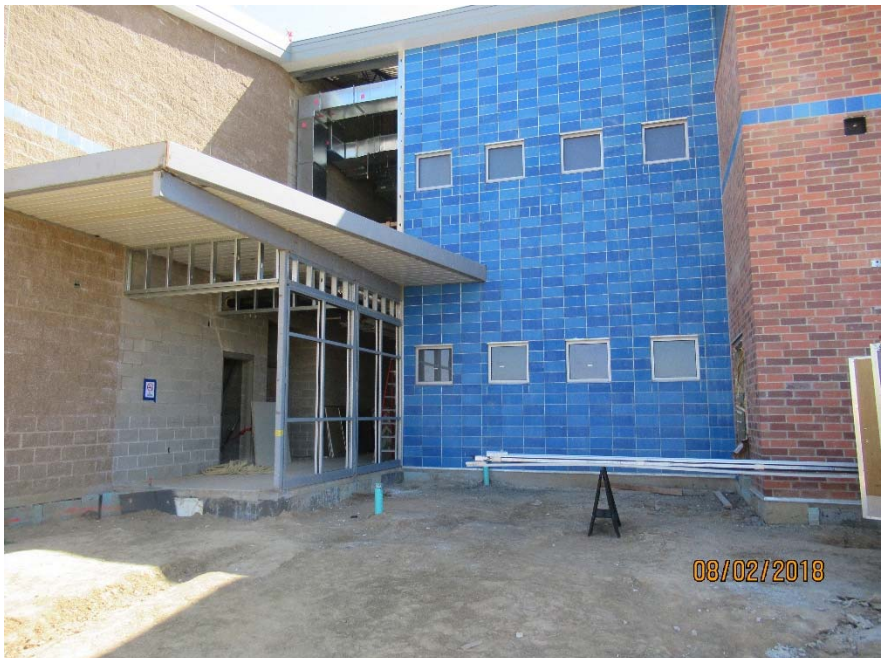
3. **The south side of the aluminum storefront window system at the northwest entrance has been installed.**

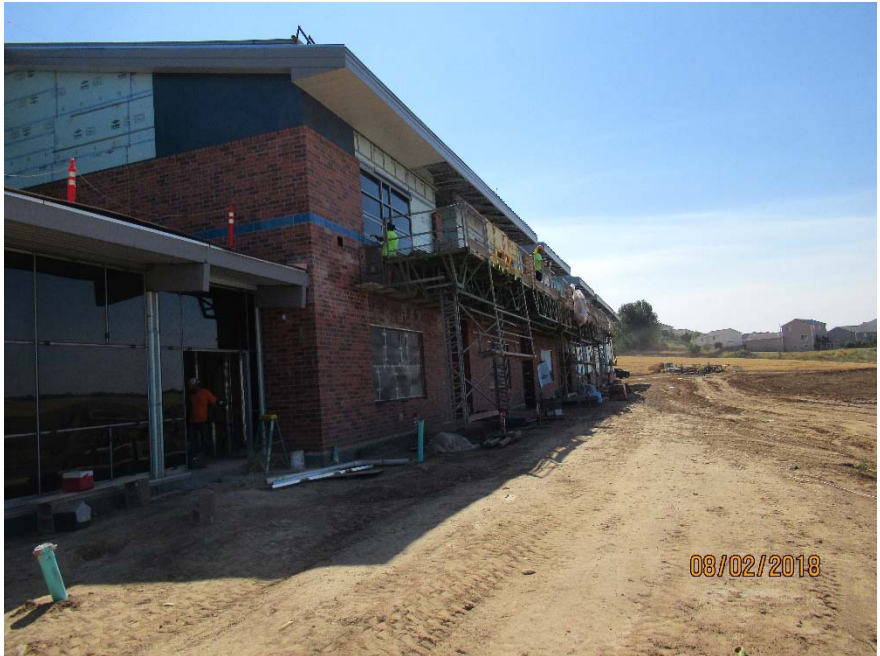
- 4. Installation of exterior metal wall panels as well as soffits continues.**

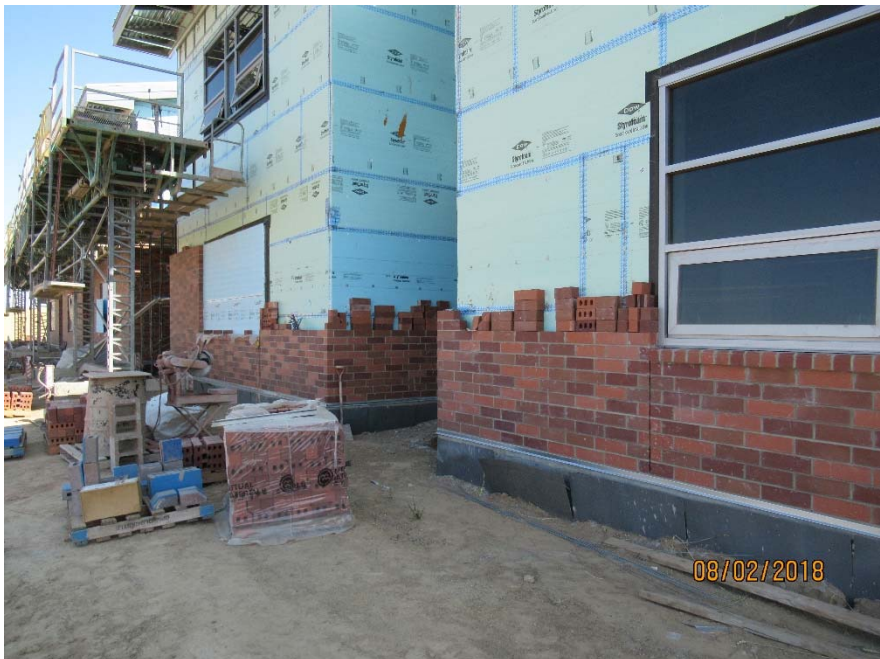
- 5. Mason continues to layup west exterior wall brick veneer.**

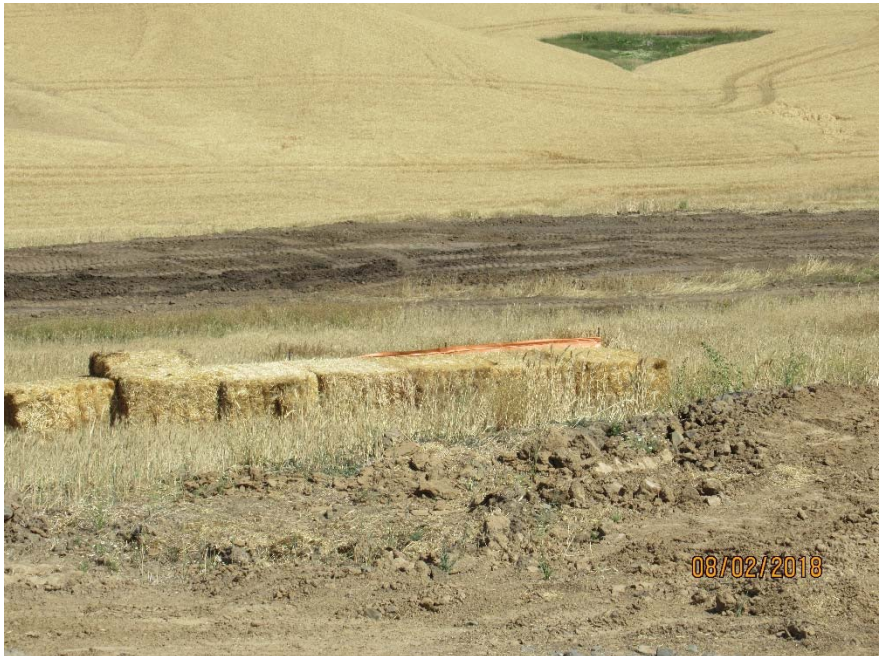
6. **Motley has begun moving previously staged topsoil north of the Kamiak site.**

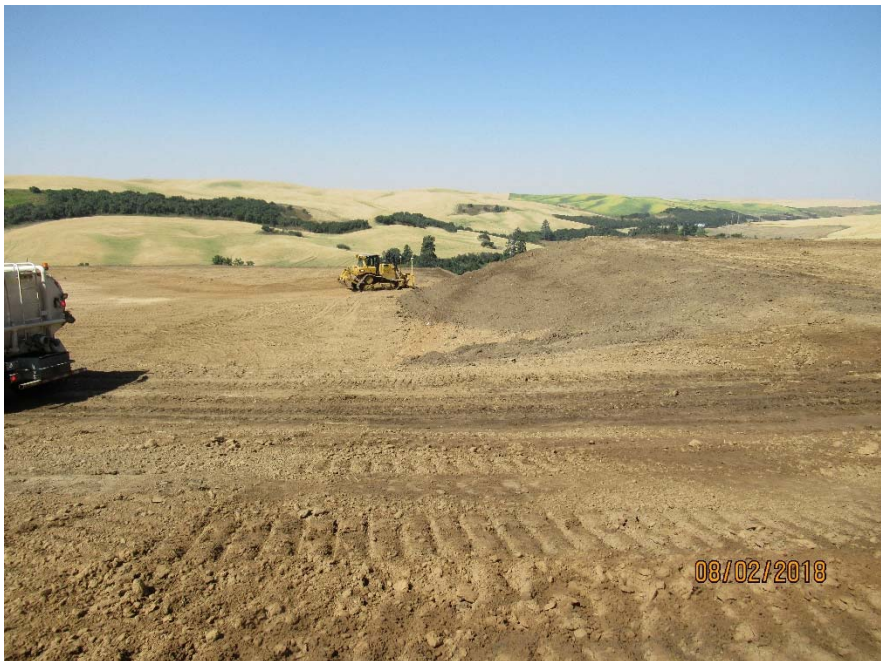
7. **Staged topsoil from north of Kamiak site is being spread on slopes between and on the west side of the playfields.**

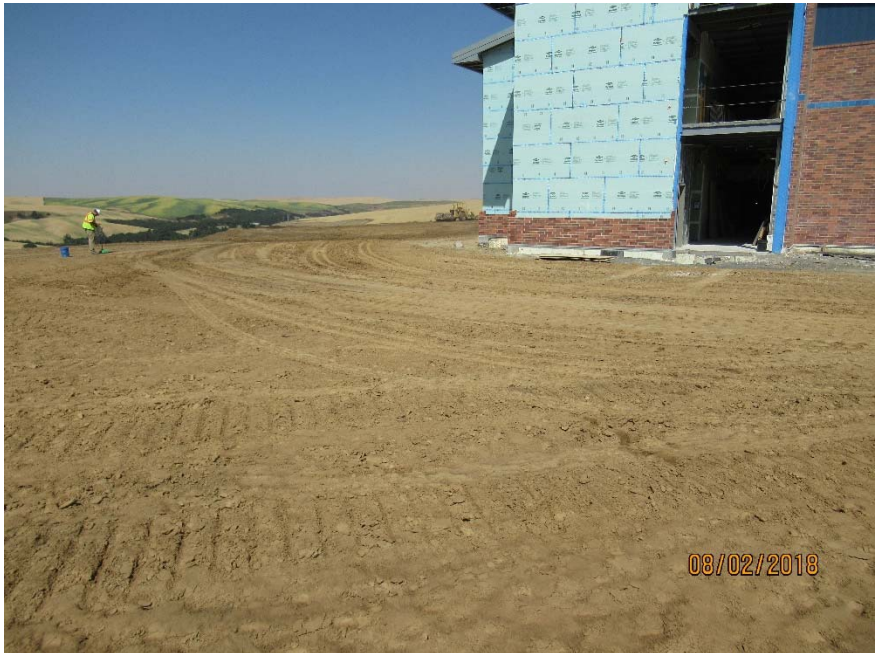
8. It appears the area on the south of the building is nearing subgrade elevation.

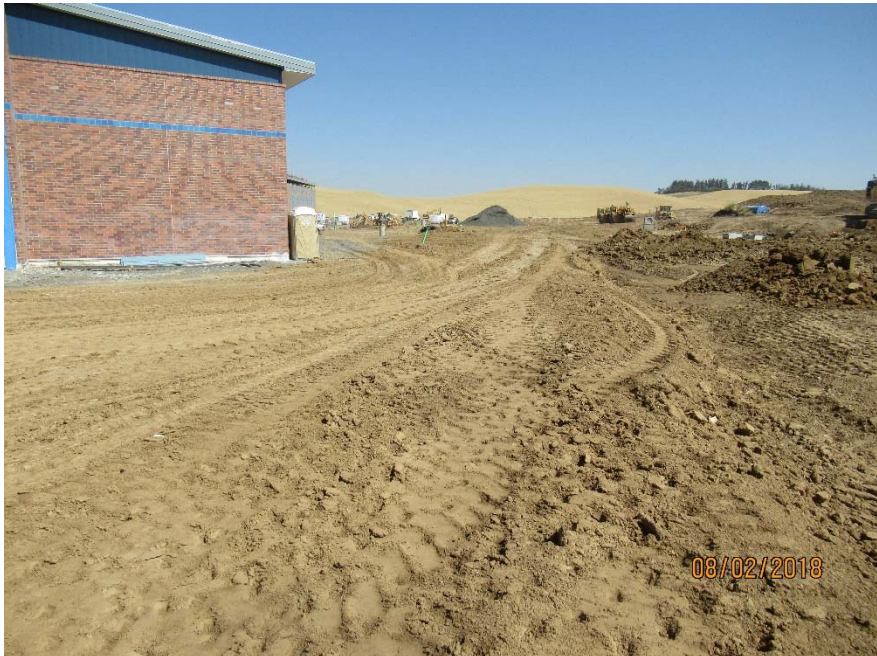
9. It appears the area on the south of the building is nearing subgrade elevation.

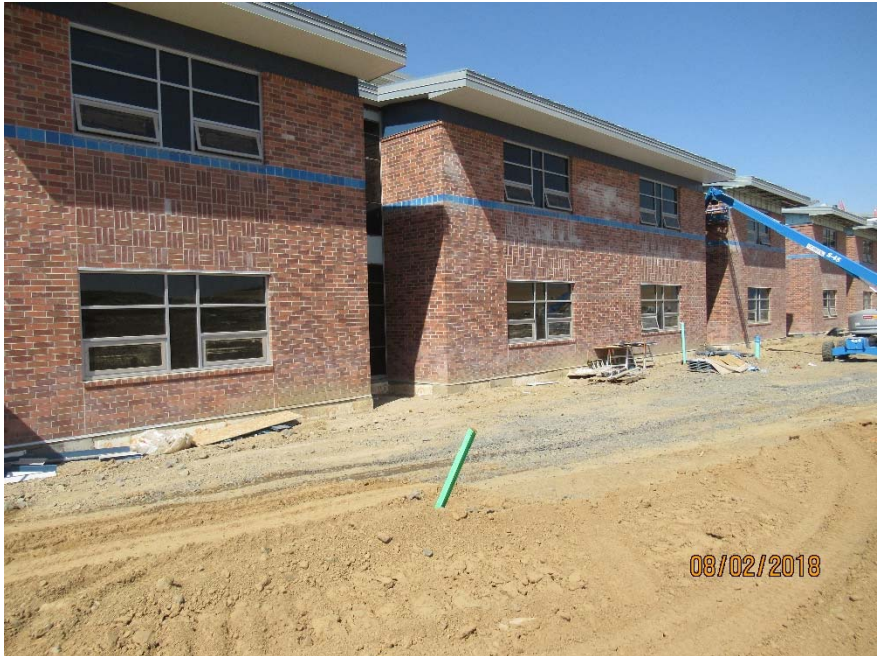
10. Metal soffit and wall panel installation continues.

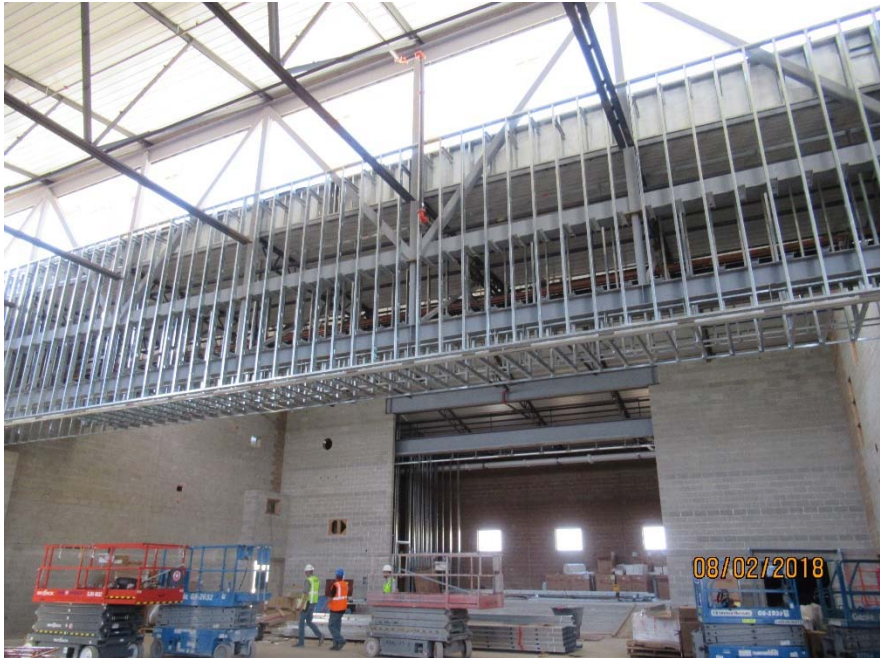
11. Framing of soffit between Gymnasium and Commons is nearing completion.

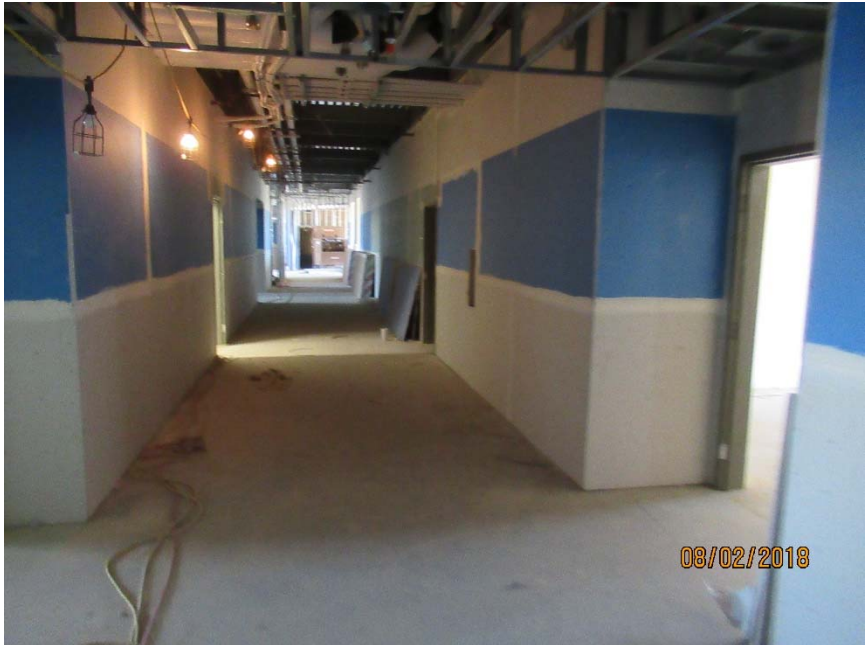
- 12. Lower Level Area A wallboard walls appear complete, taping of these walls underway.**

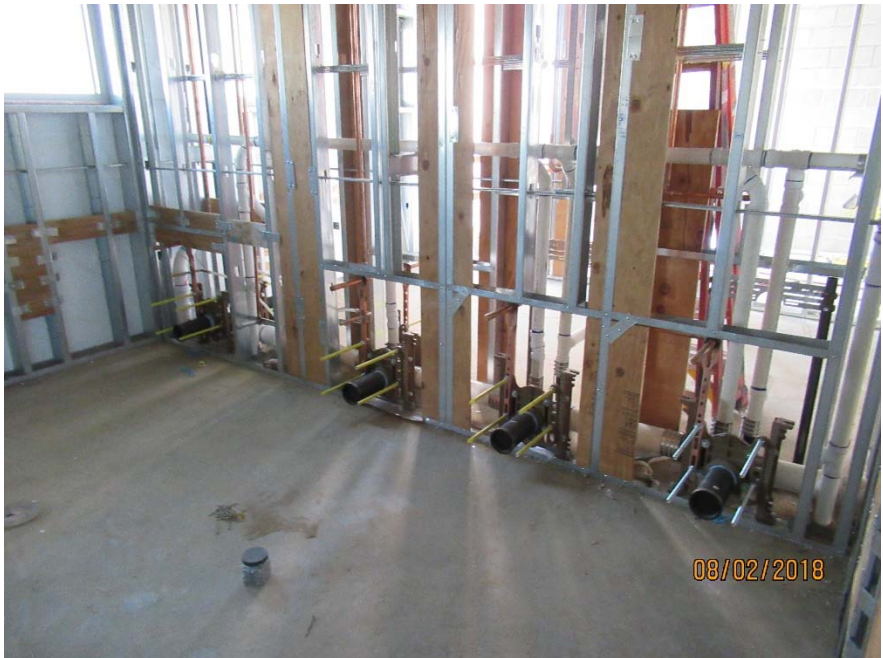
- 13. Lower Level Area B, it appears blocking and backing installation is nearly complete.**

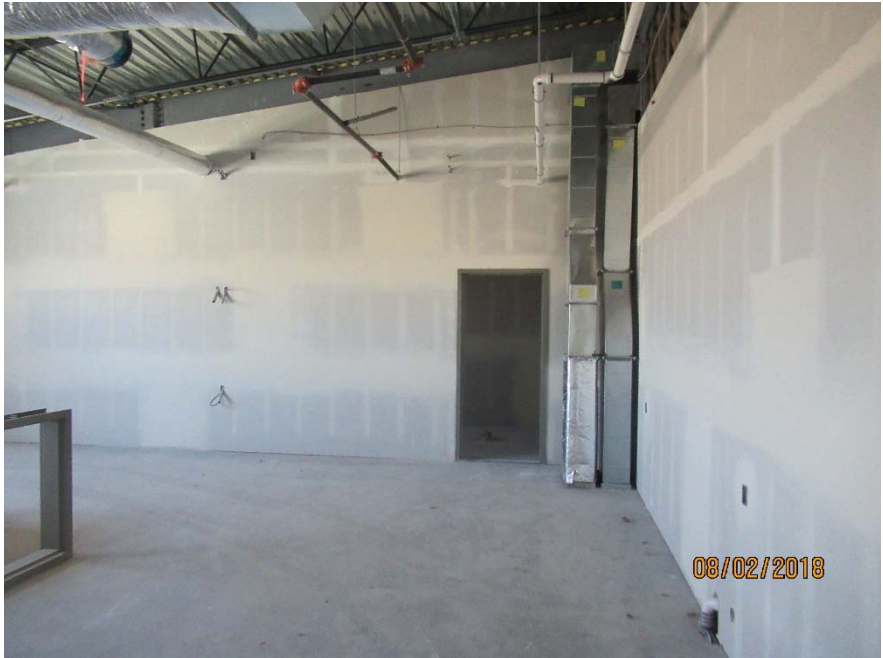
- 14. Upper Level Area A it appears taping is for the most part completed.**

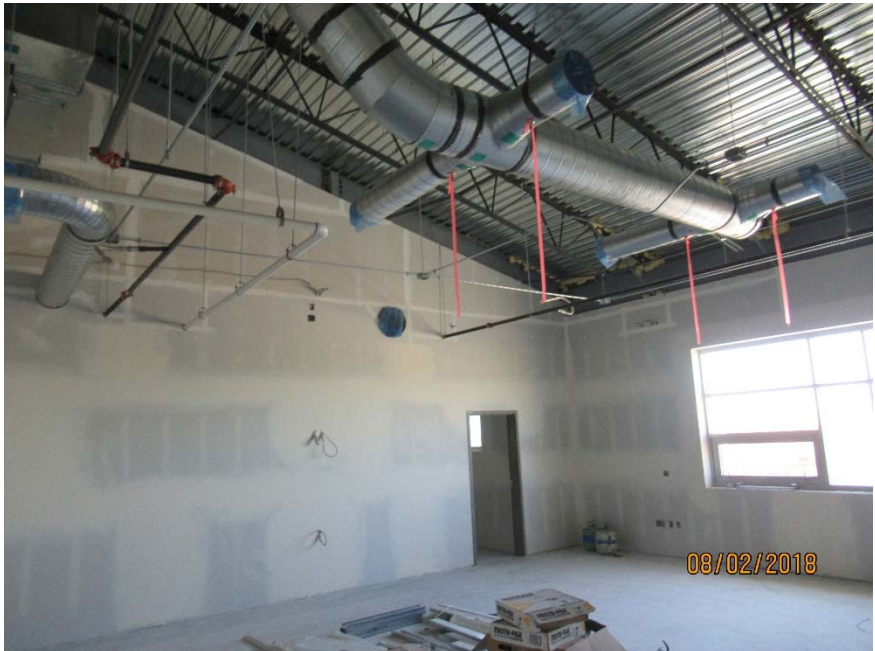
- 15. Upper Level Area A it appears taping is for the most part completed, as is fire sprinkler, water and duct rough in.**

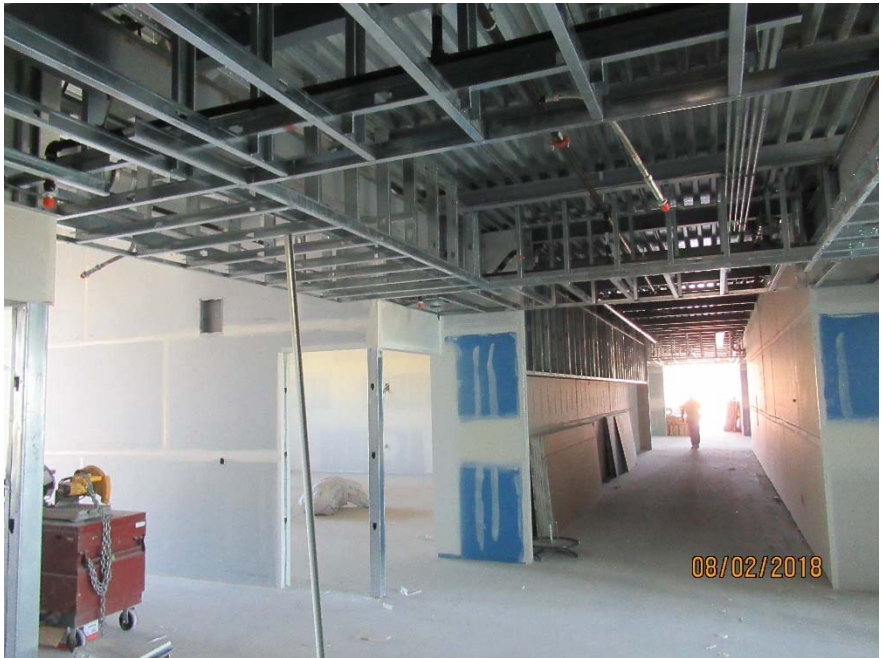
**16. Soffit framing at Upper
Area A appears complete.**

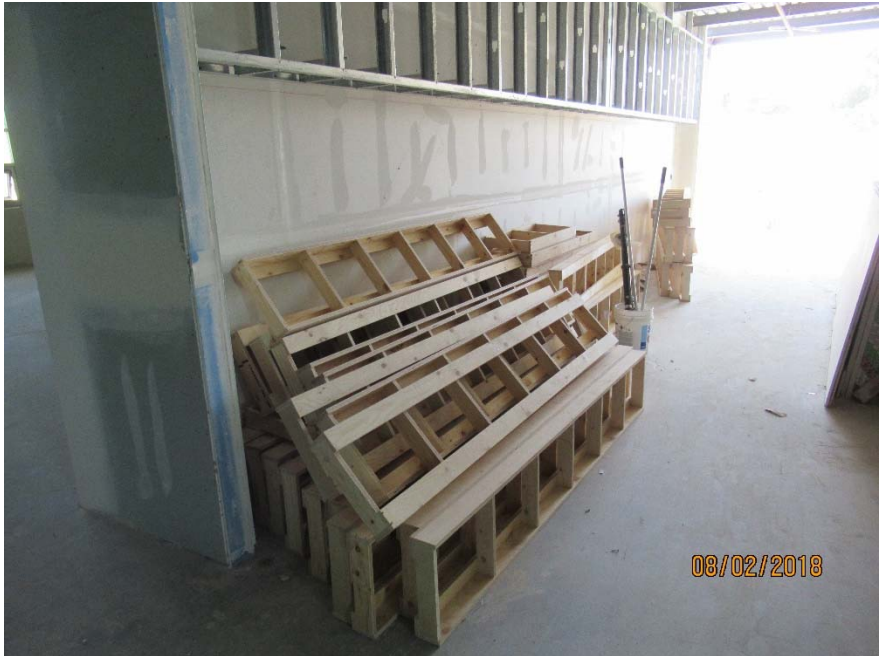
**17. Casework base has been
delivered.**

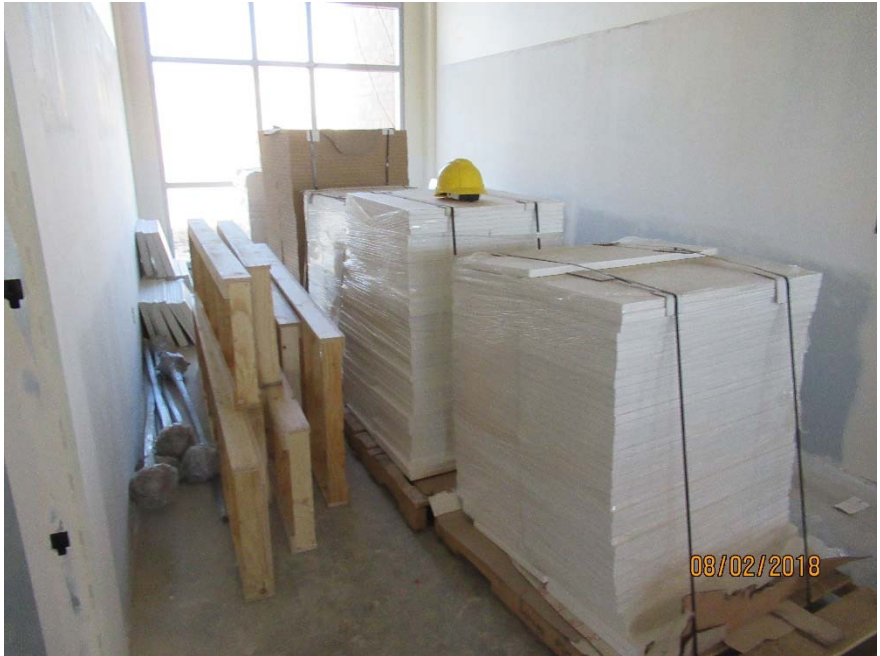
**18. Casework interior shelving
has been delivered.**

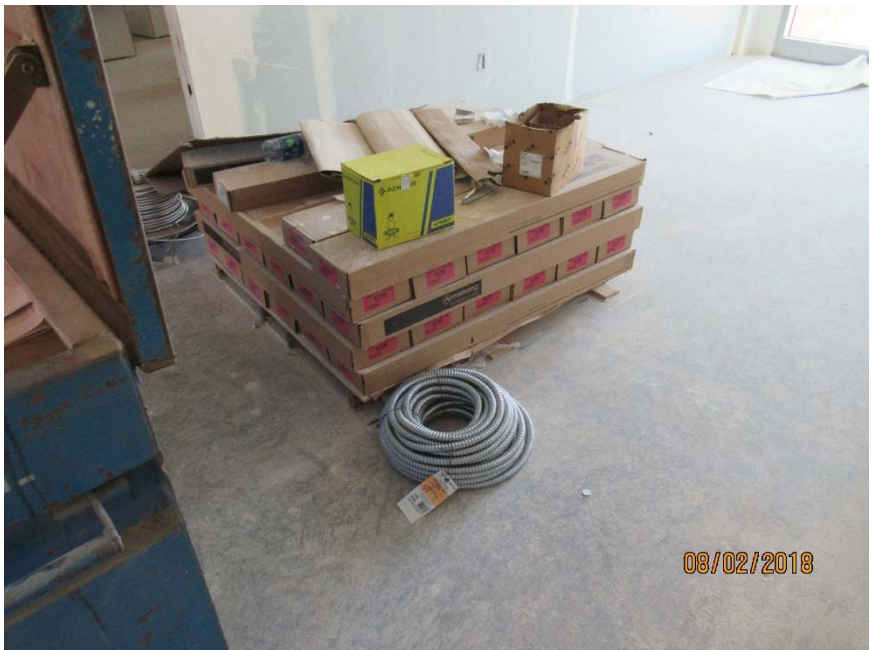
19. Ceramic tile delivered.

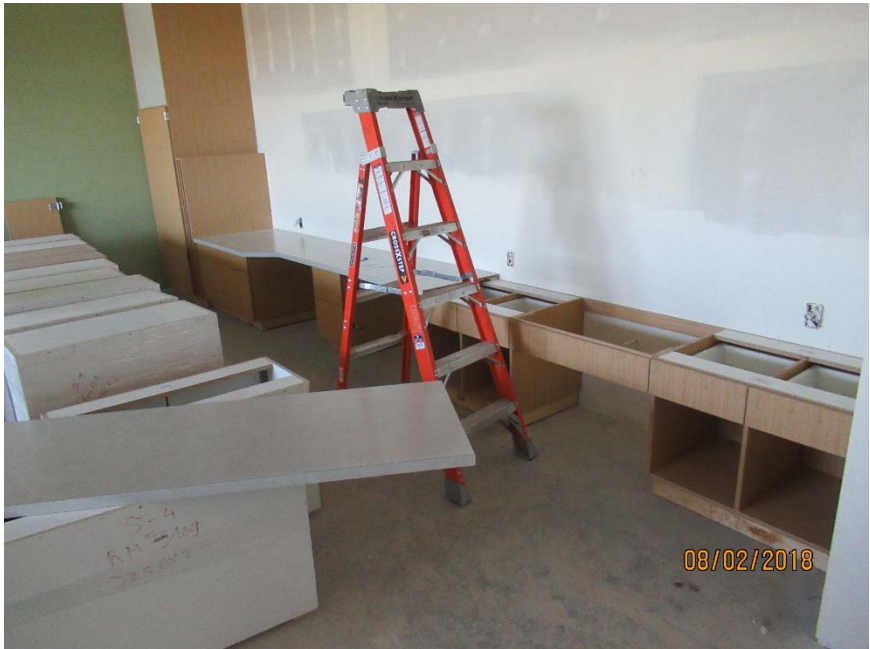
**20. Lower Floor Area A:
Kindergarten classroom
lower casework installation
is underway.**

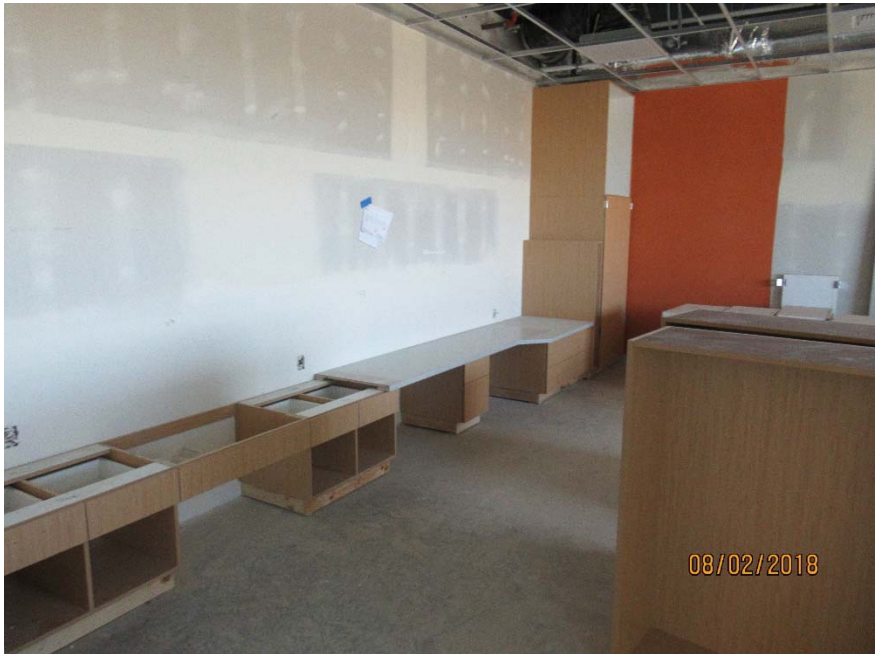
**21. Lower Floor Area A:
Kindergarten classroom
lower casework installation
is underway.**

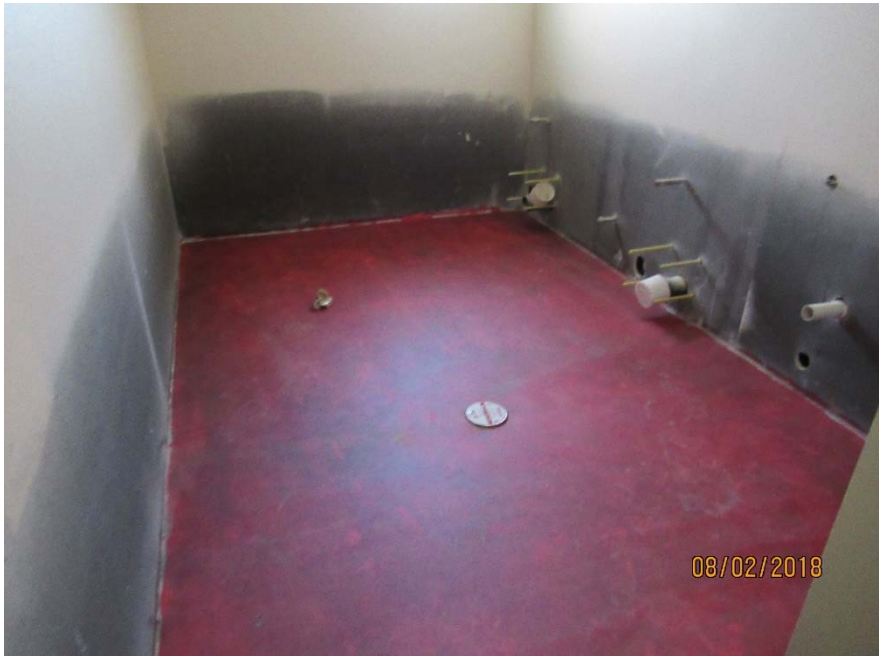
22. Contractor has applied the ceramic tile floor substrate sealant.

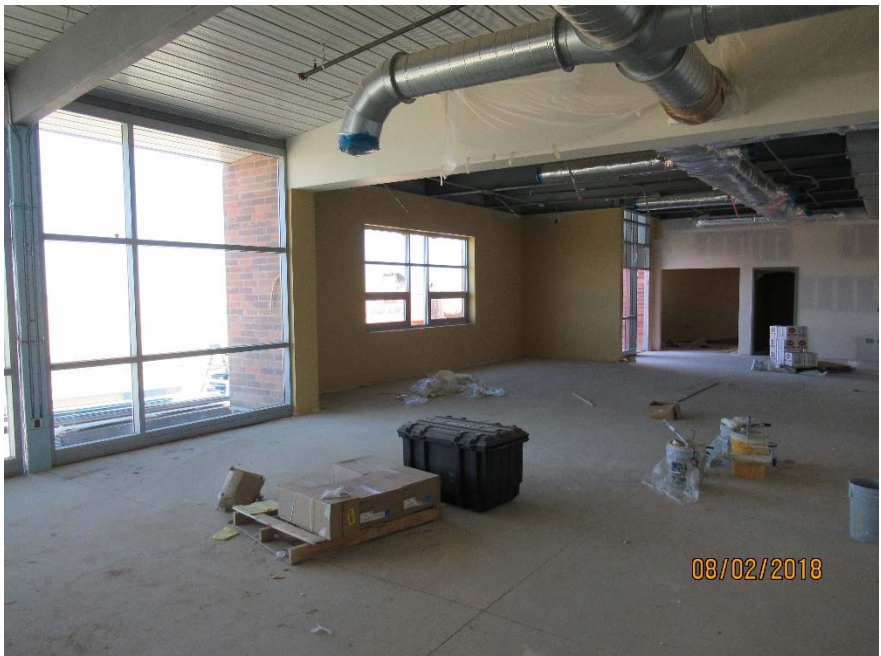
23. Appears the Library accent wall has been painted.

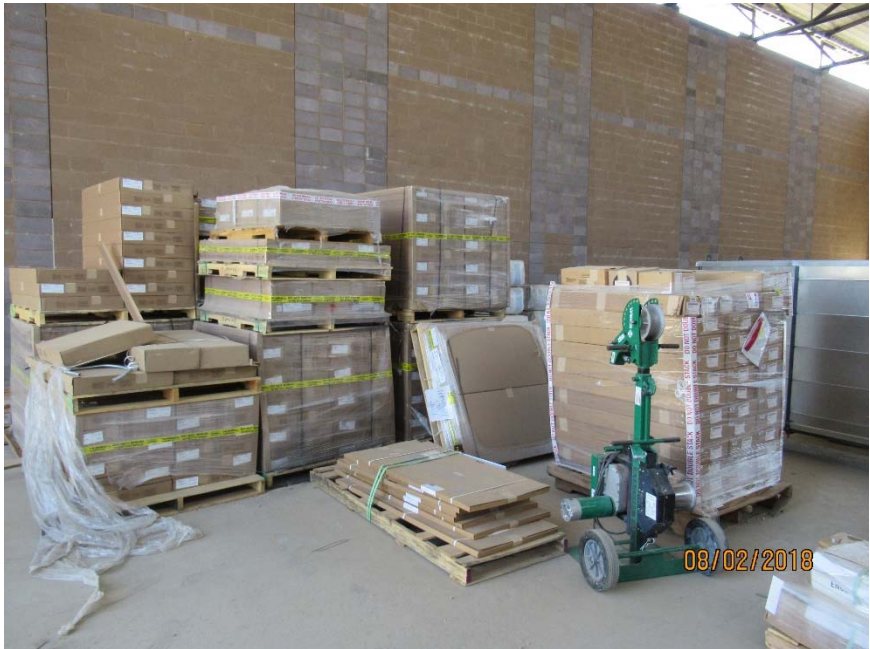
24. Appears the contractor has accepted delivery of light fixtures.
