**Project: PSD: Kamiak Elementary School****Date: August 9, 2018****Weather conditions:**

**Discussion with:** See Construction Progress Meeting dated 8/9/18.**Construction Activities:**

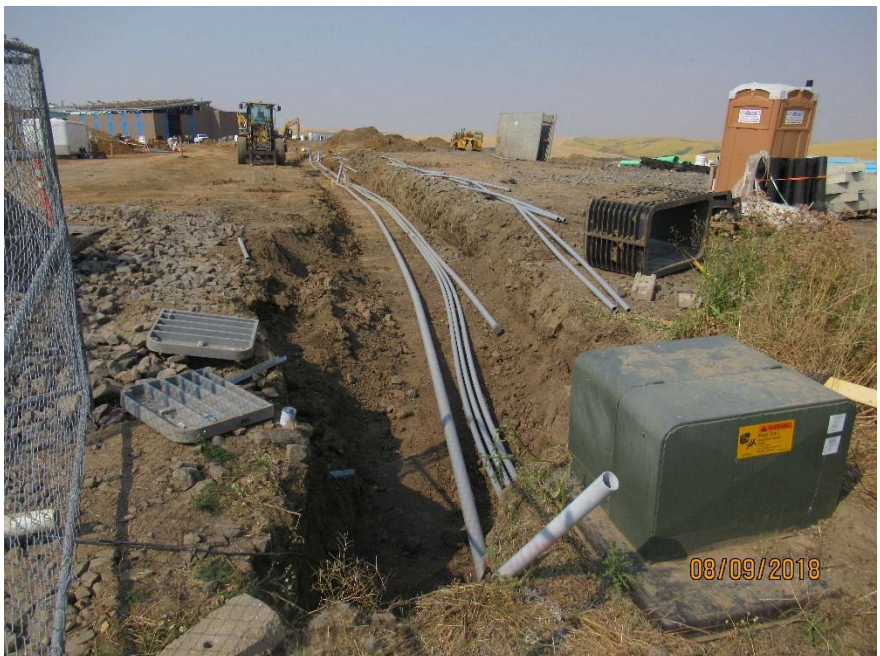
1. It appears the developer has begun installing the dry utilities. Power and fiber conduits. The District added conduit for the District fiber has not yet been installed. There appears to be a fiber run across the road near where the Districts conduit run is supposed to be run but it is not the Districts. Developer was notified today at the Project Meeting that the District conduit run is for District use only and the Districts fiber is not to be run in others fiber conduit.

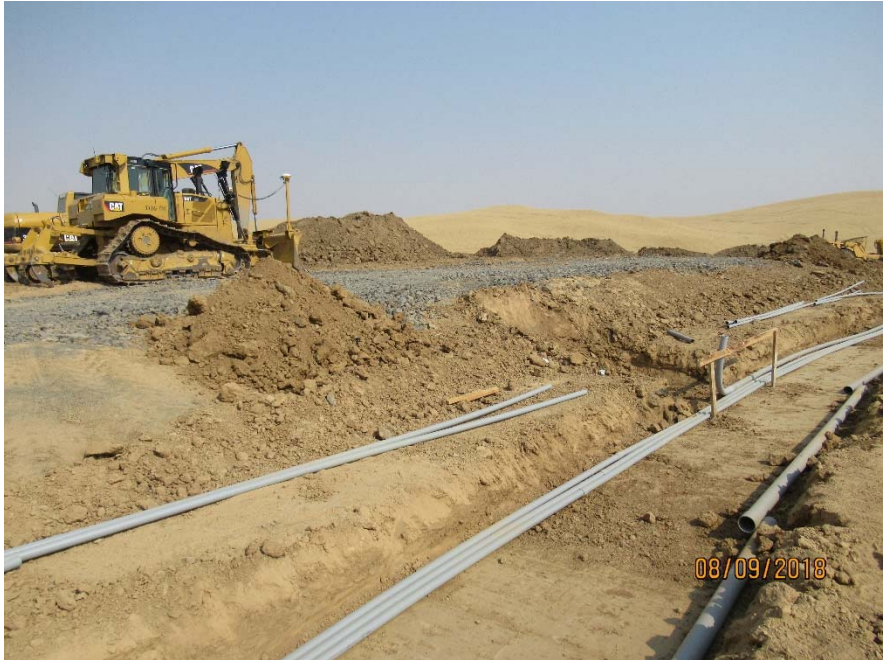
2. Another photo of dry utilities install looking northwesterly. Note the temp road has not yet been taken down in elevation. Walker stated removal will begin next week.

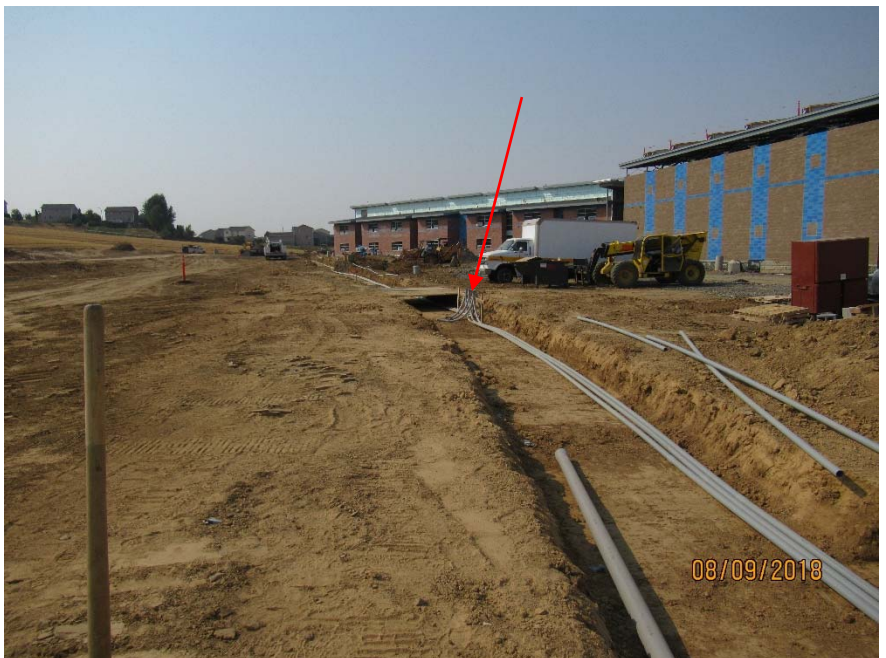
3. Dry utilities install looking south. Note (arrow) developer has stubbed up the electrical north of the entry. The District fiber stub up will be on the south side of the entry. Architect will draft a PR to extend electric to stub up on north side of entry.

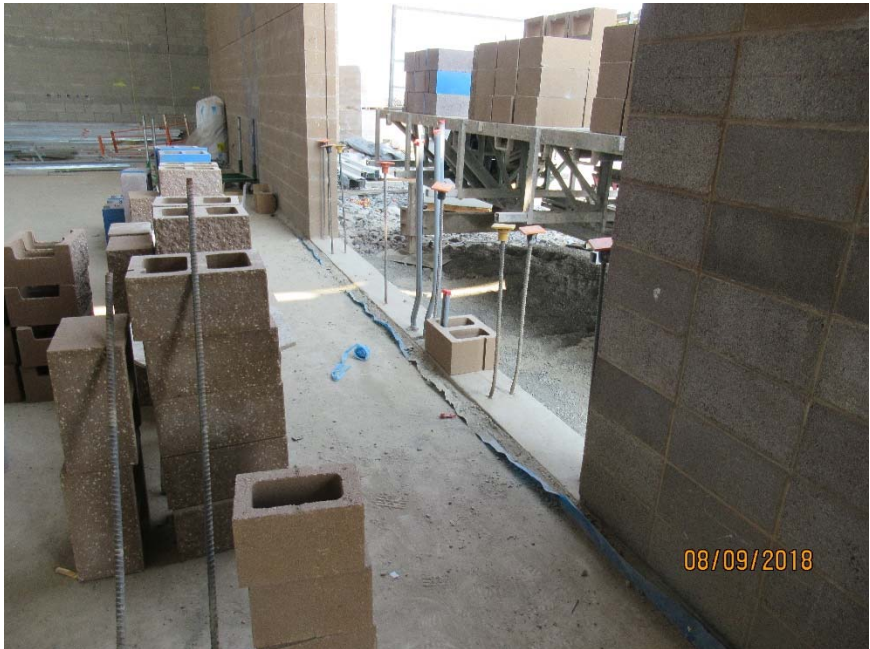
- 4. It appears the masons have CMU staged and scaffolding set to enclose gymnasium wall access opening.**

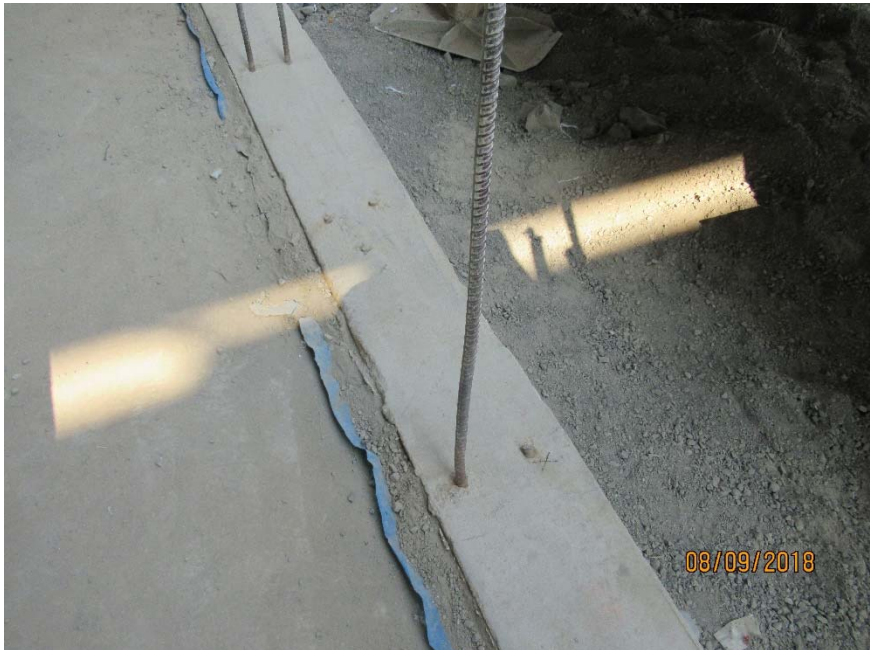
- 5. This is a close up of the above photo. Contractor broke off three rebar stub-ups when straightening. There is a RFI concerning approval to drill and epoxy new rebar vertical reinforcing into the foundation.**

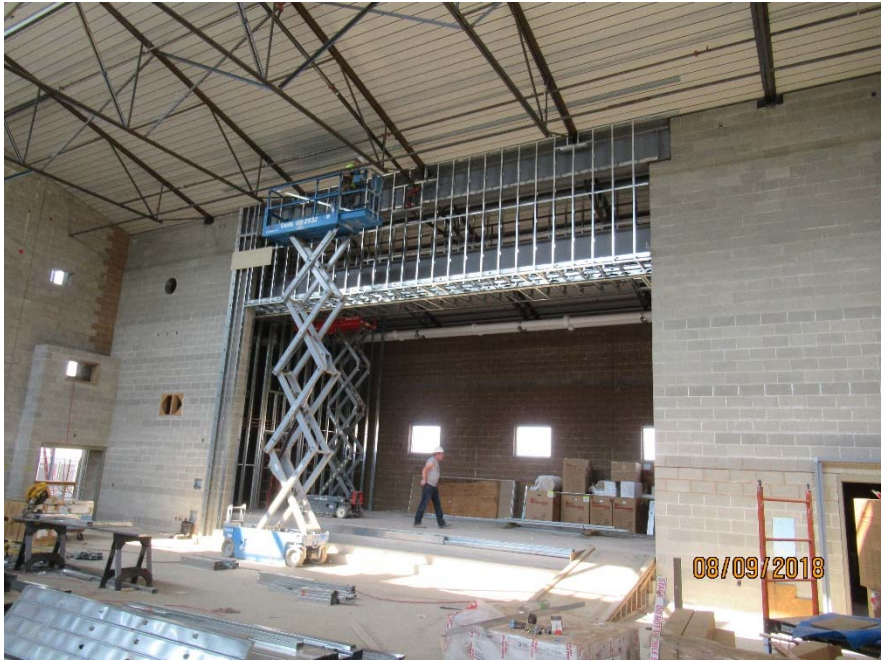
6. Contractor continues framing in the gymnasium. Currently framing the proscenium soffit. Behind the scissor lift the framing of the Storage room can be seen.

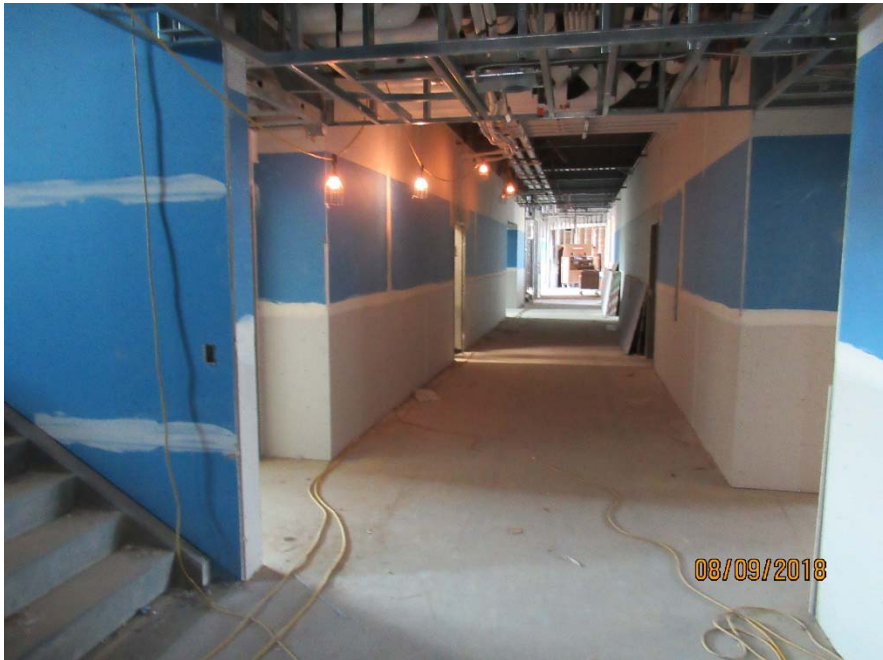
7. Area B lower level: Contractor continues taping wall board.

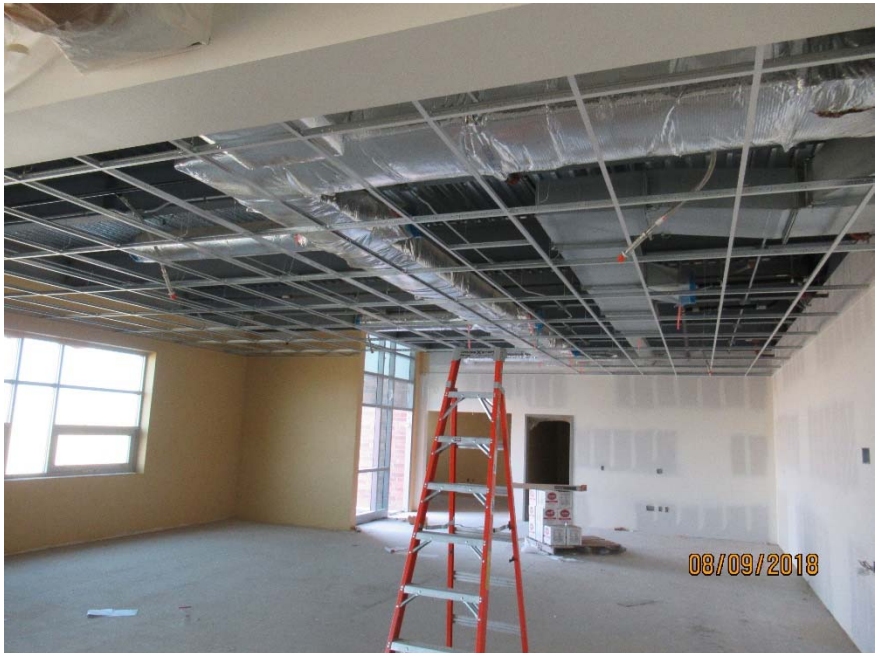
8. **Area B lower floor:** The contractor has installed the ceiling grid in north portion of Library.

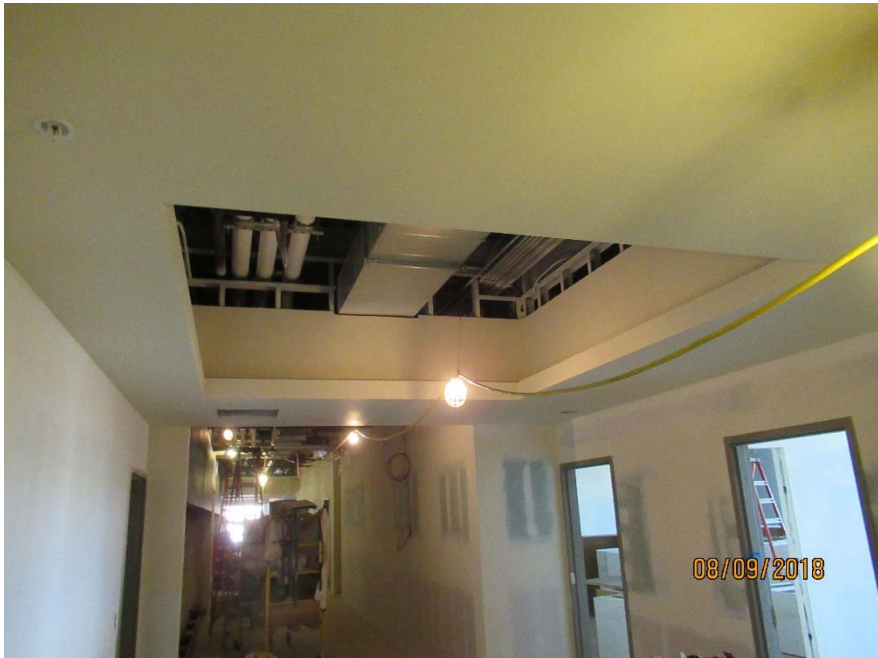
9. **Area A lower floor:** Corridor soffits have been painted.

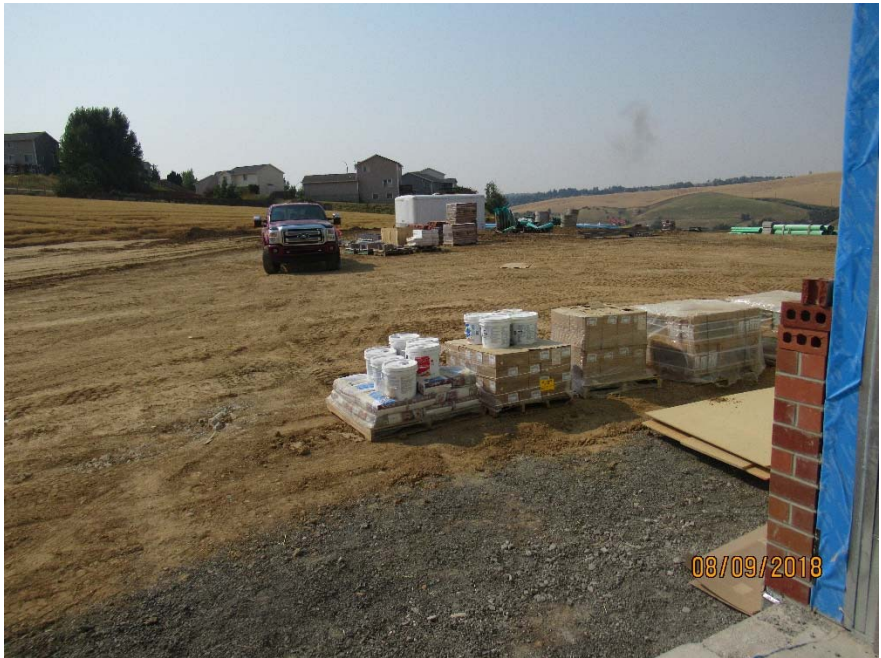
- 10. South end of the building: It appears the playground area is up to subgrade.**

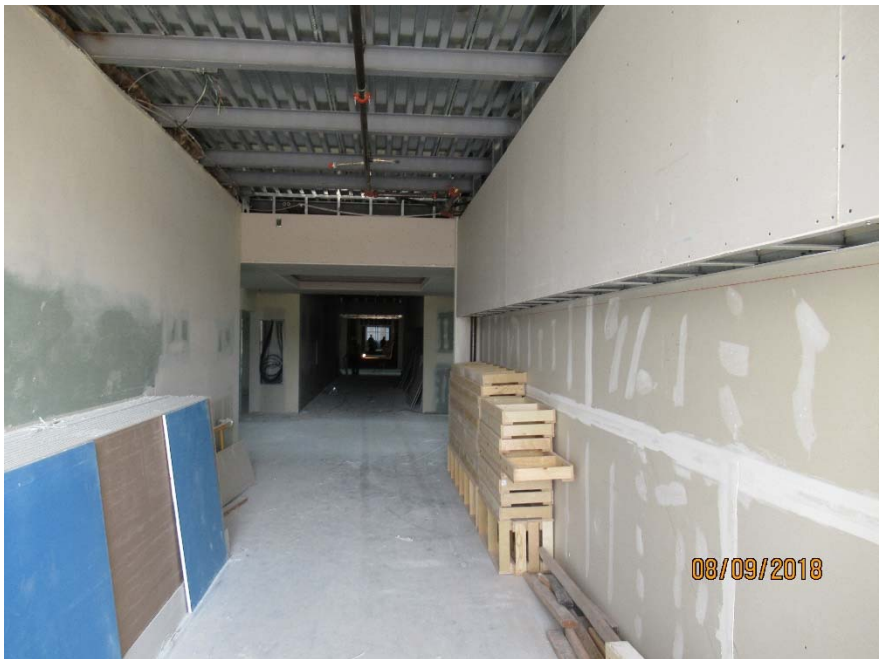
- 11. Area A upper level: Appears contractor is nearing completion of wallboard install. Most classrooms have been taped, and taping finishing corridor wallboard is underway.**

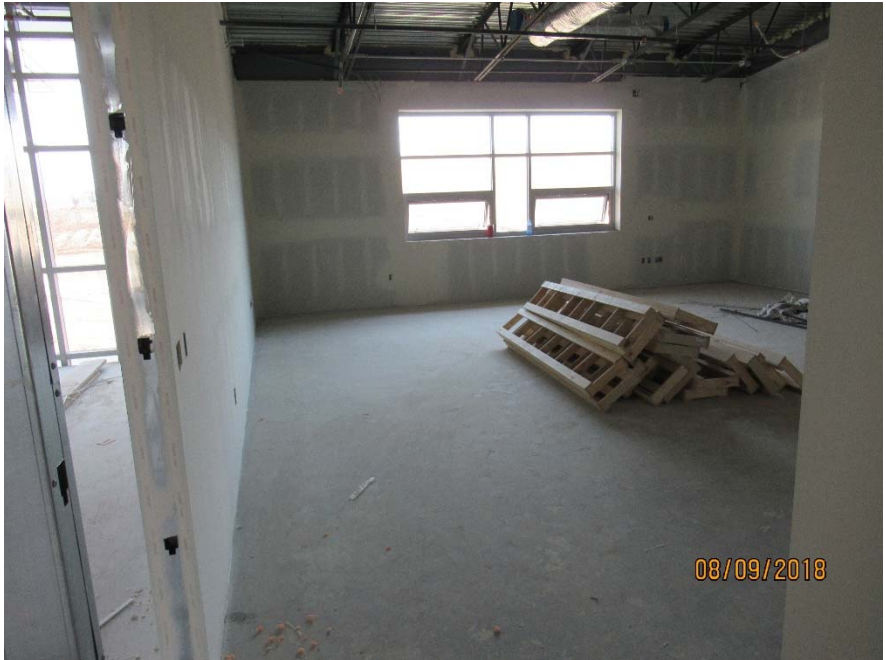
- 12. Area A upper level: Many if not all classrooms have been taped. Casework bases are staged in some Classrooms.**

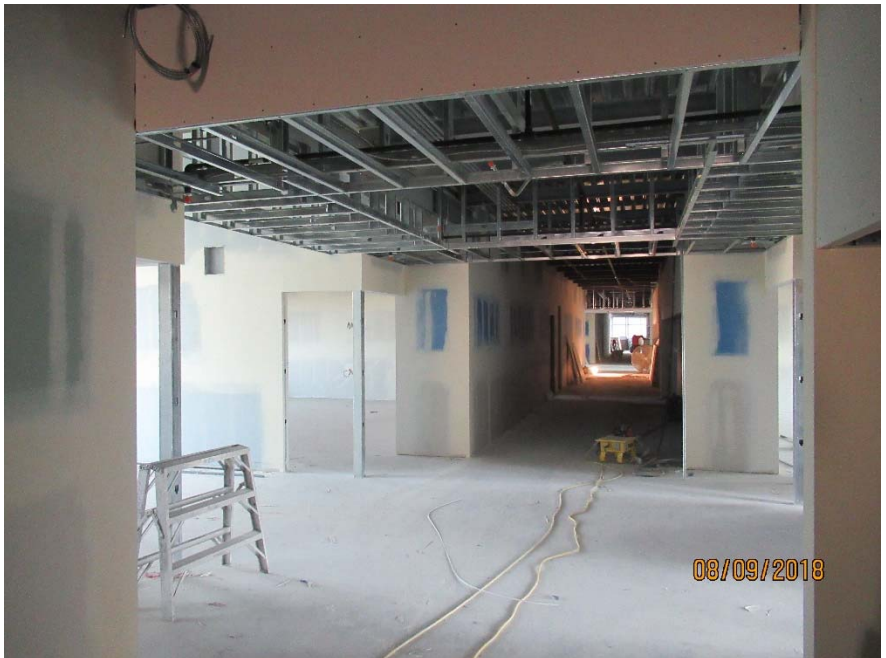
- 13. Area A upper level:  
Wallboard installation at  
corridor soffits underway.**

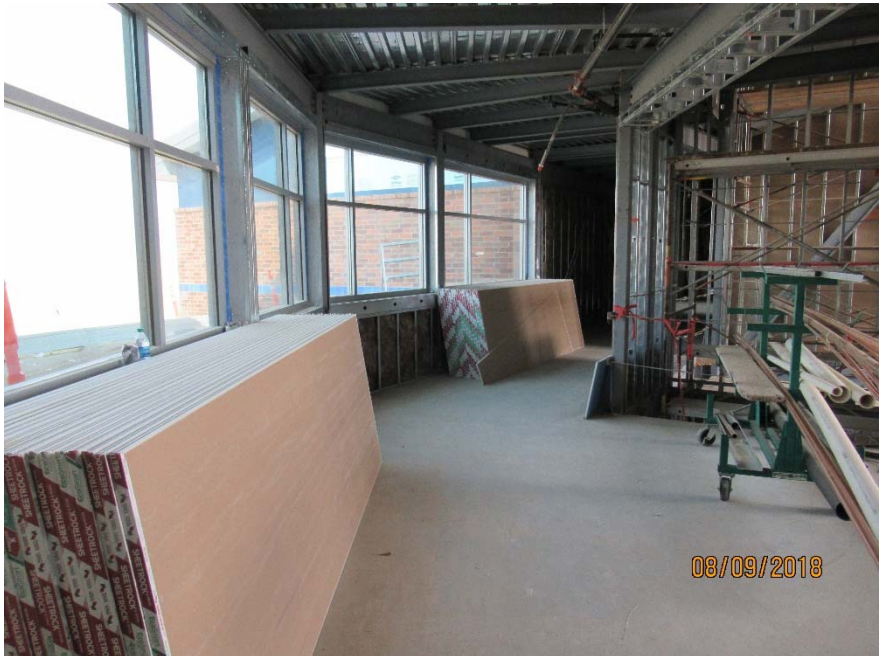
- 14. Juncture of Area A and B upper level: Appears most framing has been completed. There are a few framing questions that need to be addressed before wallboard installation can begin.**

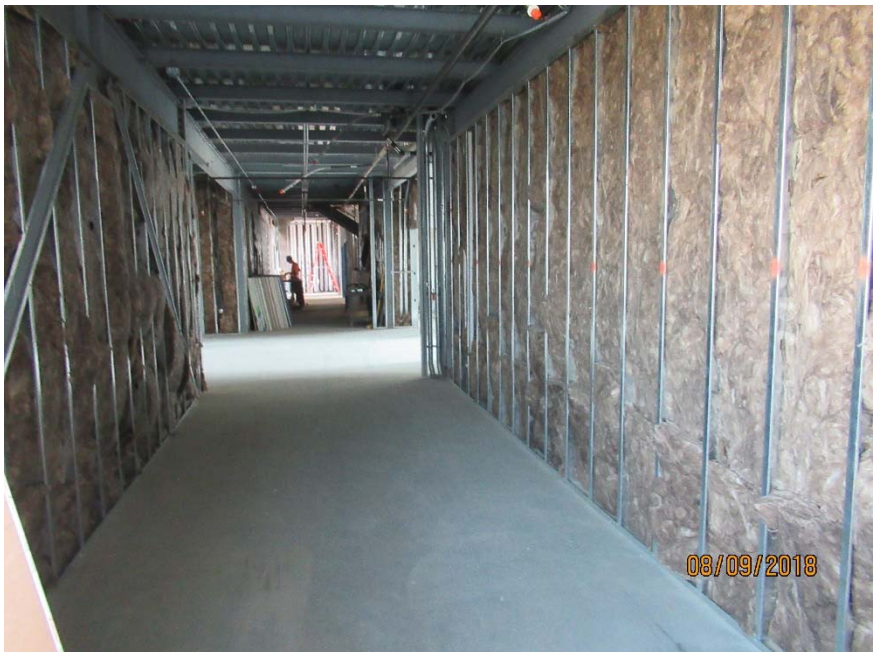
- 15. Area B upper level: It appears most the blocking and backing has been installed and acoustical insulation is installed. Wallboard installation will begin next week.**

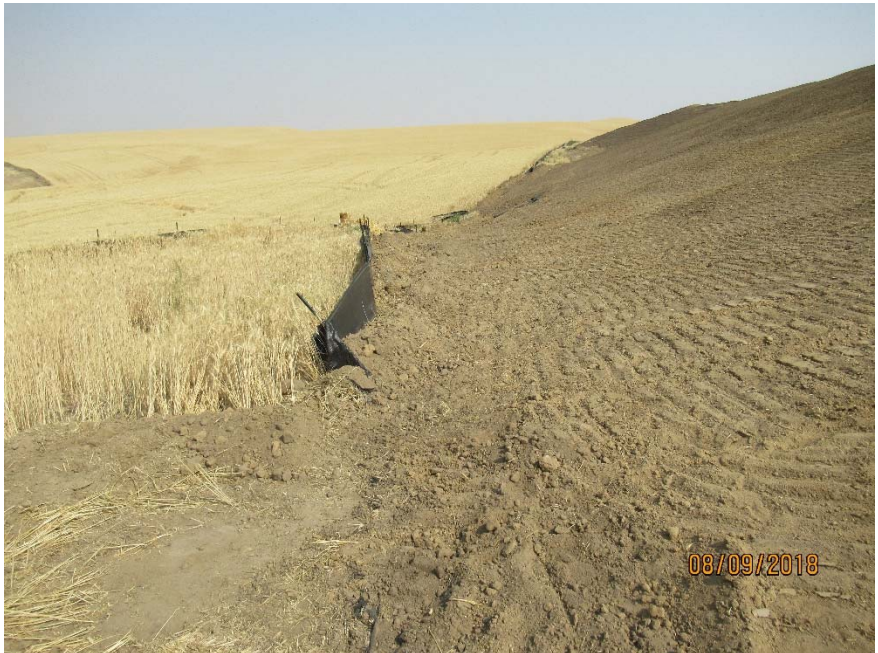
- 16. Photo is looking north at the base of slope west of lower playfield: I informed the contractor that Motley has left a large berm at the bottom of the slope that will need to be addressed.**

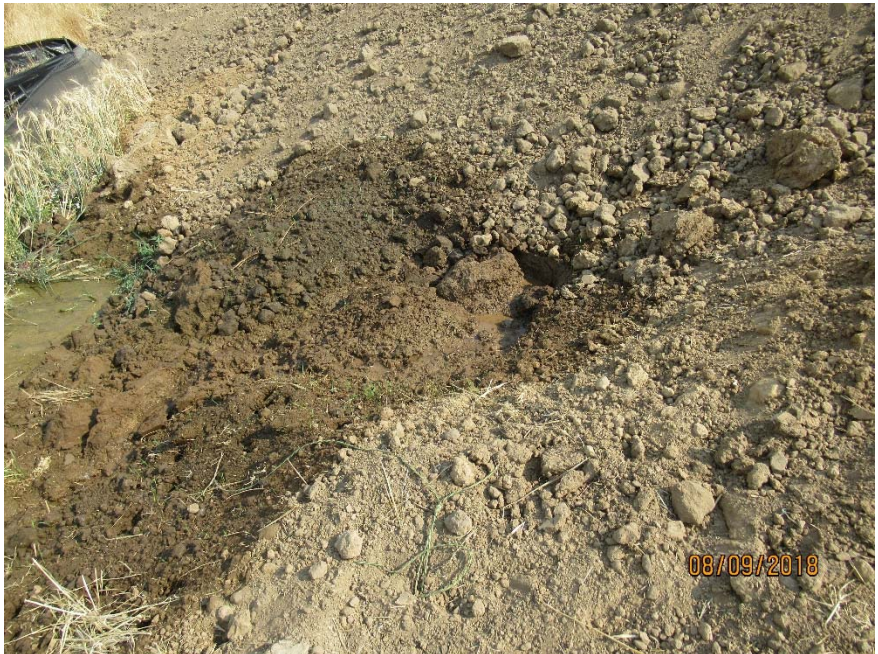
- 17. This is a photo of the underdrain west of the lower playfield. There is a PR that has been put into C.O. 2 to extend and improve the underdrain where it daylights. I reminded the contractor this needs to be addressed while area around outflow is accessible.**

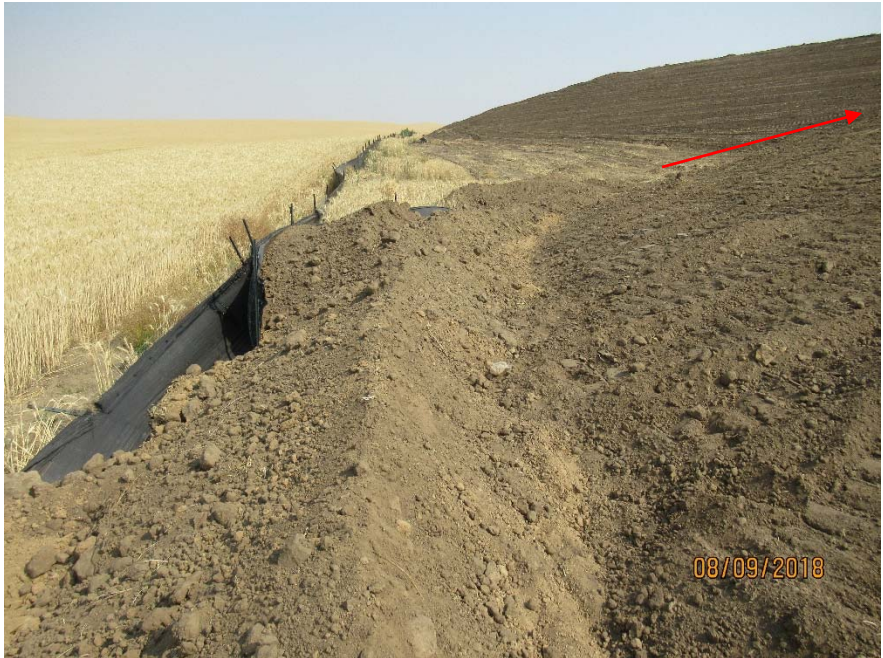
**18. Photo is looking north at the base of north end of west slope of lower playfield: I informed the contractor that Motley has left a large berm at the bottom of the slope that will need to be addressed.**

**Arrow shows where the valley that runs up between upper and lower playfields.**

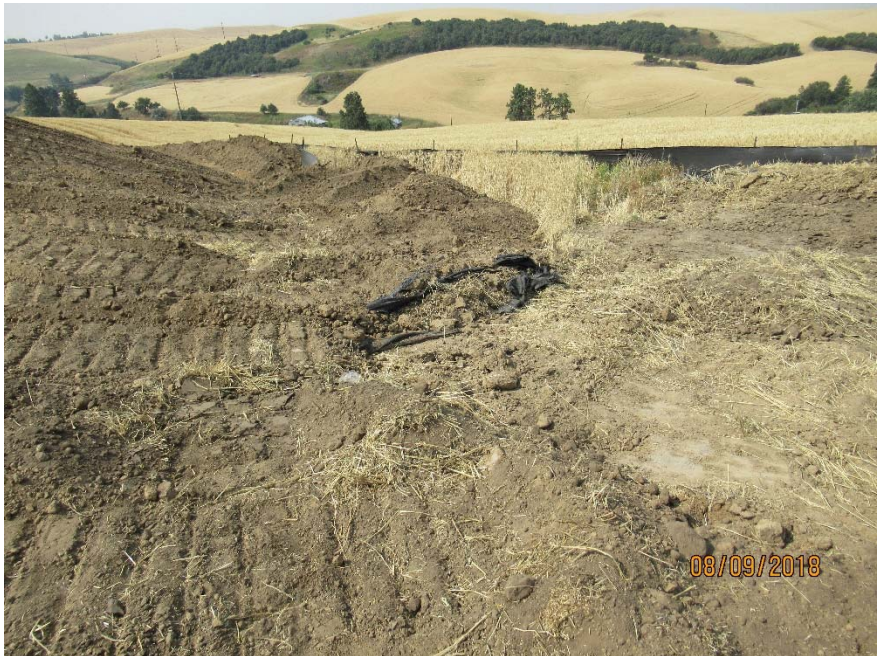
**19. Photo is looking north at the base of north end of west slope of lower playfield: I informed the contractor that Motley has left a large berm at the bottom of the slope that will need to be addressed.**

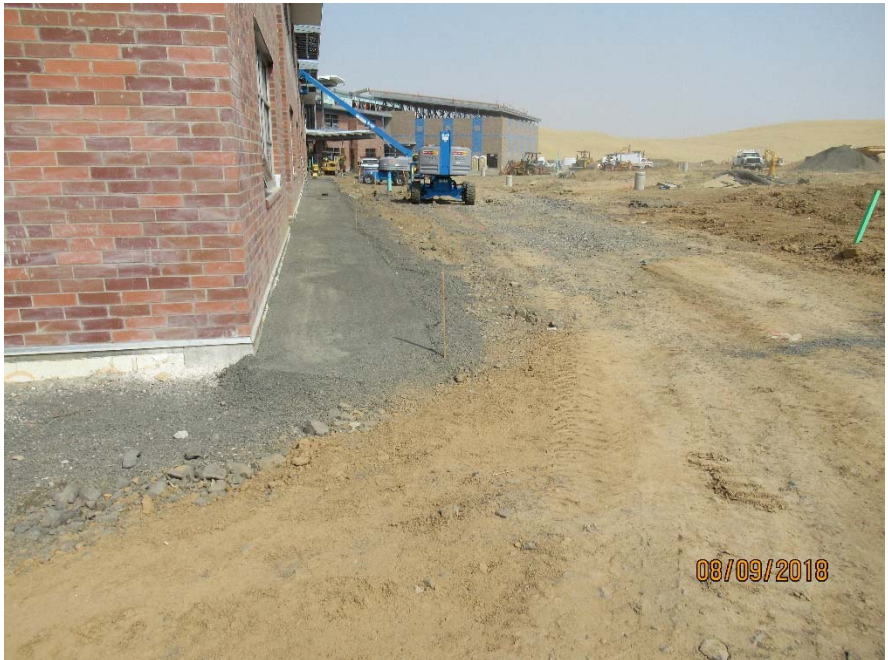
- 20. Looking north along the east side of the building. It appears the contractor has placed base for sidewalk.**

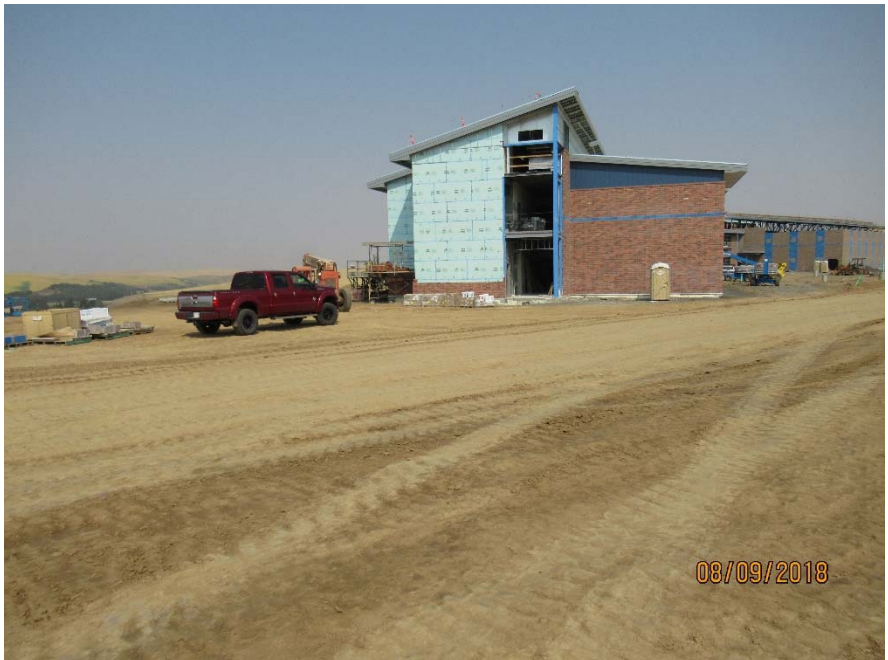
- 21. Looking north at the south end of the building. See scaffolding to the left. Masons laying brick veneer. Area where the truck is and to the right of it will be the playground area.**

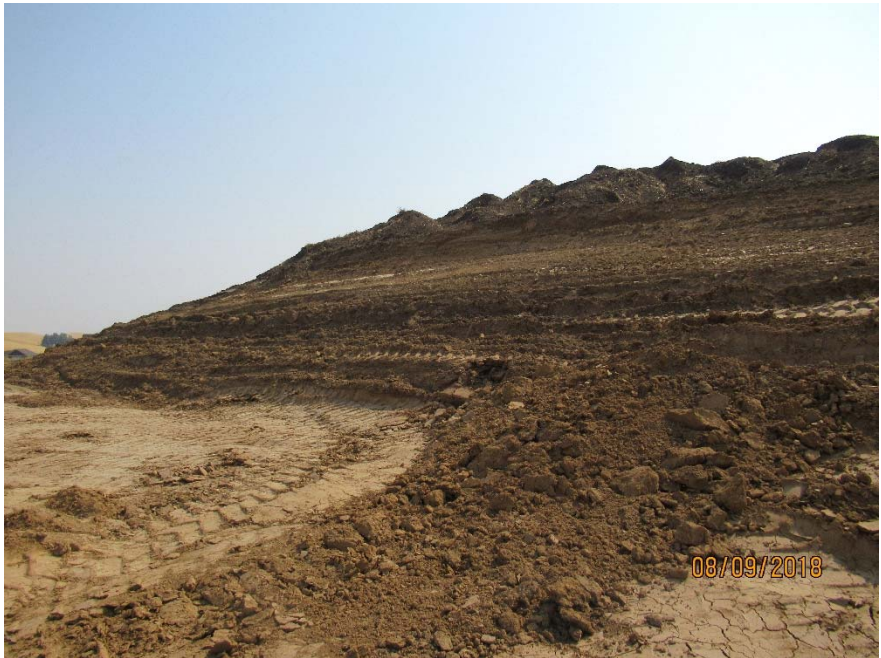
**22. View is looking northeasterly at the easternmost side of the borrow area.**

**The rough piles at the top are top soil. According to Walker, Motley will push and shape piles over the hill towards me. I have notified the District and the Developer the condition of this topsoil needs to be discussed, it is not addressed in the MOU as far as erosion control is concerned.**

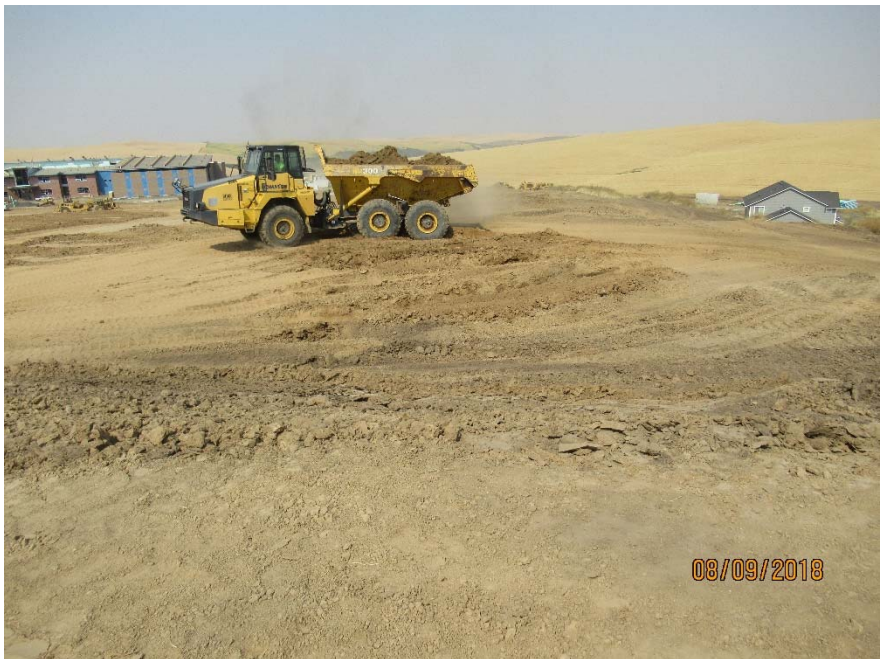
**23. It appears as the developer is moving dirt from 3 building sites to the north of the borrow site and running dump trucks over one of the building pads that Motley built as part of the borrow. There are a number of locations along the dump route where the dump trucks have rutted the area. It appears the rutted areas are possibly pumping.**

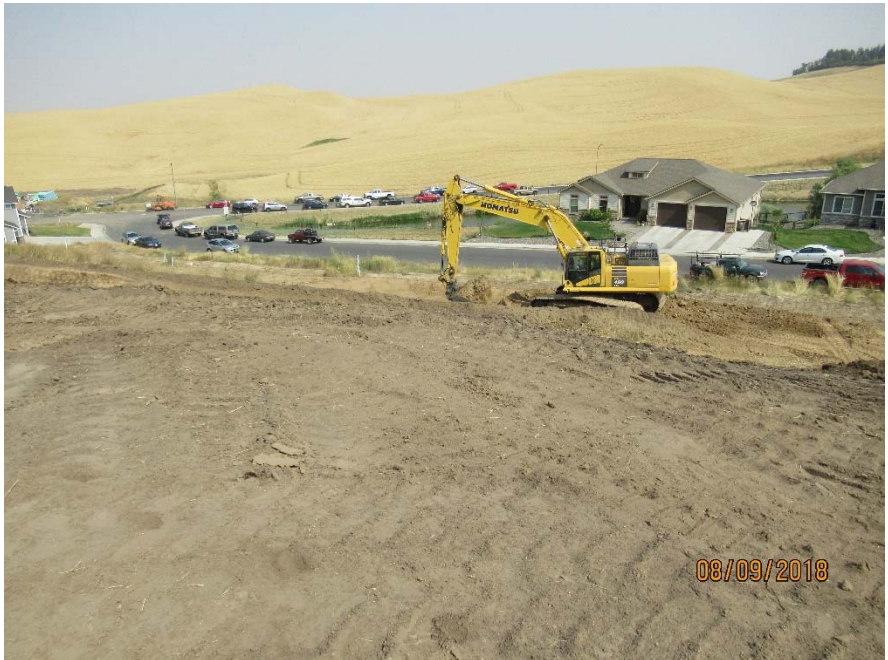
24. A view to the north of the borrow site where the developer is developing three building sites.

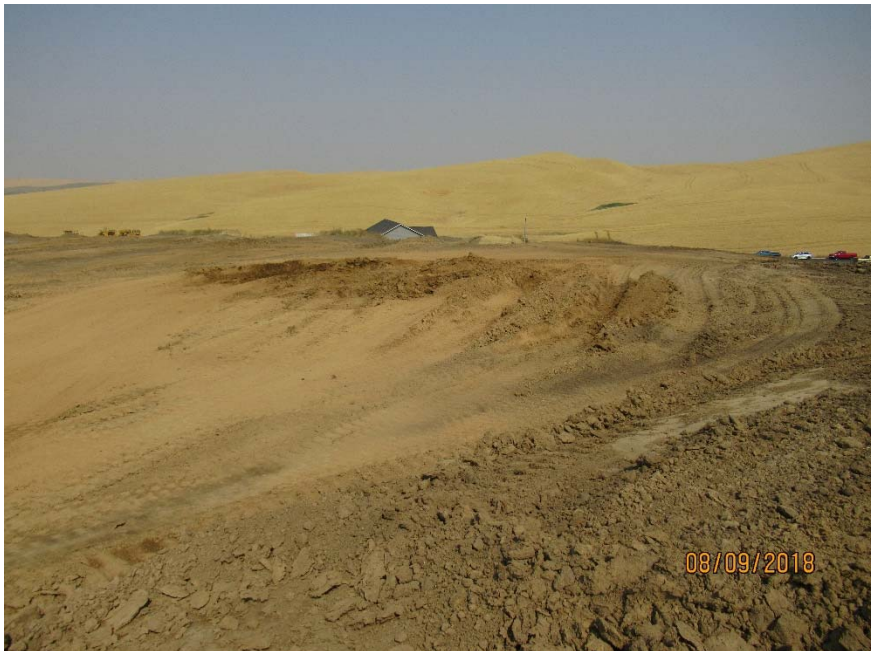
25. Another photo where the dump route has degraded the soils at one of the building pads that were roughed in by Motley.
