**Project: PSD: Kamiak Elementary School****Date: September 27, 2018****Weather conditions:**

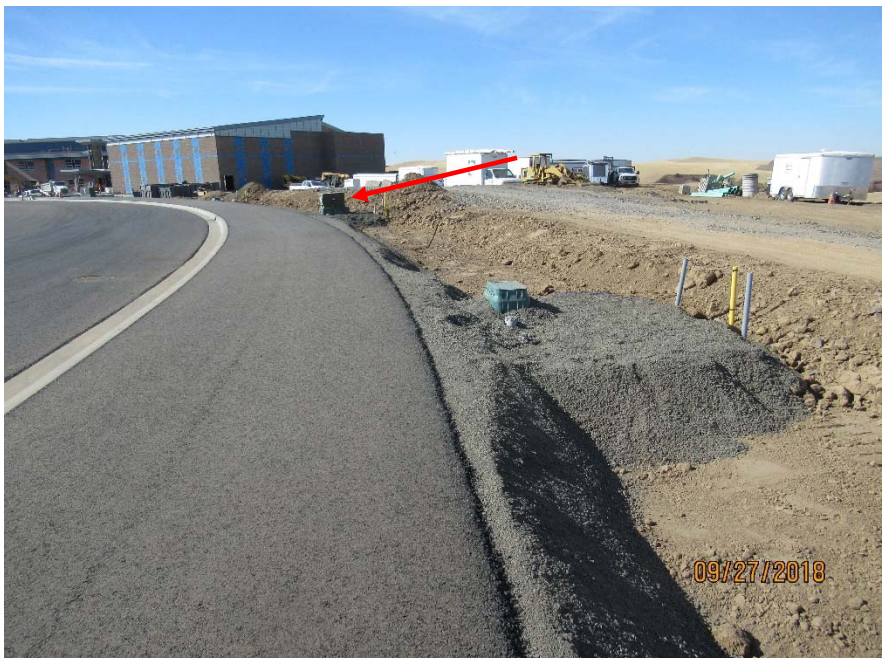
1. Avista has installed transformers and run the power to past the school. Walker now has power to the building.

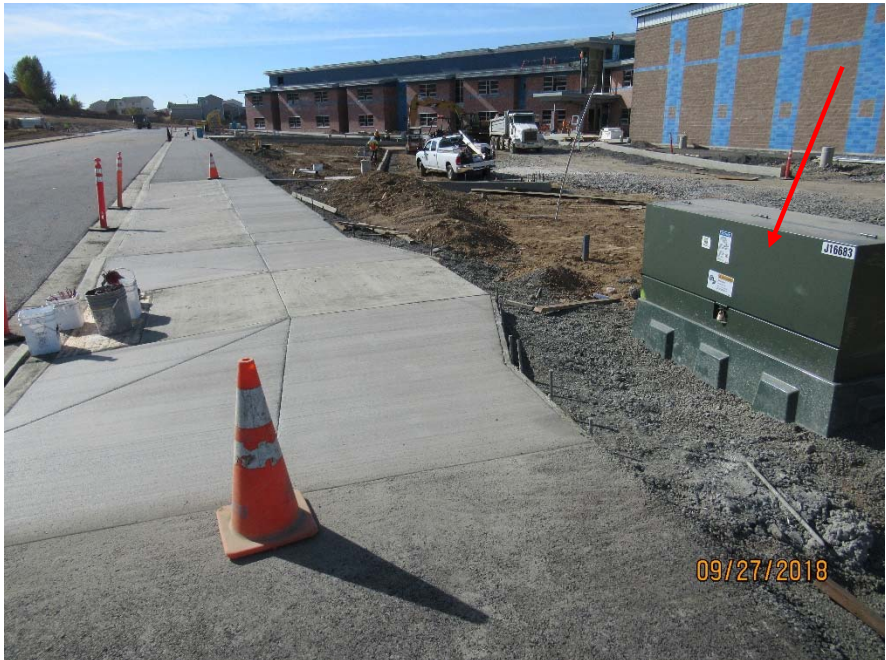
2. Avista has installed transformers and run the power to past the school. Walker now has power to the building. Driveway approaches have been placed Friday last week and one on Monday this week. The developer needs to let these cure for 10 days before Walker can cross them.

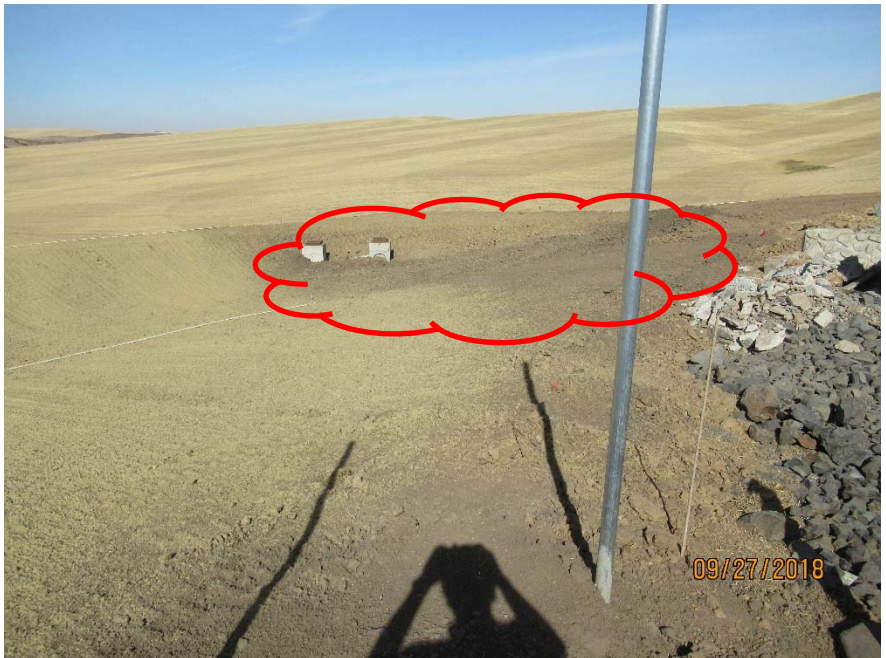
3. It appears most of the northeast retainage pond has been hydroseeded. Appears the northeast area has not been seeded.

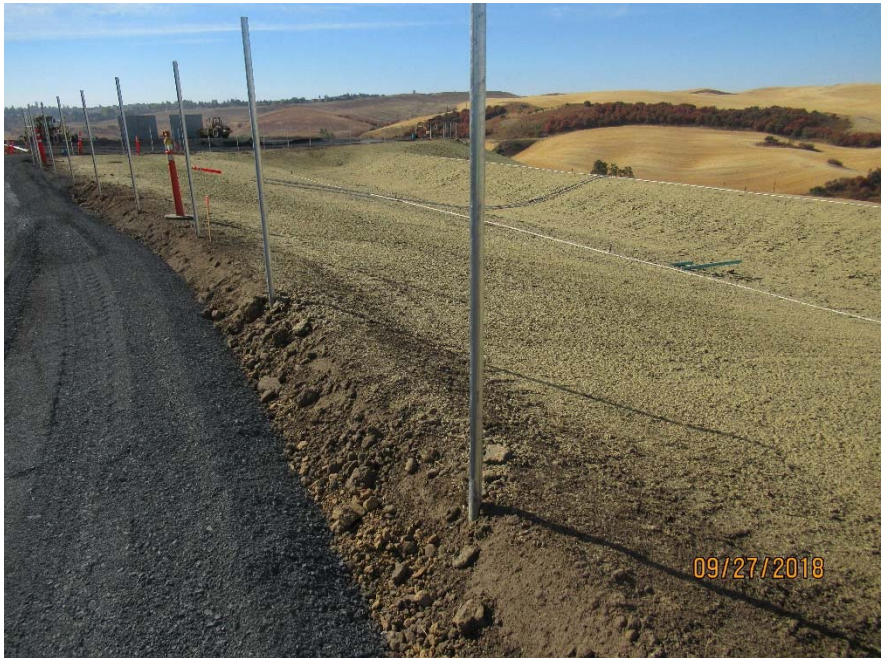
4. This a view to the south of the same retainage pond in the above photo.

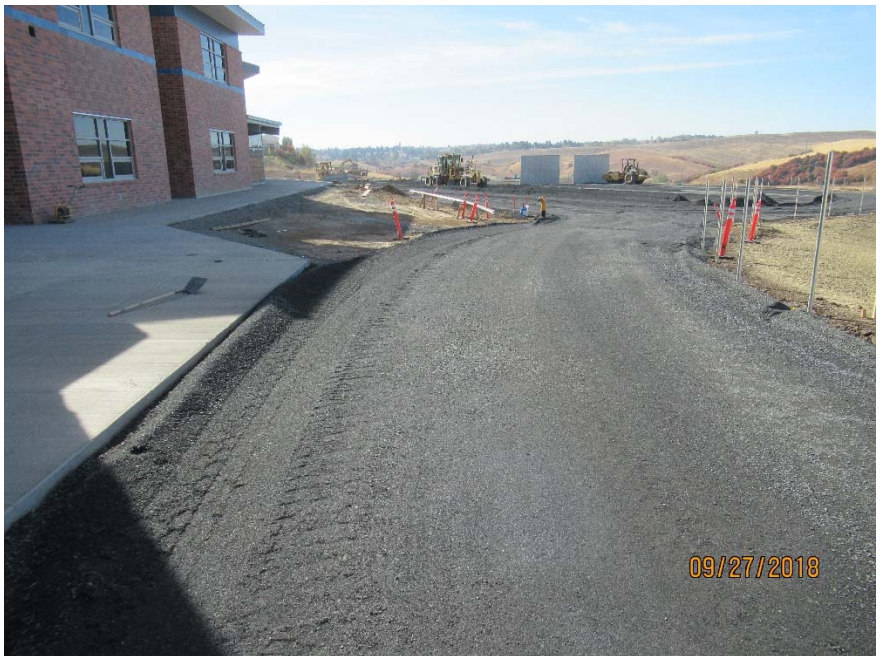
5. It appears the earthwork contractor continues to spread gravel for asphalt placement. Asphalt is scheduled for October 3rd, 4th and 5th. OR if the highway asphalt placement is that week it will be delayed to the week of October 8th.

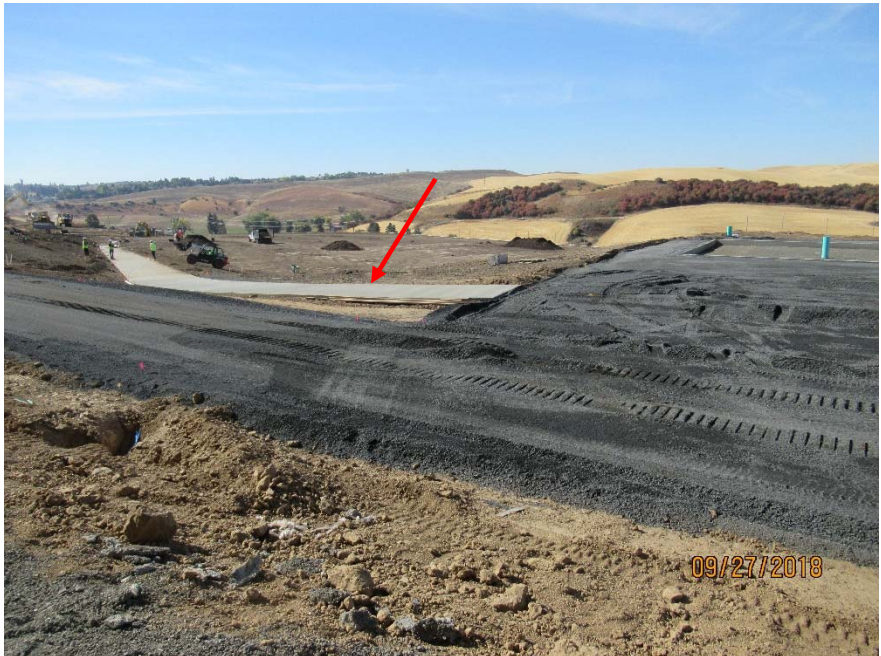
6. It appears the earthwork contractor continues to spread gravel for asphalt placement. Contractor has placed the north end of the concrete walk.

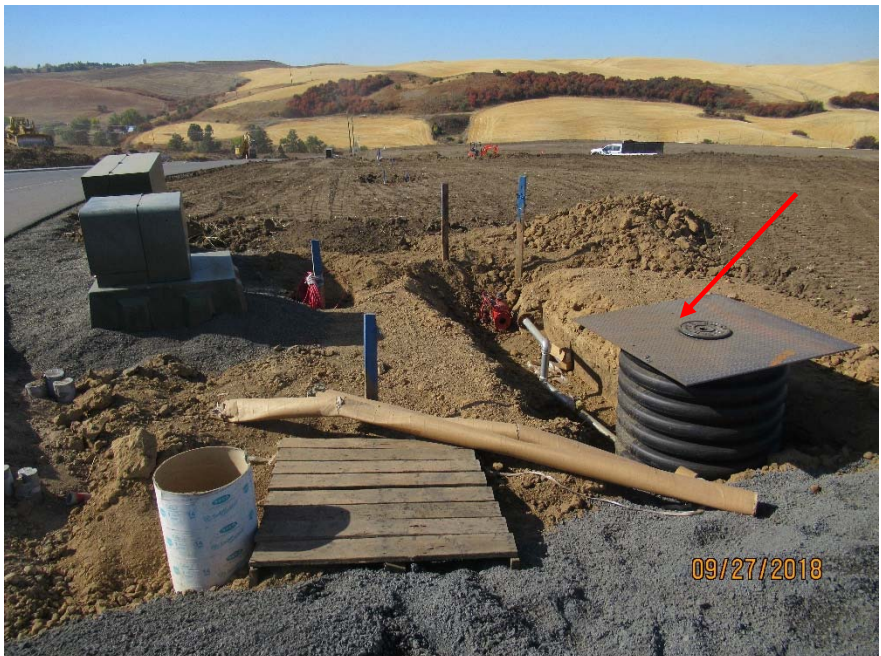
7. Appears the City has installed the irrigation water meter, also in this photo are the electrical boxes that Avista placed south of the school along the new NW Terre View Drive asphalt path.

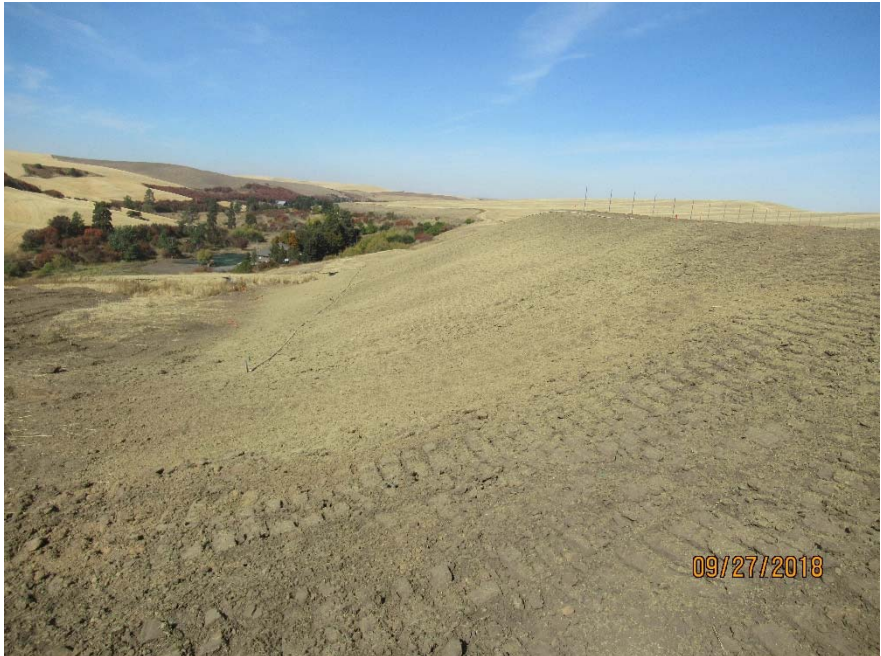
- 8. Contractor has hydroseeded the west slopes per contract documents.**

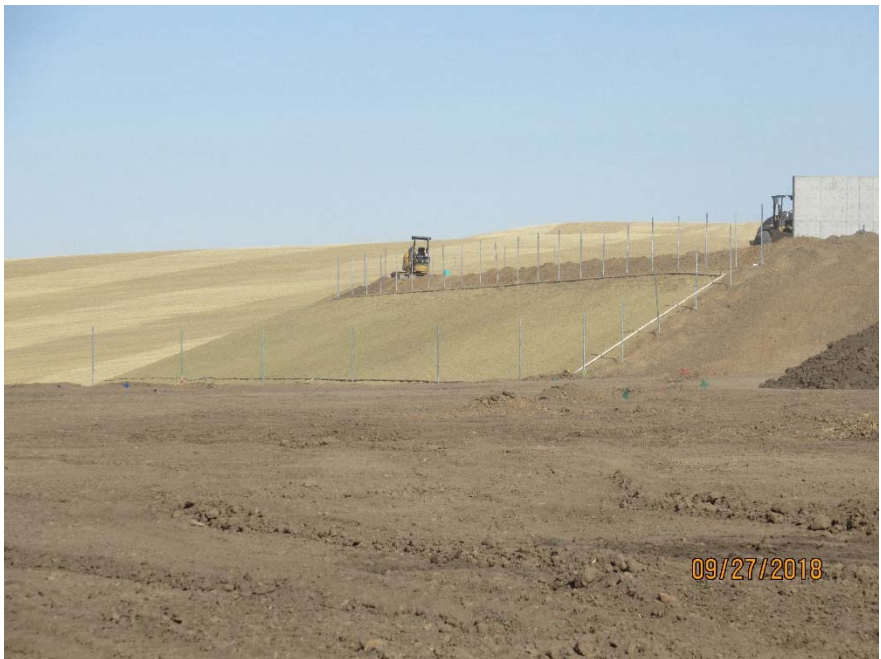
- 9. Contractor has hydroseeded the west slopes per contract documents.**

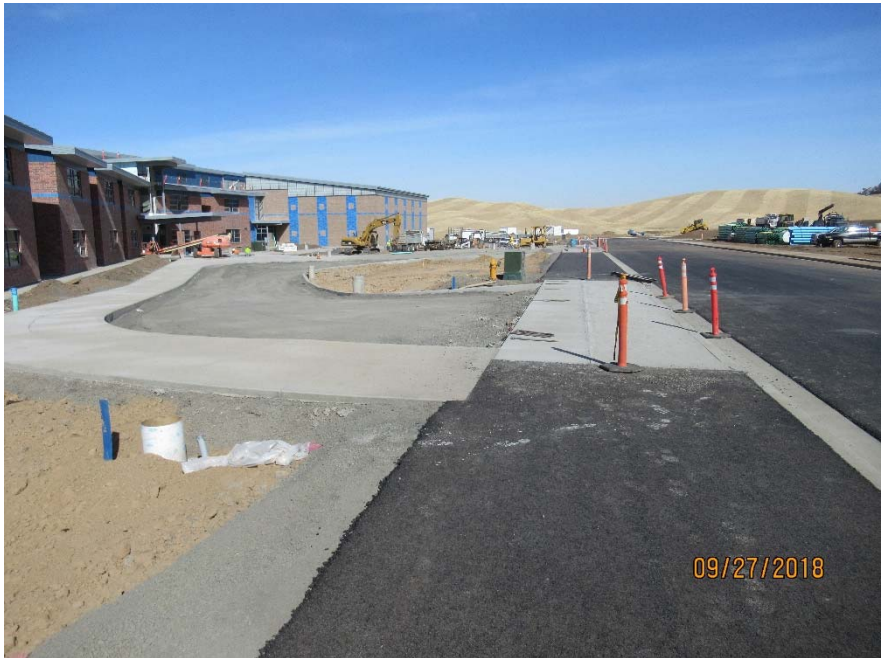
- 10. Appears the contractor continues installation of curbs and gravel east of the school.**

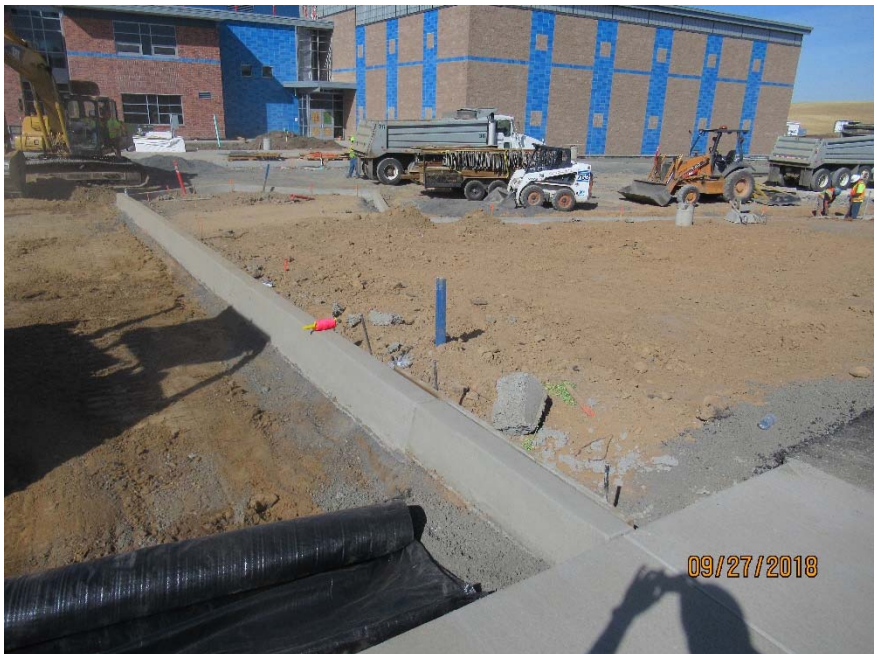
- 11. Appears the contractor continues installation of curbs and gravel east of the school.**

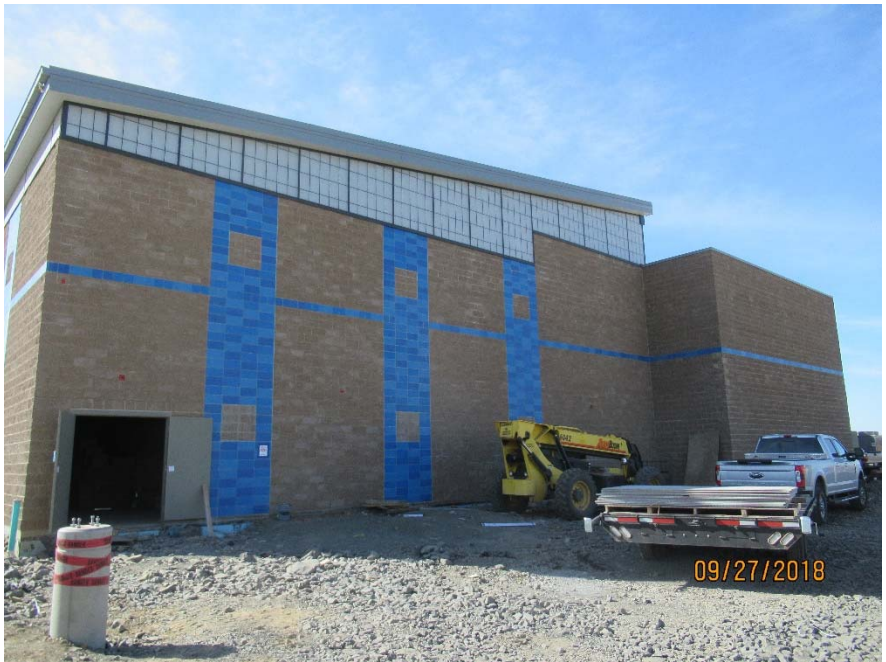
- 12. It appears the translucent panels at the gymnasium have been installed.**

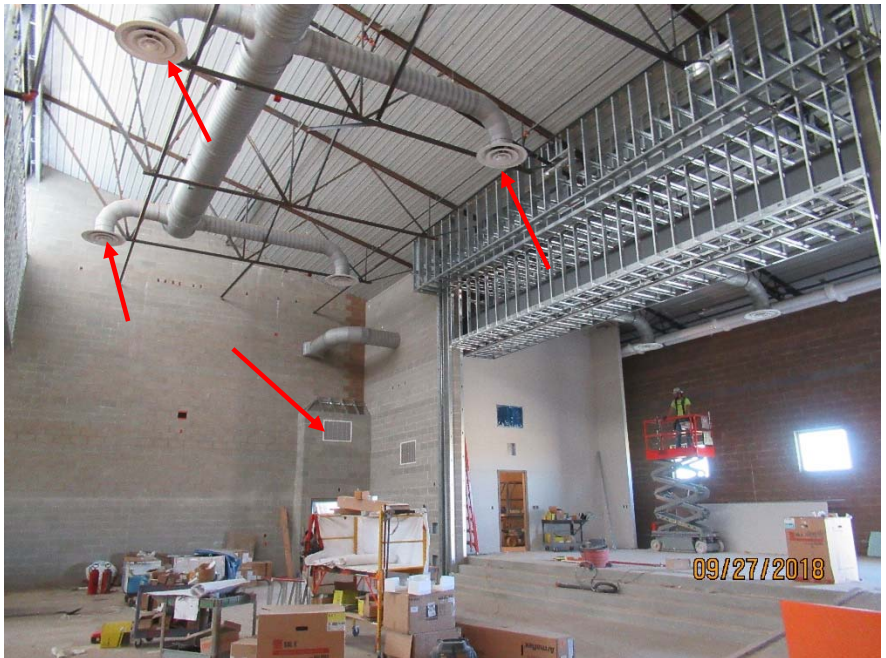
- 13. Appears the contractor has still not covered open ductwork as mentioned in the commissioning issues report.**

Deficiencies: Covering the HVAC diffusers an ongoing issue not yet addressed.

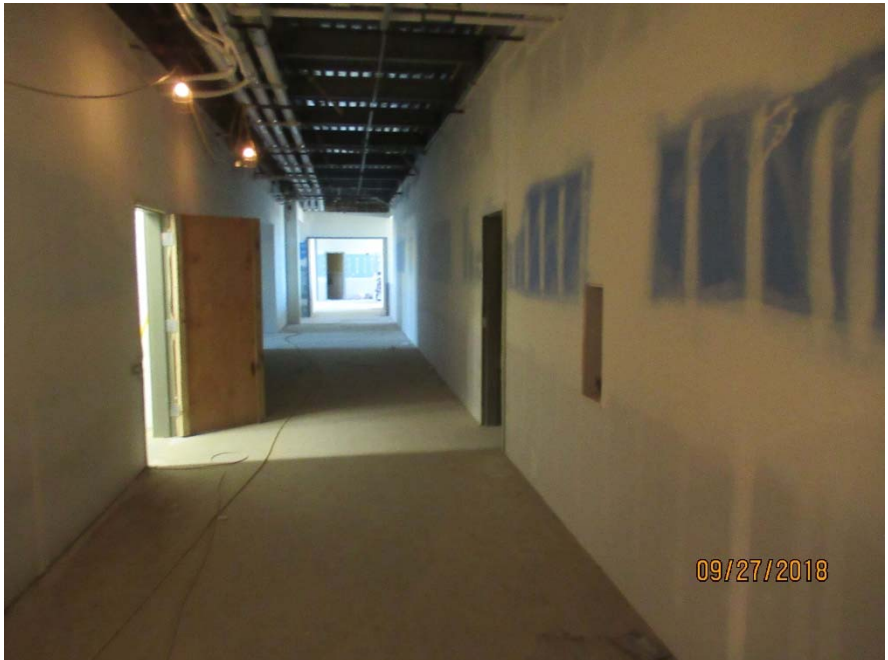
- 14. Contractor continues finishing wallboard in Area B lower level.**

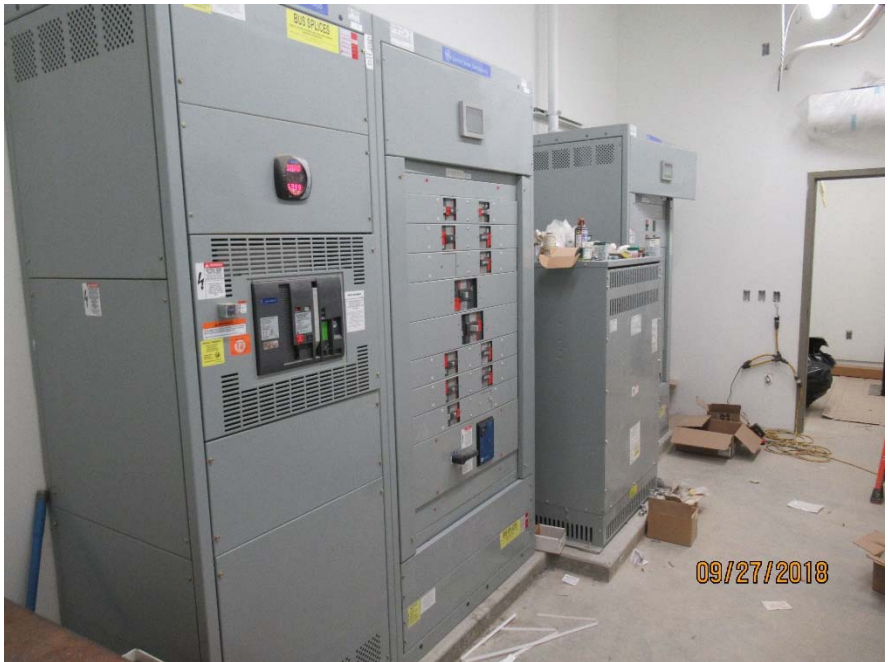
- 15. Contractor has power to the building.**

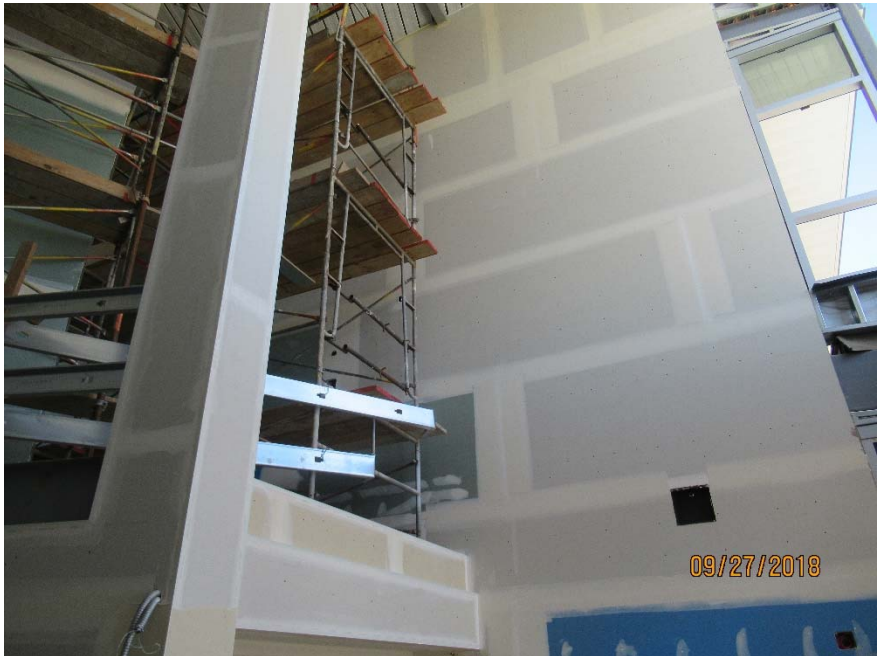
- 16. The contractor continues to finish wallboard at main entry.**

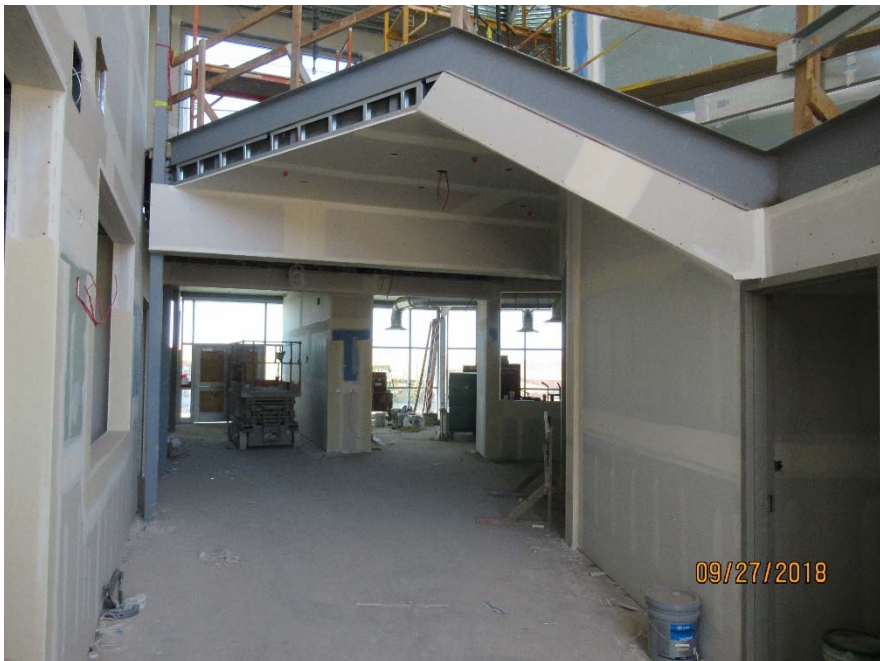
- 17. The contractor continues to install and finish wallboard at main entry.**

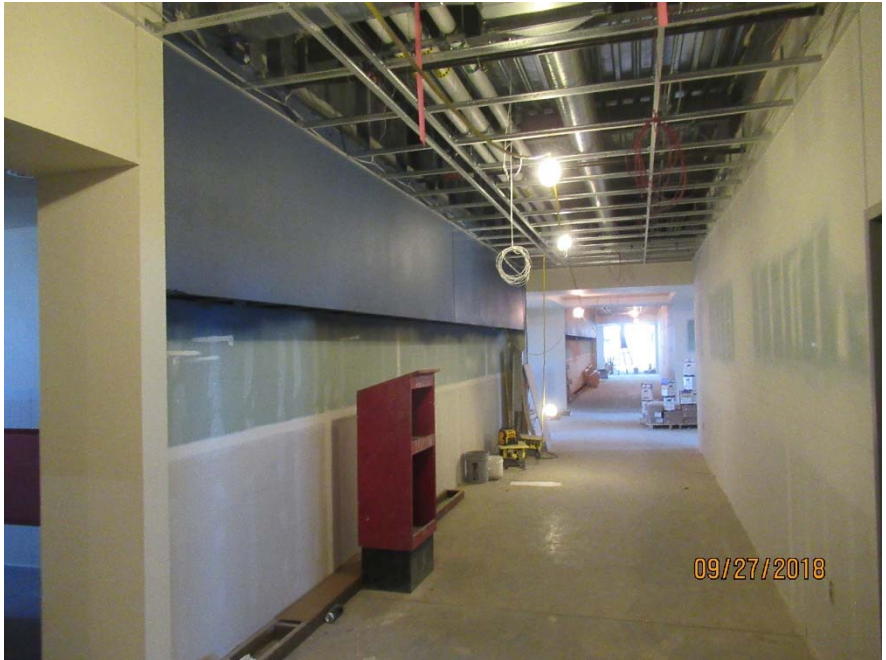
- 18. Contractor has installed ceiling grid in corridor Area A lower level.**

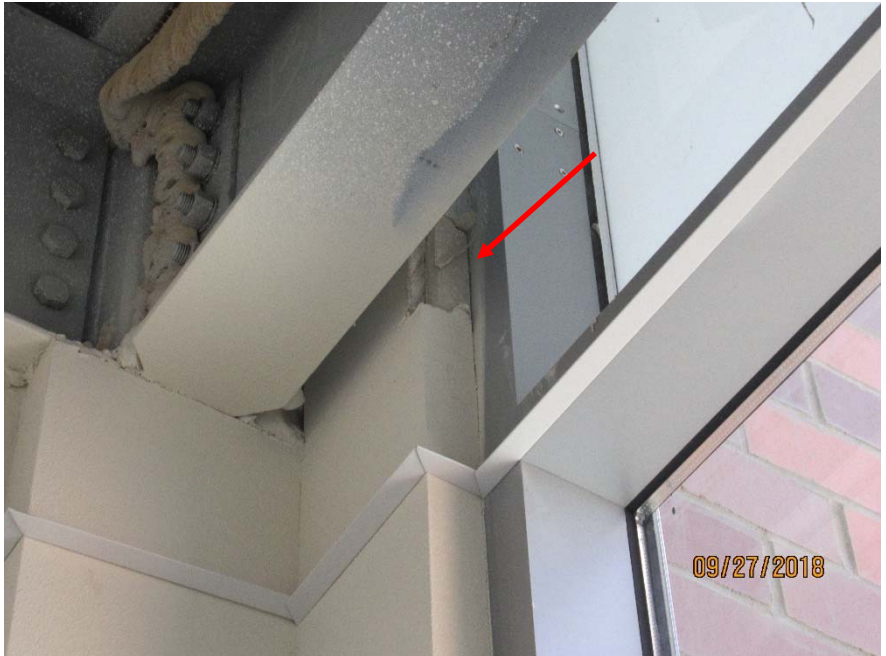
- 19. It appears the contractor has not yet sealed between window frame and adjacent surface. This needs to be done before covering. This is on the commissioning issues list.**

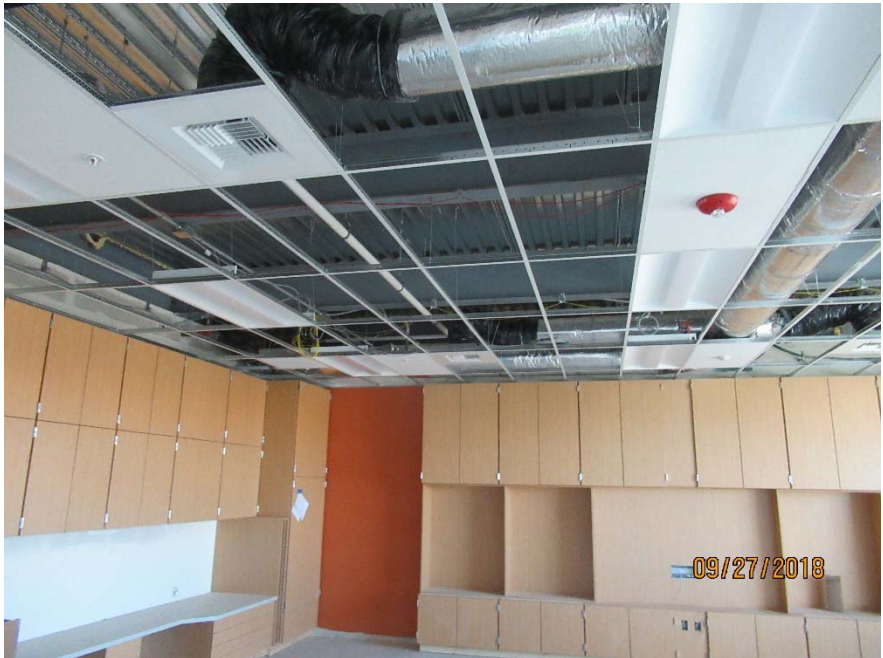
20. Casework installation continues.

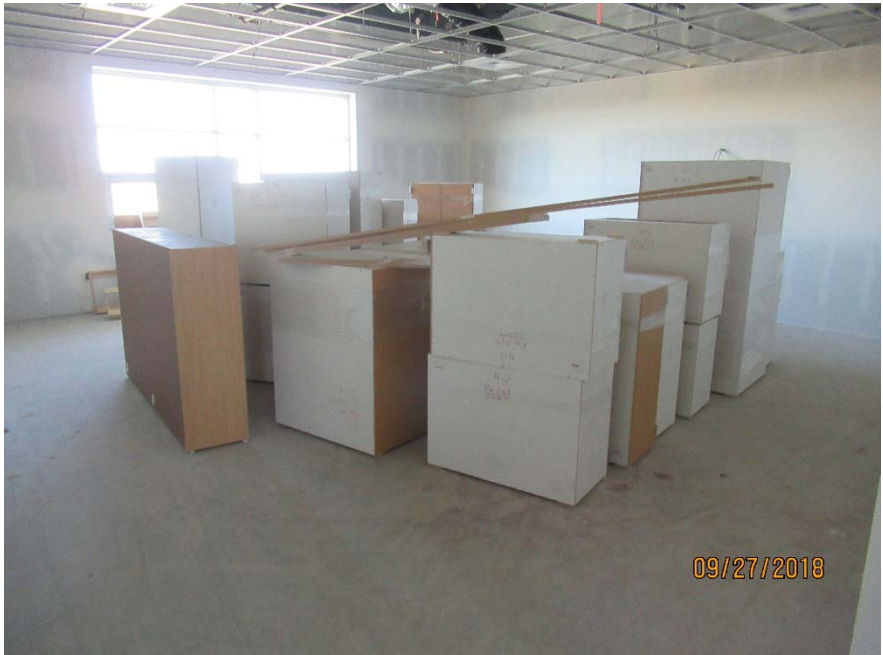
21. It appears the contractor has accepted additional casework deliveries.
