**Project: PSD: Kamiak Elementary School****Date: January 10, 2019****Weather conditions:**

Discussion with: See Construction Progress Meeting minutes dated 1/10/19**Construction Activities:**

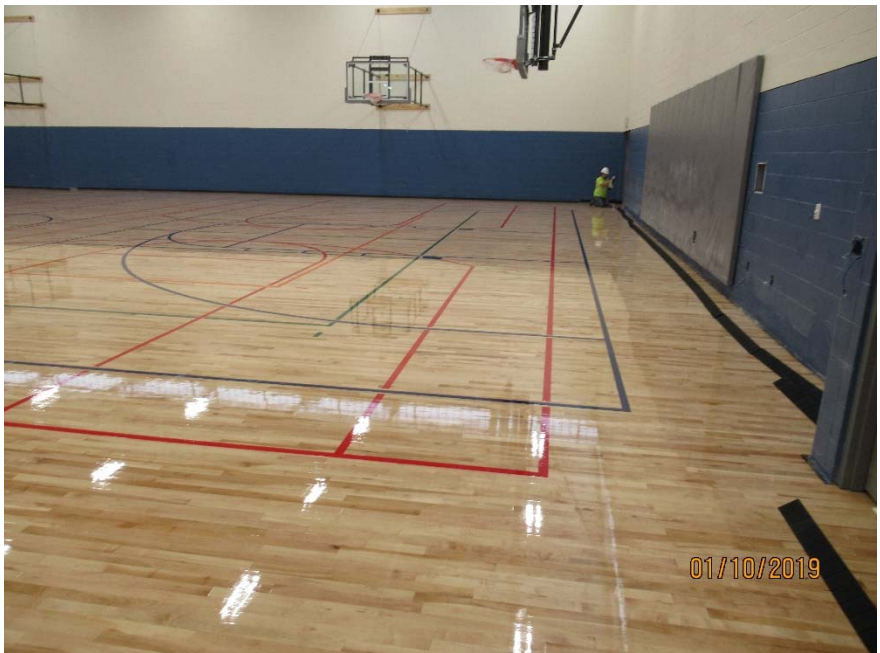
1. Contractor has finished gymnasium floor, currently installing vented wall base. There is some issue with thresholds the Architect is working through with the Contractor.

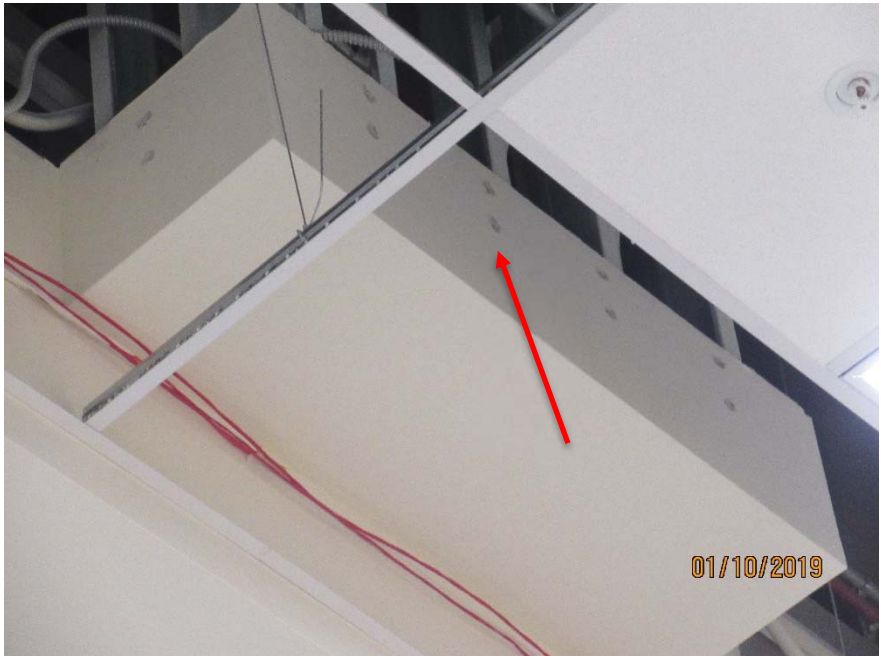
2. This is a better photo of the holes drilled in the outside of the box for the projector that will be in the soffit between the gym and multi-purpose rooms.

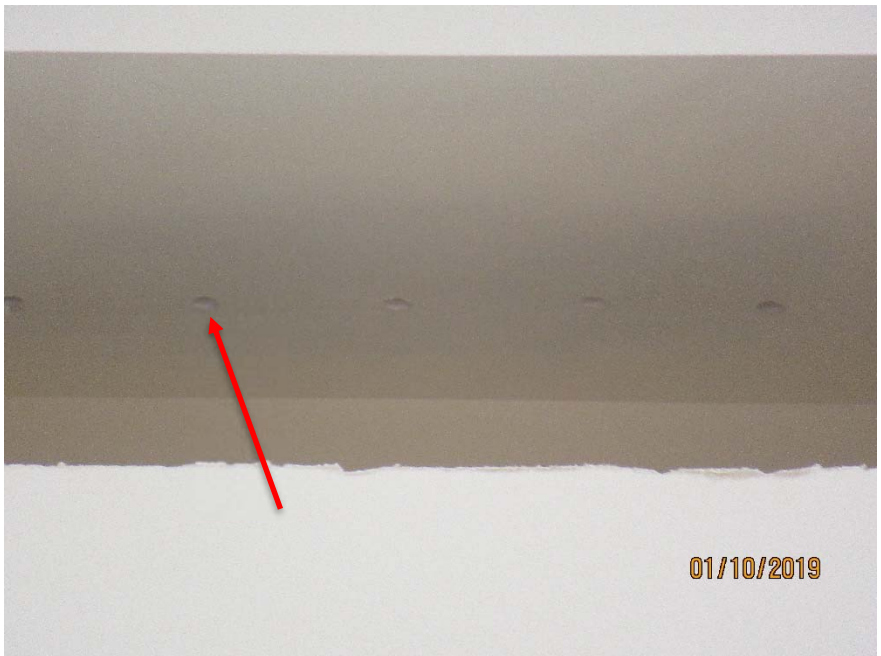
3. This is a photo of the holes drilled in the inside of the box for the projector that will be in the soffit between the gym and multi-purpose rooms.

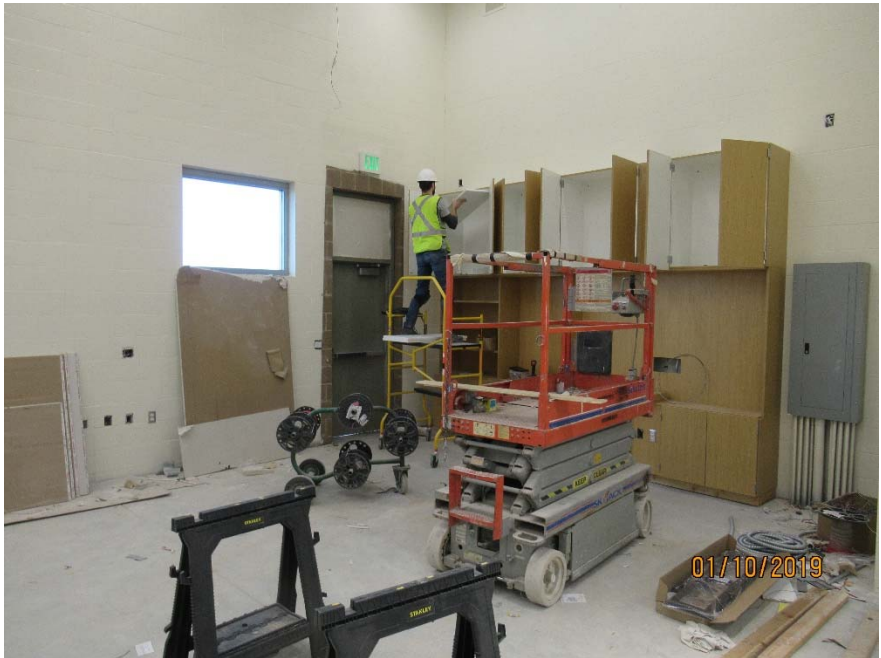
- 4. Casework installer continues installing casework throughout the building. This photo is on the stage.**

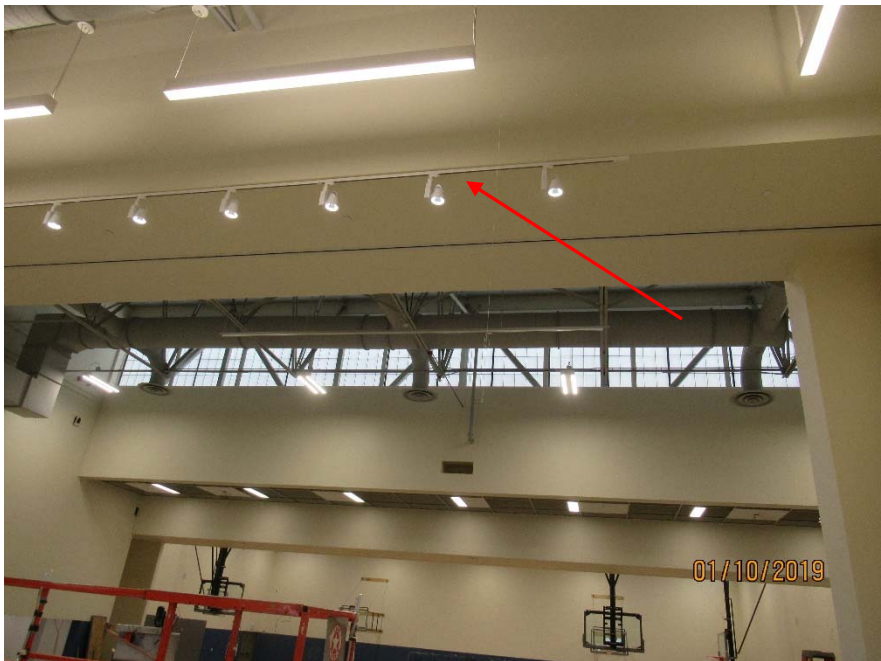
- 5. Appears the contractor has installed strip lighting in soffit at stage.**

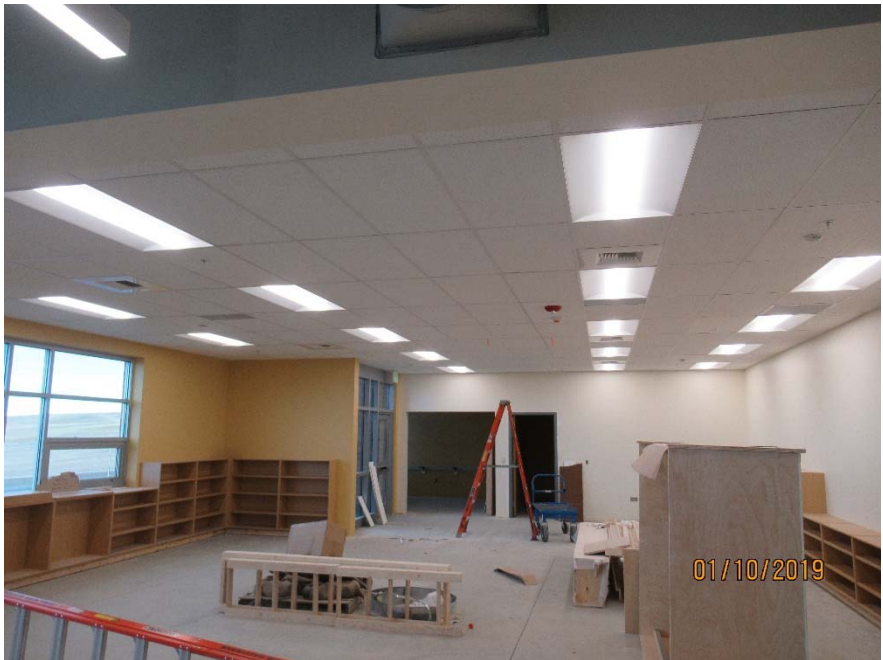
6. Contractor has adjusted fire sprinkler heads and finished installation of drop in ceiling in Library.

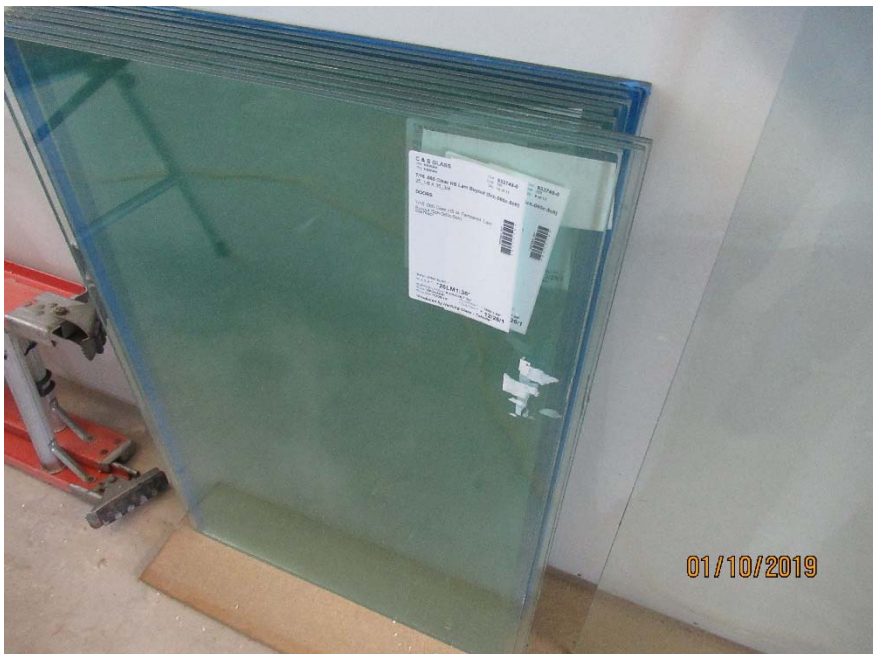
7. It appears the contractor has taken delivery of the correct, laminated glass for the interior windows.

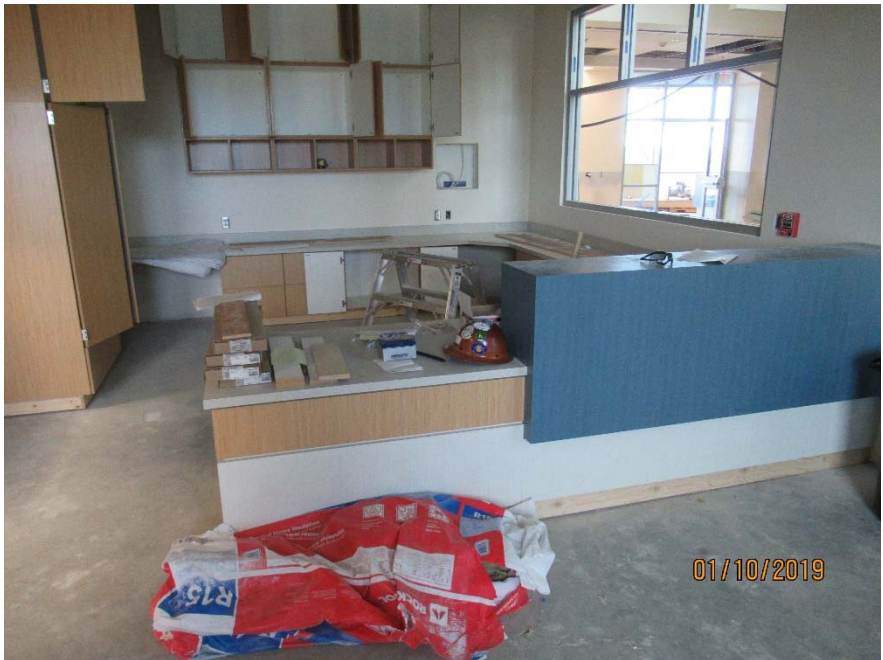
- 8. Installation of Admin work stations appears to be underway.**

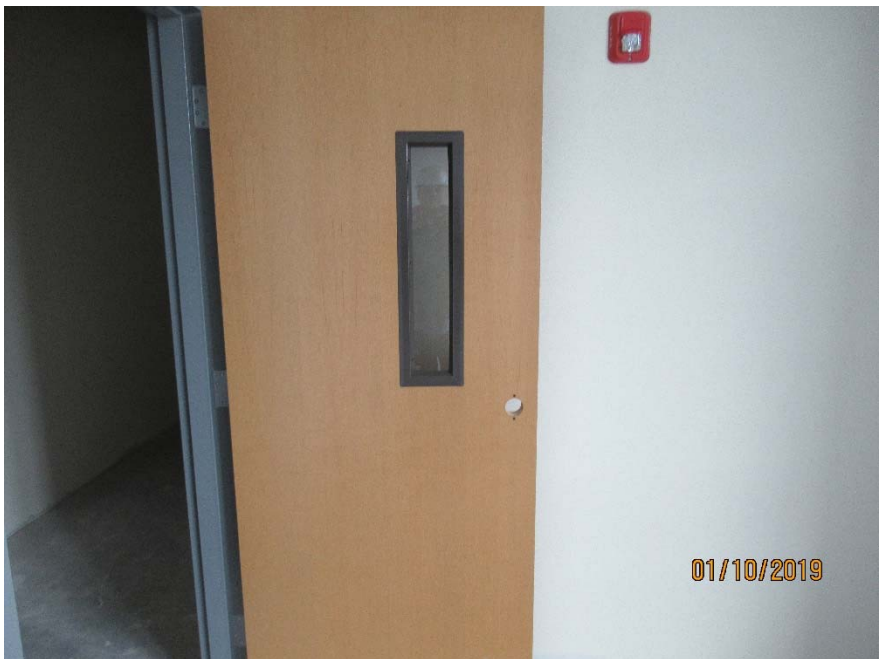
- 9. Contractor has begun installing glass in door relites.**

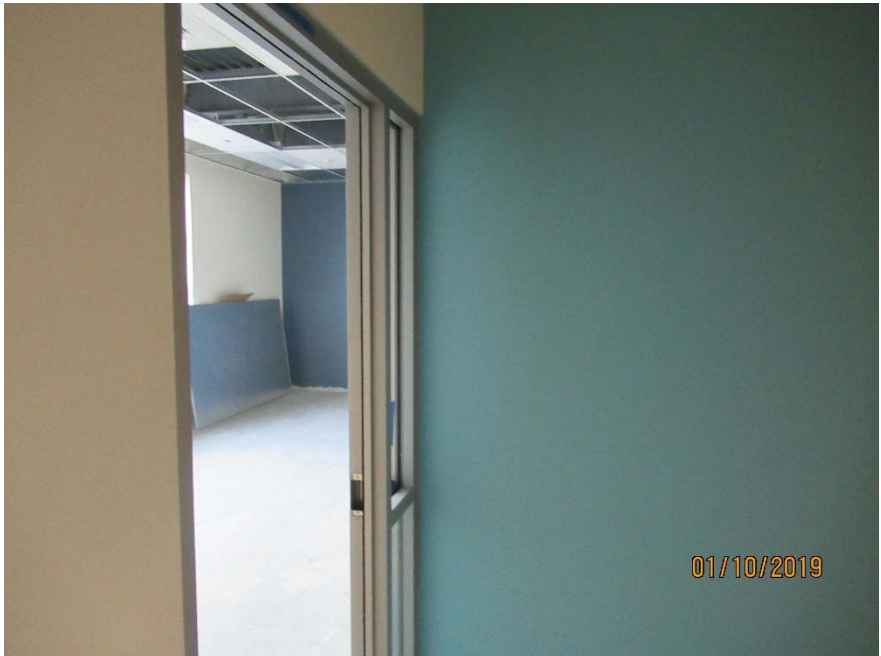
10. It appears to me that the blue on the right in this photo is incorrect. This is the only place in the building that has this shade of blue. I believe it should be like the blue on the left side of this photo. I have notified the Architect.

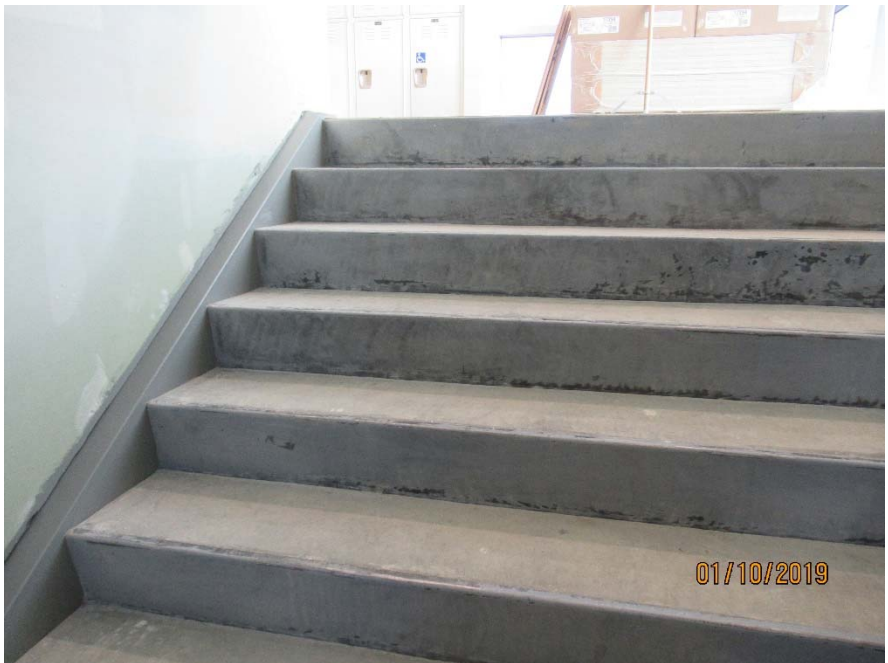
11. Appears the contractor has cleaned up and painted the stair stringers.

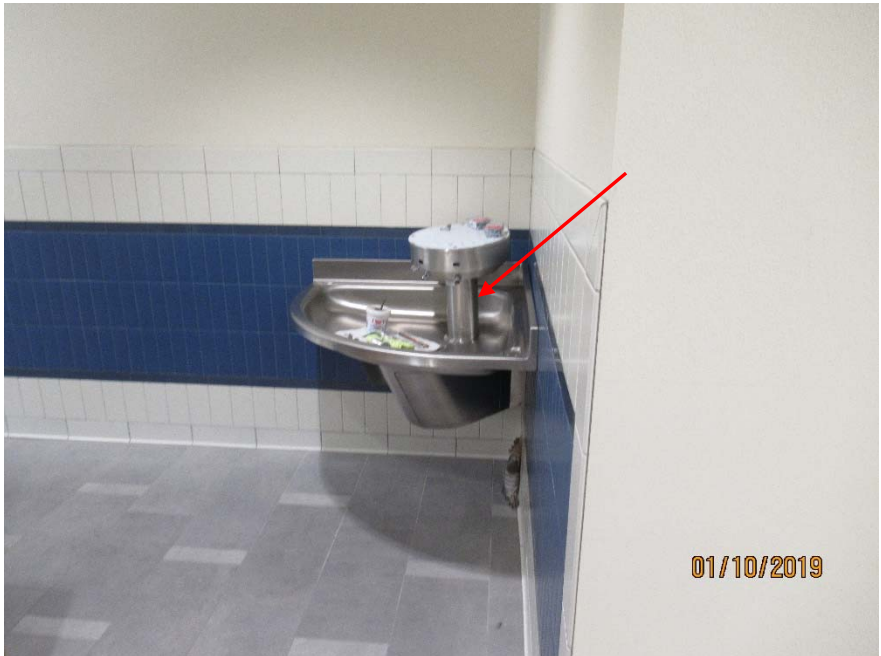
12. This photo is of the hand wash station outside Restroom 114. I notified the contractor that the column and cap are out of plumb.

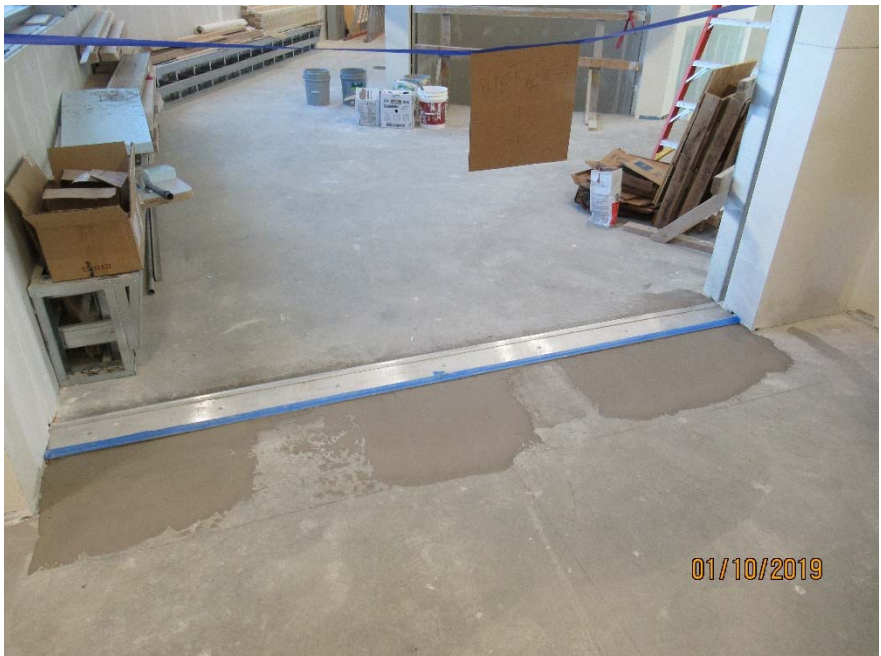
13. Contractor appears to be prepping the expansion joint in the corridor for floor finish.

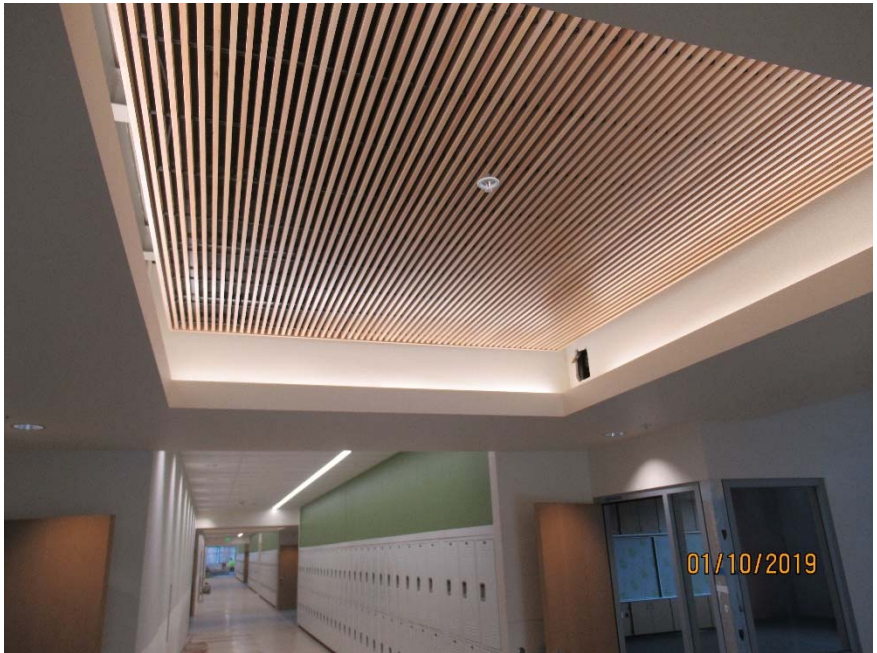
- 14. Contractor has installed the upper floor wood ceiling. Note the contractor has removed the p-trap that was projecting into the soffit space. Wallboard will be repaired.**

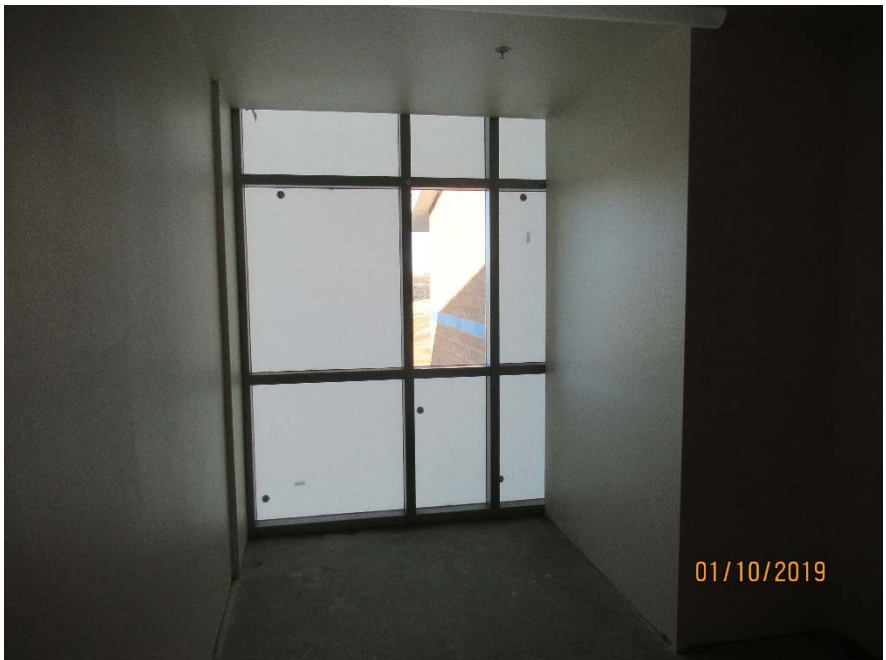
- 15. Contractor has replaced clear glazing in Storage Room 243 with spandrel glass per submittal.**

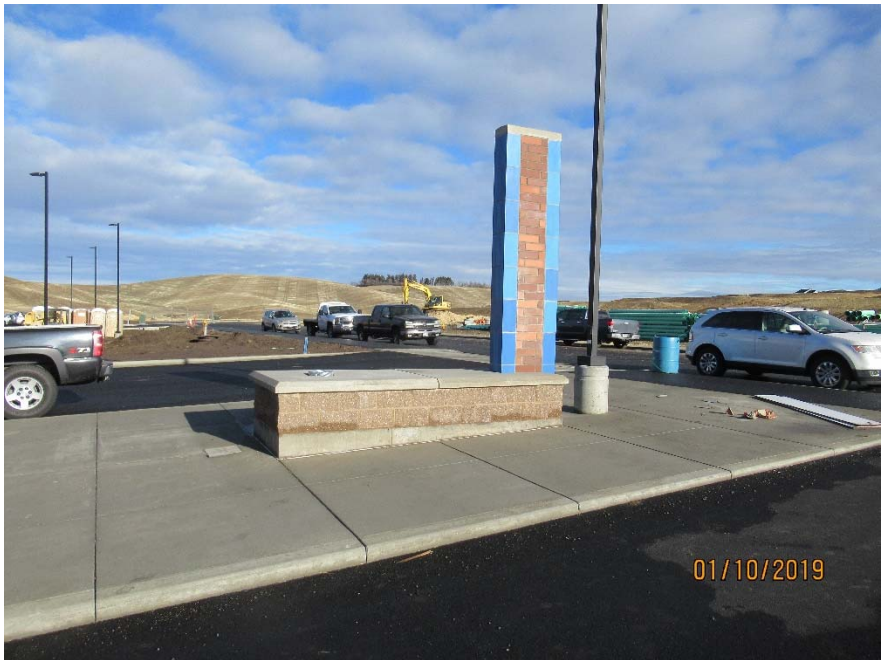
- 16. Contractor has finished removal of the cover at the monument sign and flag pole.**

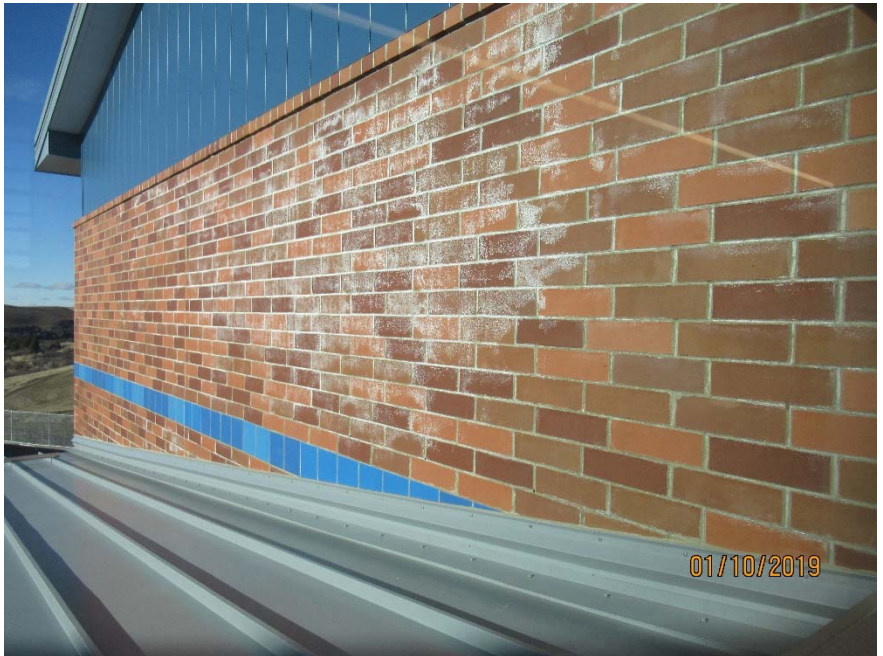
- 17. I notified the contractor that it appears the exterior brick wall above and north of the Library does not appear to have been cleaned. This will need to be cleaned as well as any other spot locations before the sealer is applied.**
