**Project: PSD: Kamiak Elementary School****Date: January 17, 2019****Weather conditions:**

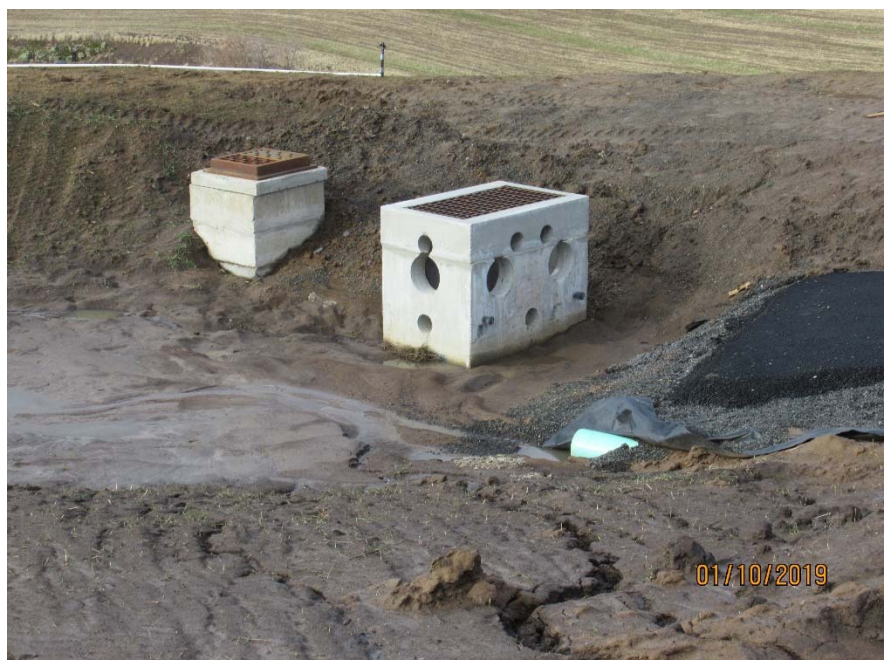
1. There was some question if the “metering” of water getting into the inlet structure was “installed”. The holes drilled in the inlet structure is the metering.

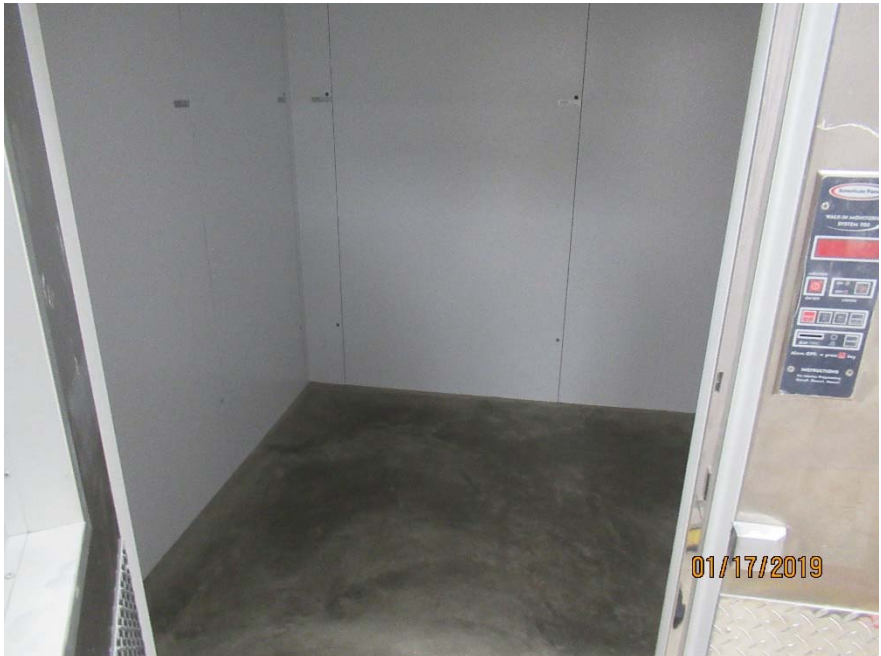
2. The cooler and freezer concrete floors have been placed.

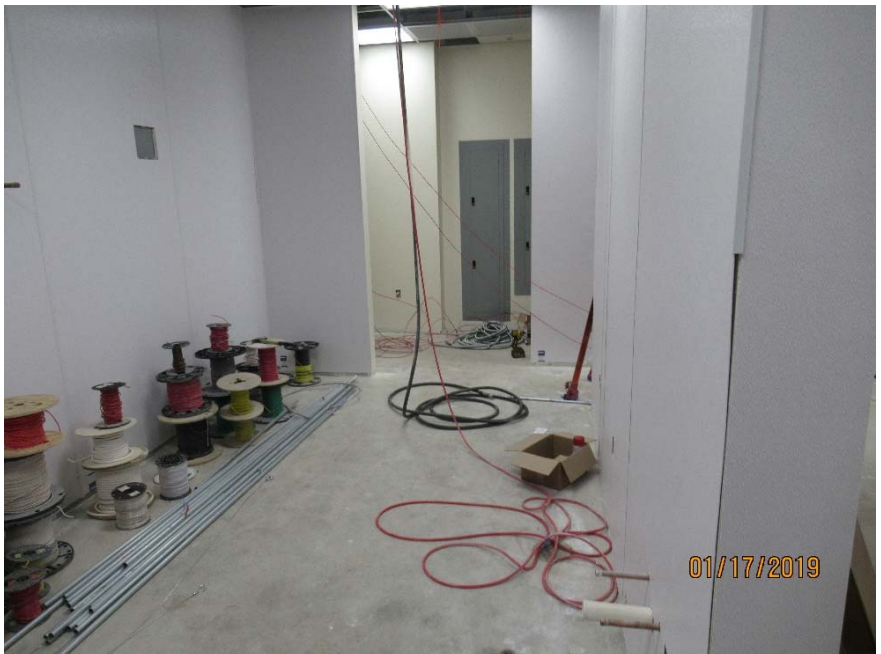
3. It appears the installation of the FRP in the Kitchen is nearly complete. Still need to install the trim in a number of areas. This photo is looking north in the dishwashing (scullery) area.

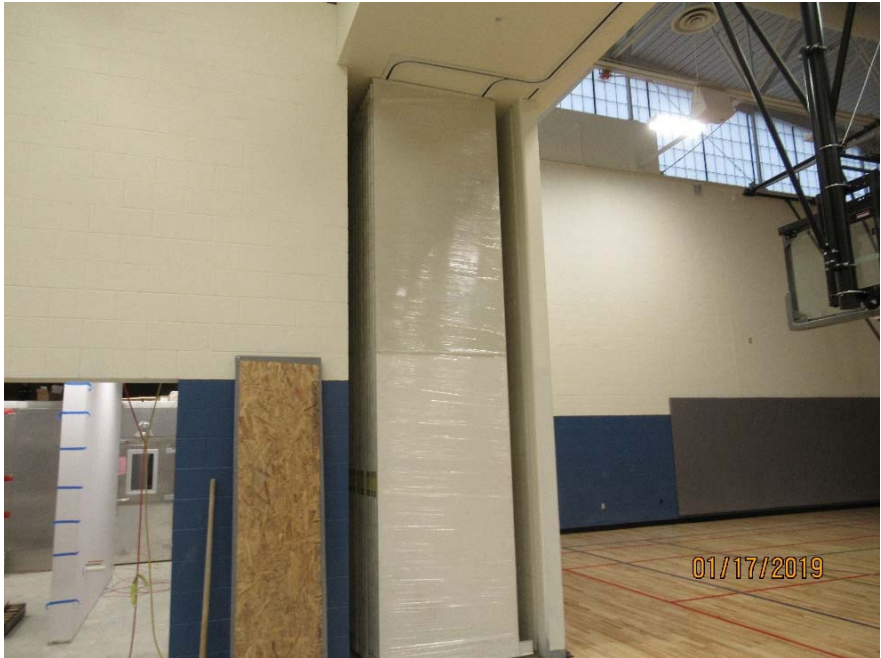
4. Contractor is in the process of installing the operable wall between the Gymnasium and Multi-Purpose room.

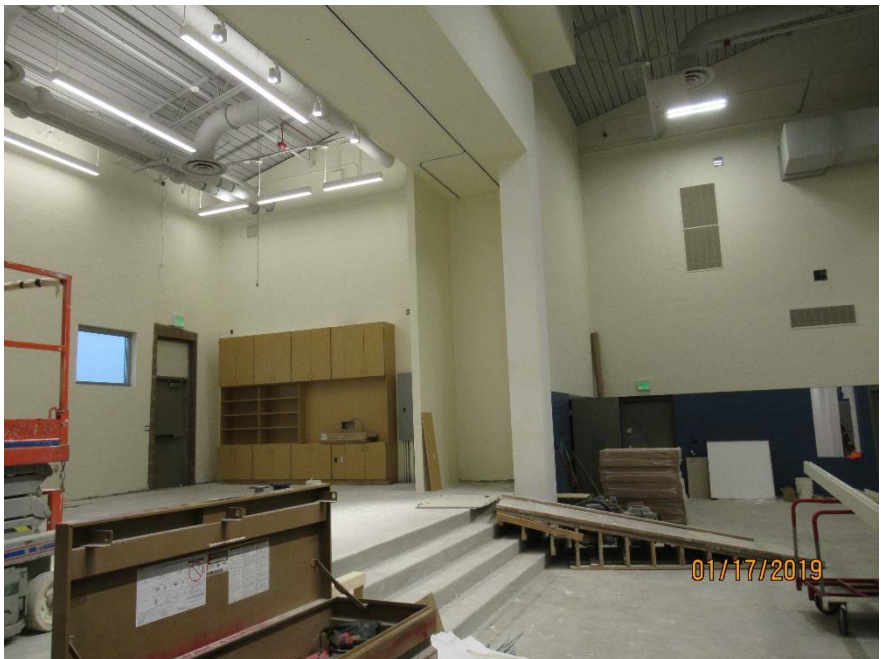
5. Contractor has not begun the process of installing the operable wall between the Stage and Multi-Purpose rooms.

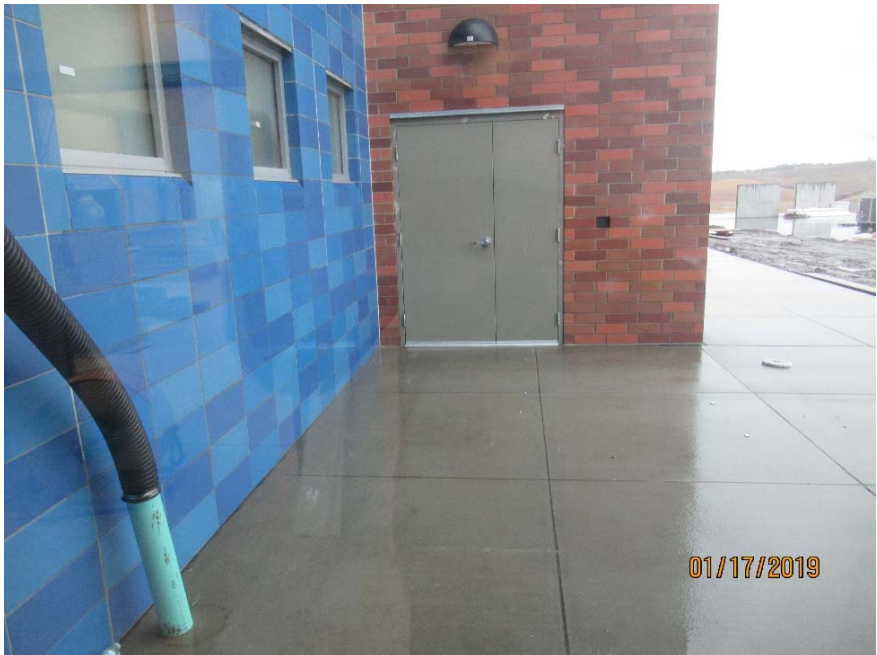
6. Area outside doors 135B continues to be an issue. Water is puddling slightly along the blue glazed CMU wall and the doors.

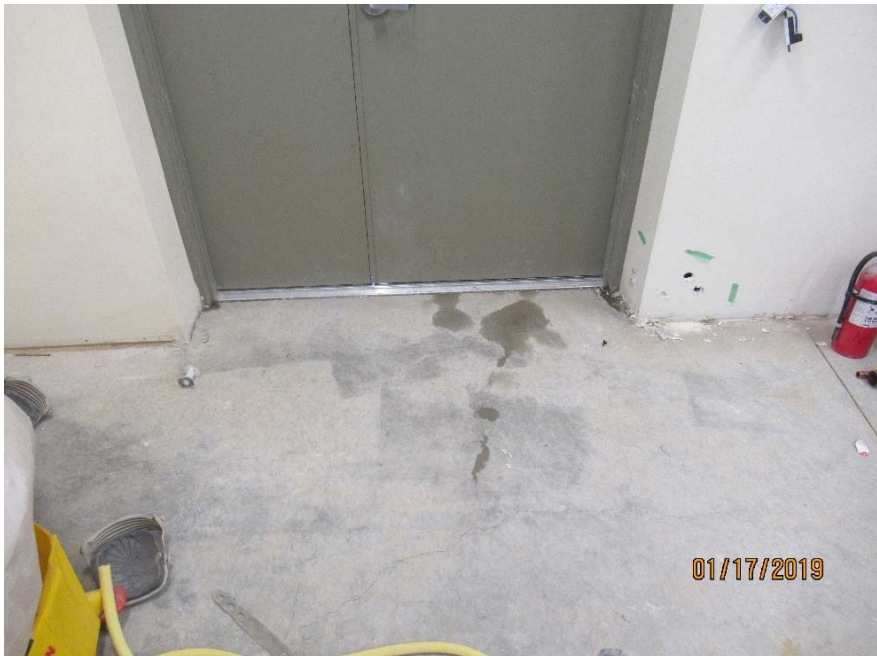
7. This is a photo of the inside of the above doors 135B. It appears water is seeping under the caulked threshold.

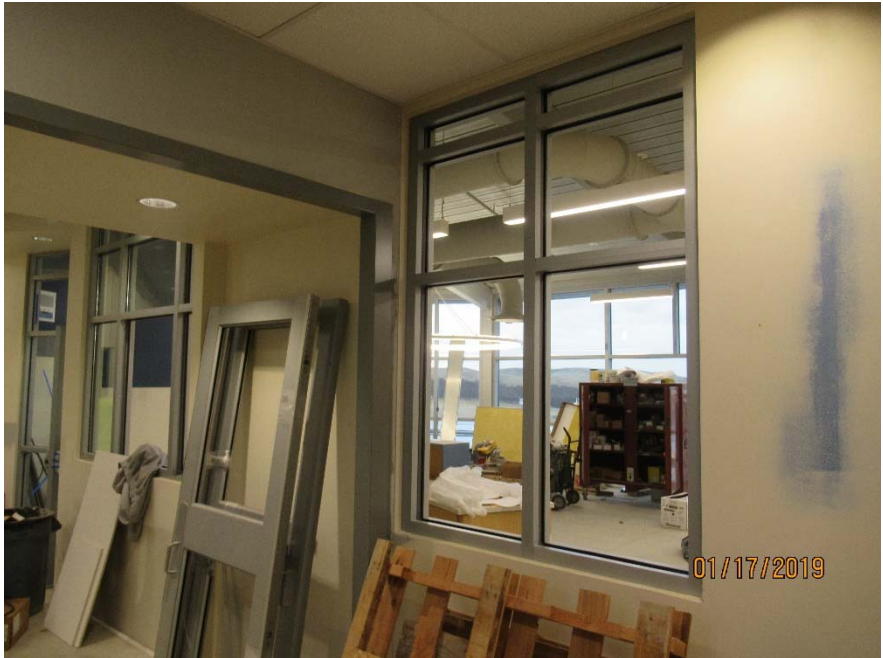
- 8. Contractor has installed the windows on the east wall of the Library.**

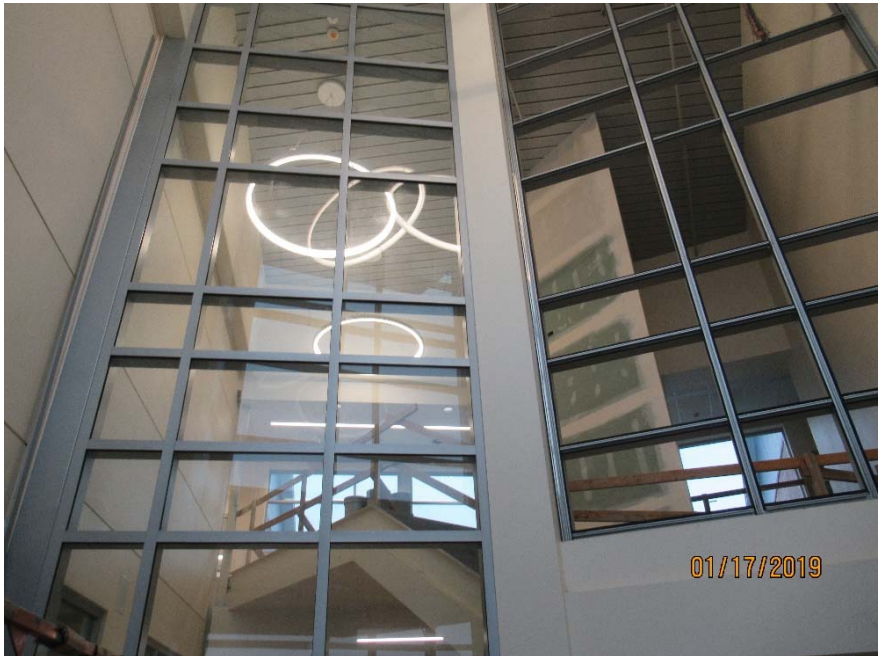
- 9. Contractor continues to install glazing in Main Entry.**

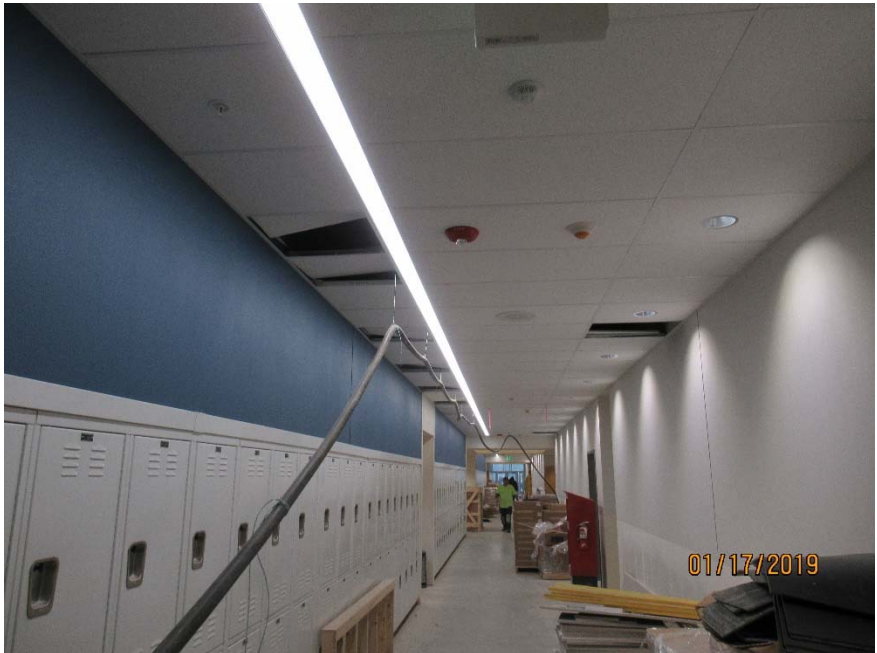
- 10. Contractor continues to install suspended ceiling in lower floor.**

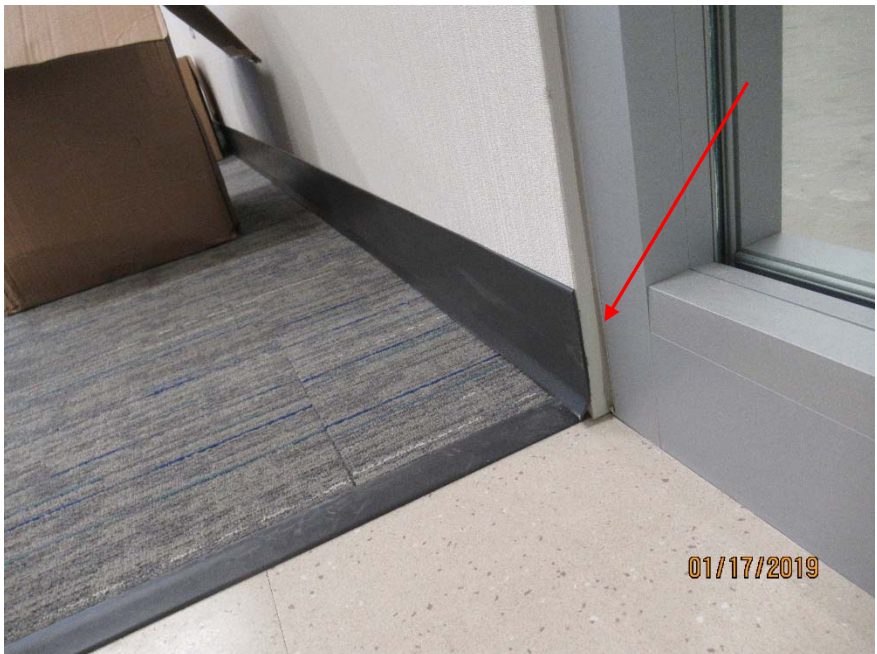
- 11. I noticed the installed rubber base does not return to the aluminum frames. I notified the Architect, the area in question is raw wallboard. Architect will review and provide direction.**

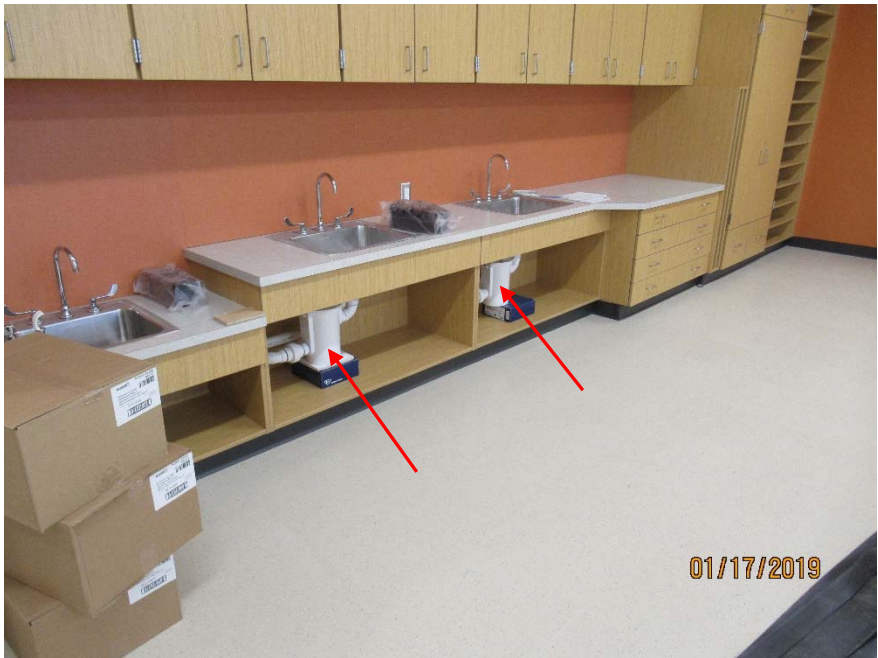
- 12. It appears the contractor has installed the solids interceptors at the Art room sinks.**

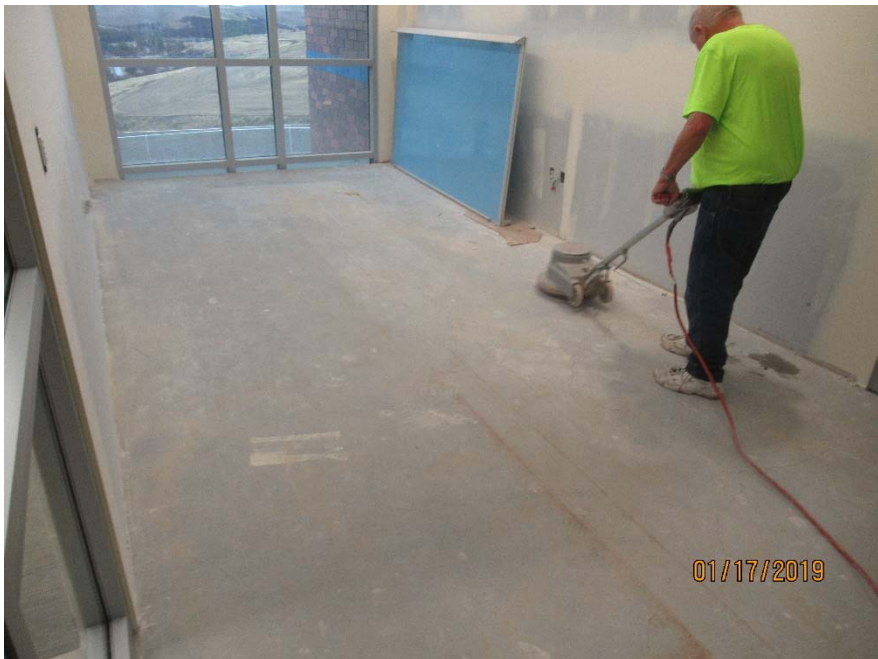
- 13. Contractor prepping floors for tile.**

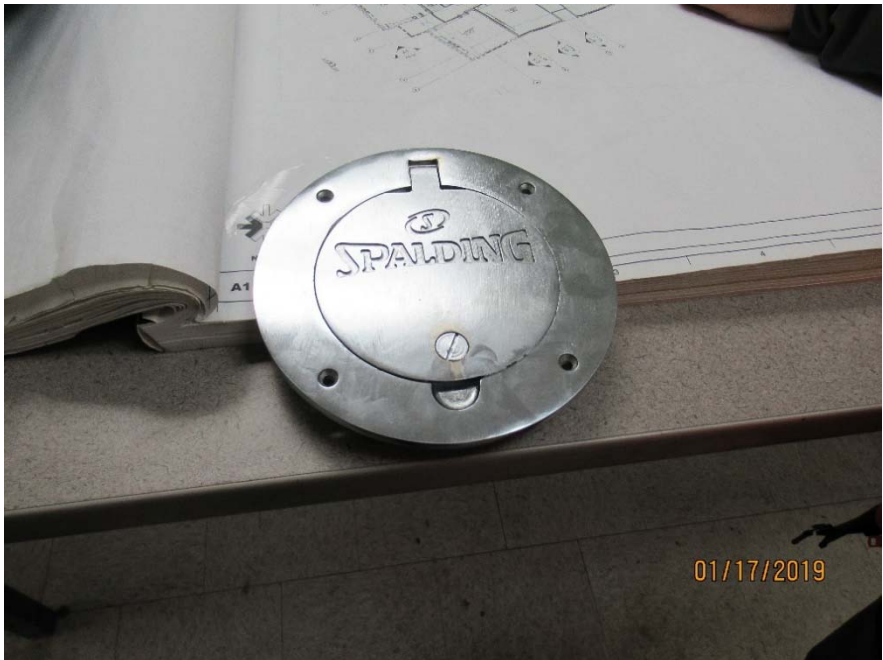
- 14. This product was approved for use in the Gymnasium as volleyball sleeve covers.**

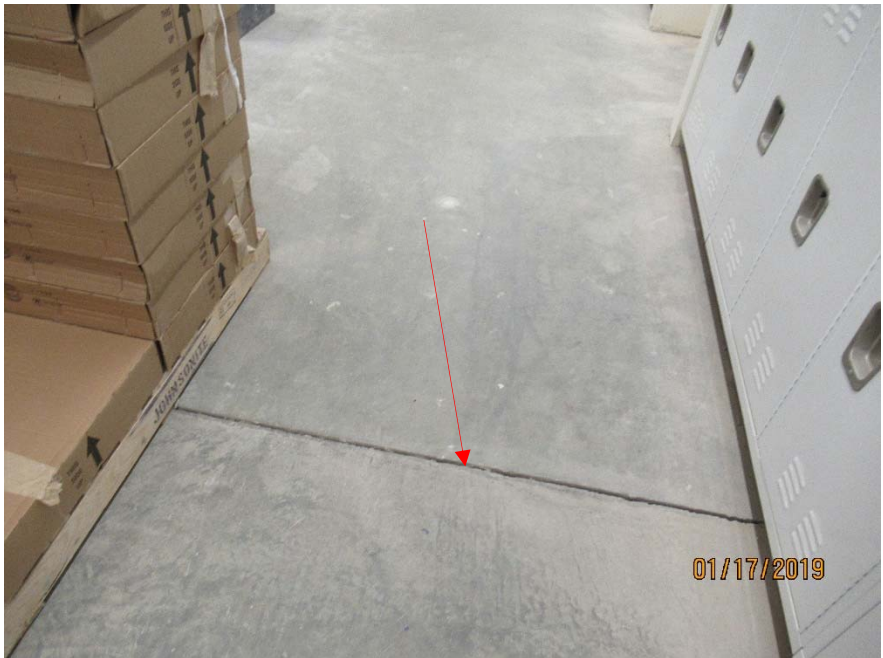
- 15. The Architect is reviewing this cold joint condition. It is the belief of the team that this joint will fluctuate in width over time. The Architect will provide direction for filling of the joint with a product that is malleable as the size changes over time.**

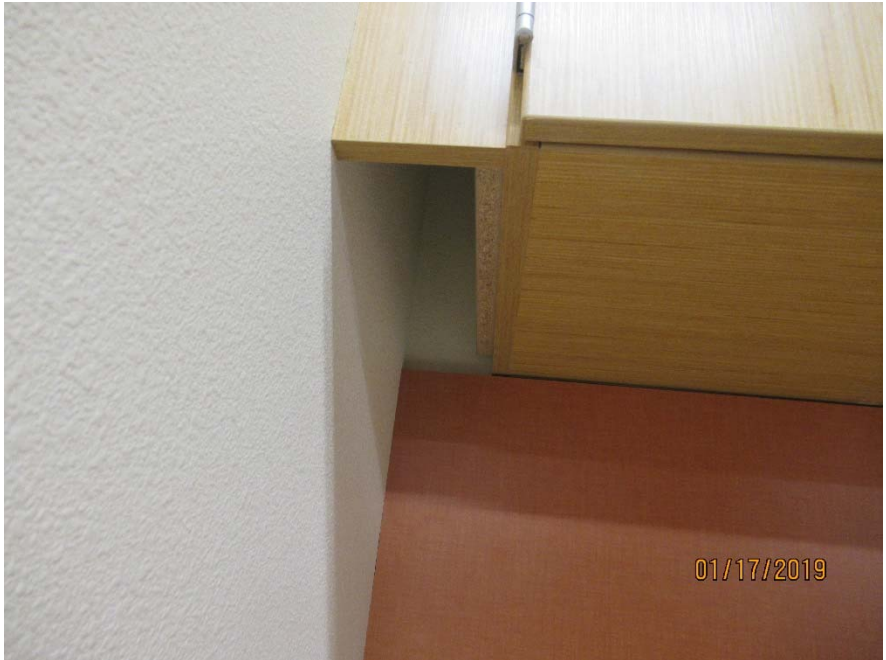
- 16. This photo is of the upper casework. Contractor confirmed with the Architect that this space at the top and bottom needs to be filled.**

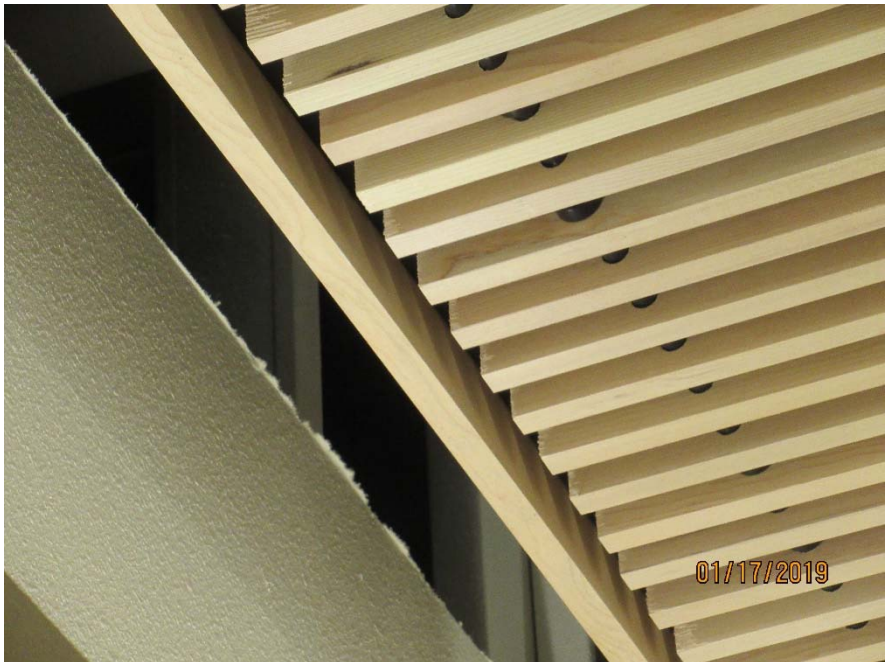
- 17. Architect will review documents to check if the wallboard should be run higher up the framing at the wood slat ceiling.**

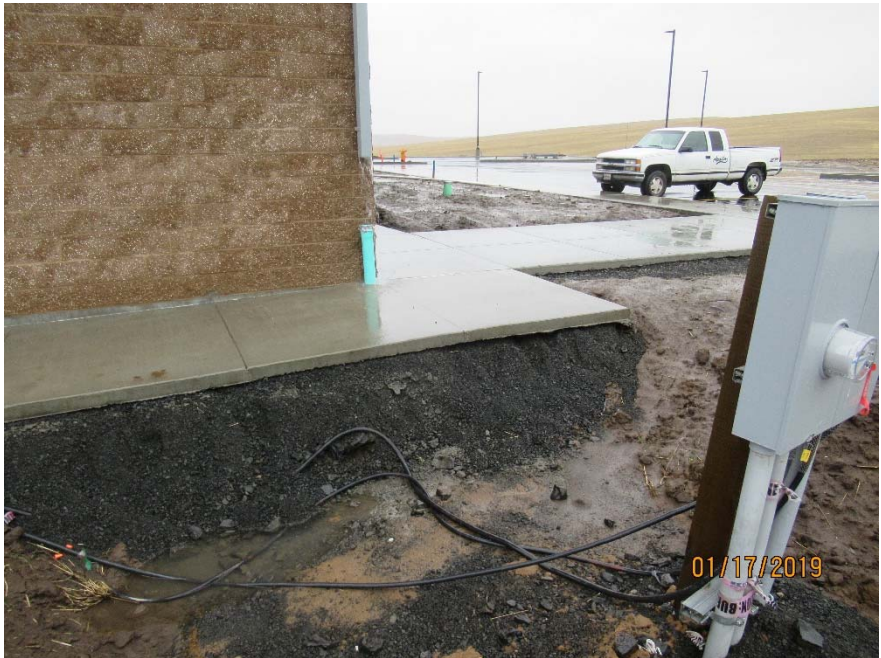
**18. The contractor has not yet connected all the down spouts. This is allowing roof water at the northeast corner of the gym to splash on sidewalk and against the not yet sealed exterior CMU wall. I have checked inside the gym and there are no signs of water intrusion in this corner.**

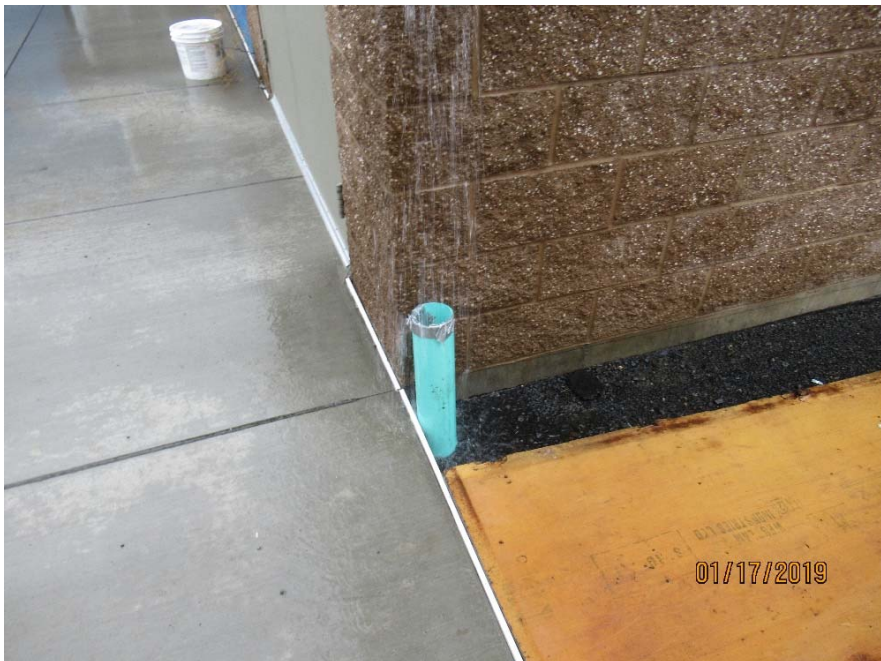
**19. The contractor has not yet connected all the down spouts. This is allowing roof water at the southeast corner of the gym to splash on sidewalk and against the not yet sealed exterior CMU wall. I have checked inside the gym and there are no signs of water intrusion in this corner.**
