**Project: PSD: Kamiak Elementary School****Date: January 24, 2019****Weather conditions:**

Discussion with: See Construction Progress Meeting minutes dated 1/24/19**Construction Activities:**

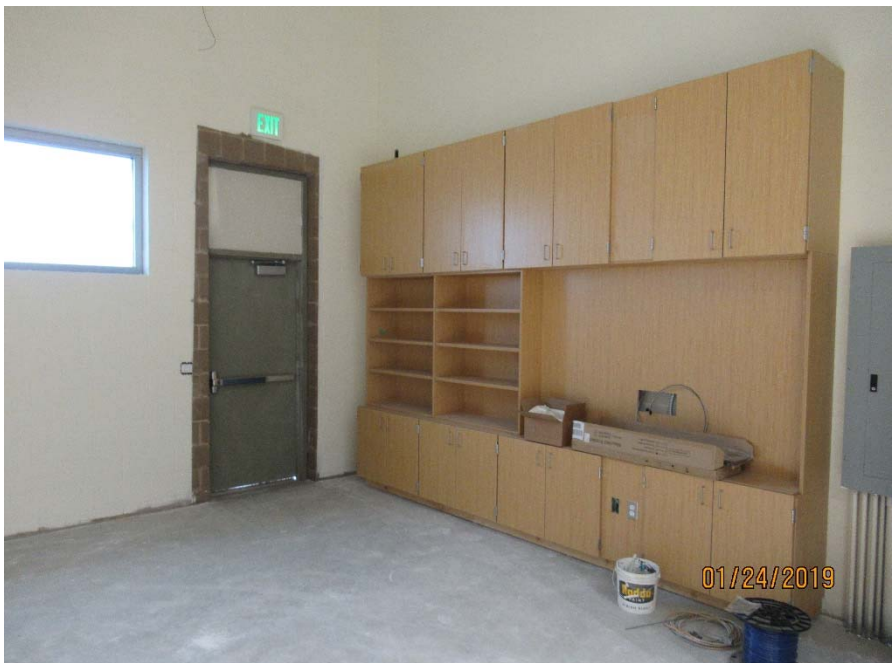
1. There are a number of areas that still need to be painted. General Contractor and Architect was notified.

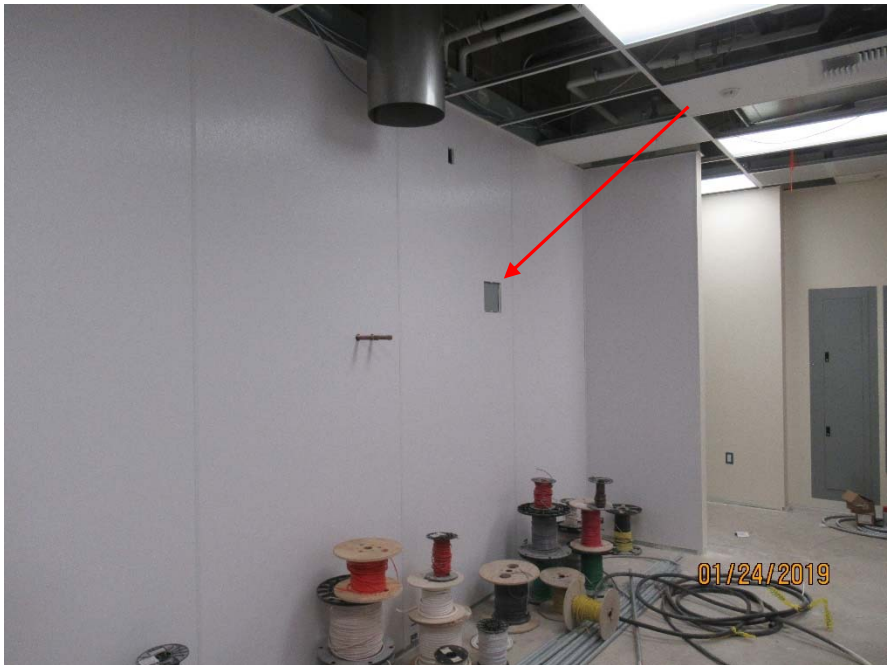
2. Looking north in scullery area of the Kitchen. Arrow is pointing to box that needs to be trimmed out properly.

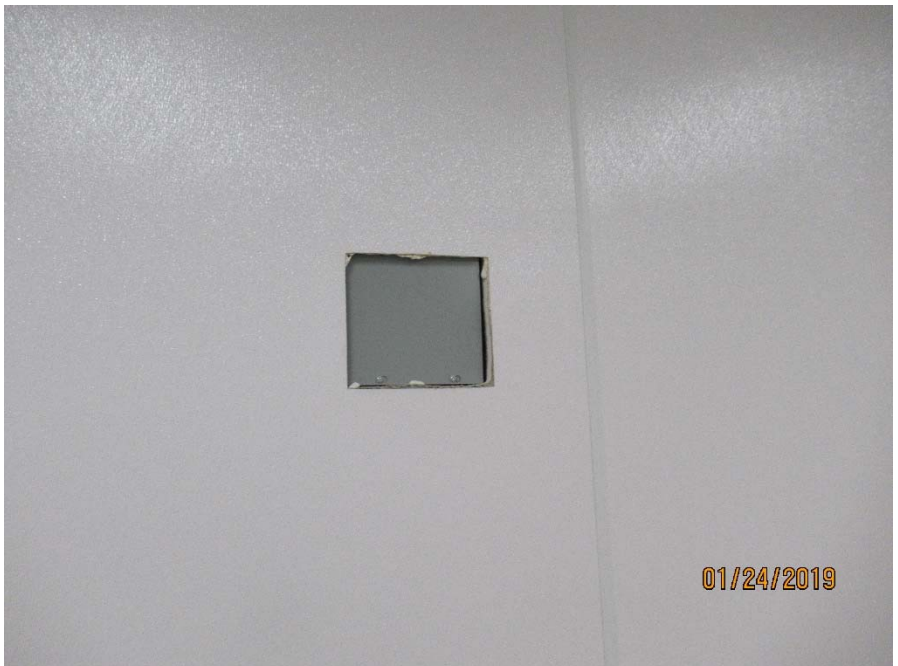
3. This is a close up view of the above mentioned box. This box will need to be properly trimmed out.

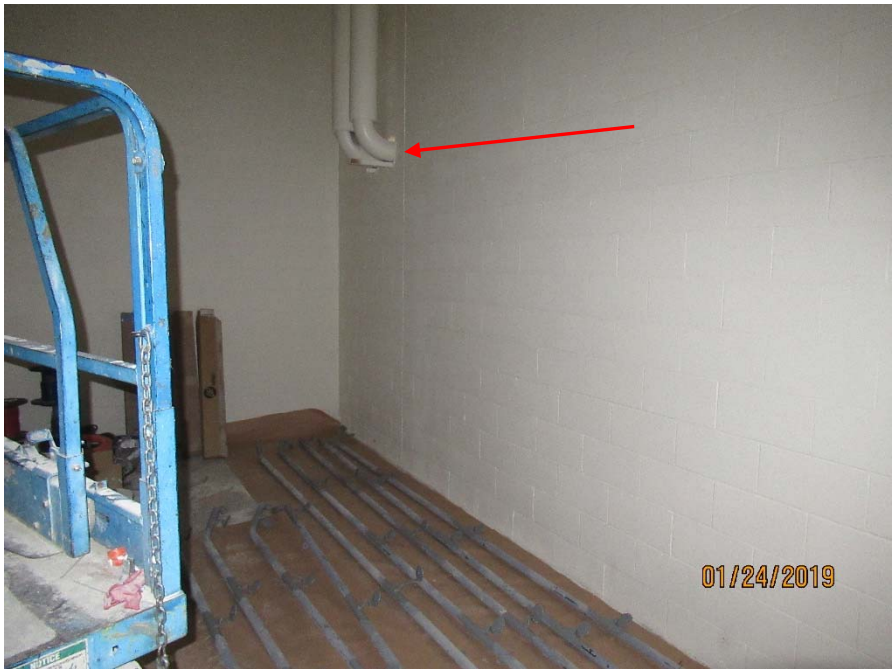
4. This is the storage room at the northwest corner of gymnasium box. Note the contractor has taken delivery of stairway railings. Also I notified the contractor the chiller hydronic piping wall penetrations still need to be sealed.

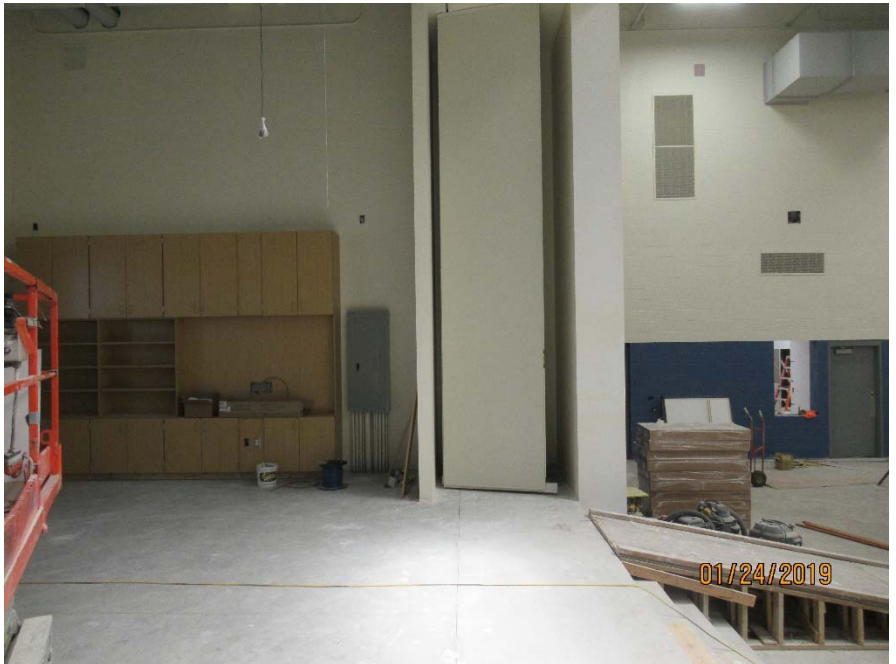
5. Appears the contractor has installed the operable wall between the Multi-Purpose room and Stage.

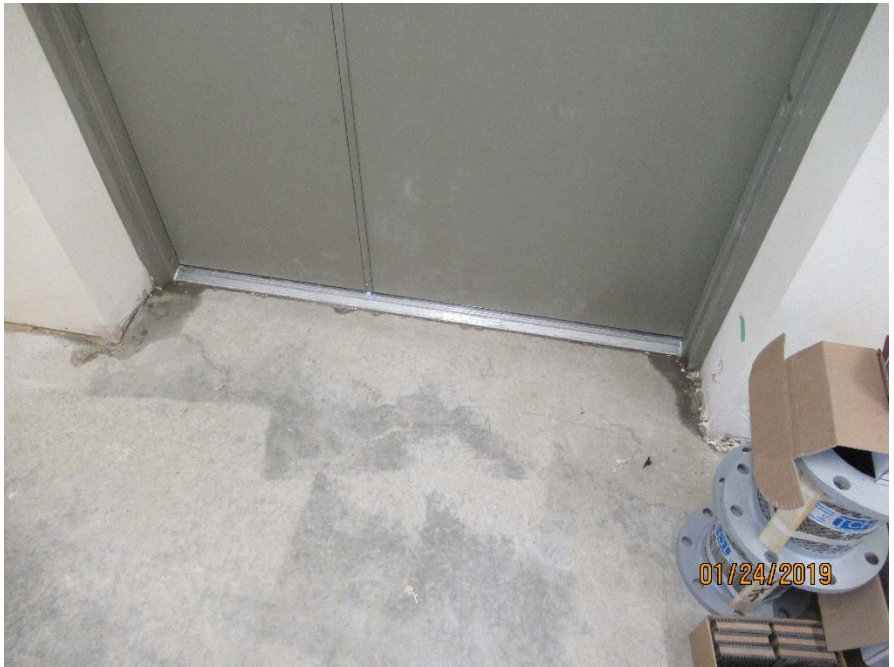
6. This is a photo of doors 135B. It appears water is seeping at each side of the door and is continuing under walls.

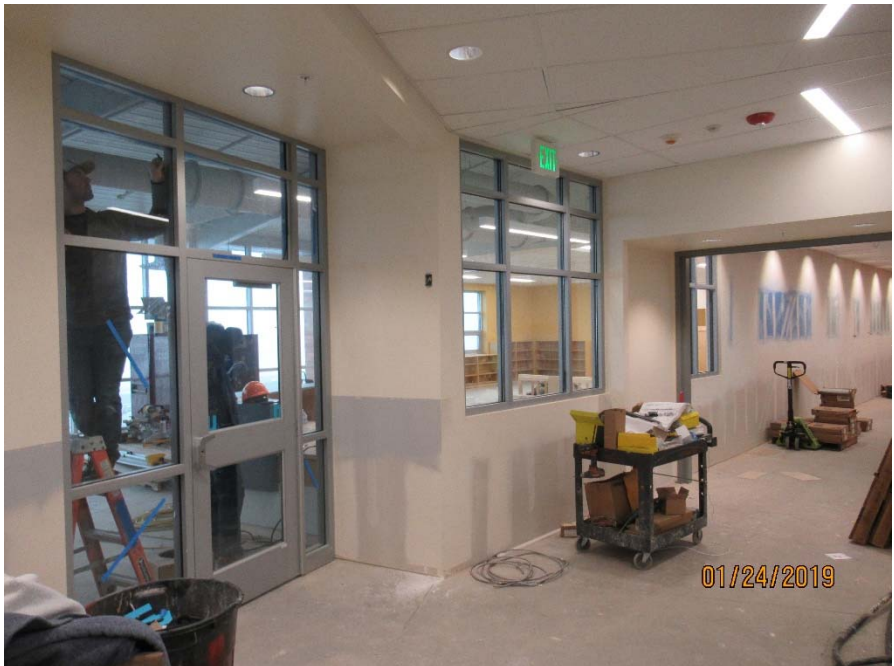
7. Contractor continues installation of aluminum frames, door and glazing at Library.

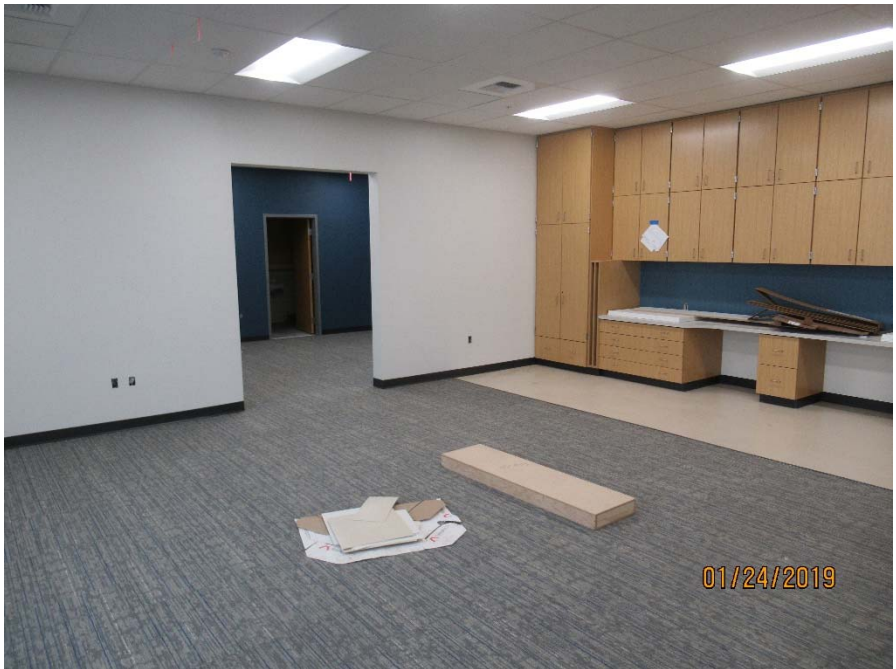
8. Photo is looking north standing in Spec. Education room 121. Thru wall opening into the Program Space 121B, the door past that is to Restroom 121C.

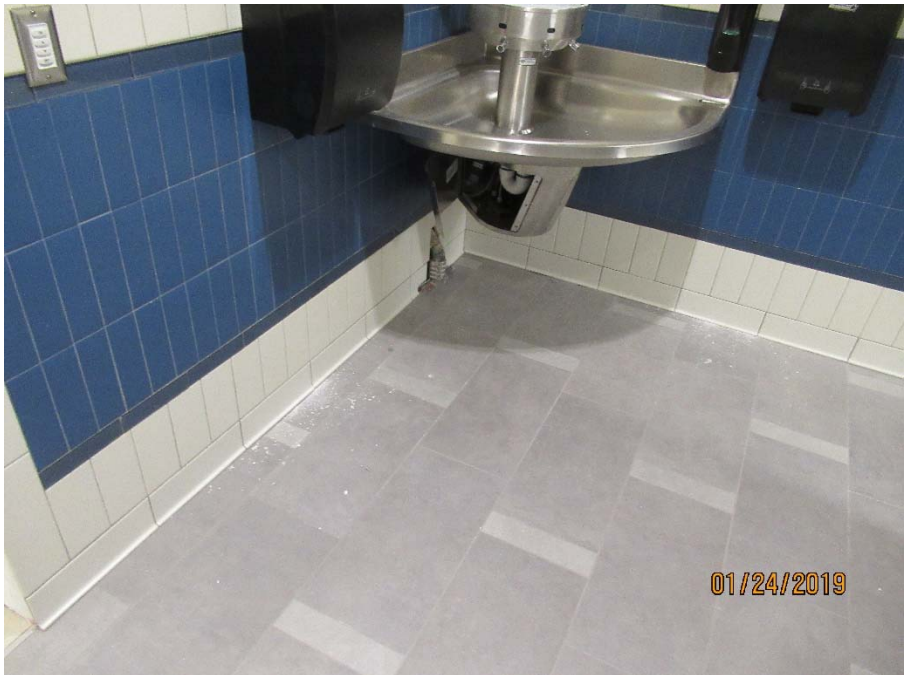
9. Appears there are a number of gang hand wash stations that are in different phases of installation. PR-40 shrouds to cover protruding piping are not installed

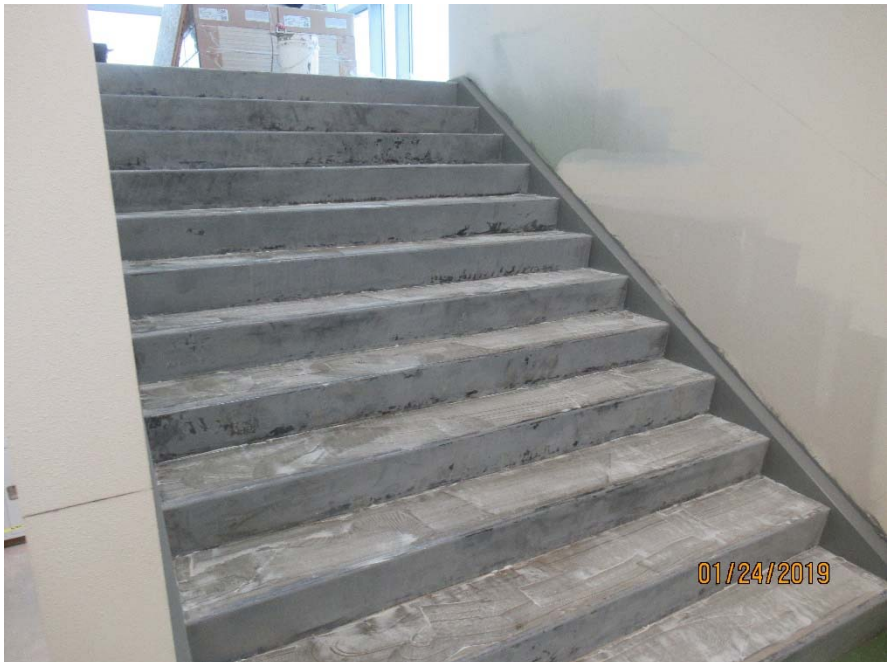
11. Contractor has applied adhesive for tile installation at lower portion at south stairway.

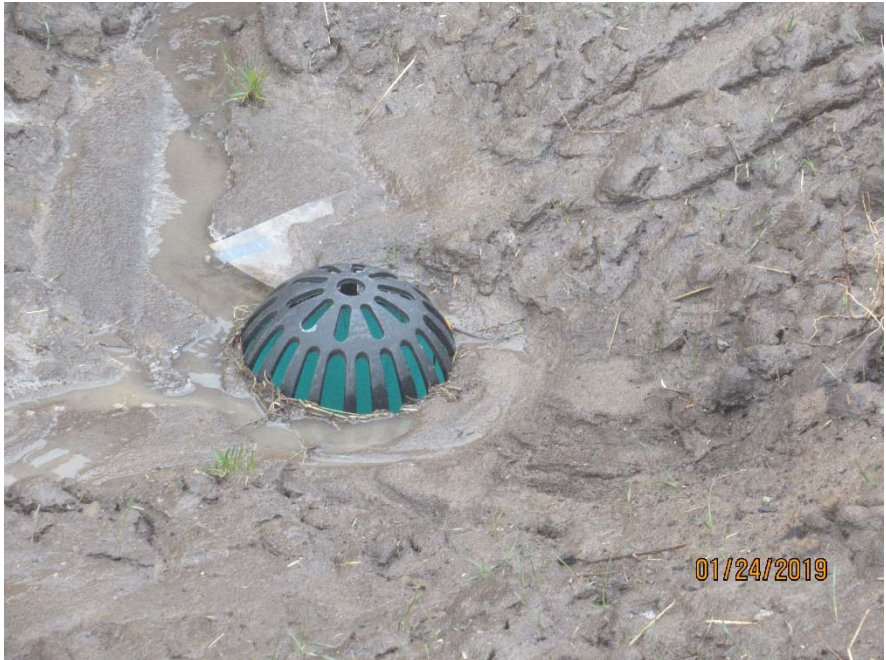
- 12. Contractor and architect notified that a filter needs to be added to drain installed in area southeast of the building. Currently the piping is susceptible to filling with mud.**

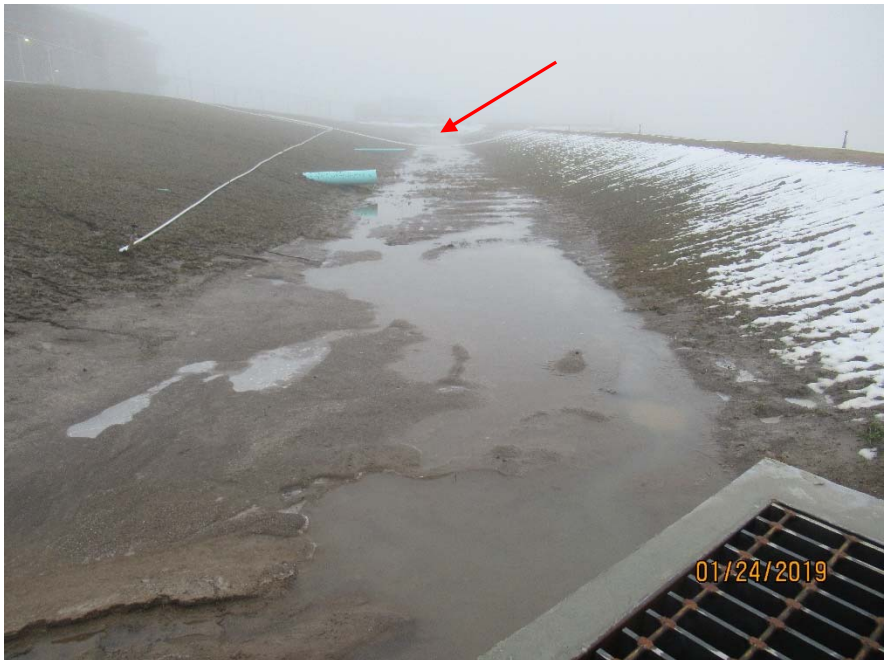
- 13. Looking south down north east pond. Arrow is pointing to a drain structure that the Civil Engineer has informed the contractor appears to be 2" or 3" high. Contractor to review and adjust as necessary.**

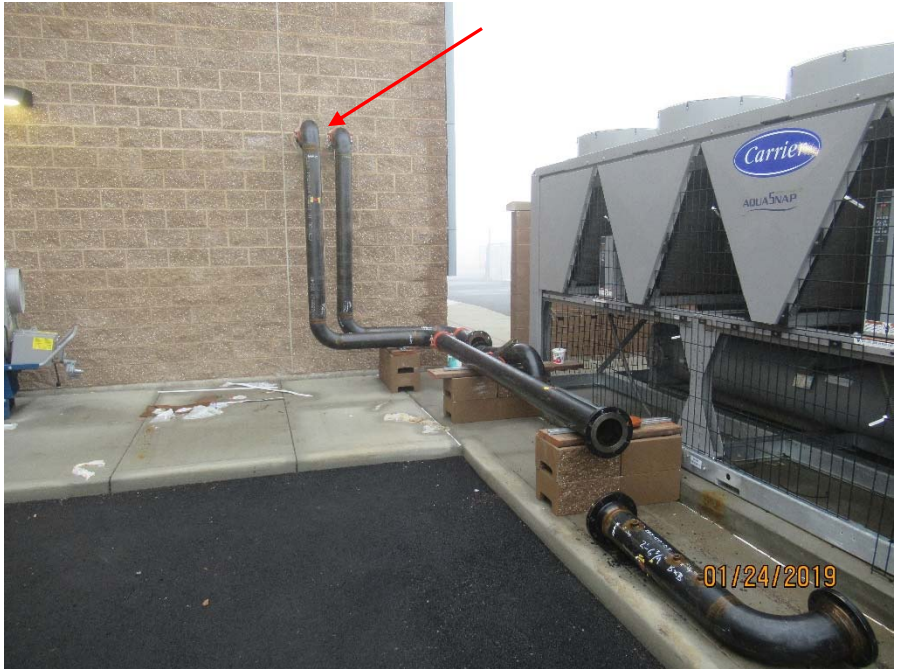
- 14. Contractor is progressing with the installation (welded connections) of the chiller hydronic lines. See photo 4 for interior view of the pipe penetrations.**

Please note below excerpt from Commissioning Field Report from May 2018. I am concerned the welded vertical hydronic piping is installed, assuming the chiller is at its final elevation before they install the missing pieces under the chiller which will likely change the elevation of the chiller.

I will notify Architect and Commissioning Authority.

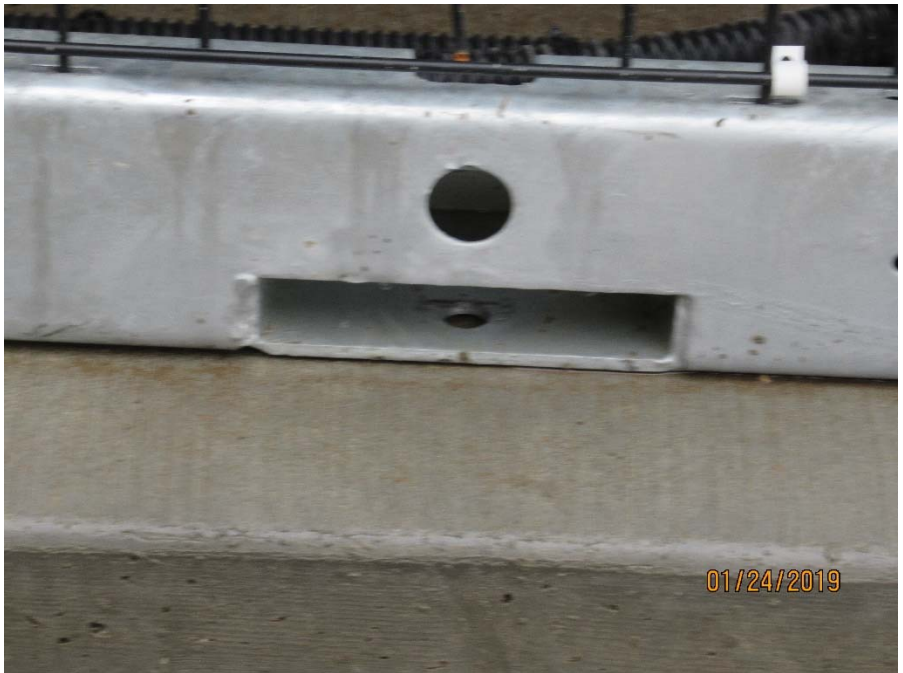
- 15. It appears there has been no change to chiller: Commissioning Report #1, Observation SOR-1-003: "Chiller is set directly on concrete housekeeping pad. Still needs to be set on elastomeric isolation pad, chiller base frame and anchored to concrete."**

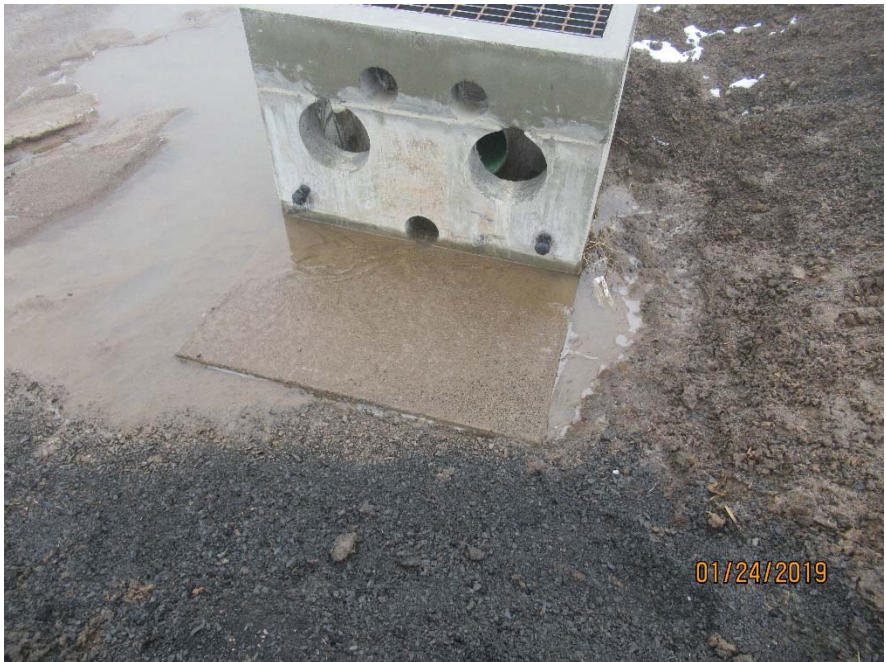
- 16. It appears the contractor has now installed the housekeeping pad.**

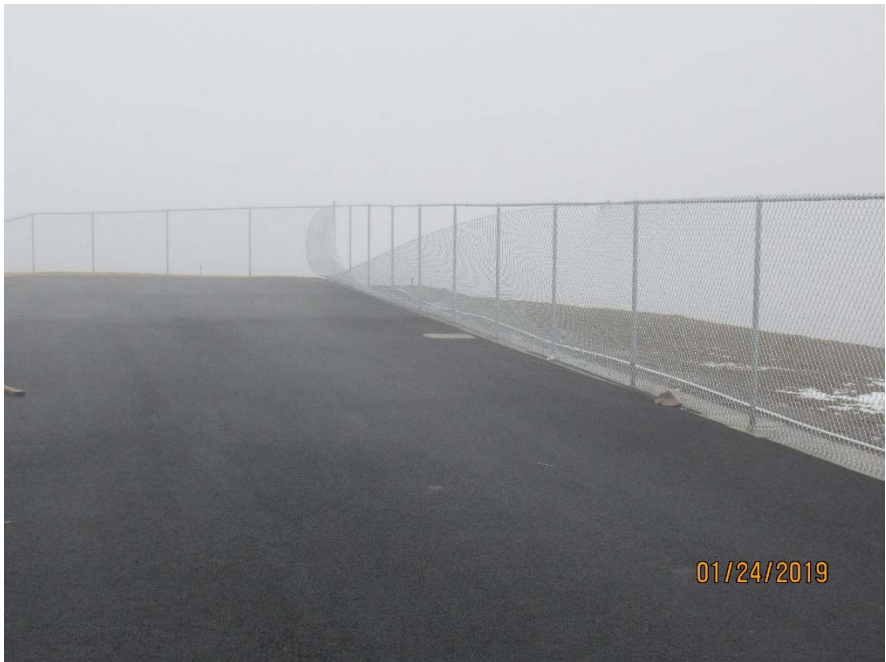
- 17. It appears there is another piece of fencing fabric coming of fence frame. I notified the contractor and architect.**

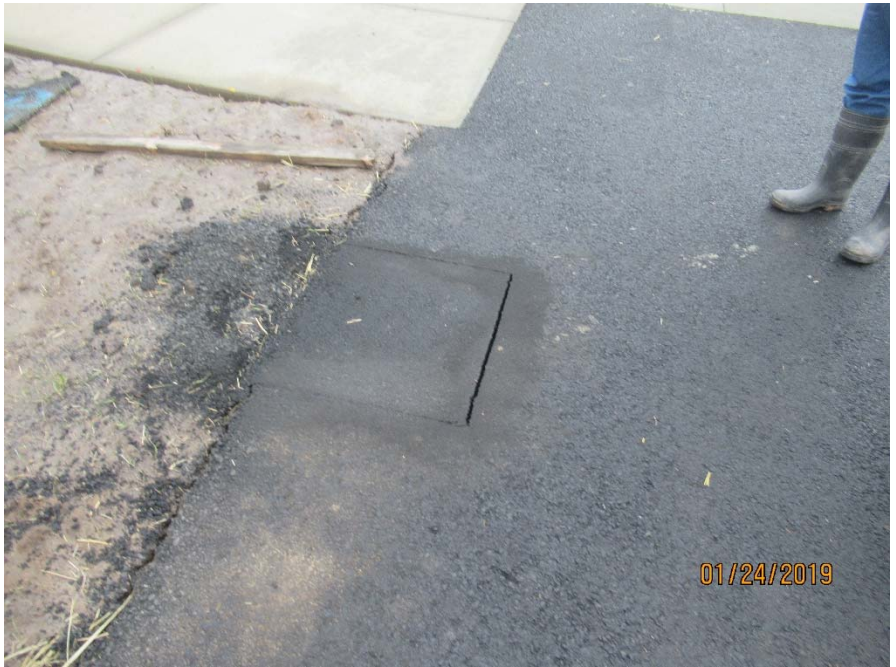
18. It appears that 2 of the previous asphalt path repairs are failing. I notified the contractor and architect.
