**Project: PSD: Kamiak Elementary School****Date: July 18, 2019****Weather conditions:**

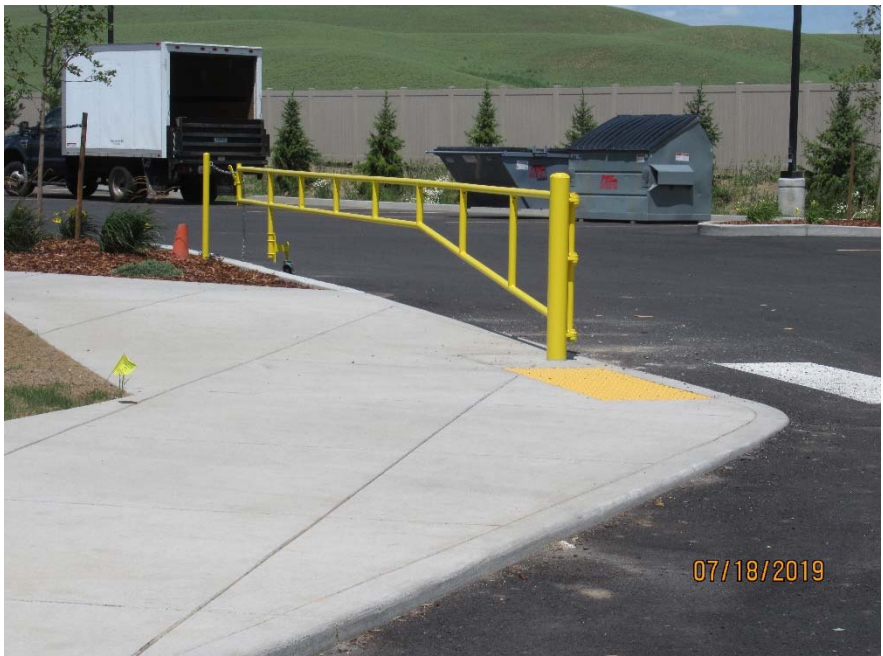
1. North parking lot gate is installed and painted. Owner asked that the contractor keep this gate closed after work hours to keep people out of the play area on the west side of the building.
There are also removable bollards that need to be installed at the northwest corner of the school that need to be installed.

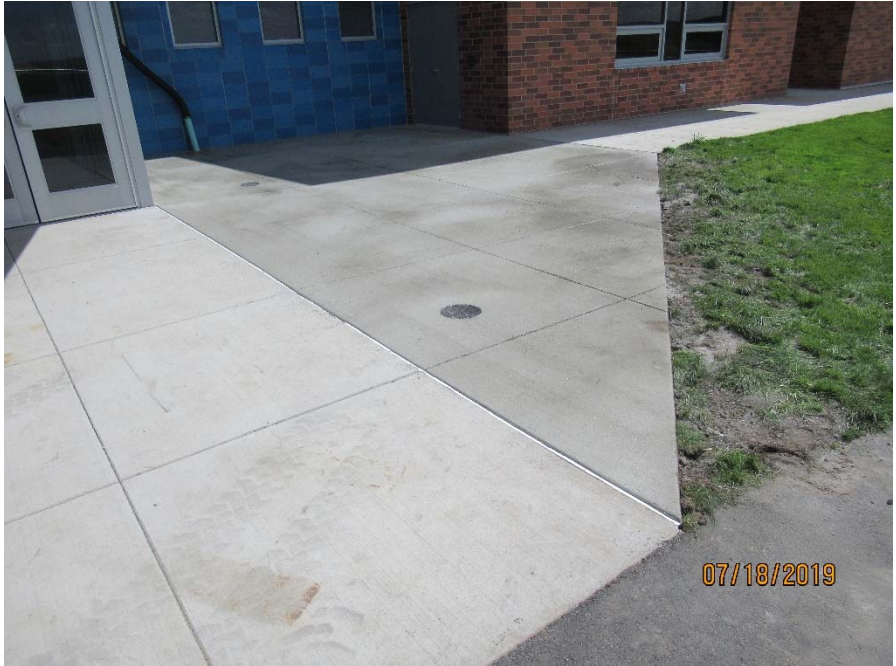
2. It appears the contractor has replaced the slab that was sloped incorrectly. There appears to be damage to the adjacent grass. Contractor should reseed area.

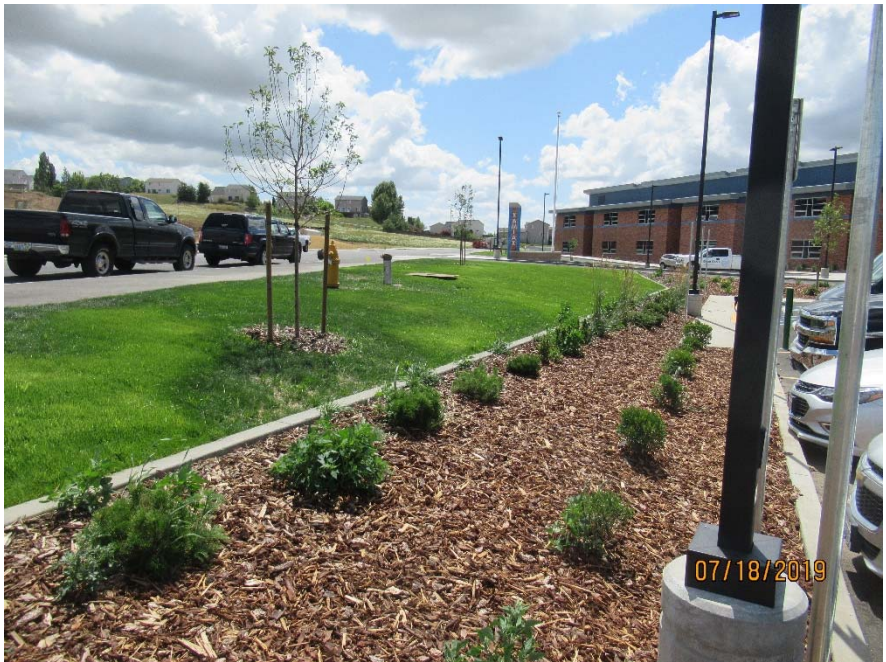
3. Seeded areas appear to be growing nicely.

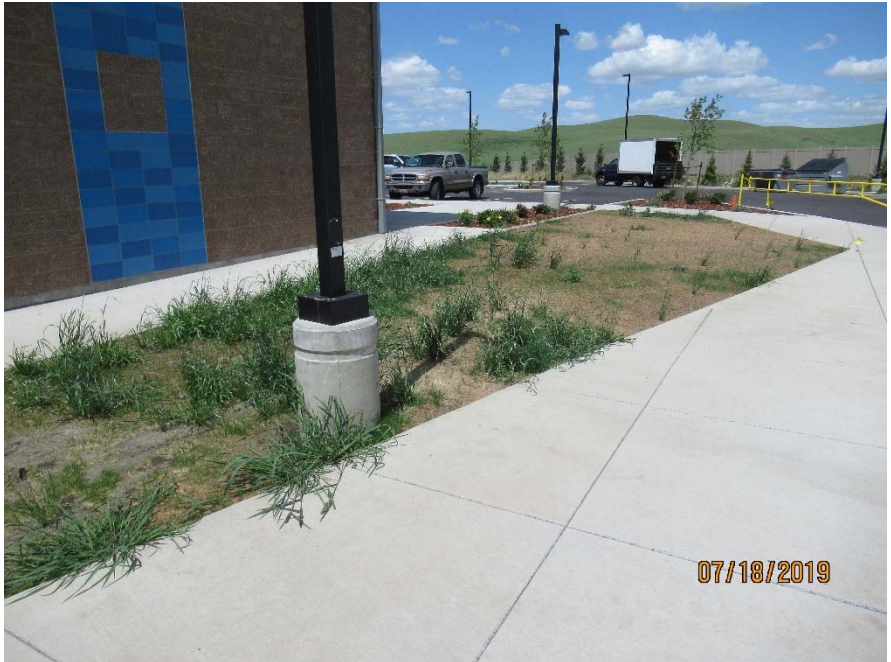
4. This hydroseeded area is not growing. Contractor said he will get this area reseeded now that water is working.

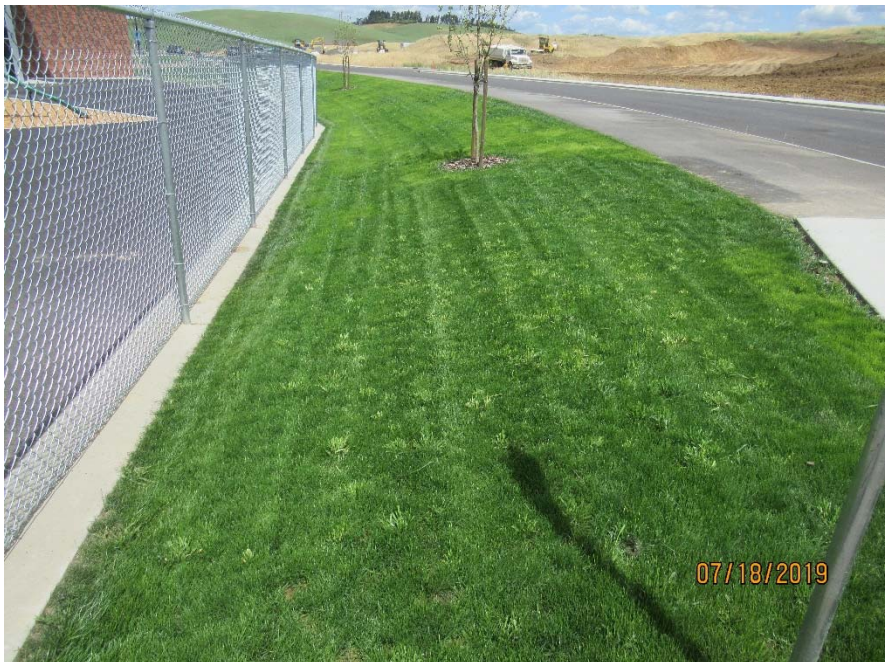
5. Seeded areas between the asphalt path and fence appears to be growing nicely.

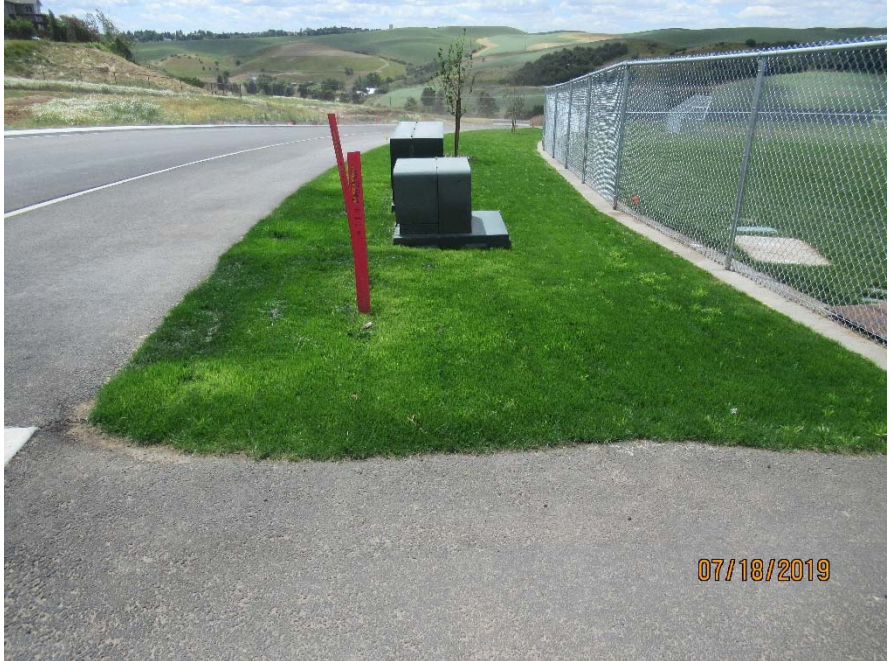
6. Seeded areas between the asphalt path and fence appears to be growing nicely.

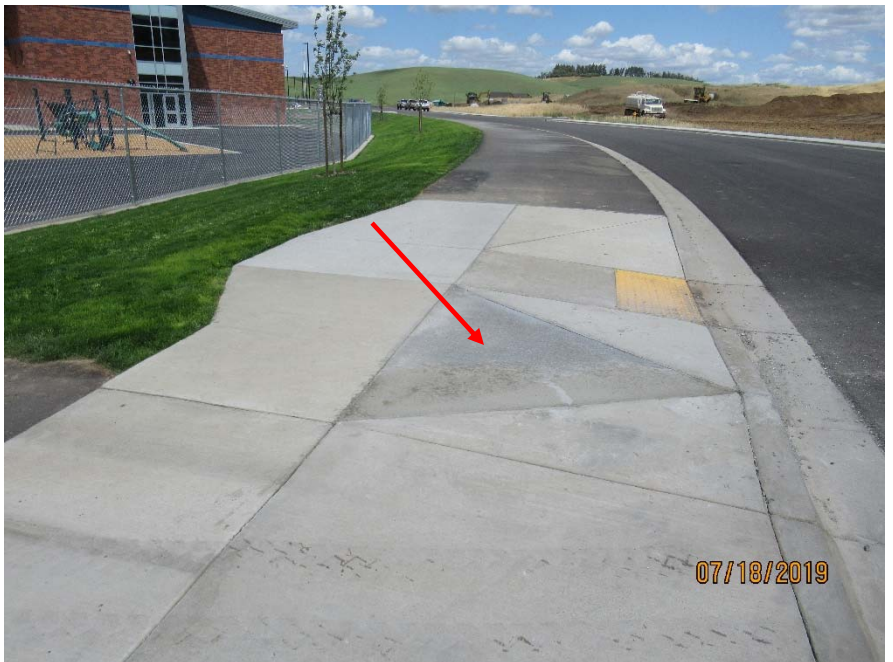
7. The last piece of broken sidewalk adjacent to the Kindergarten play area has been replaced.

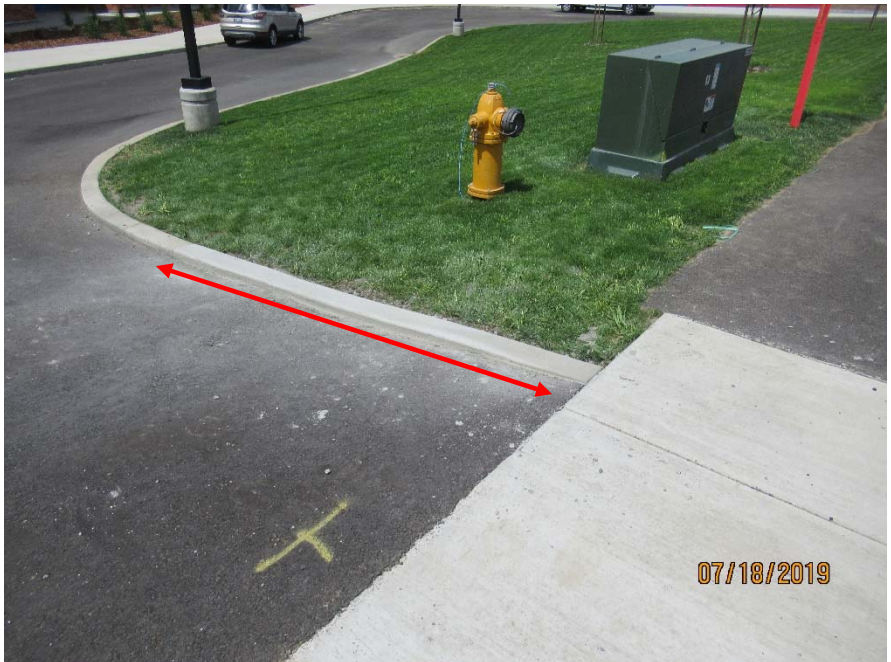
8. Appears the contractor has replaced the north curb that was low at the bus drop off exit. There appears to be minor damage to the grass that should grow back in.

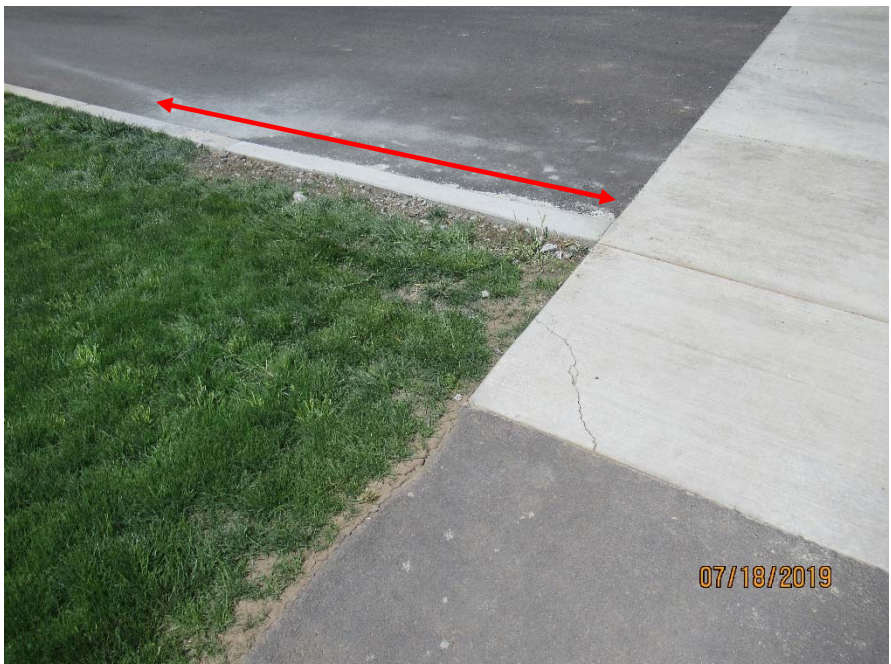
9. Appears the contractor has replaced the south curb that was low at the bus drop off entrance. There appears to be damage to the adjacent grass. Contractor should reseed area.

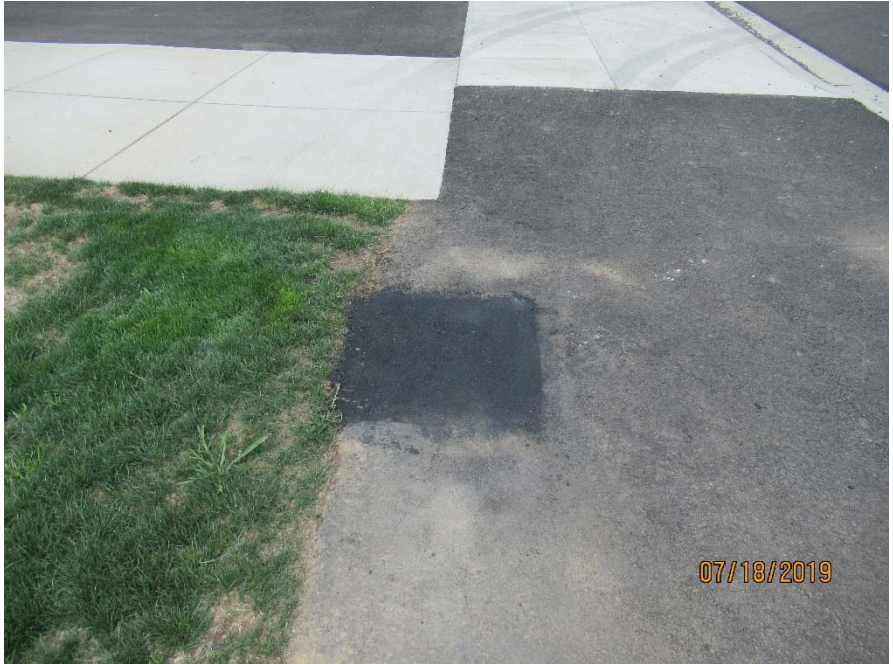
- 10. Appears the contractor has replaced broken asphalt at the asphalt path along Terre View.**

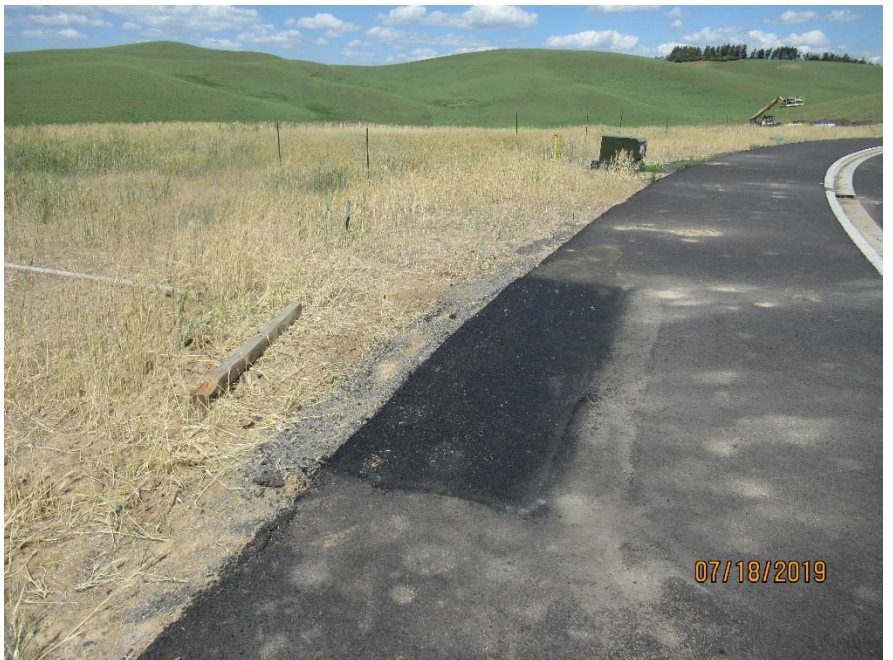
- 11. Appears the contractor has replaced the asphalt they broke removing construction material that was stored north of the Kamiak site**

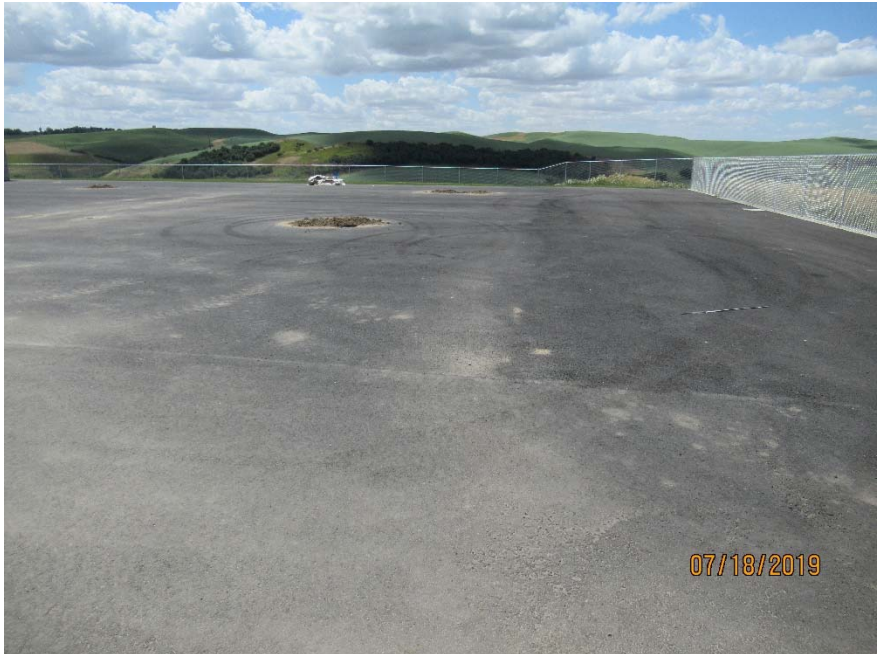
- 12. Although difficult to see in this picture, Bob M. notified the contractor it appears someone has been doing doughnuts in the asphalt play area. With that the contractor was directed to close all gates and install bollards after work hours.**

Note there 4 open holes where the basketball backboard poles will be installed.

Also in the background you can see contractor still has construction material staged in area.

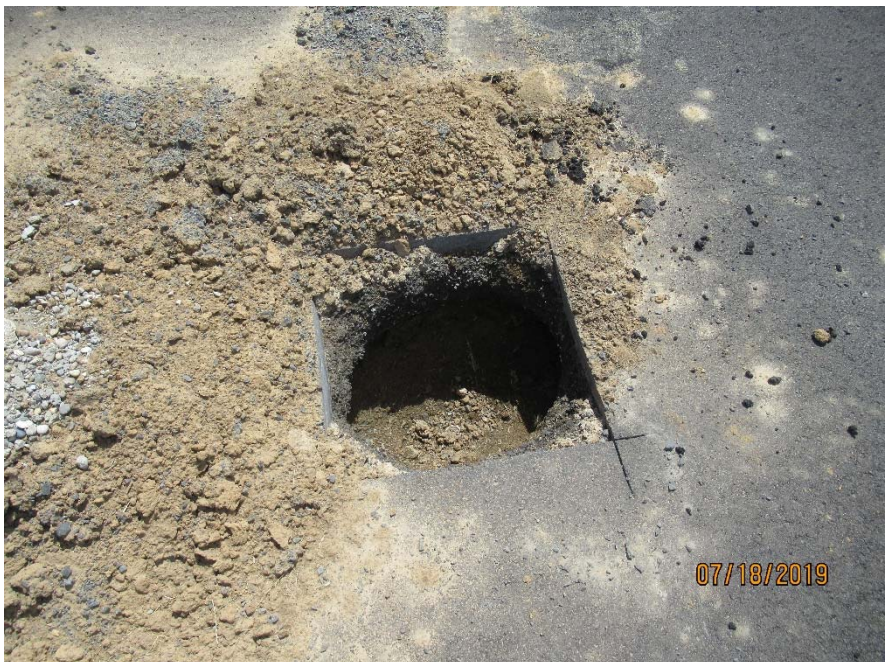
- 13. The 4 holes for the basketball poles have been left open waiting for pole installation. This makes the area unusable to the Owner.**

The holes are not deep enough to install poles, yet deep enough to pose a safety hazard if the Owner were to use the area.

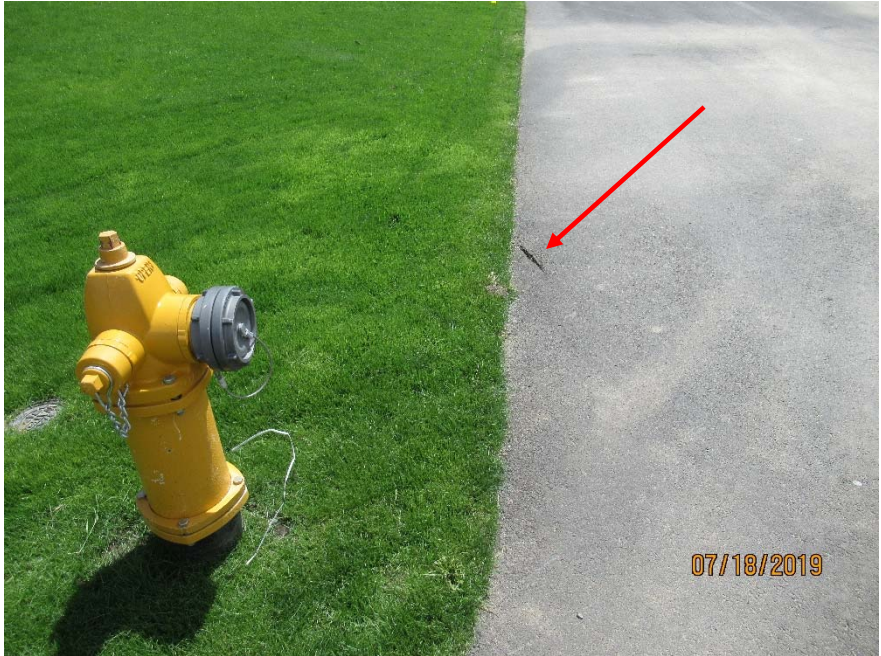
- 14. Bob M. notified the contractor there is damaged asphalt near the fire hydrant.**
