**Project: PSD: Kamiak Elementary School****Date: September 20, 2018****Weather conditions:**

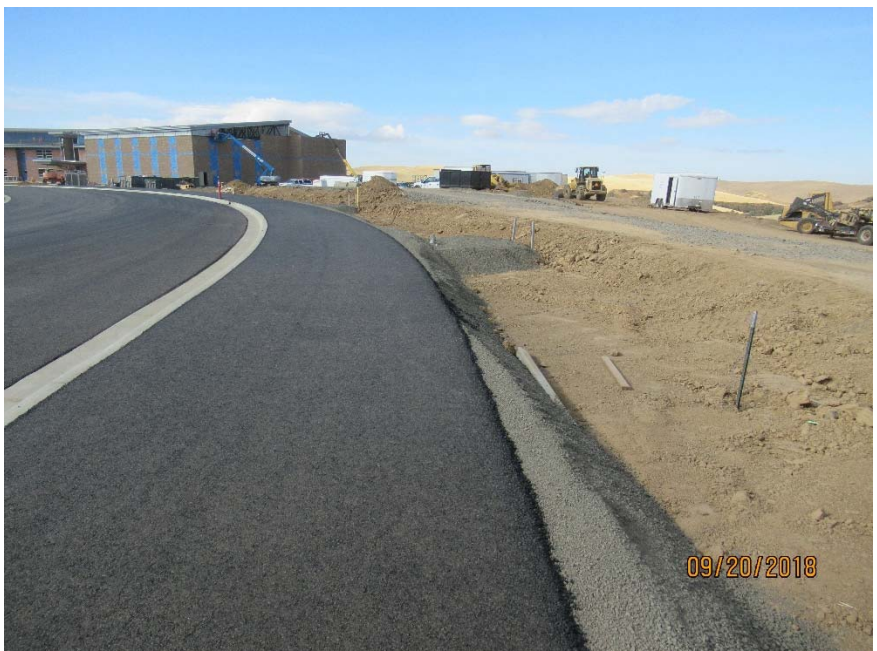
1. Looking southerly: It appears the contractor has completed the pavement from the existing NW Terre View Drive to just south of the School District property.

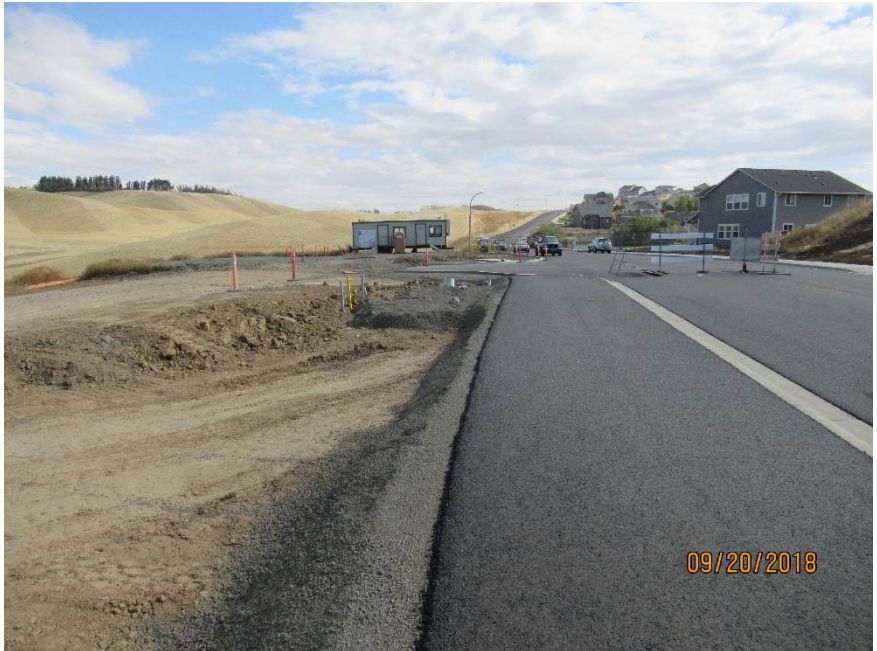
2. **Looking north toward existing NW Terre View Drive.**

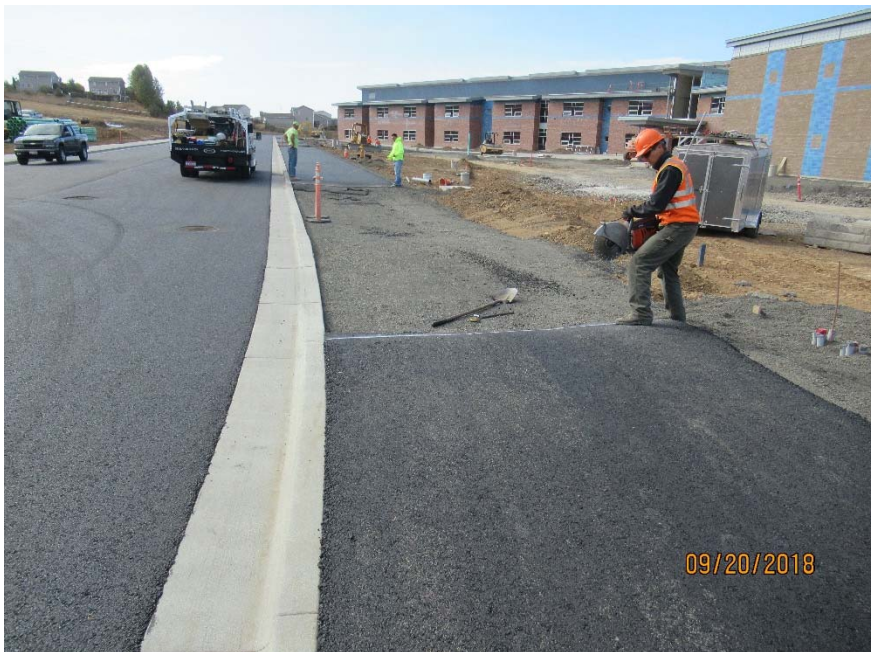
3. **The developer's contractor is cutting asphalt walkway to install the driveway accesses.**

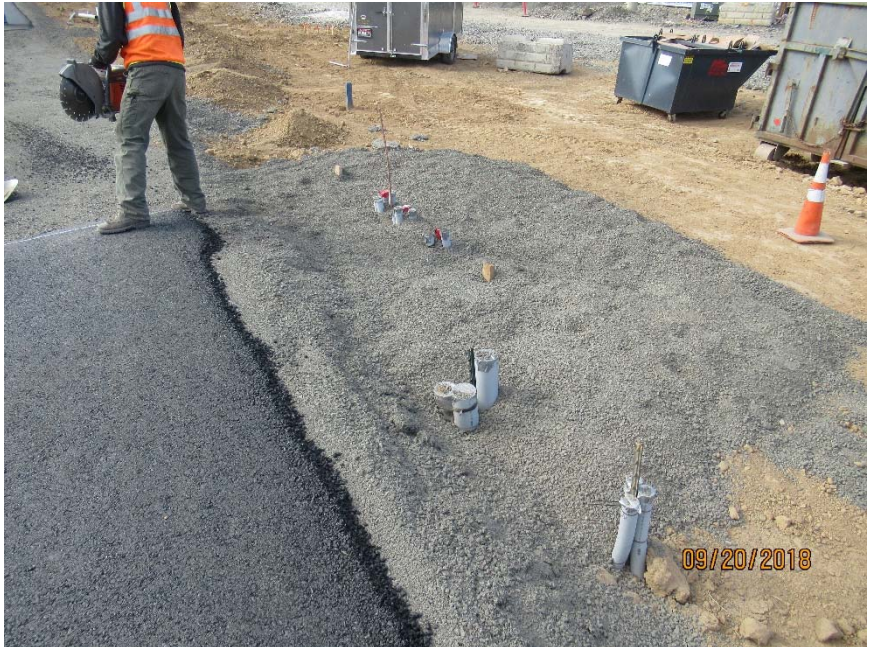
- 4. It appears the developer has not yet placed the power pad(s) so Avista can run the power to the school. The urgent need for this was a topic of discussion with the developer's civil engineer at the progress meeting today. We need permanent power by the end of September to allow HVAC startups and such to happen when scheduled.**

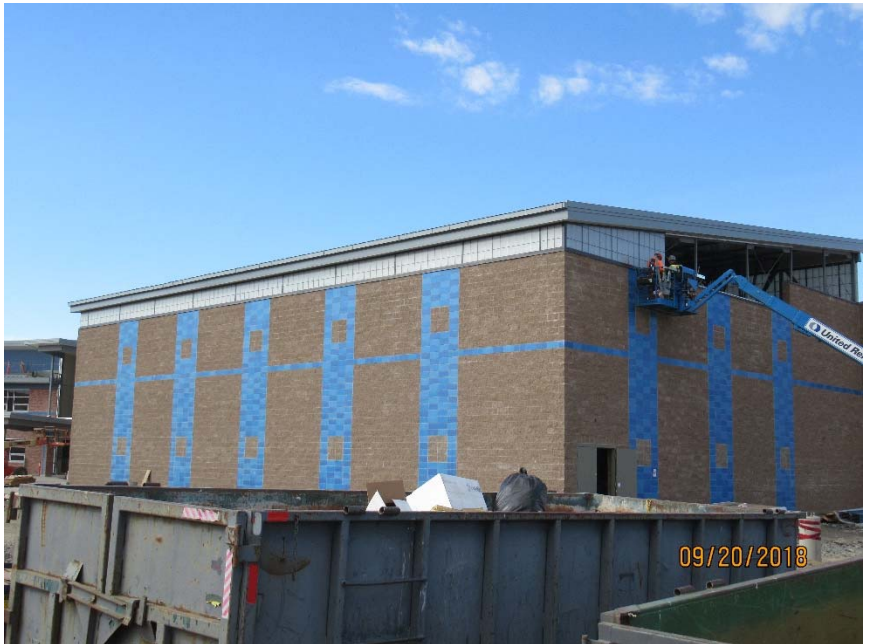
- 5. Contractor appears to be installing translucent panels in the Gymnasium.**

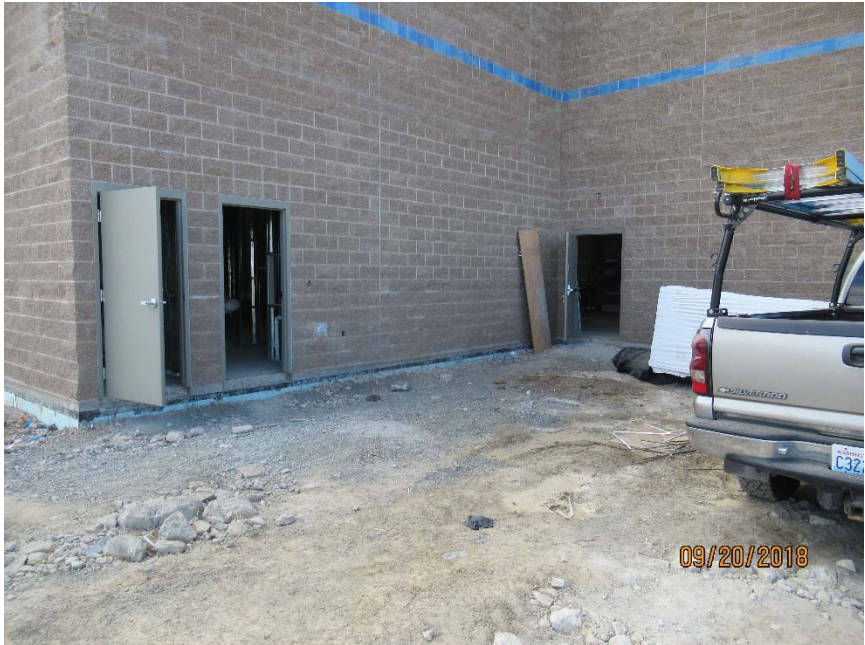
6. Contractor appears to be installing exterior H.M. doors. The contractor will soon be able to secure the building, once the main entry is buttoned up.

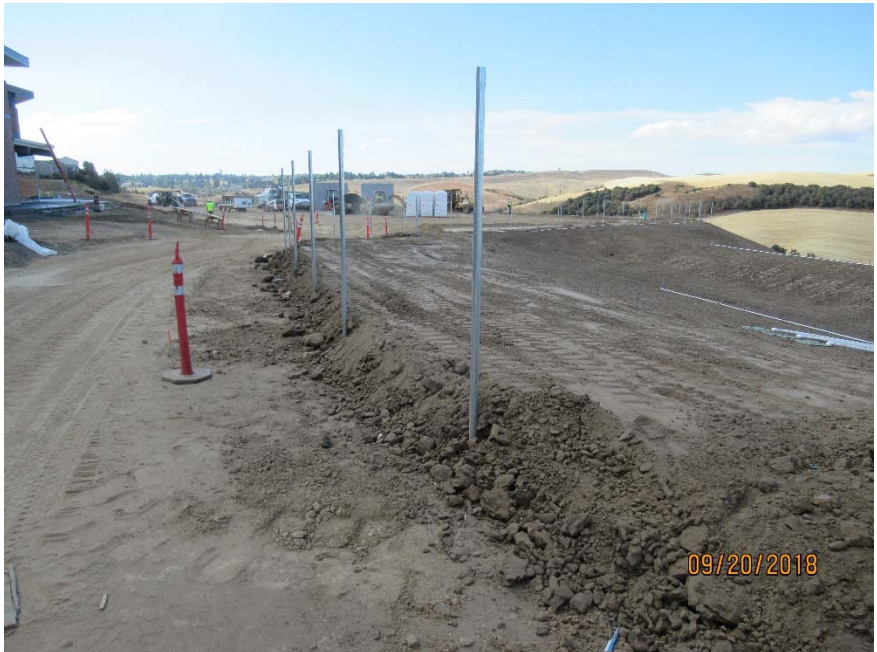
7. Contractor has placed concrete for the fence posts.

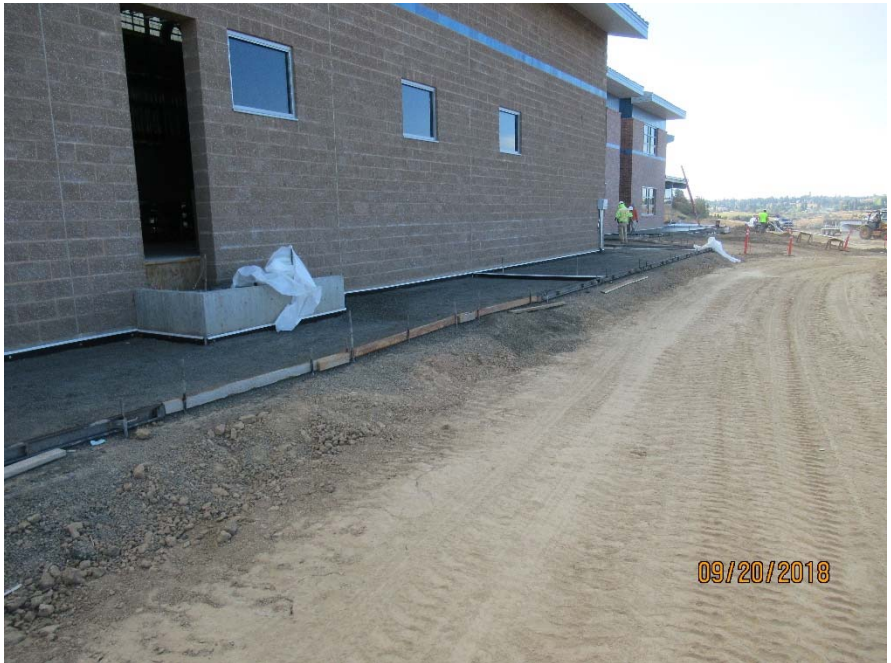
8. Contractor working on forming and placing sidewalk on the west side of the building. Appears the east side is for the most part completed to the Gymnasium box.

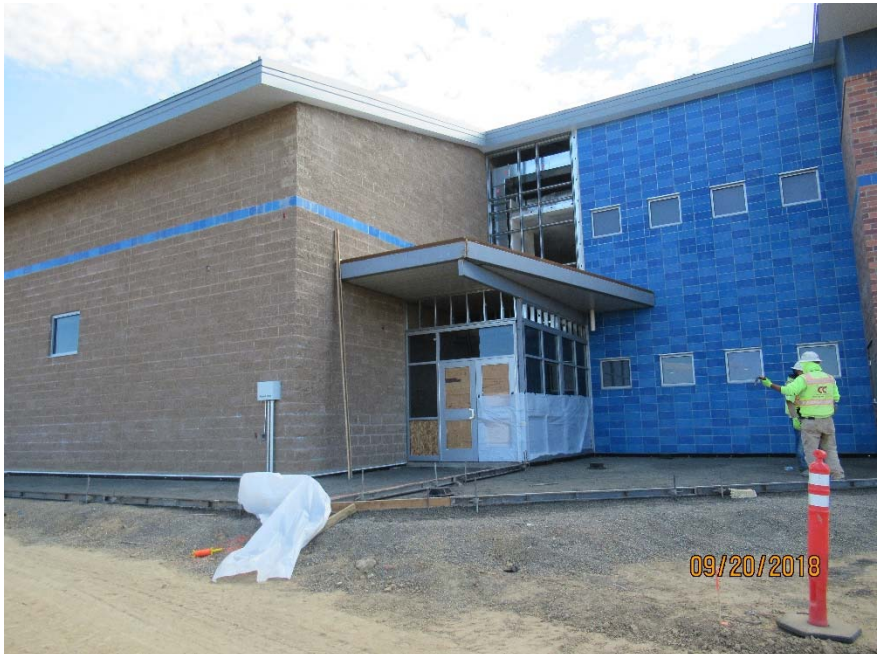
9. Contractor working on forming and placing sidewalk on the west side of the building.

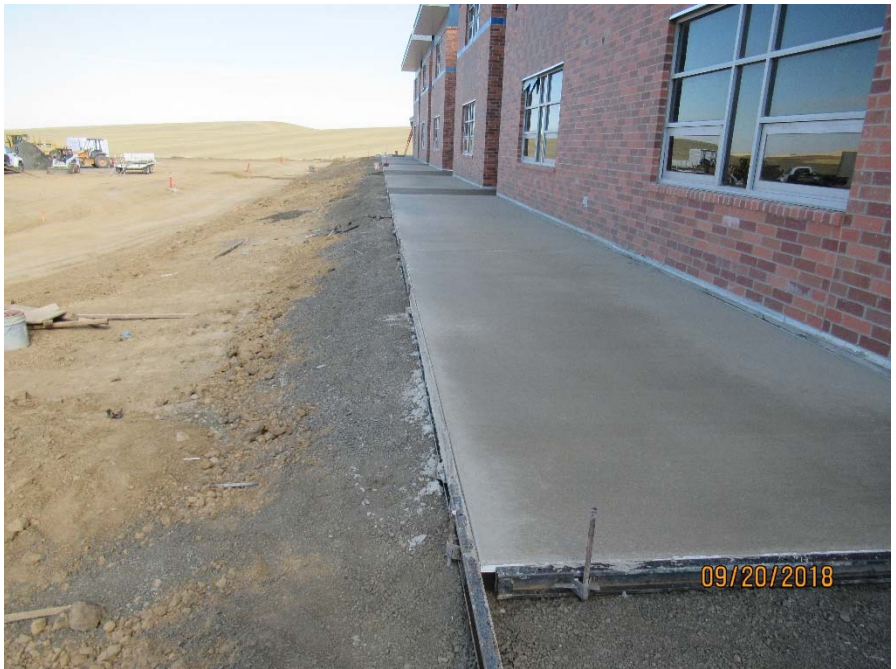
- 10. Contractor working on forming and placing sidewalk on the west side of the building.**

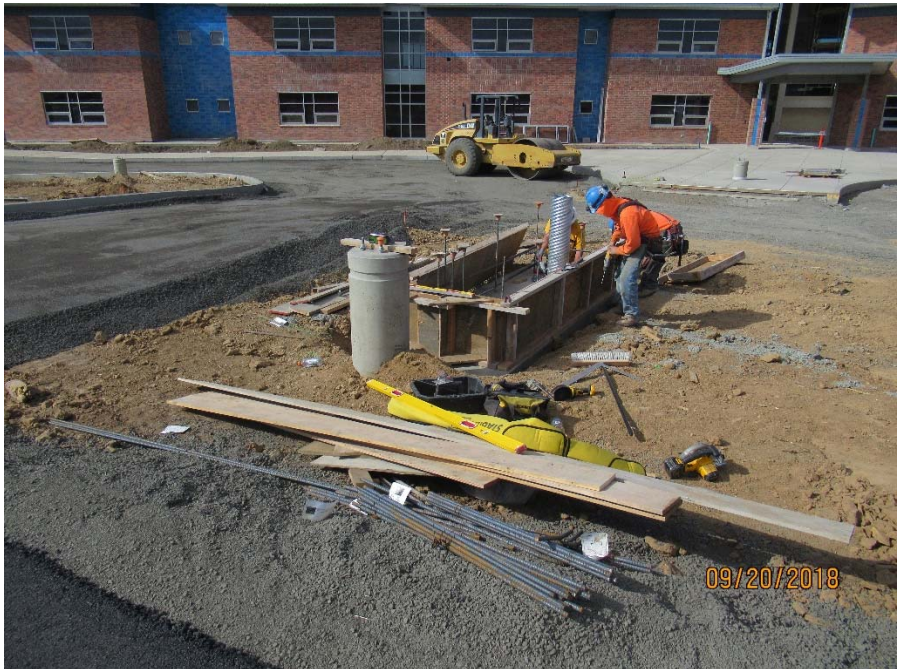
- 11. Appears contractor is forming for concrete at the flag pole and signage.**

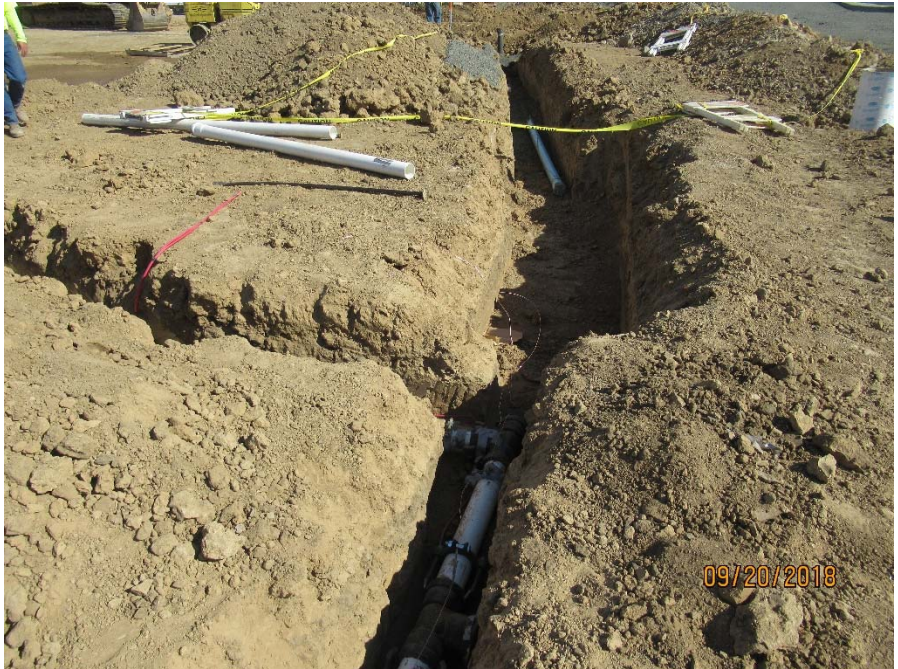
- 12. The Landscape contractor appears to be ready for the city to install the irrigation meter. Expect the city to install the meter Monday 9/24/18.**

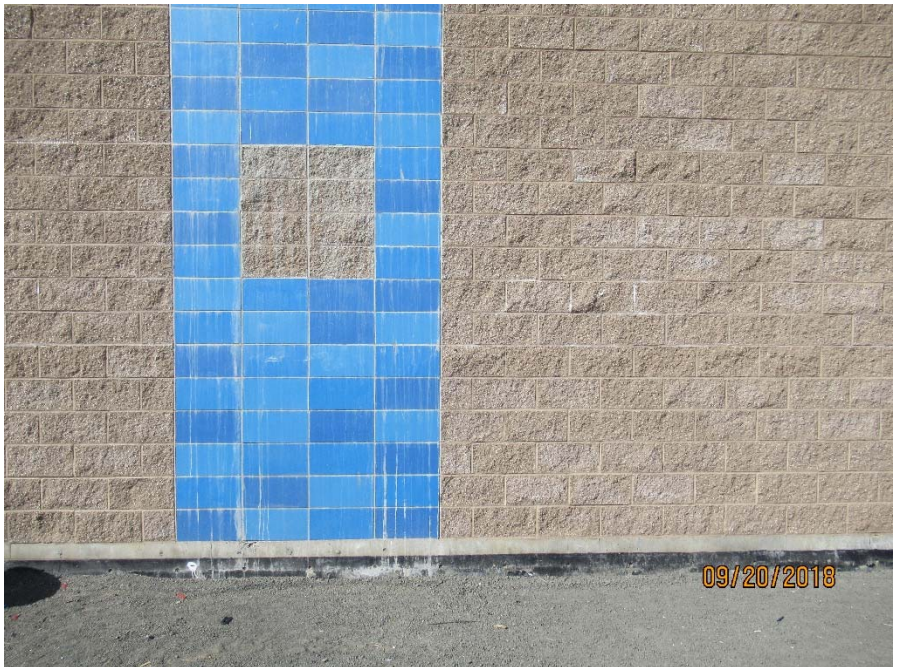
- 13. The contractor needs to clean and seal the exterior CMU and veneer walls before wet and cold weather does not allow.**

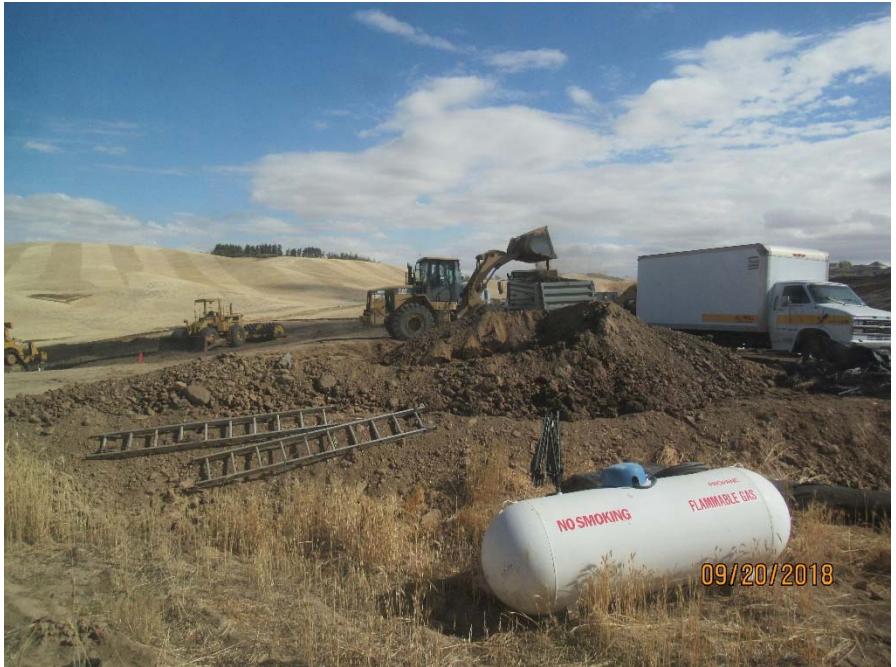
- 14. Appears the earthwork contractor is moving the piles of dirt placed on the north end of the site.**

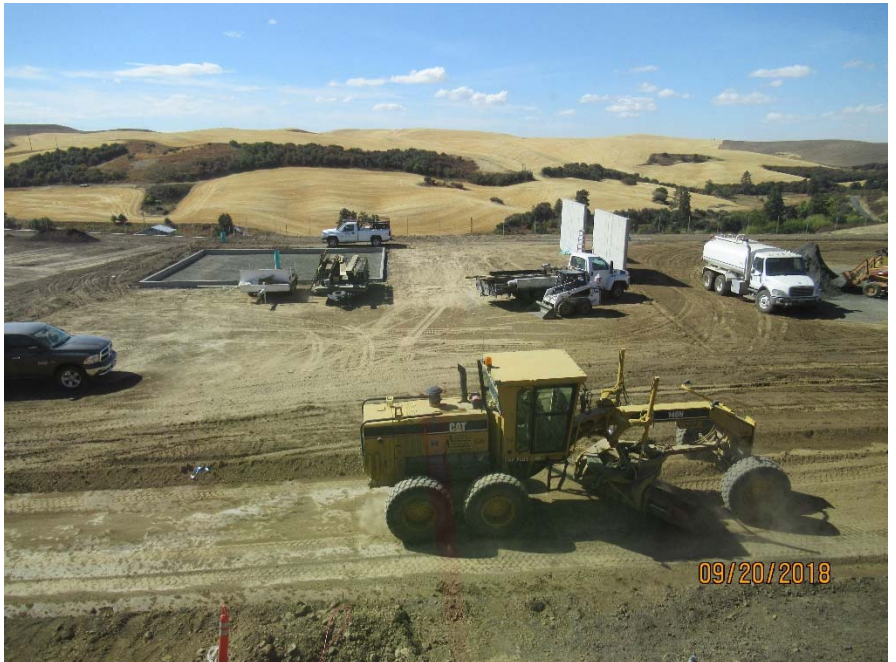
- 15. Contractor has installed the 2 ball walls, and the curb for the accepted Alternate #1 – Lower Playground Play and Sports Equipment.**

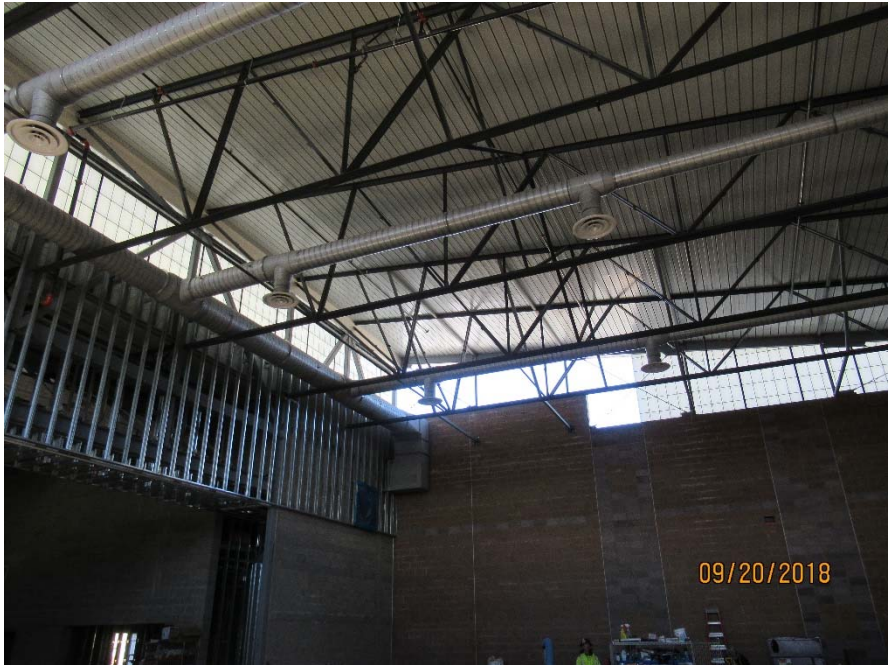
- 16. Contractor has not covered the diffusers yet. This issue is listed on the Commissioning Issues List. Note the interior view of the translucent panels at the top of the walls.**

Deficiencies: Covering the HVAC diffusers an ongoing issue not yet addressed. Contractor stated at progress meeting today that the seeding is scheduled for 9/20/18.

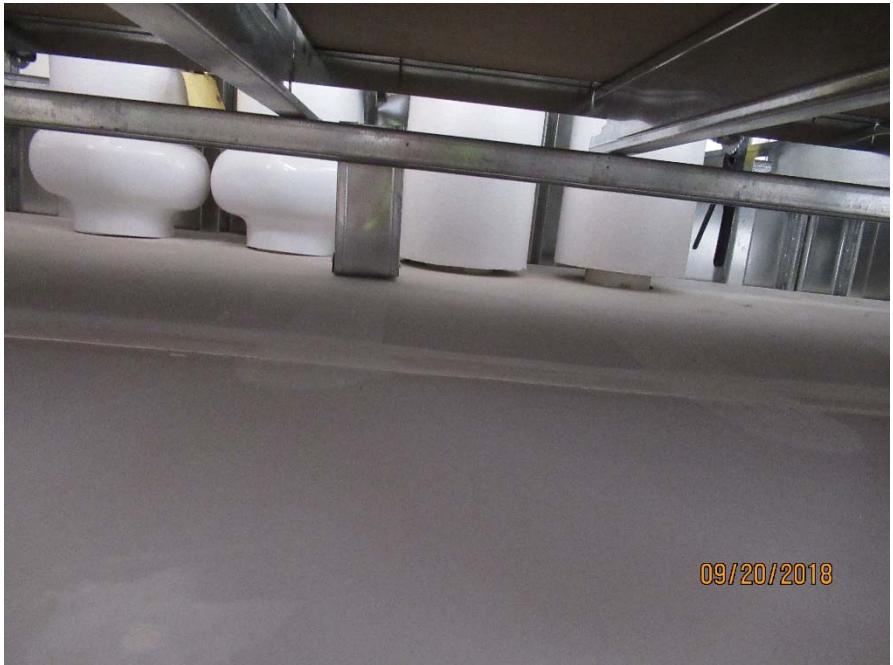
- 17. It appears the contractor has not yet addressed the Commissioning Issue concerning the pipe insulation not continuing through the wall.**
